ARCHAEOLOGICAL RESULTS

Phase IB Underwater Archaeological Resources Report for Onondaga Lake Superfund Site

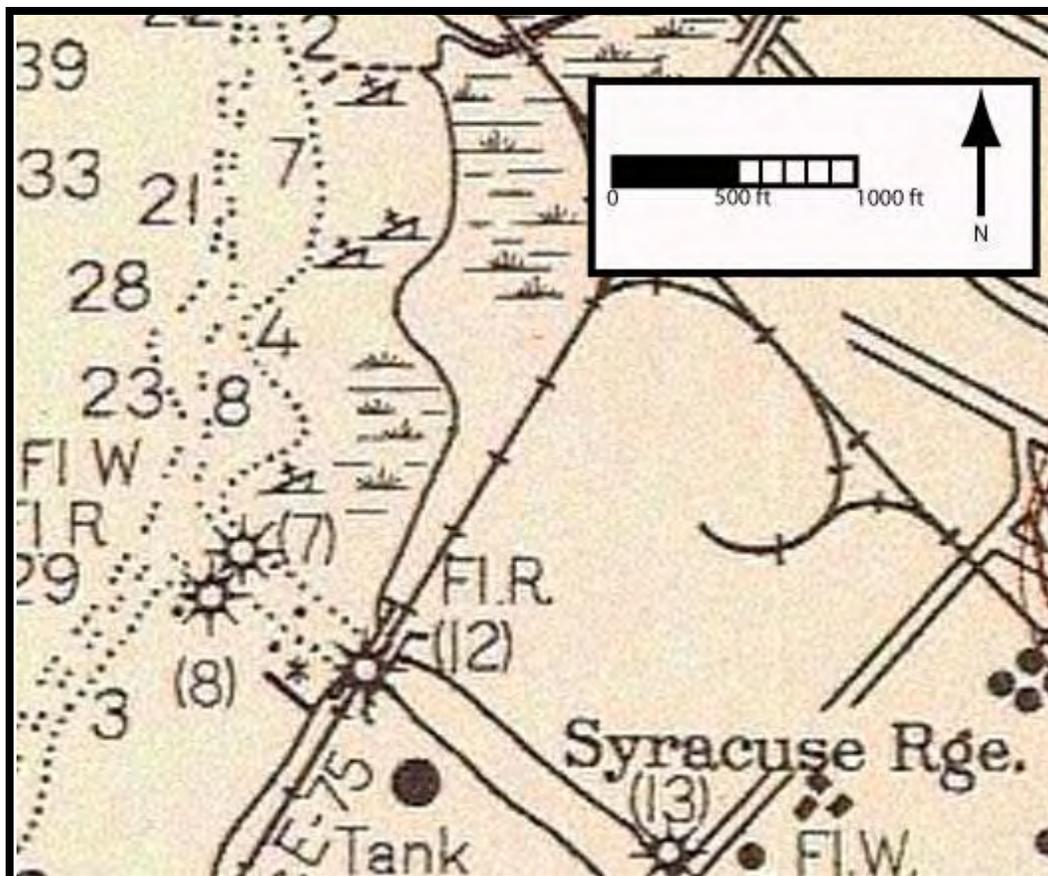
The Syracuse Maritime Historic District’s development can be tracked on mid-twentieth century navigational charts. Charts from the U.S. Lake Survey Office from 1915, 1926, 1932 and 1937 show no wrecks or derelict vessels in this area.¹²⁴ However, the 1942 edition shows derelict vessels in the approximate locations of A3, A12, A4-1 and A4-2 (Figure 37).¹²⁵

Figure 37. 1942 navigational chart showing derelict vessels at the approximate locations of A3, A4-1, A4-2 and A12, and the abandoned concrete breakwater (A45) and Salina Pier (A1 and A2) (U.S. Lake Survey Office, *New York State Canals, Chart No. 185, 1942*).

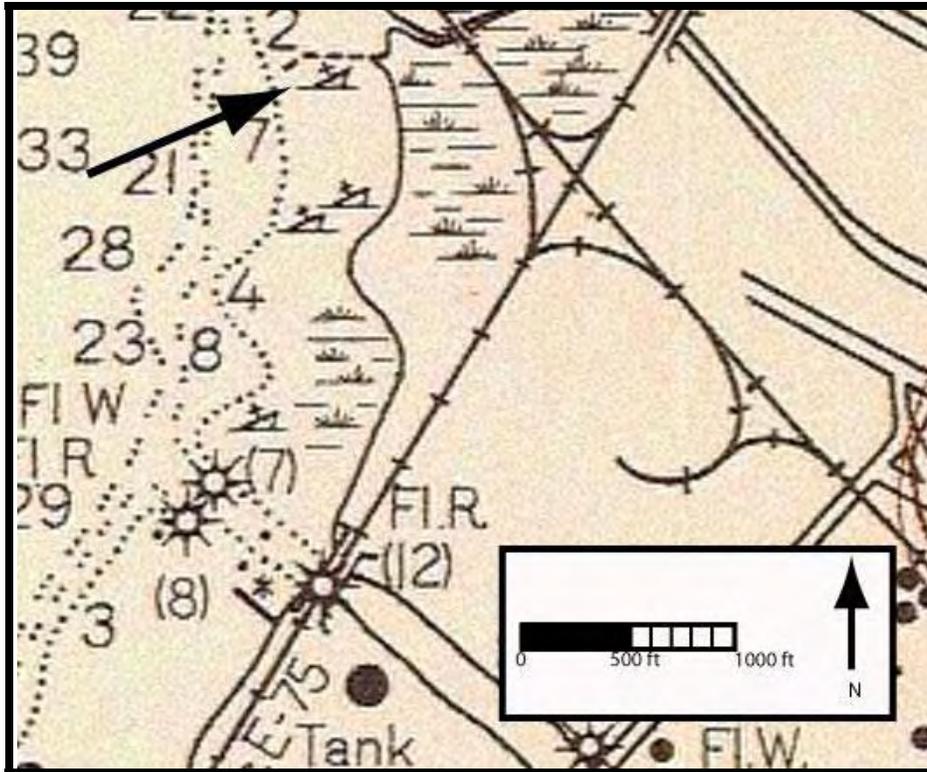
Anomalies A1 and A2 are parts of the remnants of the Salina Pier. The pier lies immediately north of A3, a barge wreck. The pier's location was known from historic accounts and charts, aerial images, and was located during CRE's 2005 remote sensing survey (Figure 38, Figure 39, and Figure 40). In the *Underwater Work Plan* two separate anomalies were identified for the pier location, but the fieldwork showed that they were separate parts of the larger pier structure. Salina Pier was a difficult site for recording good acoustic or visual imagery. The site is covered in a dense growth of aquatic vegetation, especially Eurasian milfoil, which obscured much of the structure.

Figure 38. 1942 navigational chart showing the remnants of Salina Pier (U.S. Lake Survey Office, New York State Canals, Chart No. 185, 1942).

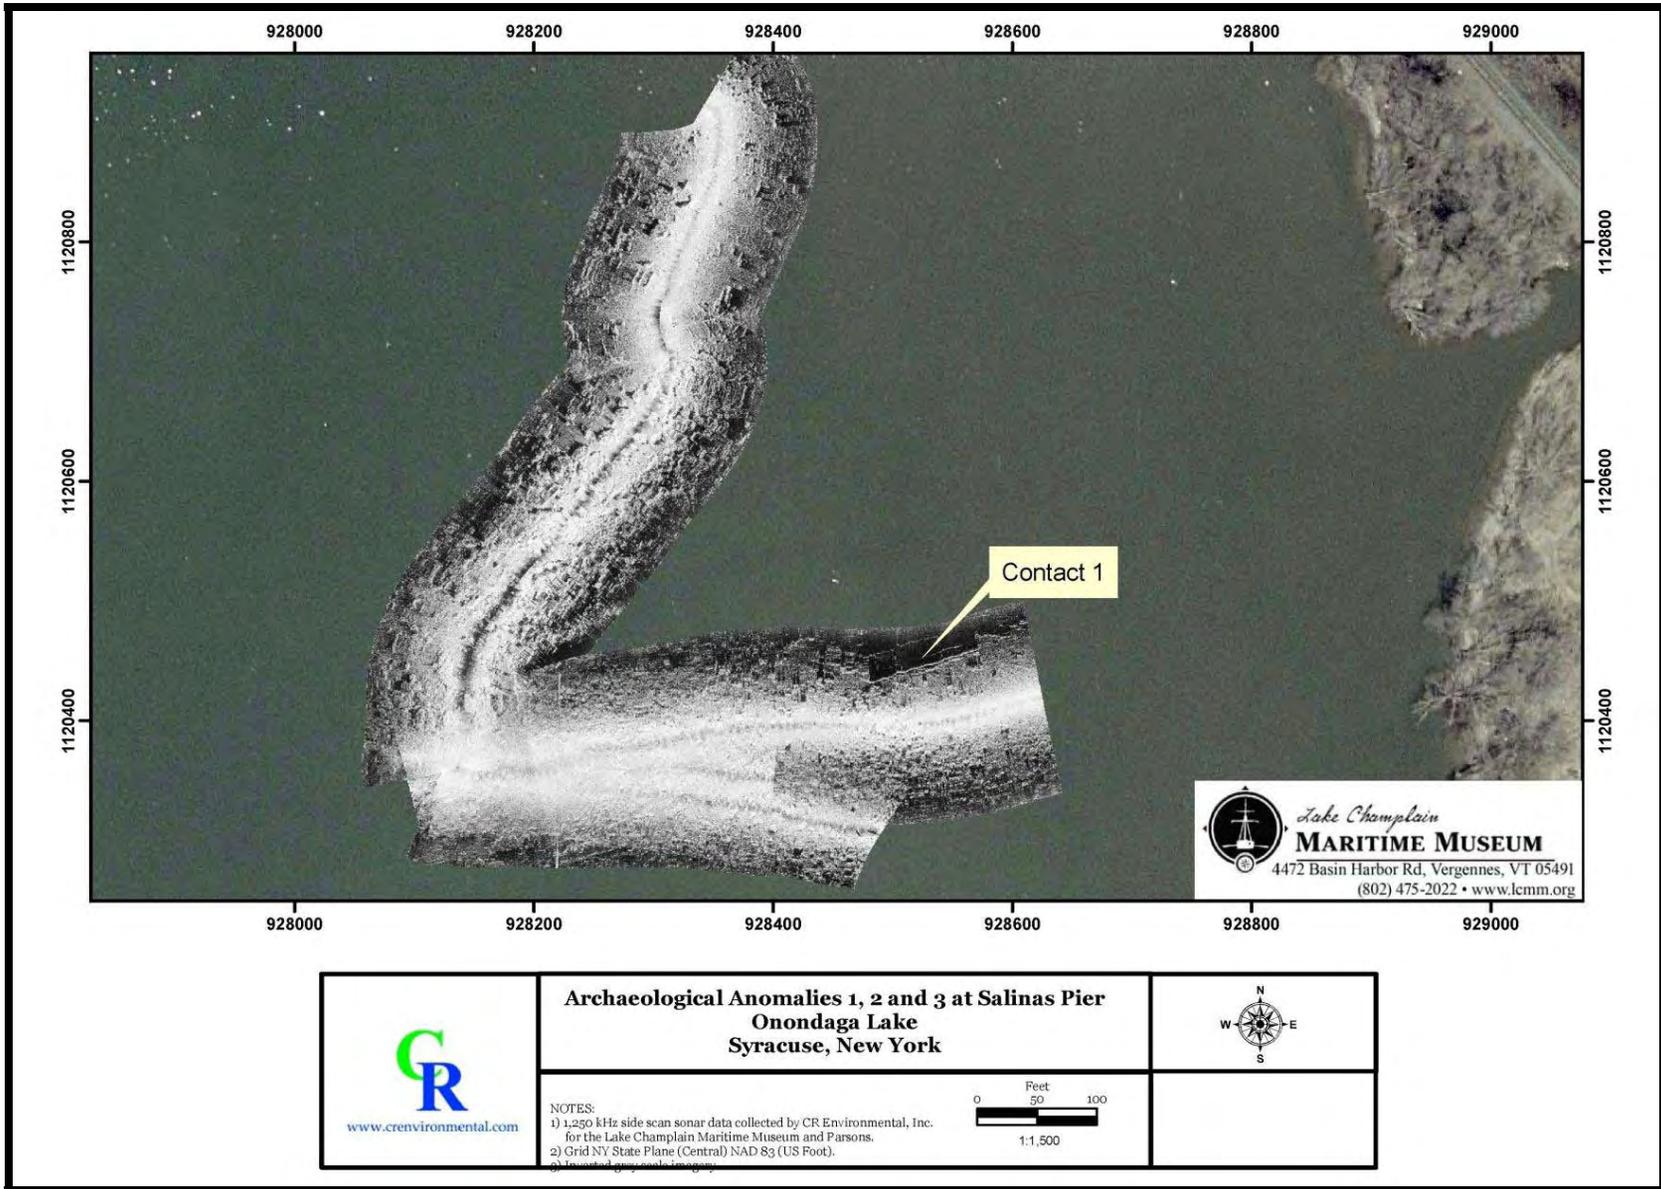
A3 is an edge-fastened, scow-ended wooden barge which is preserved up to deck level, although the deck is no longer present. The vessel is 94 feet (28.65m) long by 22 feet (6.71m) wide. A3 first appears on the 1942 navigational chart, and Phase 1B data suggests the barge’s build date is in the early twentieth century. The vessel rests in shallow water immediately south of Salina Pier. The uppermost portions of the wreck are just above the water’s surface (see Figure 39). The barge is heavily built with its construction pattern suggesting a scow barge designed to carry heavy bulk cargoes on deck.

Figure 42. Side scan sonar mosaic showing Anomaly A3 (Contact 1).

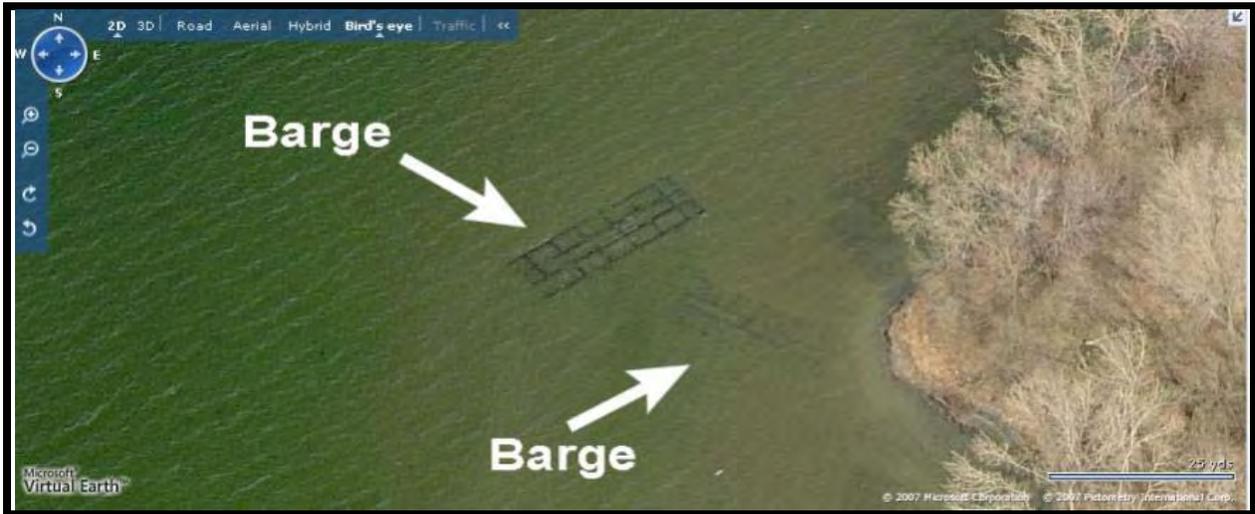
the sites differ modestly. The presence of two dump scows (A4-1 and A4-2) next to each other suggests that they were abandoned here contemporaneously by the same owner.

Figure 43. Aerial view showing barges A4-1 (left) and A4-2 (right). (courtesy Microsoft® Virtual Earth).

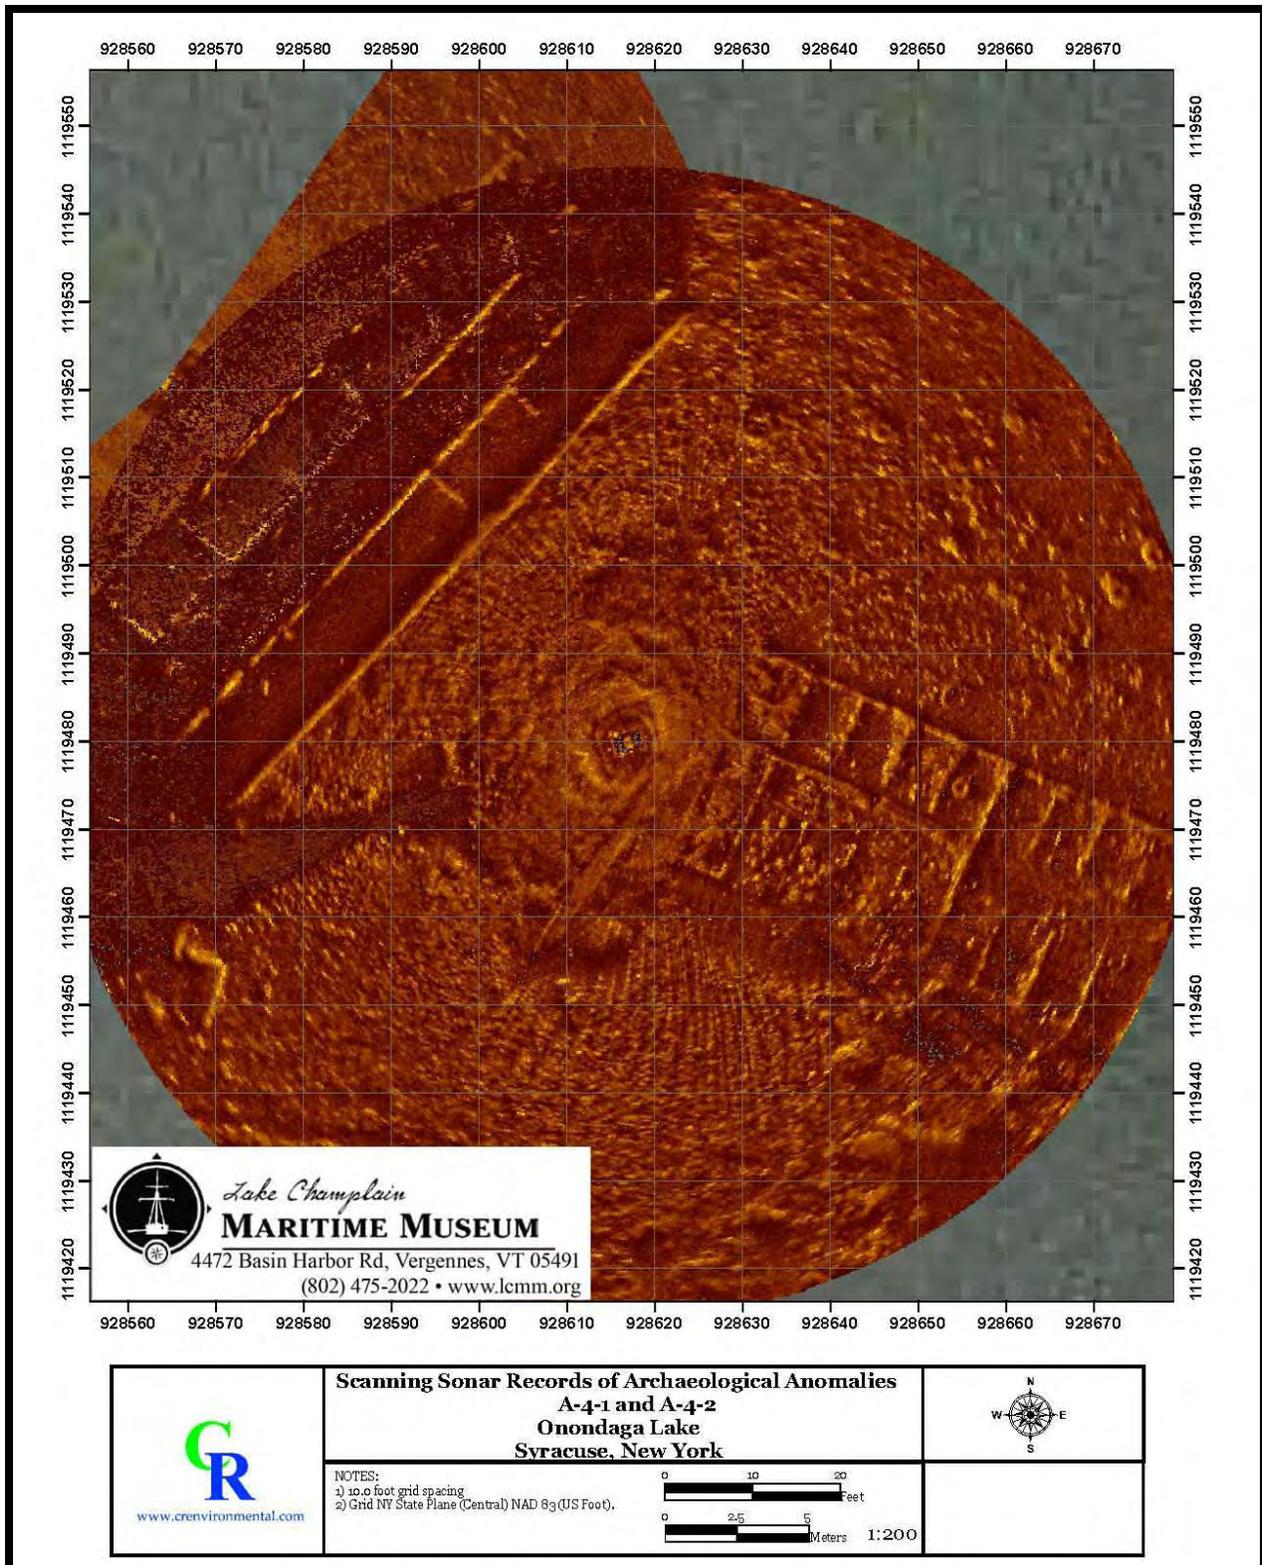
Figure 45. Scanning sonar image showing Anomaly A4-1 (left) and A4-2 (right).

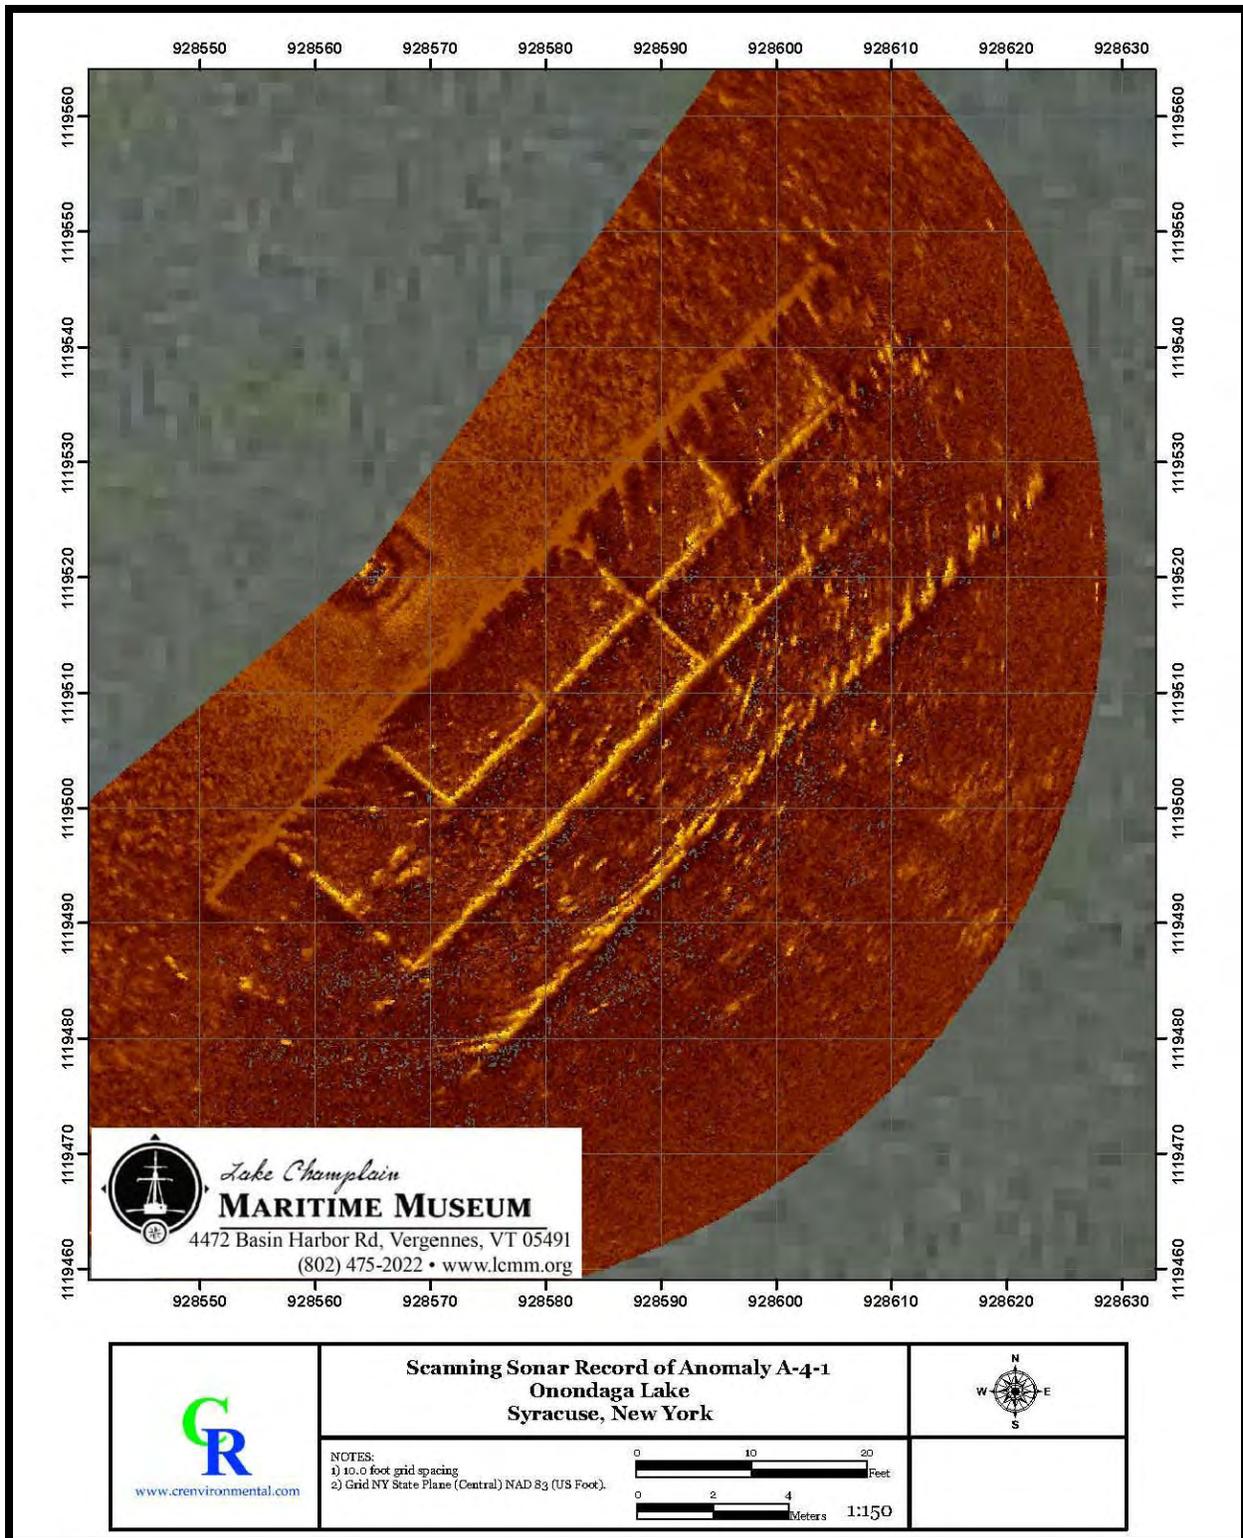
A4-1 is an edge-fastened scow barge which is preserved up to the deck level, although the deck is no longer present. The vessel is 78 feet (23.77m) long and 27 feet (8.23m) wide. A wreck marker appears in the vicinity of A4-1 on a 1942 navigational chart (see Figure 37). The barge rests in shallow water just off shore, and adjacent to another barge, A4-2 (Figure 43, Figure 44 and Figure 45). The archaeological data suggests that the barge’s build date is in the early twentieth century. The uppermost portions of the vessel are just below the water’s surface. The vessel’s hull structure suggests that it is a dump scow.

Figure 46. Scanning sonar image showing Anomaly A4-1.

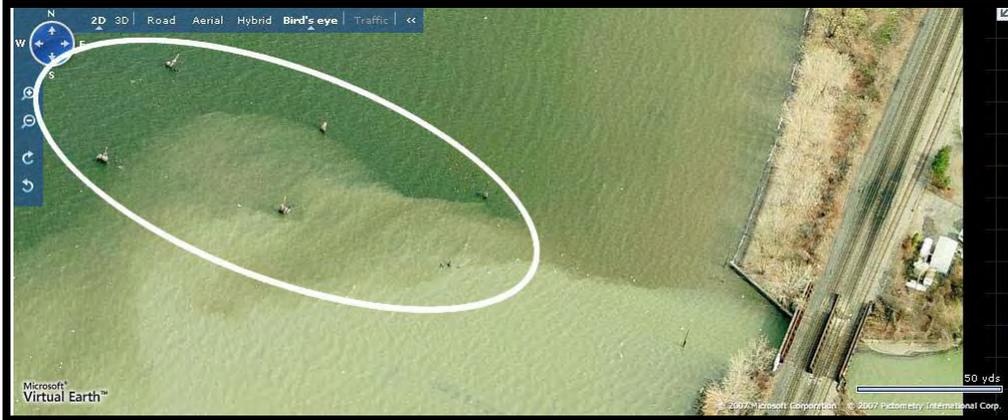
Anomaly A7 was identified from aerial images and the 2005 remote sensing survey (Figure 48). The anomaly is a series of six piling clumps marking the entrance into Syracuse’s inner harbor. The clumps consist of between three and ten pilings driven into the lakebed and held together with cables and/or iron bands. The clumps are visible above the surface, and were documented with side scan sonar, sector scan sonar and photographs (Figure 49 and Figure 50).

Figure 48. Canal entrance related structures creating Anomaly 7 (courtesy Microsoft® Virtual Earth).

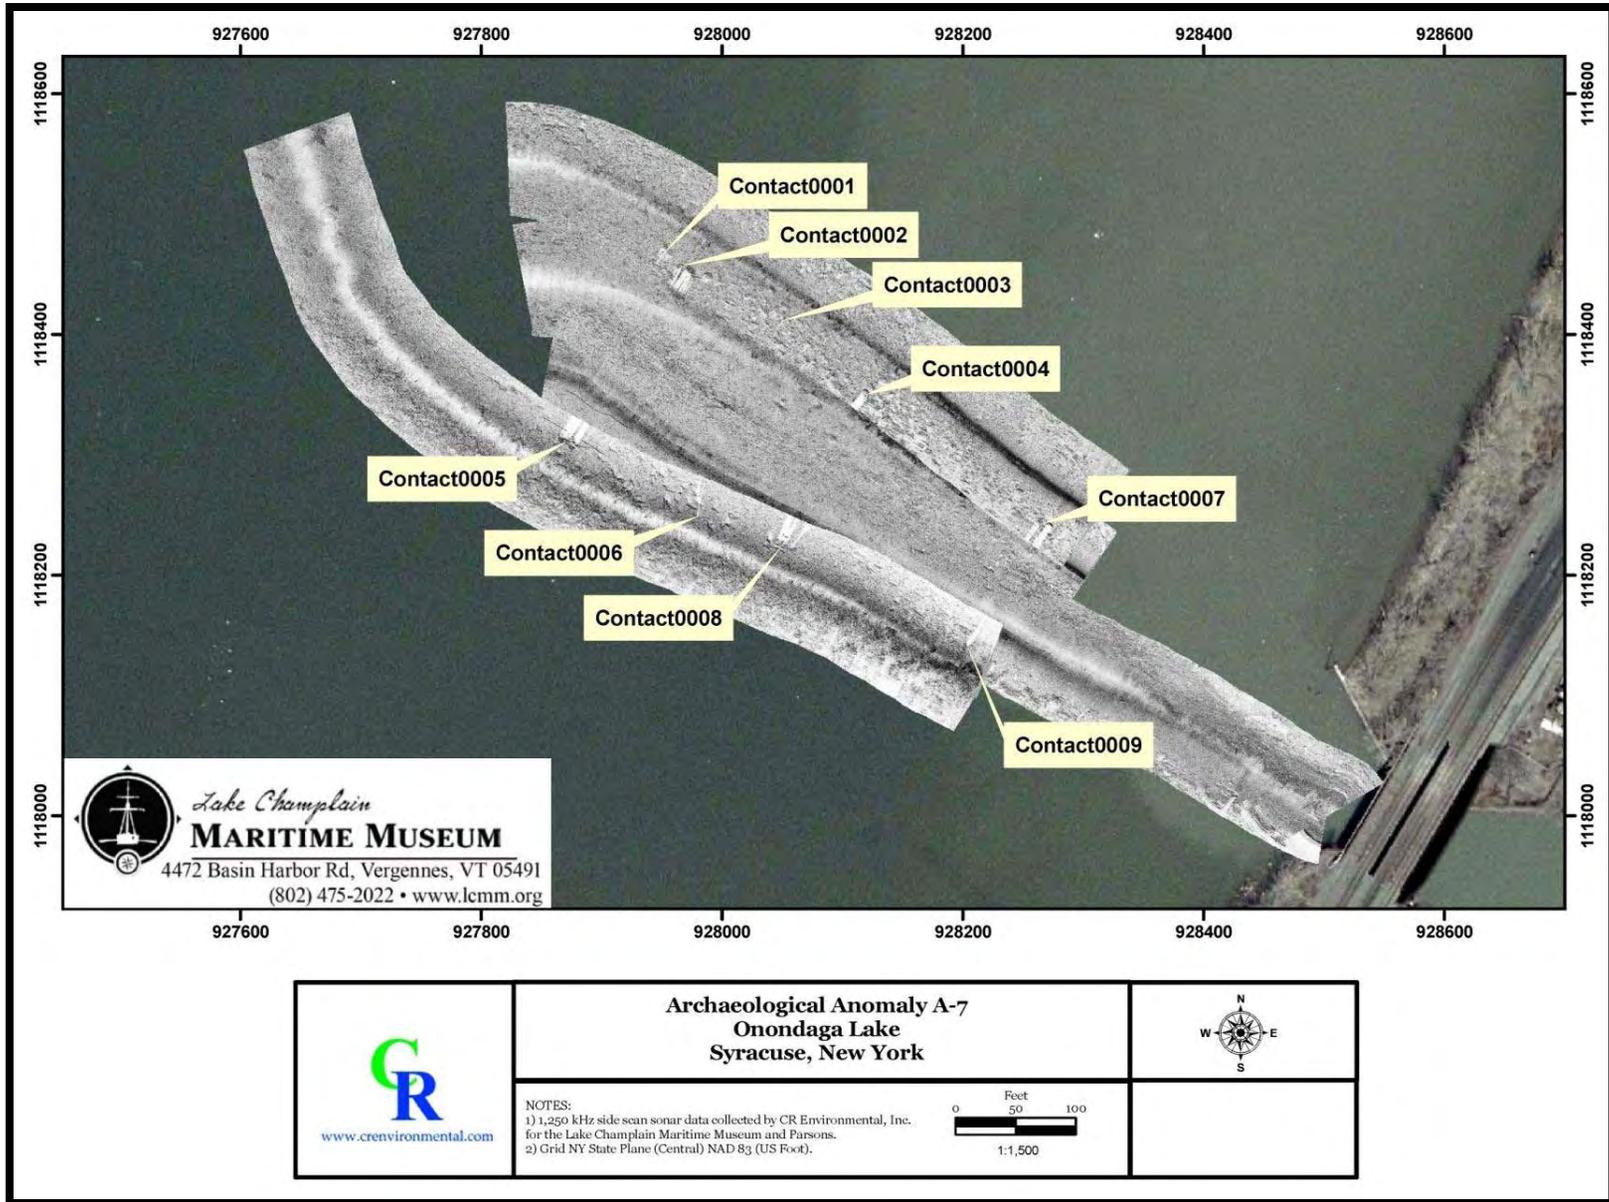
Figure 50. Side scan sonar mosaic of A7.

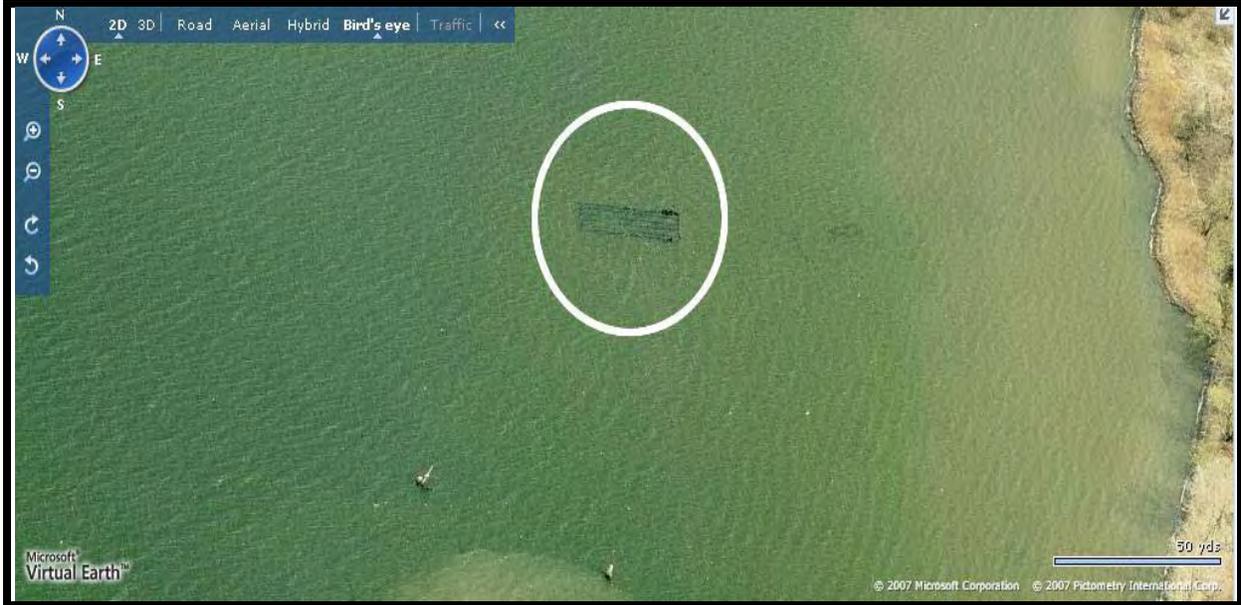
A12 is an edge-fastened, wooden derrick lighter spud barge. The barge is preserved up to the deck level, although the deck is no longer present. A wreck marker appears in the vicinity of A12 on a 1942 navigational chart (see Figure 37), and the site is clearly visible on modern aerial photographs (Figure 51). The mechanisms for holding the spuds are exposed above water, with the remainder of the barge is just below the water’s surface.

Figure 51. Anomaly A12 visible from aerial photography (courtesy Microsoft® Virtual Earth).

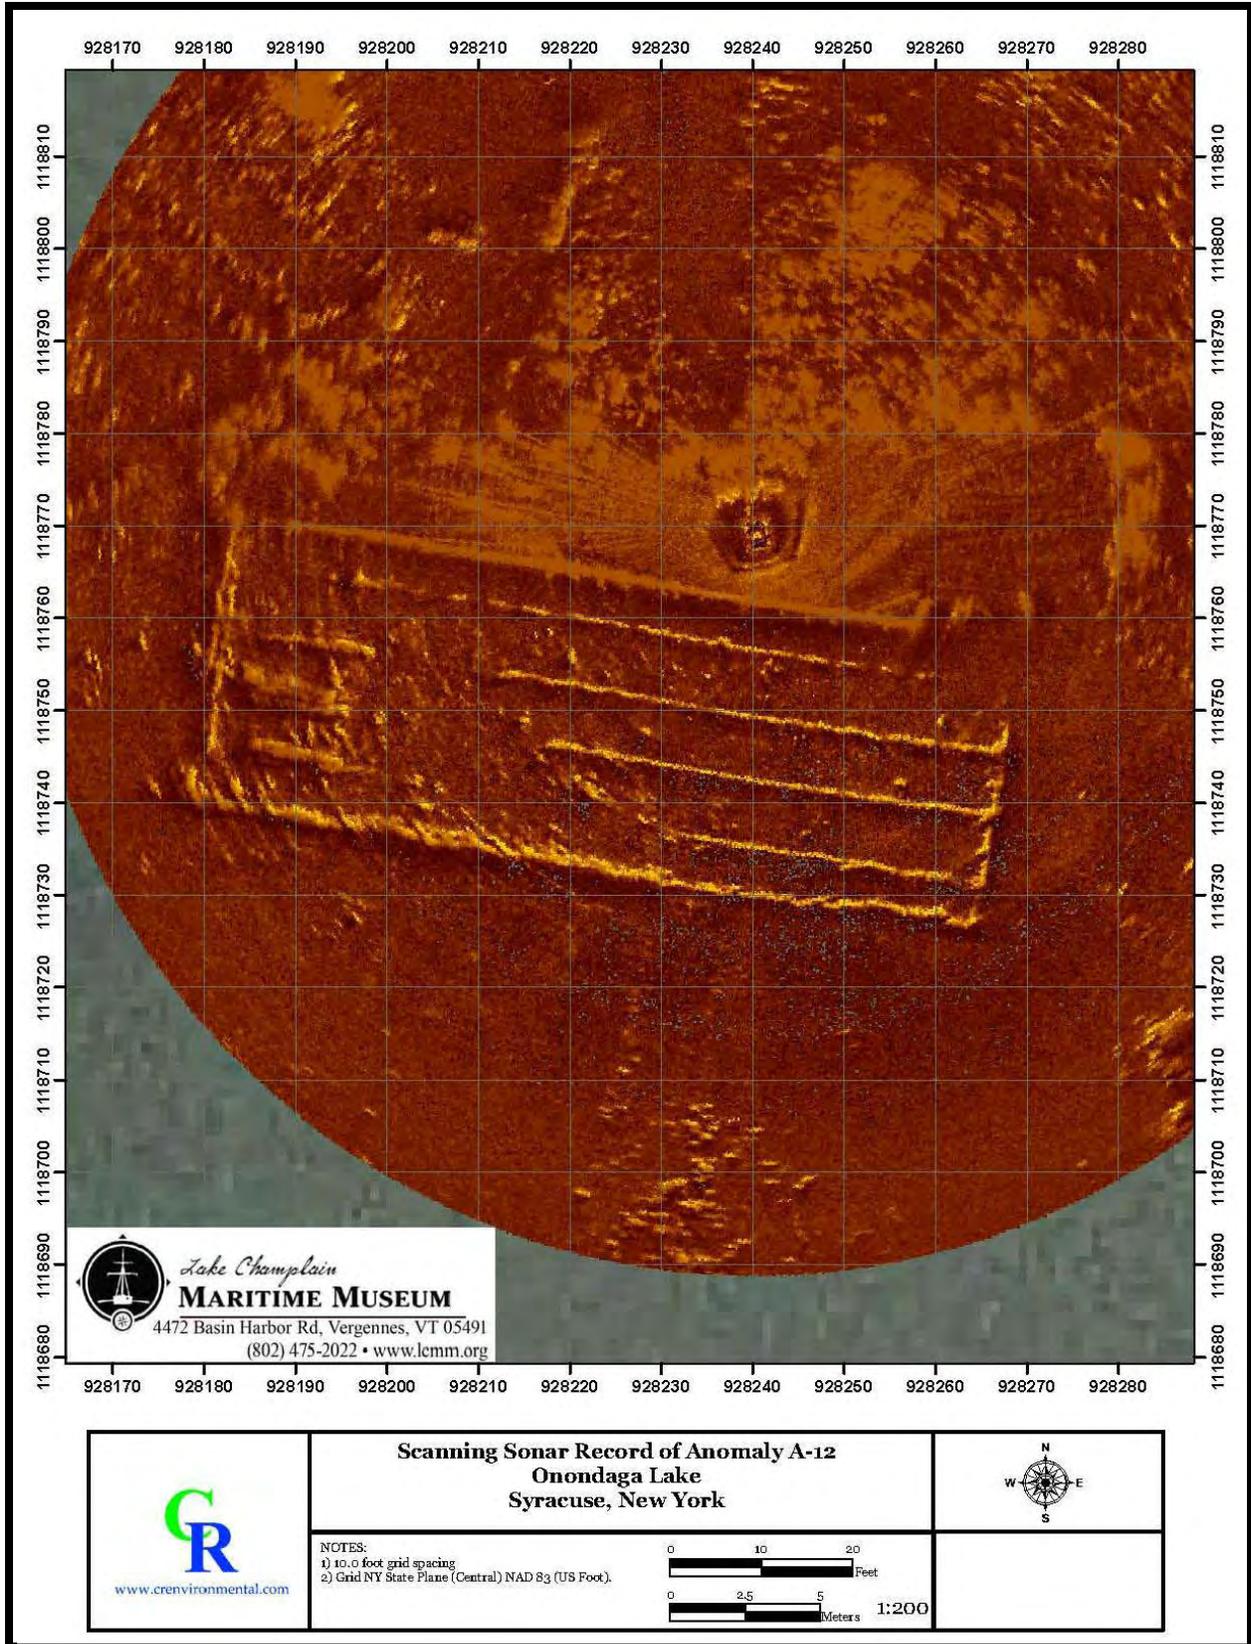
Figure 52. Scanning sonar image of A12.

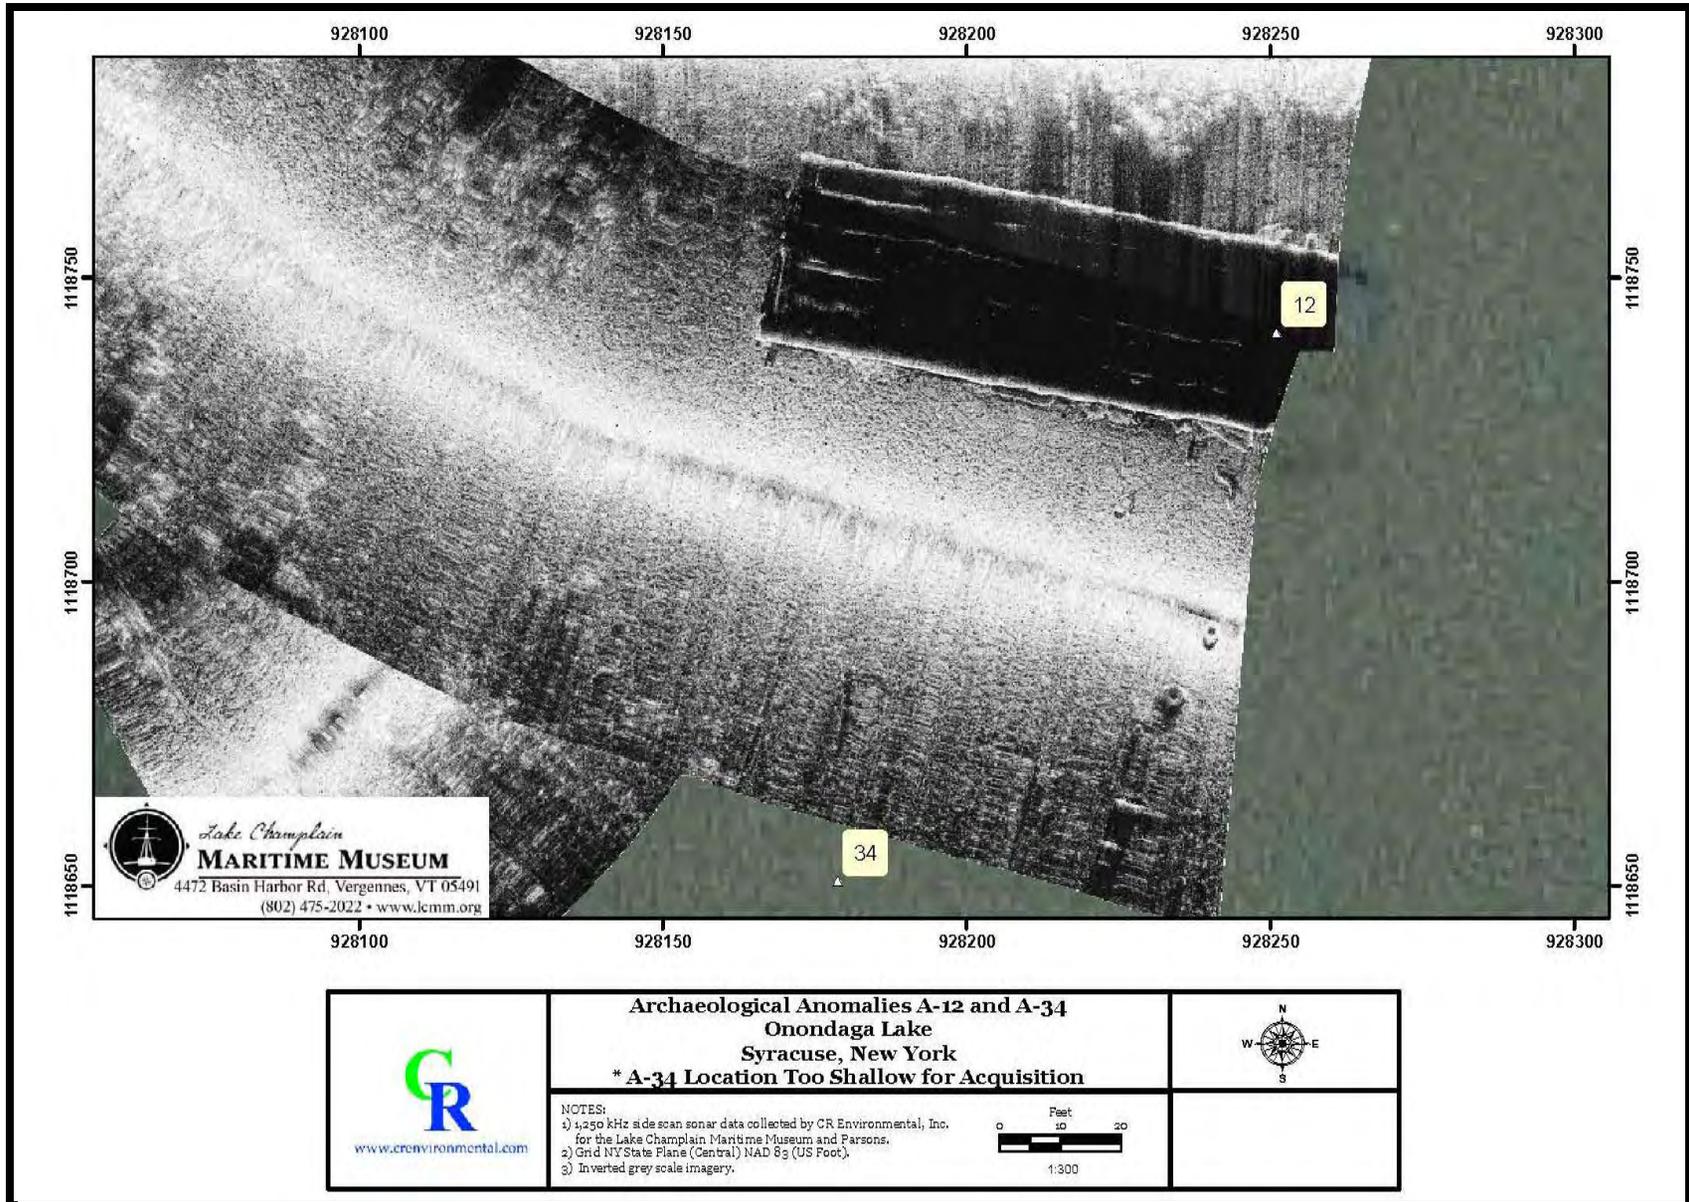
Figure 53. Side scan sonar mosaic of Anomaly A12.

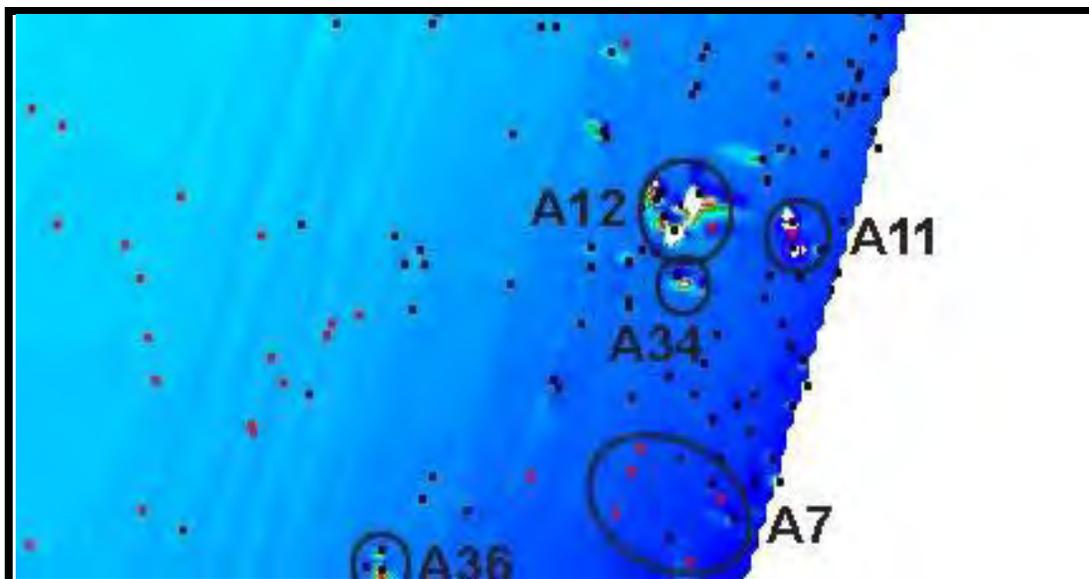
A34 is a magnetic anomaly discovered during the 2005 remote sensing survey (Figure 57). The anomaly was investigated using side scan sonar, sector scan sonar and ROV in 2010, with all results being negative. A34 was dive verified in June 2011, and determined to be a pile of stones varying sizes from 3in to 9in (8cm to 23cm). In the middle, the mound stood 12in (30cm) to 18in (46cm) above the surrounding bottom tapering at the edges, with an overall size of 42ft by 23ft (12.8m by 7.0m). Metal detecting in the mound located several iron artifacts including a 24in (61cm) long section of iron railroad rail and an unidentified iron circular object. Their location within the mound indicates a contemporaneous deposition. Extensive visual survey of the surrounding area produced no evidence for an underlying wreck or associated pier. The mound is clearly cultural in origin, most likely the result of a barge disposing of a load of stone and other debris.

Figure 57. Magnetic intensity map of Onondaga Lake showing A34 adjacent to a barge (A12).

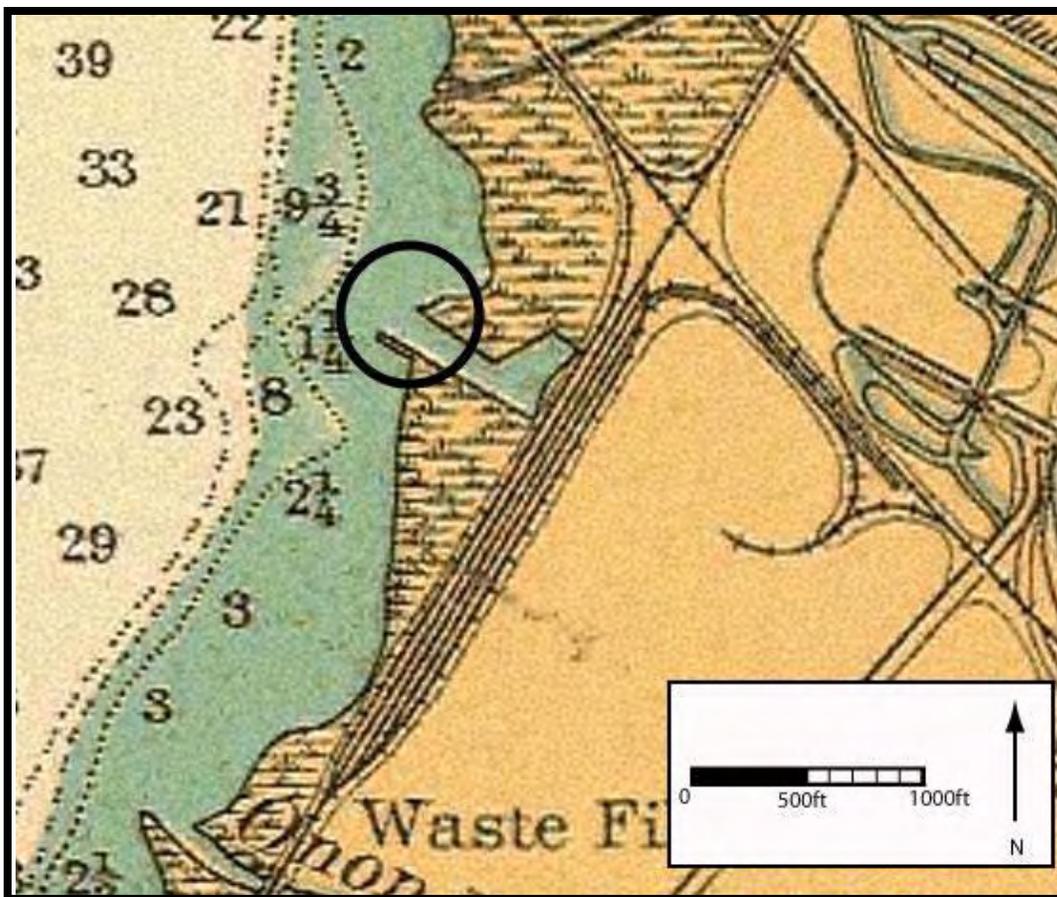
Overlays of historic maps and charts suggests that A38 is near the former location of the western end of the Iron Pier basin (Figure 60).

Figure 60. 1915 navigation chart of Onondaga Lake showing the location of A38 (U.S. Lake Survey Office, Chart No. 5, New York State Canals, Brewerton to Cross Lake and Syracuse to Oswego, 1915).

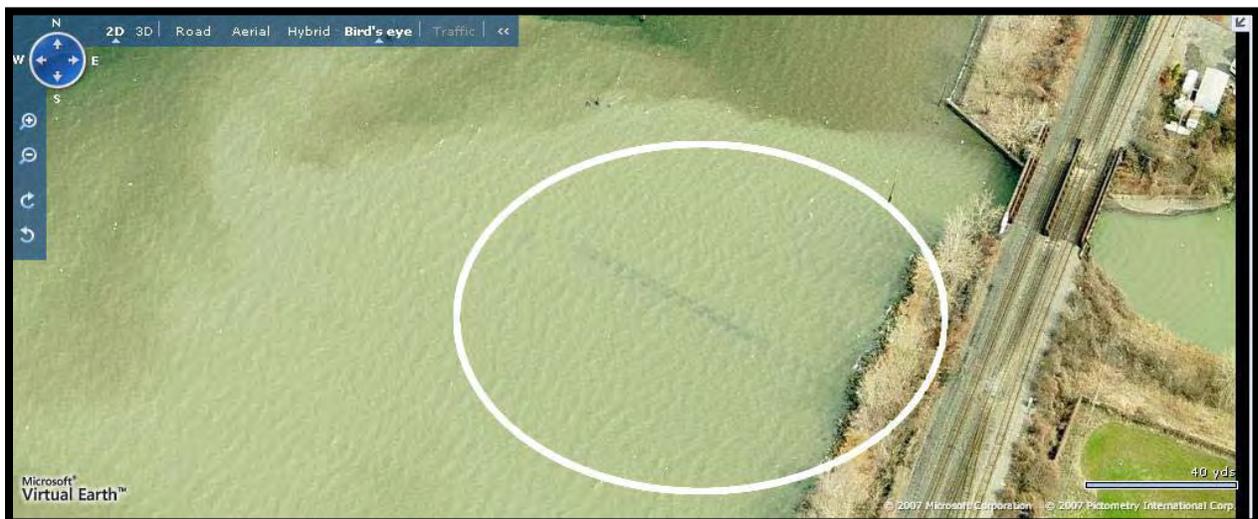
A45 is a breakwater situated southeast of the entrance to the Syracuse Inner Harbor. Analysis of navigational charts suggests that the structure was installed between 1937 and 1942 (Figure 62), and was abandoned/partially submerged by 1947. The breakwater is 20 feet wide (6.1m) and extends 250 feet (76.2m) from the shoreline (Figure 61). Dive verification in 2011 showed the site to be made of concrete bags, likely constructed by placing bags of concrete in the water. Each concrete block was pillow-shaped with two indentations from circular bands. Given the breakwater’s location, its intended purpose was likely to dampen wave action at the harbor entrance for entering and exiting boats. The structure is densely packed along the exterior walls of the breakwater with an open gap containing only sporadic concrete bags in between (Figure 63 and Figure 64). Only one tier is visible. The site lies in 2 to 3 feet (.61 to .91m) of water. No timber crib or other wooden structures were noted, suggesting that the site is a breakwater and not a pier.

Figure 61. Aerial view showing A45 (courtesy Microsoft® Virtual Earth).
