Anomaly 53: Canal Boat

Anomaly 55: Canal Scow

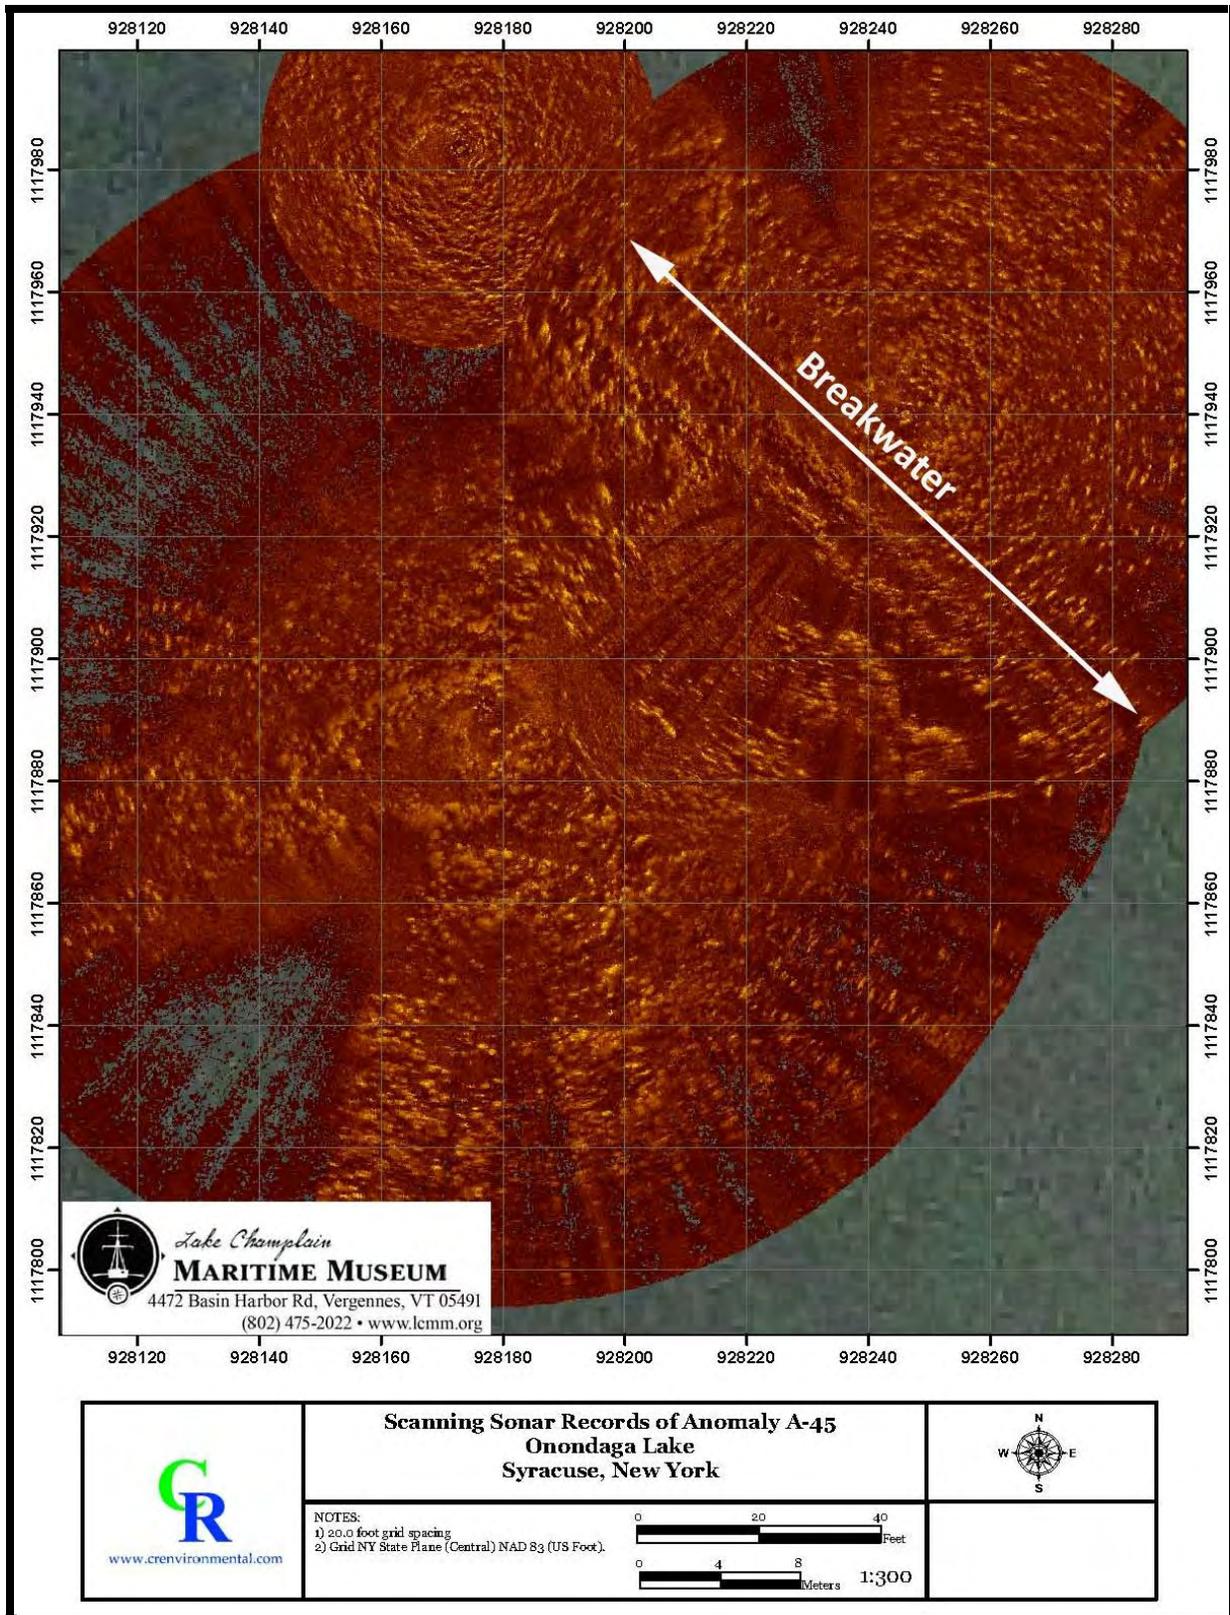
Figure 64. Scanning sonar image of A45.

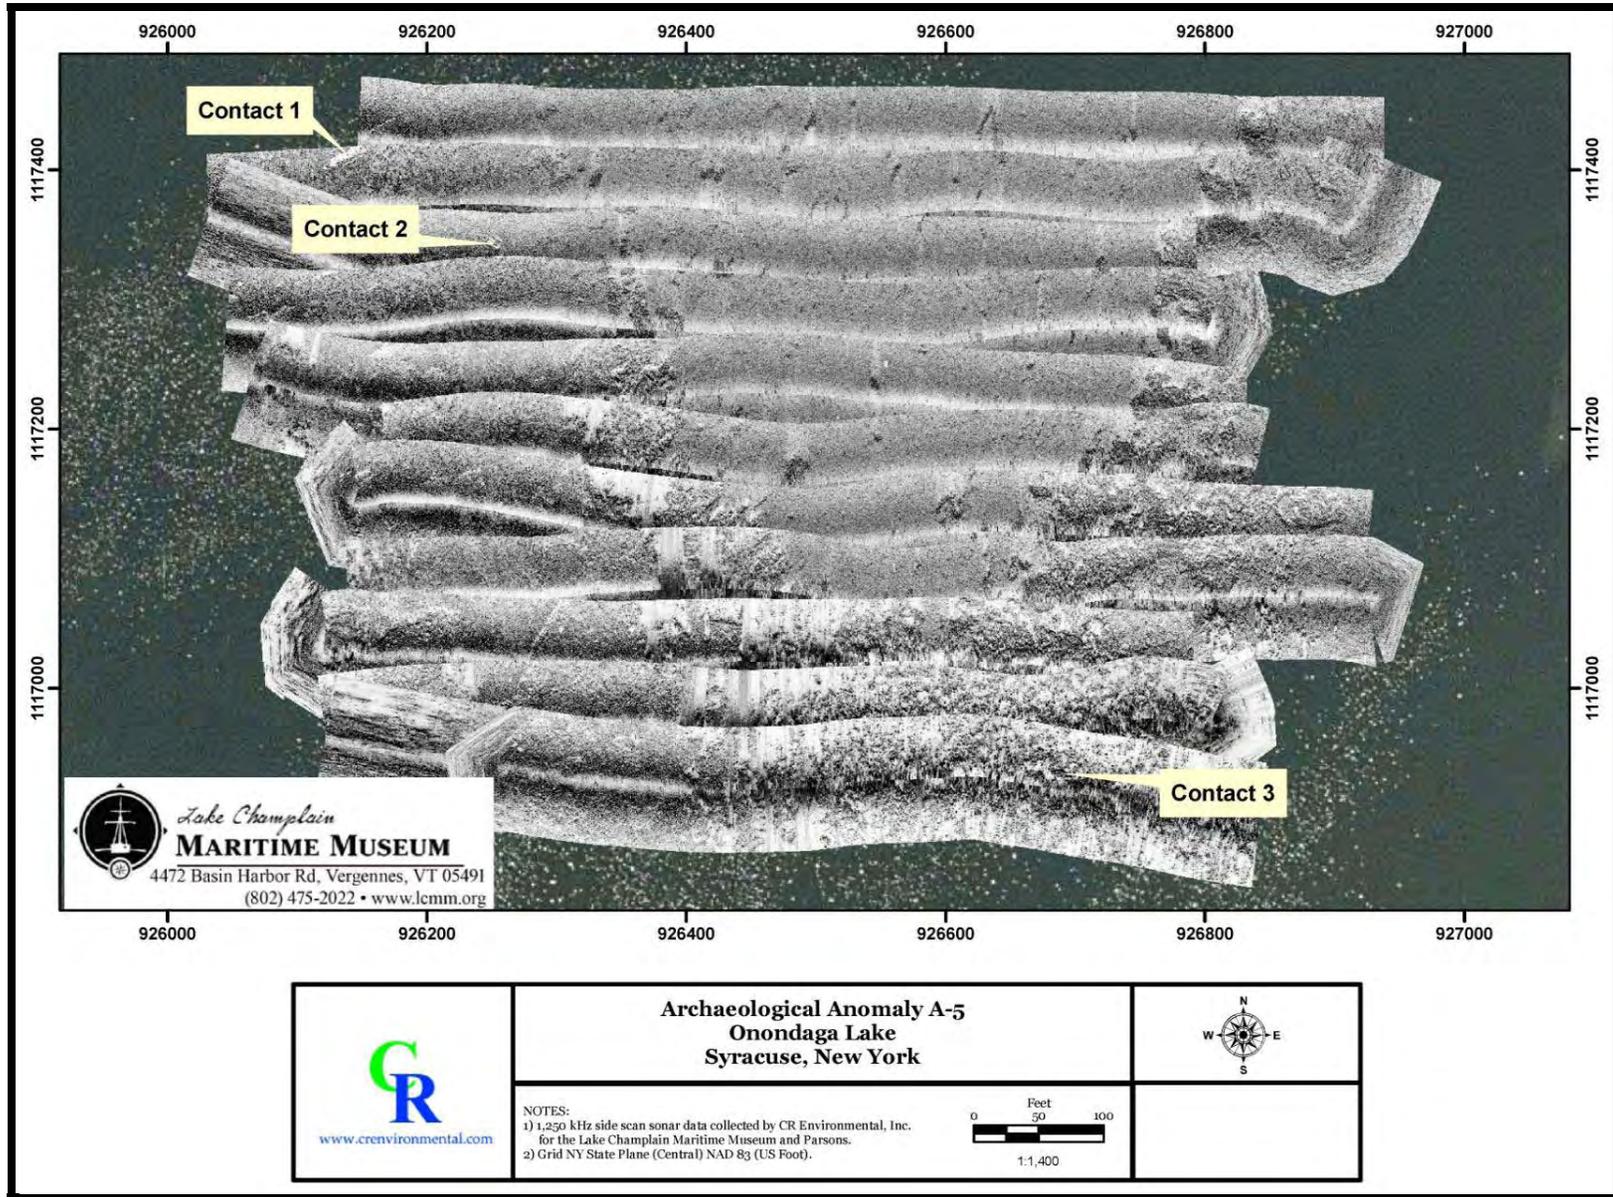
Anomaly A5 is a collection of small sonar and magnetometer targets that was selected for investigation based upon its offshore proximity to the former location of Geddes Pier. The anomaly area was investigated with sector scan sonar, side scan sonar, and the ROV. All of these methodologies were hampered by dense aquatic vegetation in the research area. Additional consultation with Parsons’ staff revealed that the acoustic anomaly located by CRE in 2005 was buoyant piping associated with water monitoring activities (Figure 69). The limited data from the inspection and the low intensity distantly distributed sonar and magnetometer anomalies from the 2005 CRE fieldwork suggest that the anomaly sources are isolated modern debris (Figure 70 and Figure 71). Map analysis also suggests that this location is too far out into the lake to be the remnants of Geddes Pier.

Figure 70. Side scan sonar mosaic of A5.

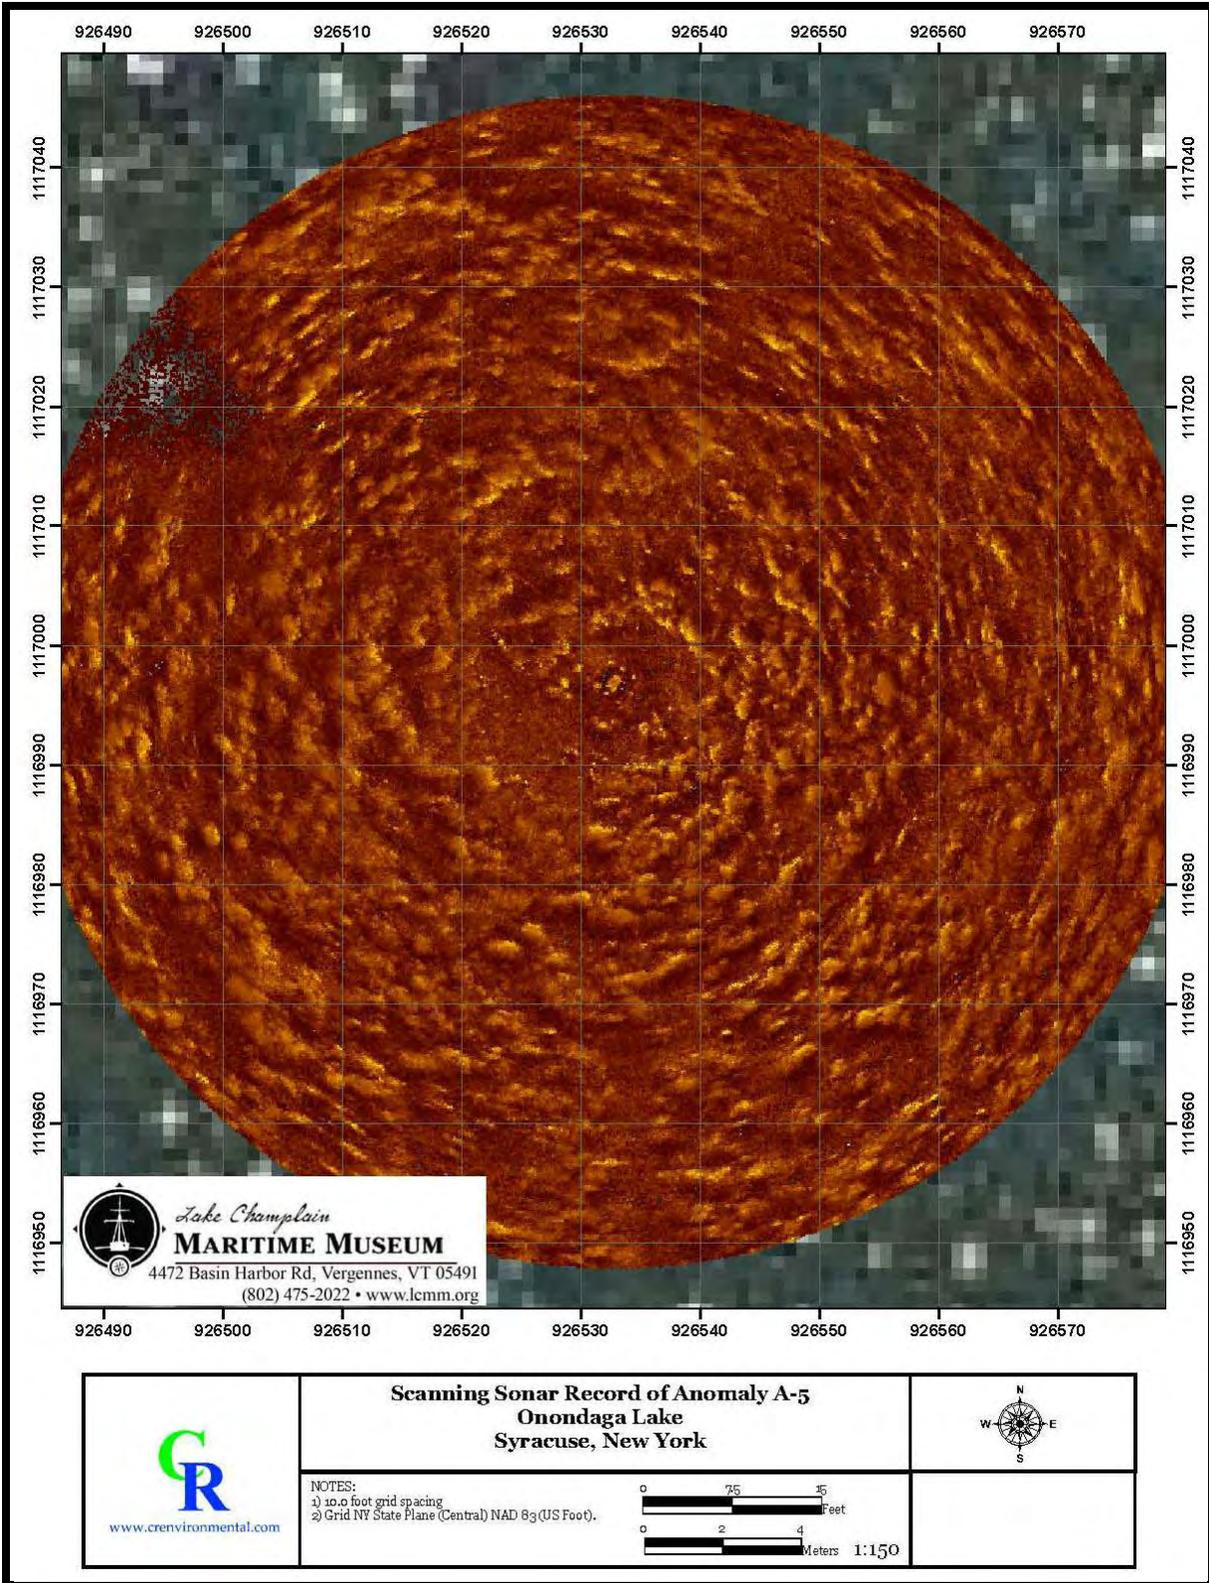
Figure 71. Scanning sonar record of A5.

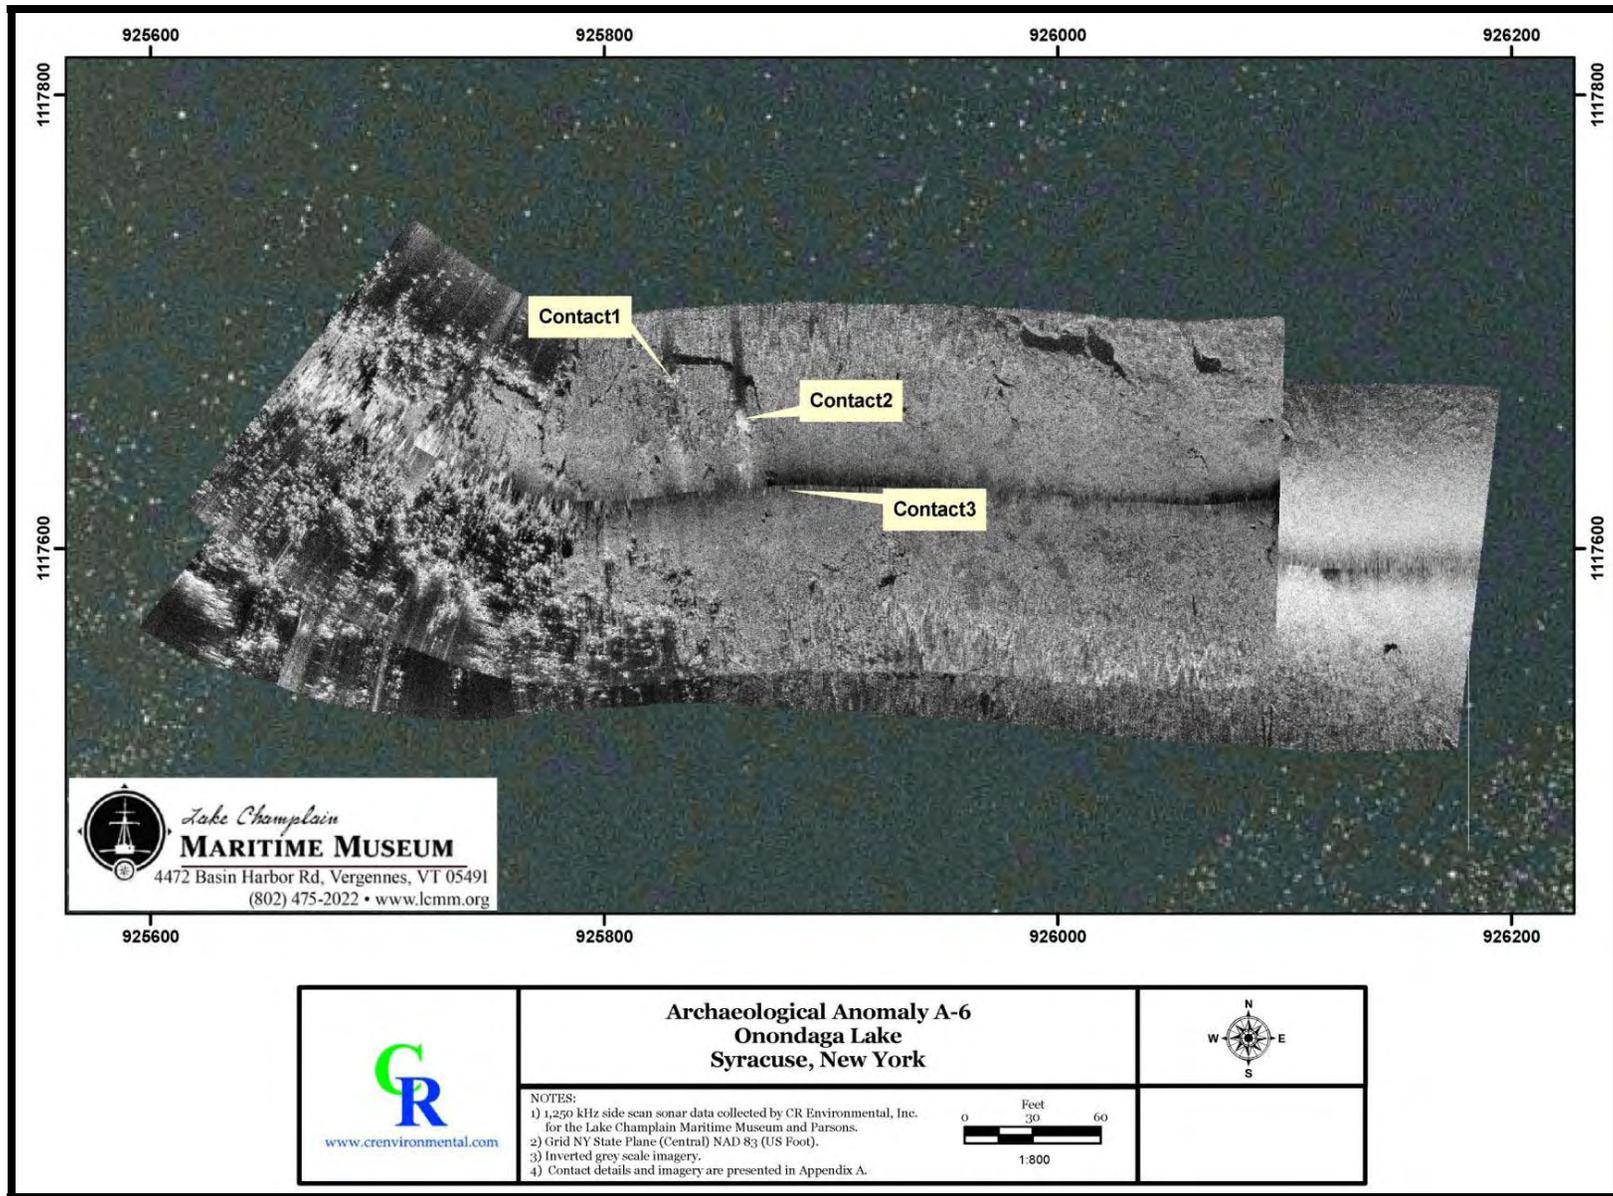
A6 is co-located with CRE’s 2005 digitized magnetic anomalies #475 and #1256 which were observed on parallel survey transects spaced 25ft (8m) apart at a depth of approximately 8ft (2m). The magnitude of these anomalies was approximately 10-15nT. Assuming a distance (range) of 7-16 ft (2-5 m), the ferrous mass of this anomaly might be 4.4 to 84lb (2 to 38kg). High resolution side scan sonar data collected in the vicinity of these anomalies in 2010 showed some isolated debris, but nothing characteristic of a cultural resource (Figure 72 and Figure 73). The ROV revealed the area to be flat bottomed with no vegetation and a layer of easily disturbed fine silt and green algae. The ROV did not locate the source of the anomaly. The area has dense aquatic vegetation with open areas of solvay waste. Diver verification in 2011, which included visual examination and metal detecting, did not locate any cultural material.

Figure 72. Side scan sonar mosaic of A6

LCMM recommends no further work for A6.

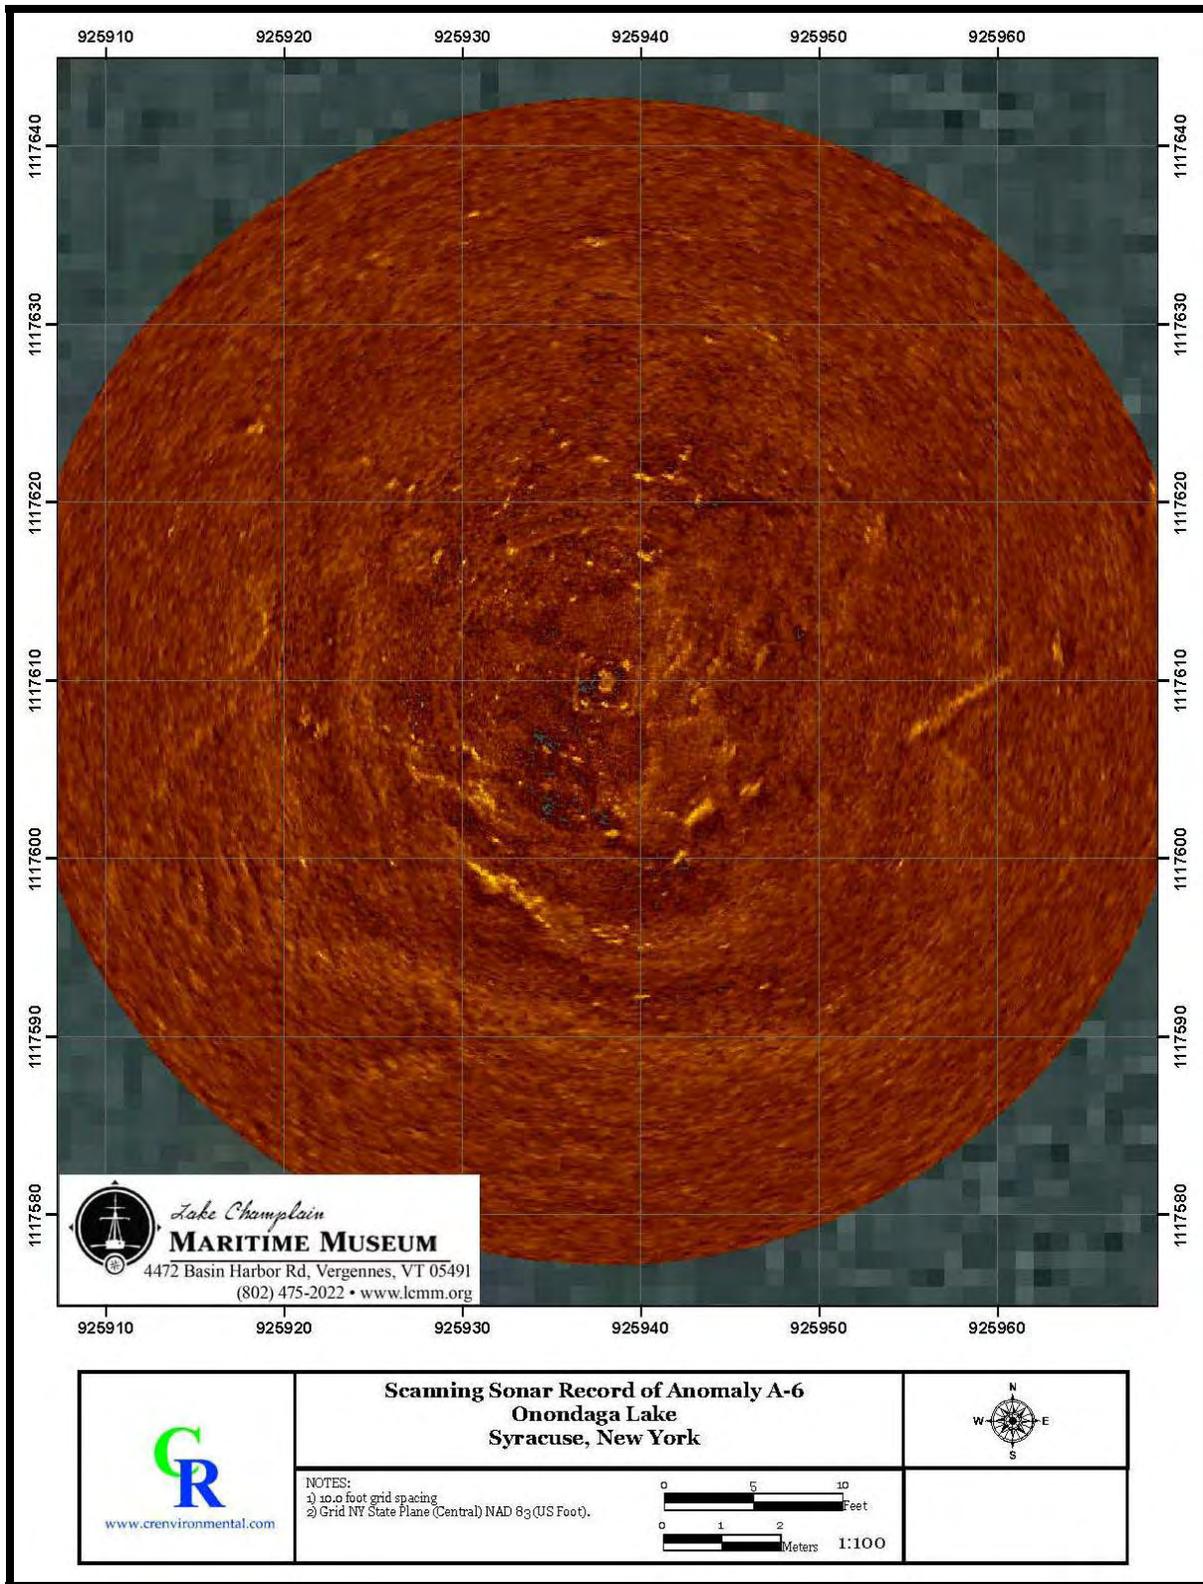
Figure 73. Scanning sonar image of A6.

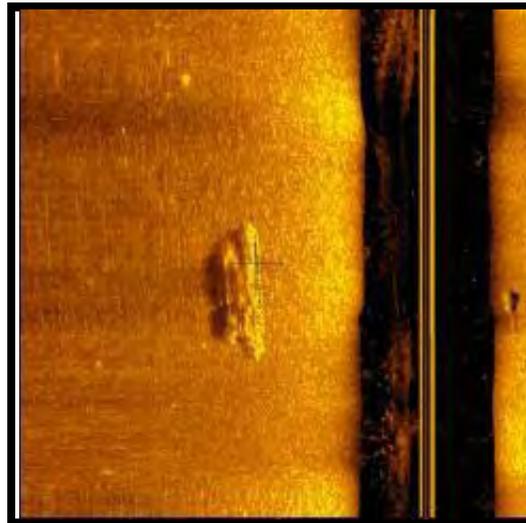
Anomaly A8 was identified based on a sonar target from the 2005 remote sensing survey (Figure 74). In 2010, the area was investigated with side scan sonar, sector scan sonar and ROV. None of the investigations showed any source for this anomaly. The area has dense aquatic vegetation and a silty bottom. Review of the original sonar data and the absence of an associated magnetometer anomaly suggest that the original anomaly was aquatic vegetation.

Figure 74. Side scan sonar image from 2005 showing A8 (courtesy CRE).

LCMM recommends no further work for A8.

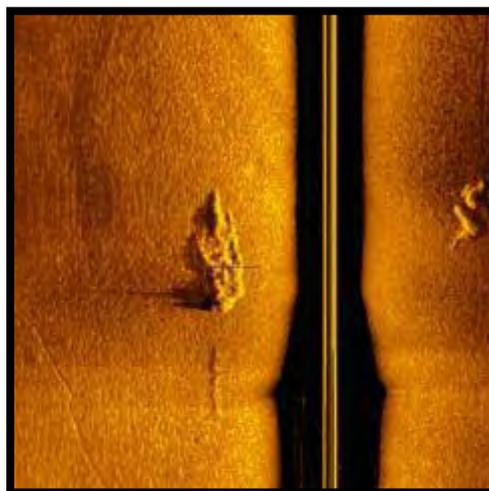
Anomaly A9 was identified based on a sonar target from the 2005 remote sensing survey (Figure 75). In 2010, the area was investigated with side scan sonar, sector scan sonar and ROV. One tree branch with vegetation hung up on it was located. The area has a silty bottom with minimal vegetation. Review of the original sonar data and the absence of an associated magnetometer anomaly suggest that the original anomaly was this tree branch.

Figure 75. Sonar image from 2005 showing Anomaly 9 (courtesy CRE).

LCMM recommends no further work for A9.

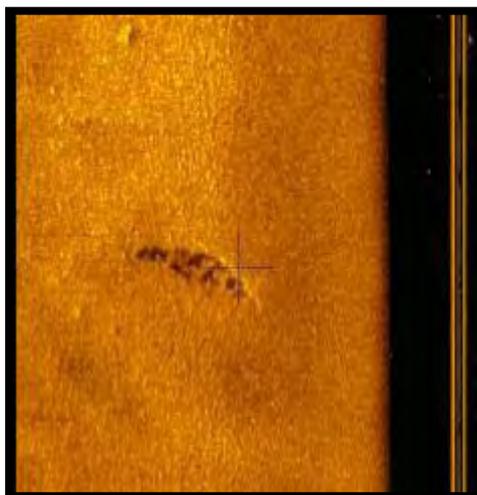
Anomaly A10 was identified based on a sonar target from the 2005 remote sensing survey (Figure 76). In 2010, the area was investigated with side scan sonar. No anomaly was present in proximity to A10 during the side scan sonar work. Due to lack of associated magnetometer anomaly, the source can confidently be characterized as aquatic vegetation.

Figure 76. Sonar image from 2005 showing Anomaly 10 (courtesy CRE).

LCMM recommends no further work for A10.

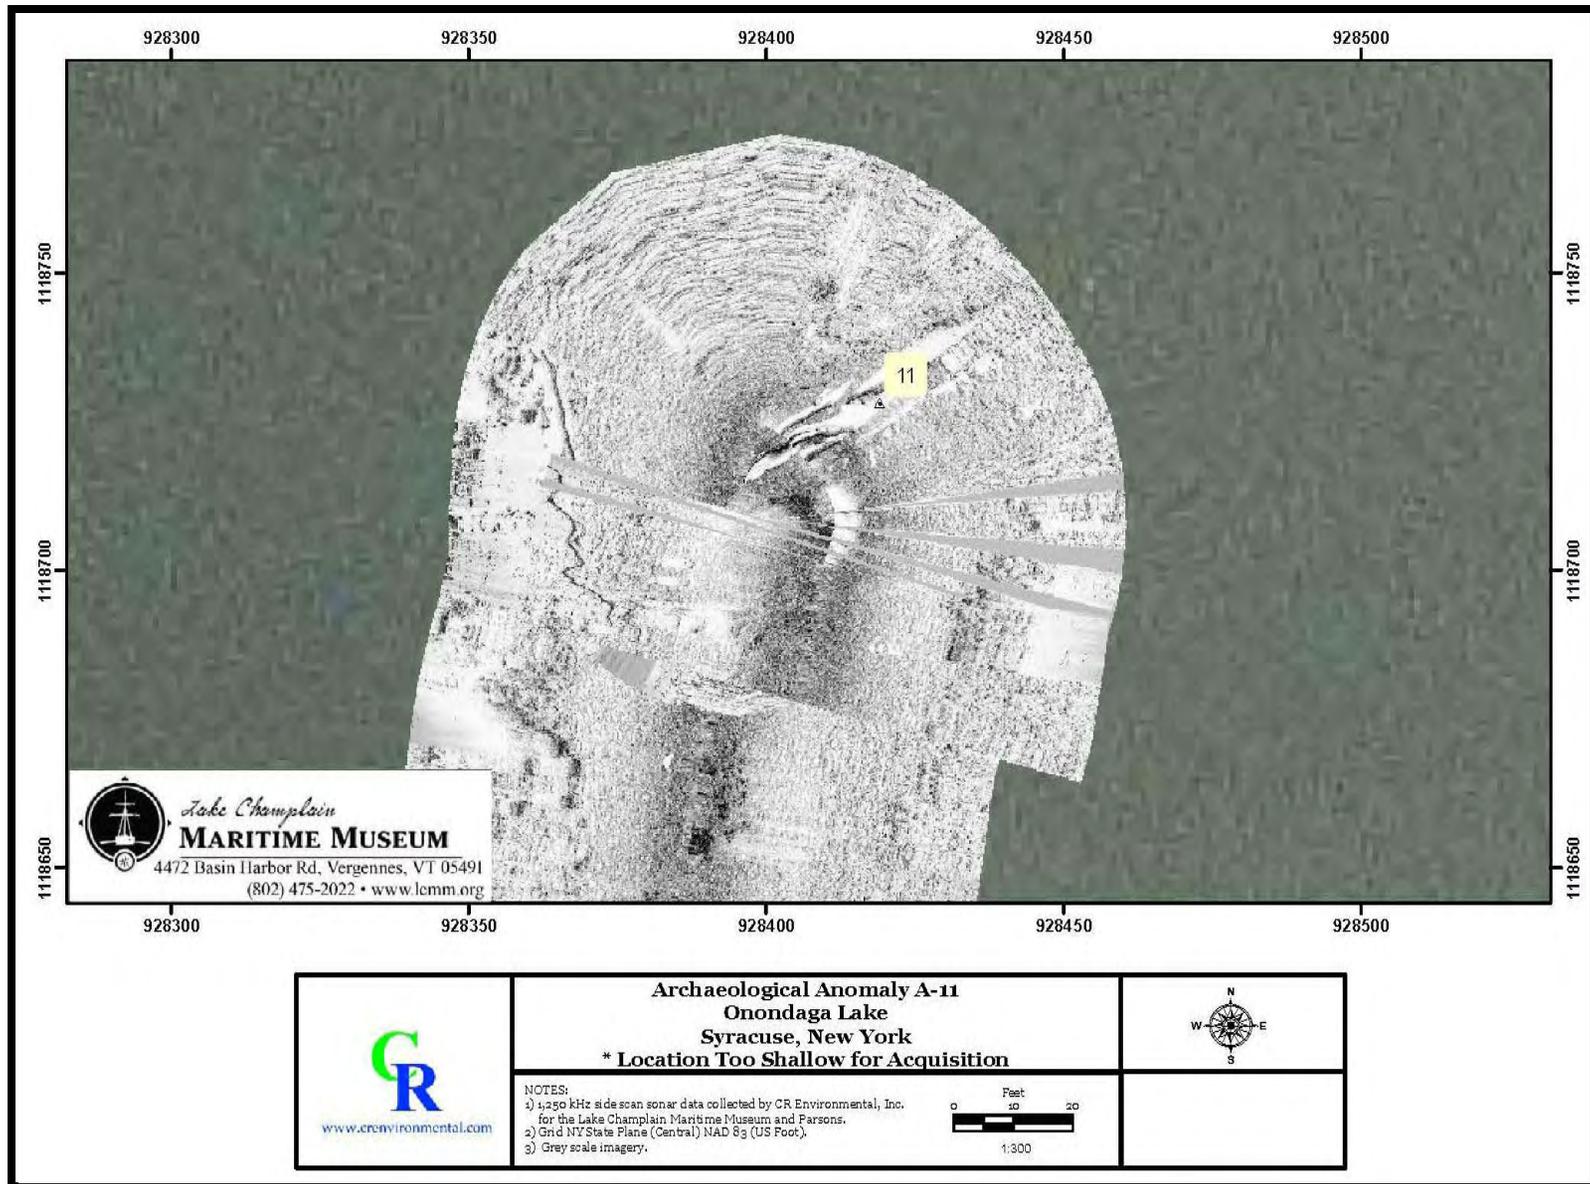
Figure 77. Side scan sonar mosaic showing A11.

LCMM recommends no further work for A11.

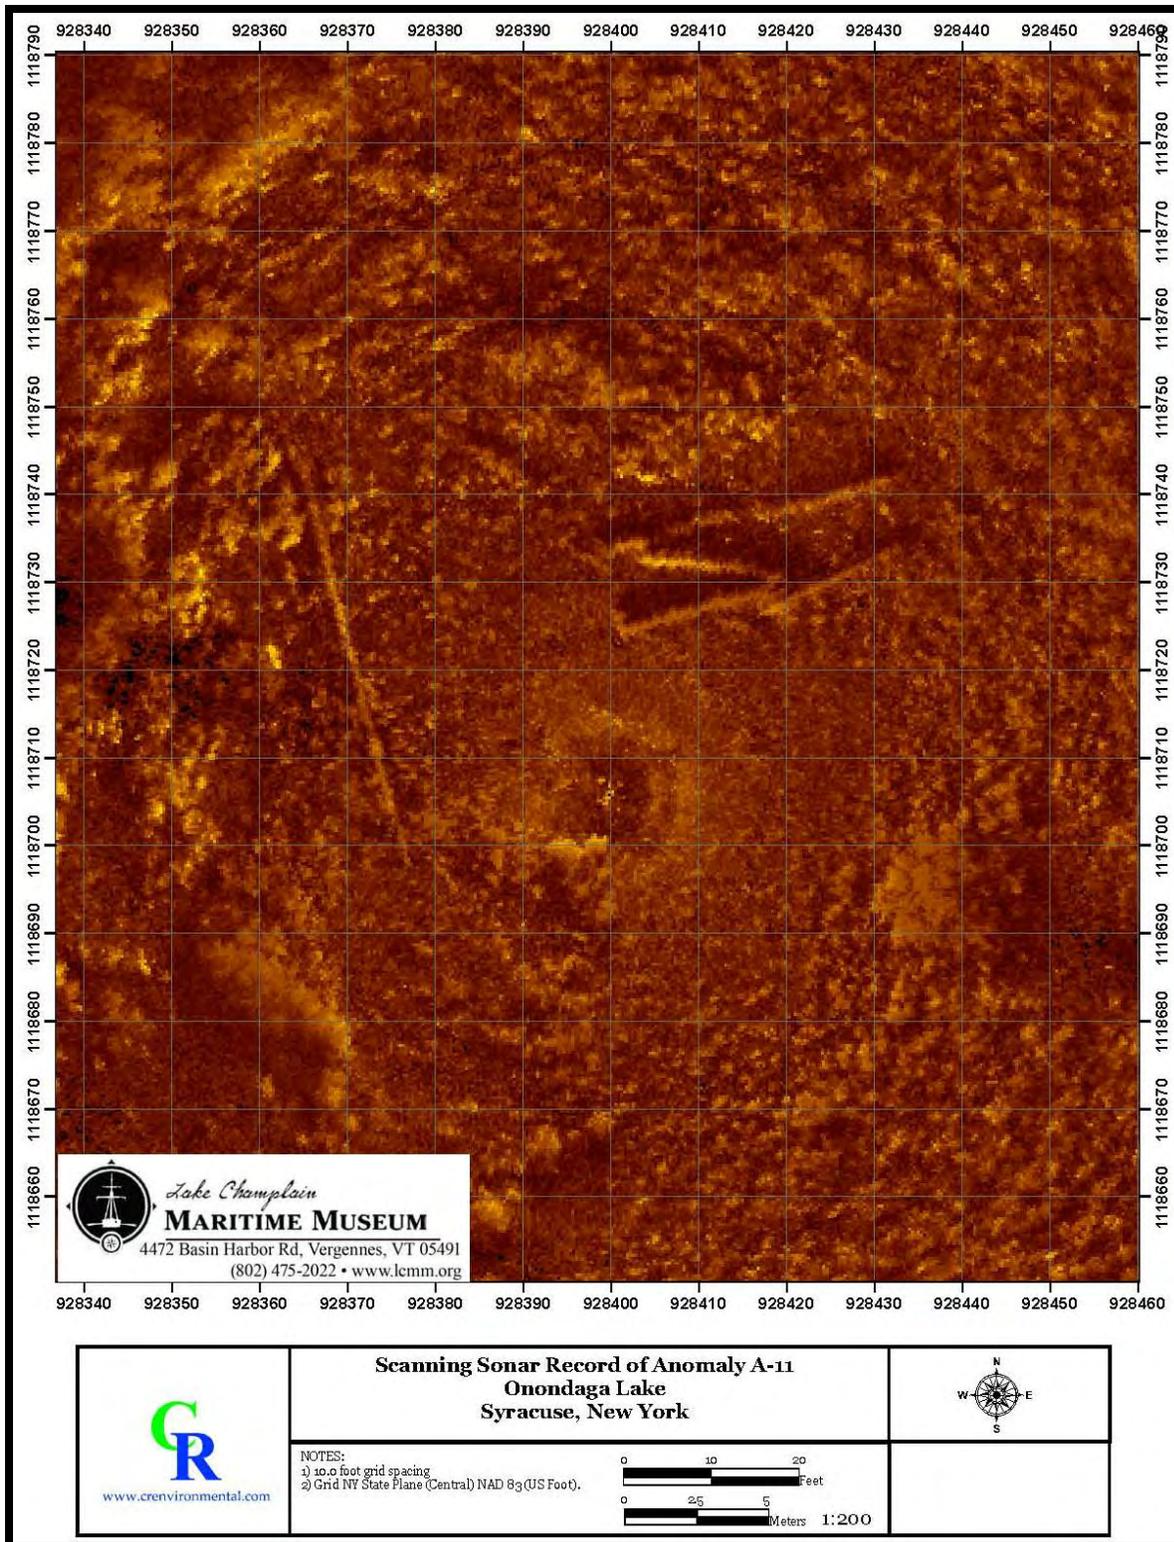
Figure 78. Scanning sonar image showing A11.

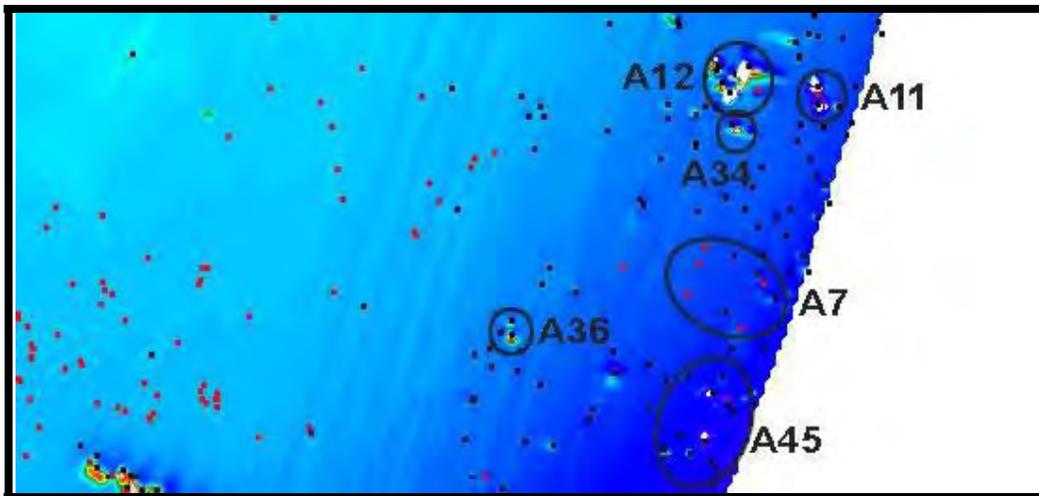
A36 is a magnetic anomaly discovered during the 2005 remote sensing survey (Figure 81). The anomaly was investigated using side scan sonar and ROV in 2010, with all results being inconclusive. Diver verification in 2011 revealed the target to be a 10ft (3m) coil of wire rope.

Figure 81. Magnetic intensity map of Onondaga Lake showing A36.

LCMM recommends no further work for A36.

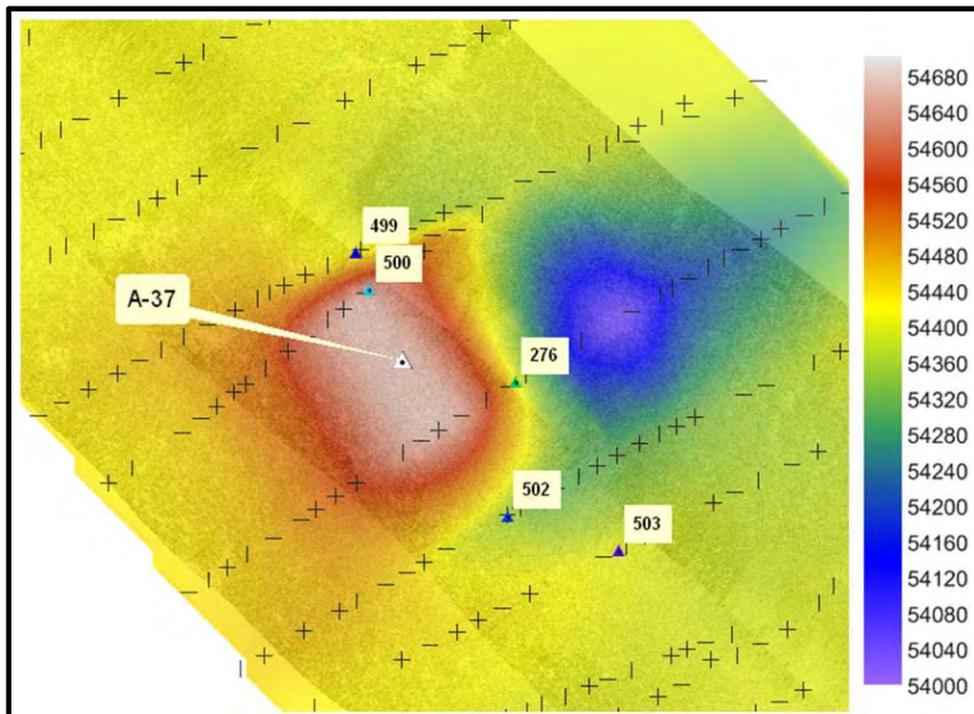
A37 is co-located with five magnetic anomalies digitized from CRE’s 2005 data: #276; #499; #500; #502; and #503 (Figure 82). These anomalies were observed on five parallel survey transects spaced 25 ft (8m) apart at a depth of approximately 10 to 12ft (3 to 4m). The magnitude of these anomalies was as high as approximately 400nT at the central dipolar anomaly #276 (Figure 83). Assuming a distance (range) of 7 to 16ft (2 to 5 m), the ferrous mass of this anomaly might be 141 to 2204lb (64 to 1000kg). Side scan sonar data collected in the vicinity of these anomalies in 2010 did not suggest the presence of surficial contacts (debris or structures). The anomaly was investigated using side scan sonar, sector scan sonar and ROV in 2010, and dive verification in 2011, with all results being inconclusive.

Figure 83. Graphical overlay of fine-scale magnetism and side scan data on A37 (courtesy CRE).

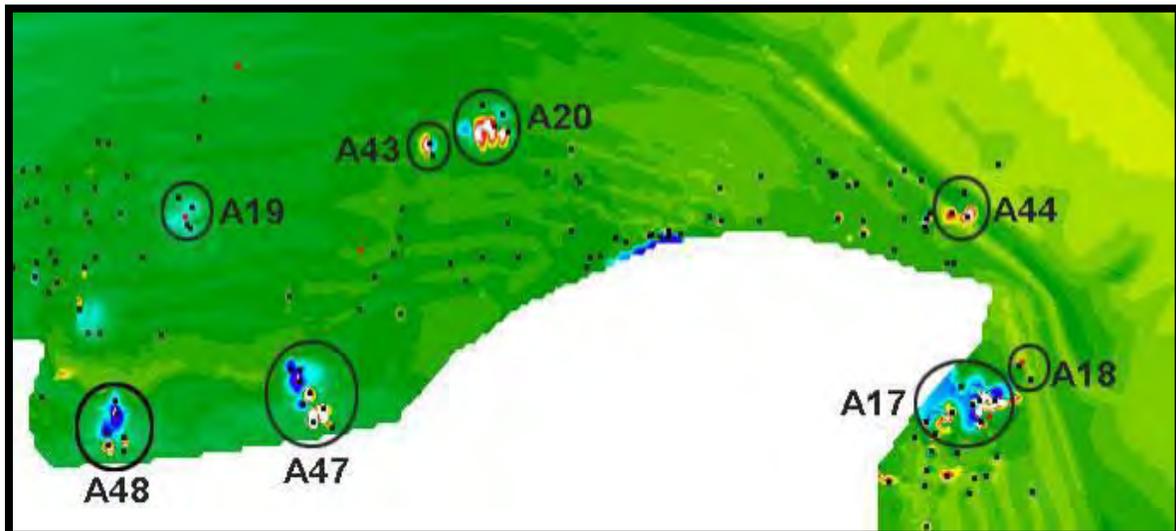
A43 is a magnetic anomaly discovered during the 2005 remote sensing survey in proximity to A20, the rock scow (Figure 84). The anomaly was investigated using side scan sonar, sector scan sonar and ROV in 2010. The ROV survey conclusively showed that the source of the anomaly was a 20 foot (6.1m) long section of iron pipe.

Figure 84. Magnetic intensity map of Onondaga Lake showing A43.

LCMM recommends no further work at A43.

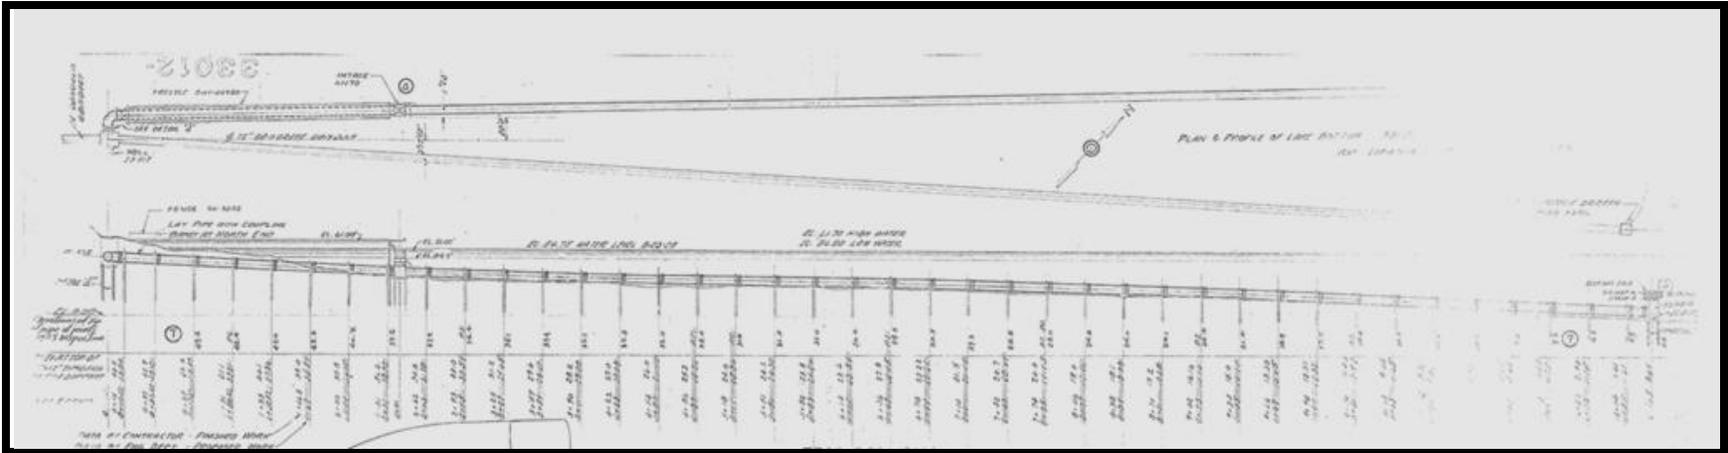
Sonar and ROV work showed that there is only one visible intake at this location, although earlier magnetometer work indicates that there are several buried suction pipes in this area. The intake structure is a heavily corroded cast iron cylinder standing approximately 8 feet (2.4m) off the bottom. There is a large lifting loop on the top which was used for its installation. The pipeline associated with the intake is buried and could not be inspected. The engineering plans for the intake exist and are presented (in part) as Figure 87 and Figure 88.

Figure 87. Profile and plan view of the engineering drawings of the Solvay Process 84 inch (213cm) suction intake (courtesy Parsons, Inc).

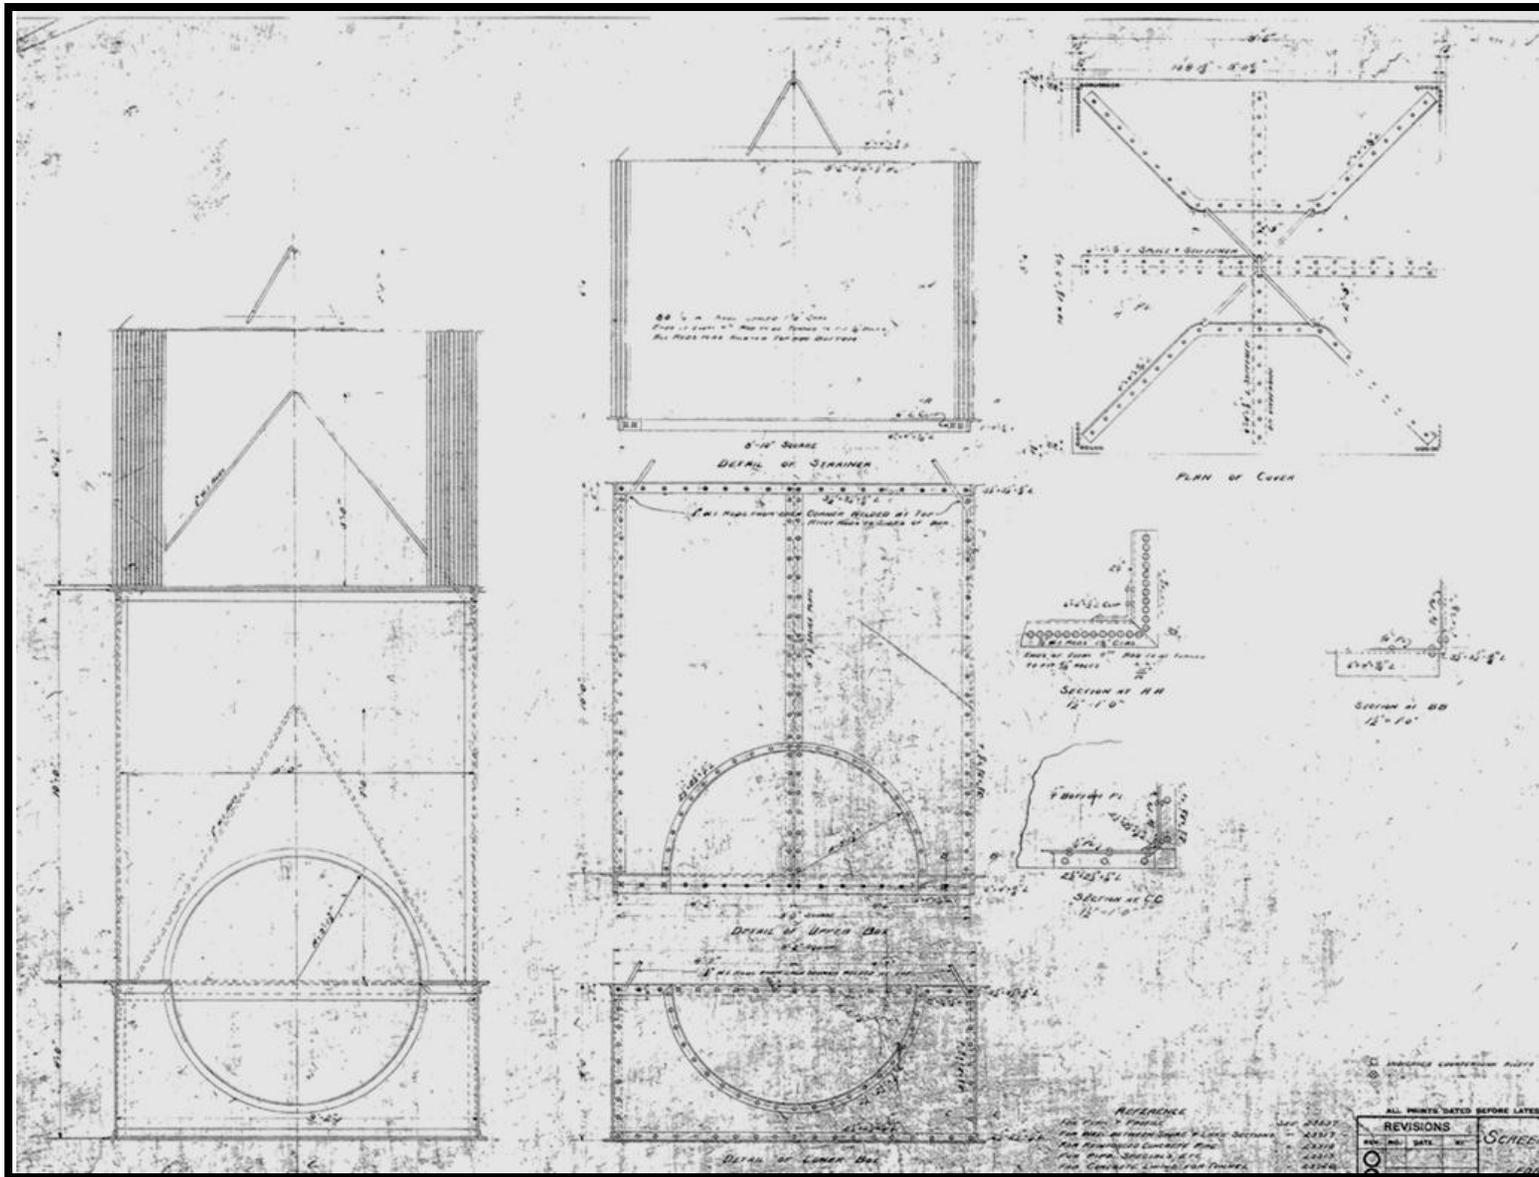
Figure 88. Engineering drawings of the intake structure for Solvay Process Company's 84 inch (213cm) intake (courtesy Parsons, Inc).

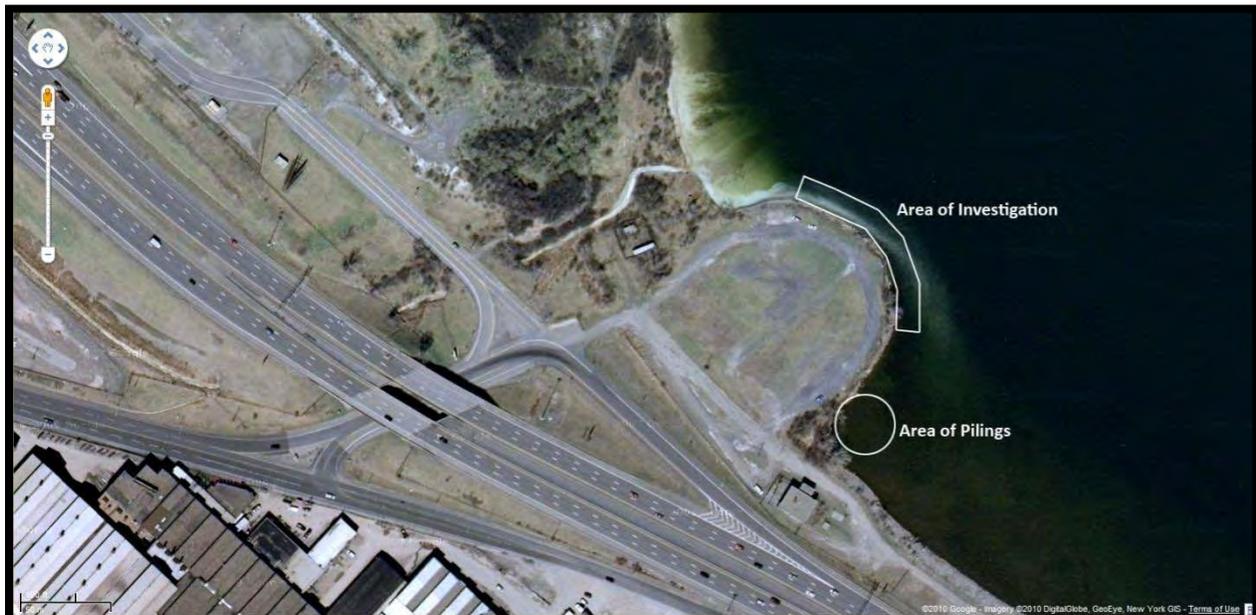
The former location of the Syracuse Yacht Club was investigated using side scan sonar and a remotely operated vehicle. The investigations were hampered by dense aquatic vegetation surrounding the site. Investigations focused on the northern half of the site where water depths greater than two feet (.61m) permitted access for the research vessel. In these areas no evidence of any wooden structures (pilings, docks, piers) were seen in any of the sonar or ROV work. However, an area of pilings does still exist in the southeast corner of the peninsula. The pilings could be seen from a distance, but extremely shallow water and dense aquatic vegetation prevented a close-up inspection (Figure 90).

Figure 90. Aerial view of A52 showing the area of investigation and an area where pilings are known to exist (courtesy Google Maps®).

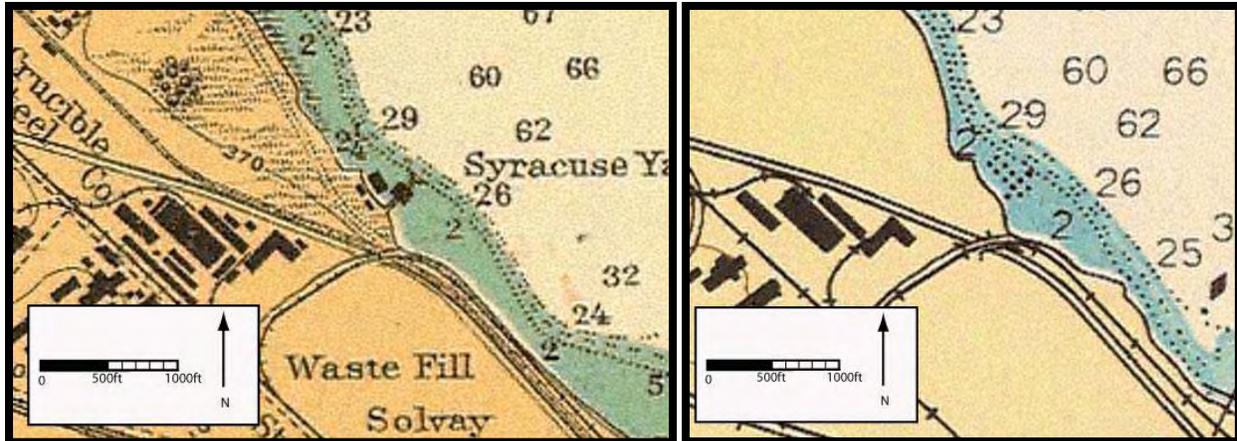
Analysis of lake charts suggests that the actual location of most of the Syracuse Yacht Club is below the peninsula which juts out into the lake (Figure 91). The shoreline is composed of slag fill likely from the adjacent Crucible Steel. Map overlays indicate that the boathouses are completely buried under fill, while the area of pilings on the southeastern edge of the peninsula is likely part of the clubhouse.

Figure 91. 1915 (left) and 1947 (right) navigational charts showing the location of the Syracuse Yacht Club (U.S. Lake Survey Office, *Chart No. 5, New York State Canals, Brewerton to Cross Lake and Syracuse to Oswego*, 1915; and U.S. Lake Survey Office, *New York State Canals, Chart No. 185*, 1947).

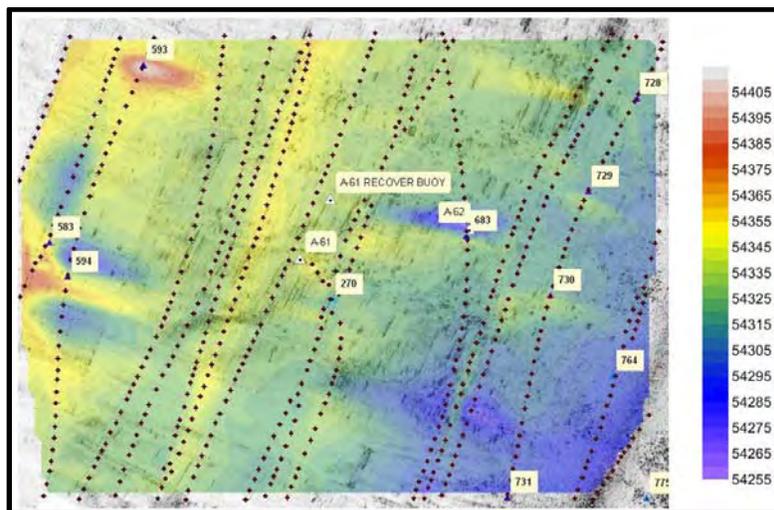
Figure 96. Graphical overlay of fine-scale magnetism and side scan data on A61 and A62 (courtesy CRE).

Anomaly 62 was approximately co-located with anomaly #683 digitized from CRE’s 2005 data (see Figure 96). Water depth was approximately 4 to 6 ft (1 to 2m). The anomaly nearest A62 (#683) was characterized as a 71nT dipole. Assuming a distance (range) of 7 to 16ft (2 to 5m), the ferrous mass of the A62 anomaly might be 24 to 397lb (11 to 180 kg). Side scan sonar data collected in the vicinity of these anomalies in 2005 did not suggest the presence of surficial contacts (debris or structures). Anomaly 62 was not located despite extensive visual diver examination and metal detecting.

LCMM recommends no further work on A61.
