Anomaly 53: Canal Boat

Anomaly 55: Canal Scow

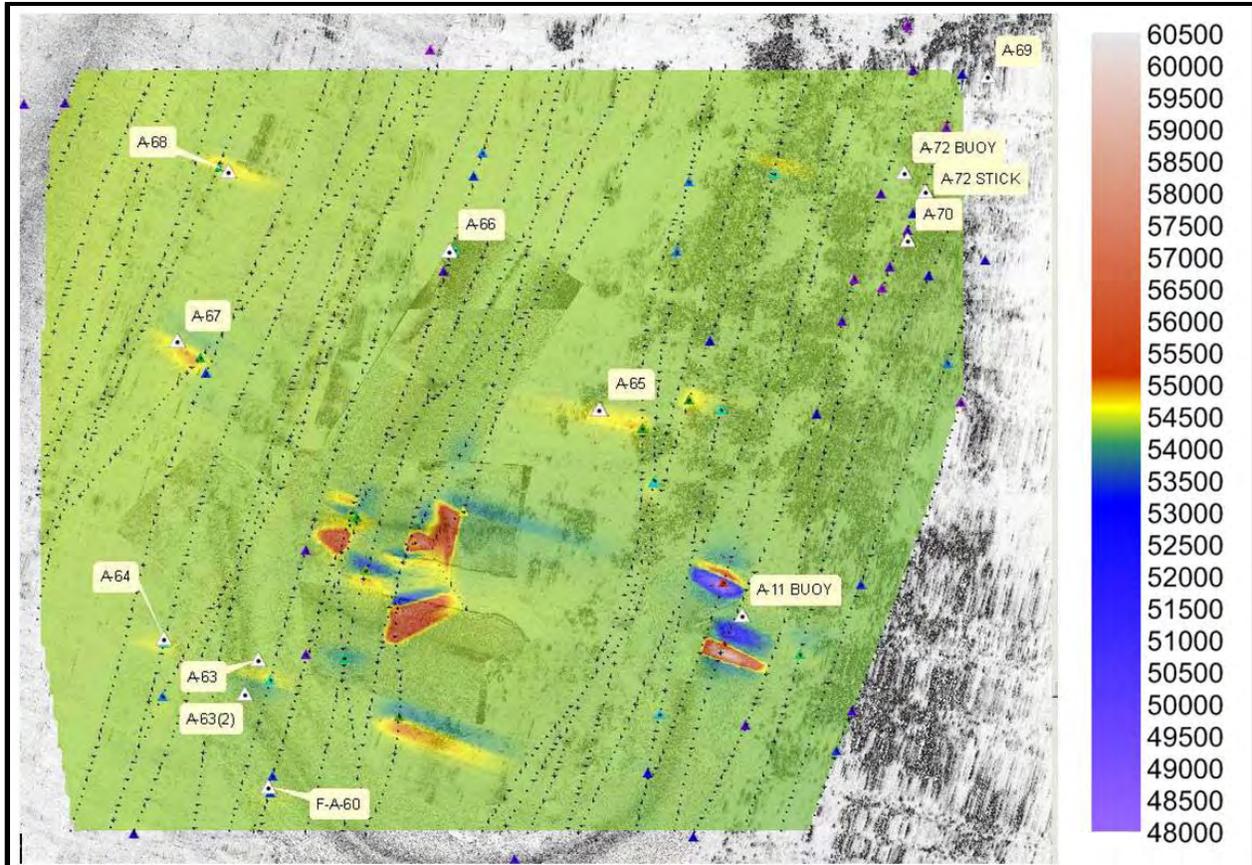
Anomaly 64 was co-located with 2005 magnetic anomaly #584, characterized as a 289nT dipole (Figure 97). It was located in 2-5ft (1-2m) of water. Assuming a distance (range) of 7 to 16ft (2 to 5 m), the ferrous mass of the A64 anomaly might be 101 to 1593lb (46 to 723kg). Side scan sonar contacts were not observed in 2005 data collected at this location. Anomaly 64 was not located despite extensive visual diver examination and metal detecting in 2011.

Figure 97. Graphical overlay of fine-scale magnetism and side scan data for A64, A65, A66, A67, and A70 (courtesy CRE).

LCMM recommends no further work on A64.
