Lake Champlain Maritime Museum (LCMM) concluded that the Phase 1B underwater archaeological research undertaken in Onondaga Lake demonstrated that several archaeological remains still lie on the lake bottom. Overall, these properties tend to be well-preserved, although many lie partly or largely buried below the lake bottom. The Phase 1B survey examined 60 anomalies of which 20 are recommended as eligible for the NRHP, while 18 were culturally derived features which are recommended as ineligible for the NRHP. Three of the anomalies were non-cultural, 15 remain unidentified, and four are identified but their NRHP status remains unevaluated.

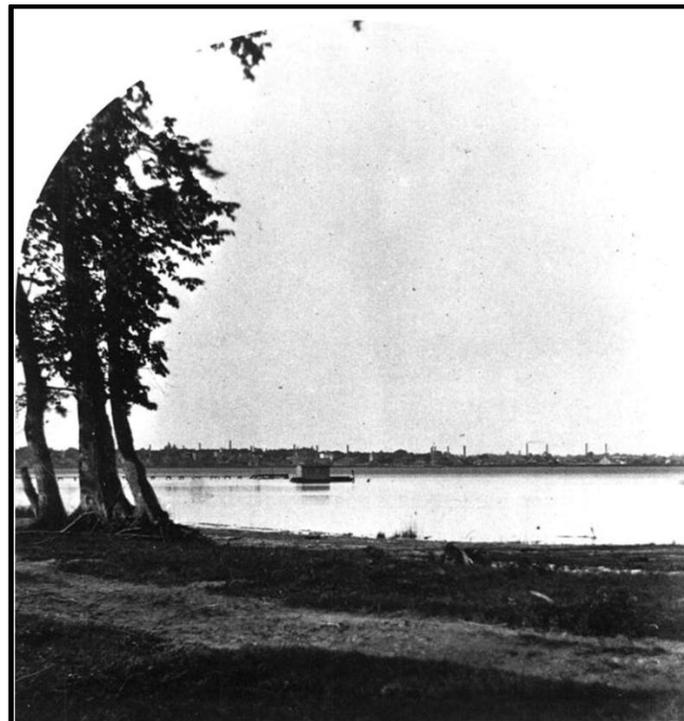
Figure 102. Lake View Point in 1878 (Smith, *Syracuse and Its Surroundings*, p115).

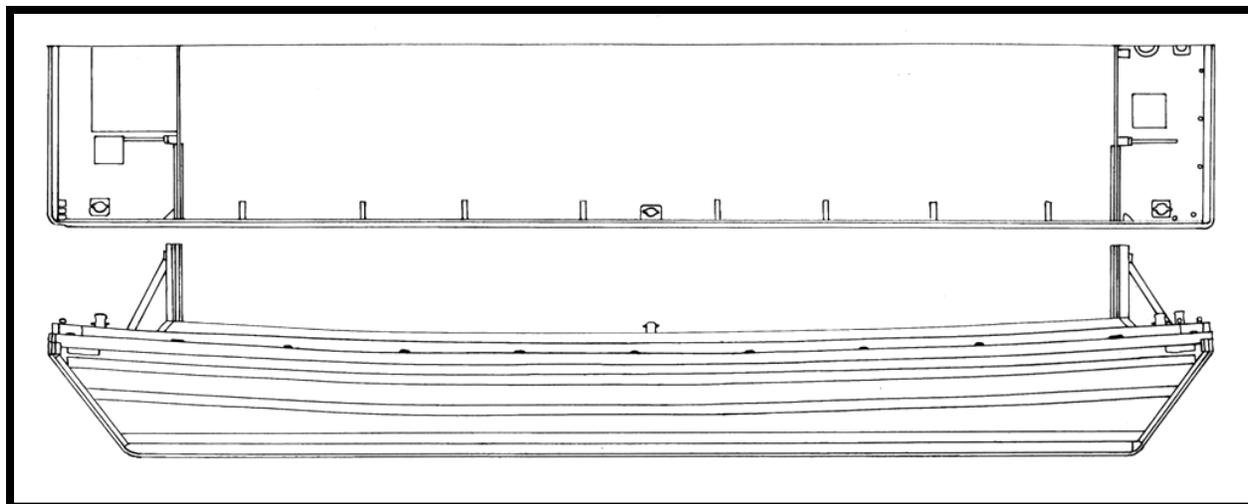
Figure 110. Plan view and profile of a rock scow (from the Feeney Collection at the Hudson River Maritime Museum in Kingston, New York, inked by Adam Kane).<sup>148</sup>

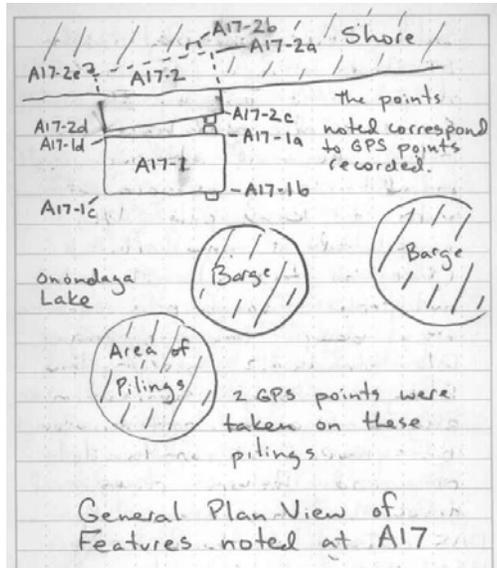
1550	Arrive at marina.
	1600	AK departs to go out to buy chest waders.
	1640	AK returns to marina with waders.
	1650	Depart marina.
	1705	Arrive hotel. End of day.
<b>June 27, 2011</b>		
	0700	Arrive marina. ST, AK & CS. Already at marina, SD & CW of CRE and KM & Pete Petrone of Parsons. Load gear. The plan for today is to document the barges at A17, followed by more shallow water survey in the afternoon.
	0745	Safety briefing.
	0820	Depart marina for A17.
A17	0830	Arrive A17. Proceed to document A17-2 (inshore barge) and A17-1 (outer barge). The barges are identical spud barges. The ends closest to the spud holders are vertical with vertical planking. The sides are vertical sides, built plank-on-frame. Approximately half of A17-2 is buried below the shore. Much of the machinery is not visible and/or gone, as opposed to A17-1, where the flywheel and other machinery is evident. The non-spud holder end of the barge is raked with transverse planking. Phragmites cover about 1/2 of A17-2. A17-1 was not documented in as much detail as A17-2 because it will not be impacted by the proposed shoreline improvements. Much of the interior structure of A17-1 is clearly visible, all the way down to the stringers and floors. The barges are both very shallow with a depth of +/- 3'. The hull structures consisted of planking, floors, and stringers. Those three, all connected, made up the entire depth of hull. The non-spud end of A17-1 had a mound of concrete immediately adjacent to it. Inspection of the concrete suggested that it was formed by pouring it into

that end of the barge, likely as ballast for the spuds and machinery on the other end. It was likely pulled out and dumped so that the vessel could be pulled into shallow water next to A17-2. While departing A17, a series of pilings were seen from the boat with tops about 4' from the surface. Visual examination elsewhere around A17 showed that there were at least two other offshore barges, however, extremely dense vegetation (particularly inside the barges) make it impossible to conclusively determine the extent of the barge remains. The pilings appear to correspond with the two barges onshore indicating that the barges formed the shore end of a pier structure.
