## DEPARTMENT OF THE ARMY

BUFFALO DISTRICT, CORPS OF ENGINEERS  
1776 NIAGARA STREET  
BUFFALO, NEW YORK 14207-3199

SUBJECT: FY07 Joint Routine Inspection of Completed Works, Flood Damage Reduction Project, Onondaga Creek, Nedrow, New York (9/13/07)

**Attachment “A” - Project Inspection Photographs**

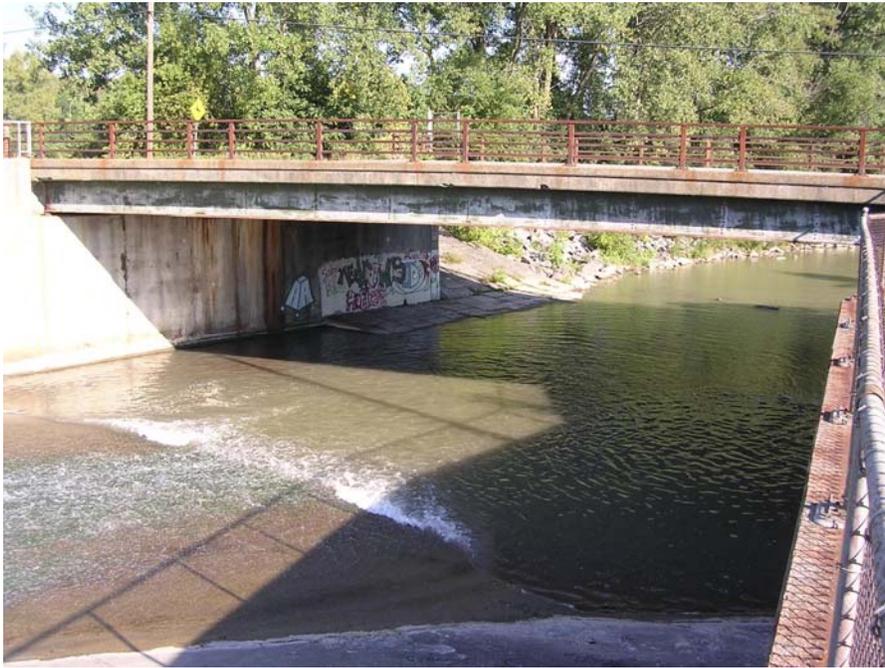
**Photo 1: Upstream limit of Onondaga Creek, Syracuse flood control project (looking downstream at Dorwin Ave. bridge) – abuts Onondaga Creek, Nedrow project.**

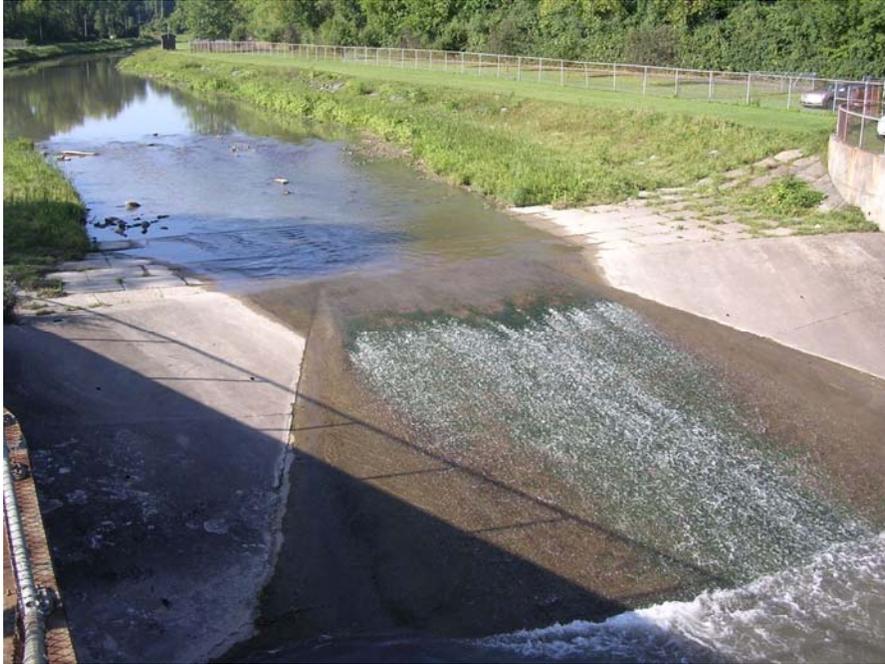
**Photo 3: Drop structure at upstream limit of Onondaga Creek, Syracuse flood control project – abuts Onondaga Creek, Nedrow project.**

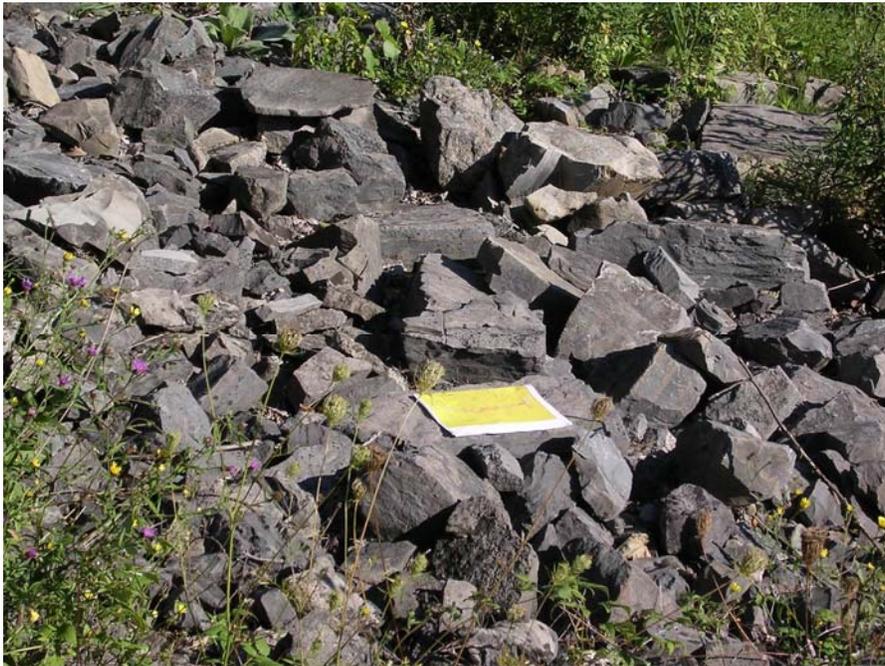
**Photo 8: Riprap on left bank of Onondaga Creek, approx. Sta. 37+00**

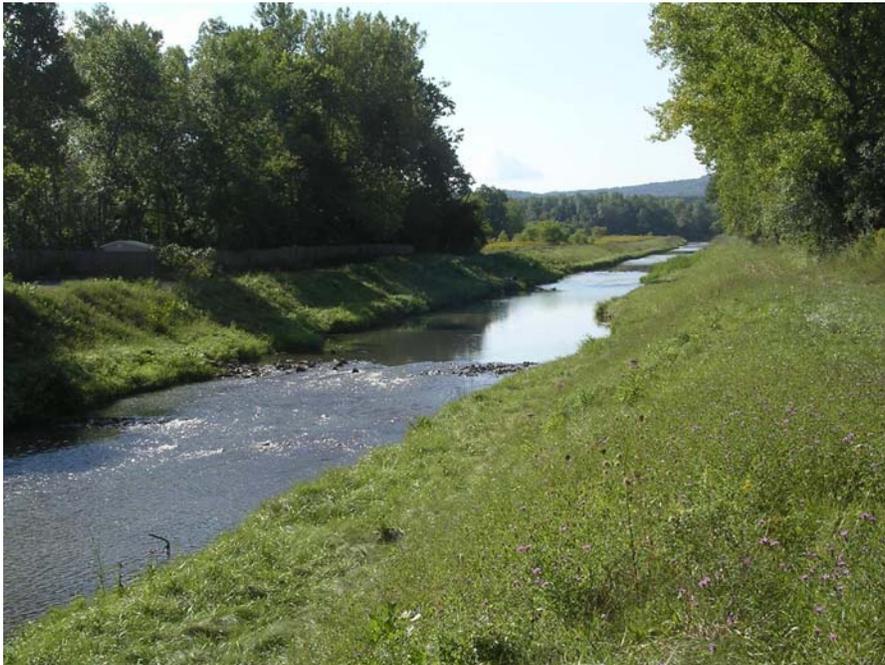
**Photo 10: Onondaga Creek, from approx. Sta. 25+00 (looking upstream).**
