SYOSSET LANDFILL

2018 ANNUAL POST-CLOSURE SUMMARY REPORT

TOWN OF OYSTER BAY

DEPARTMENT OF PUBLIC WORKS
SYOSSET, NEW YORK 11791

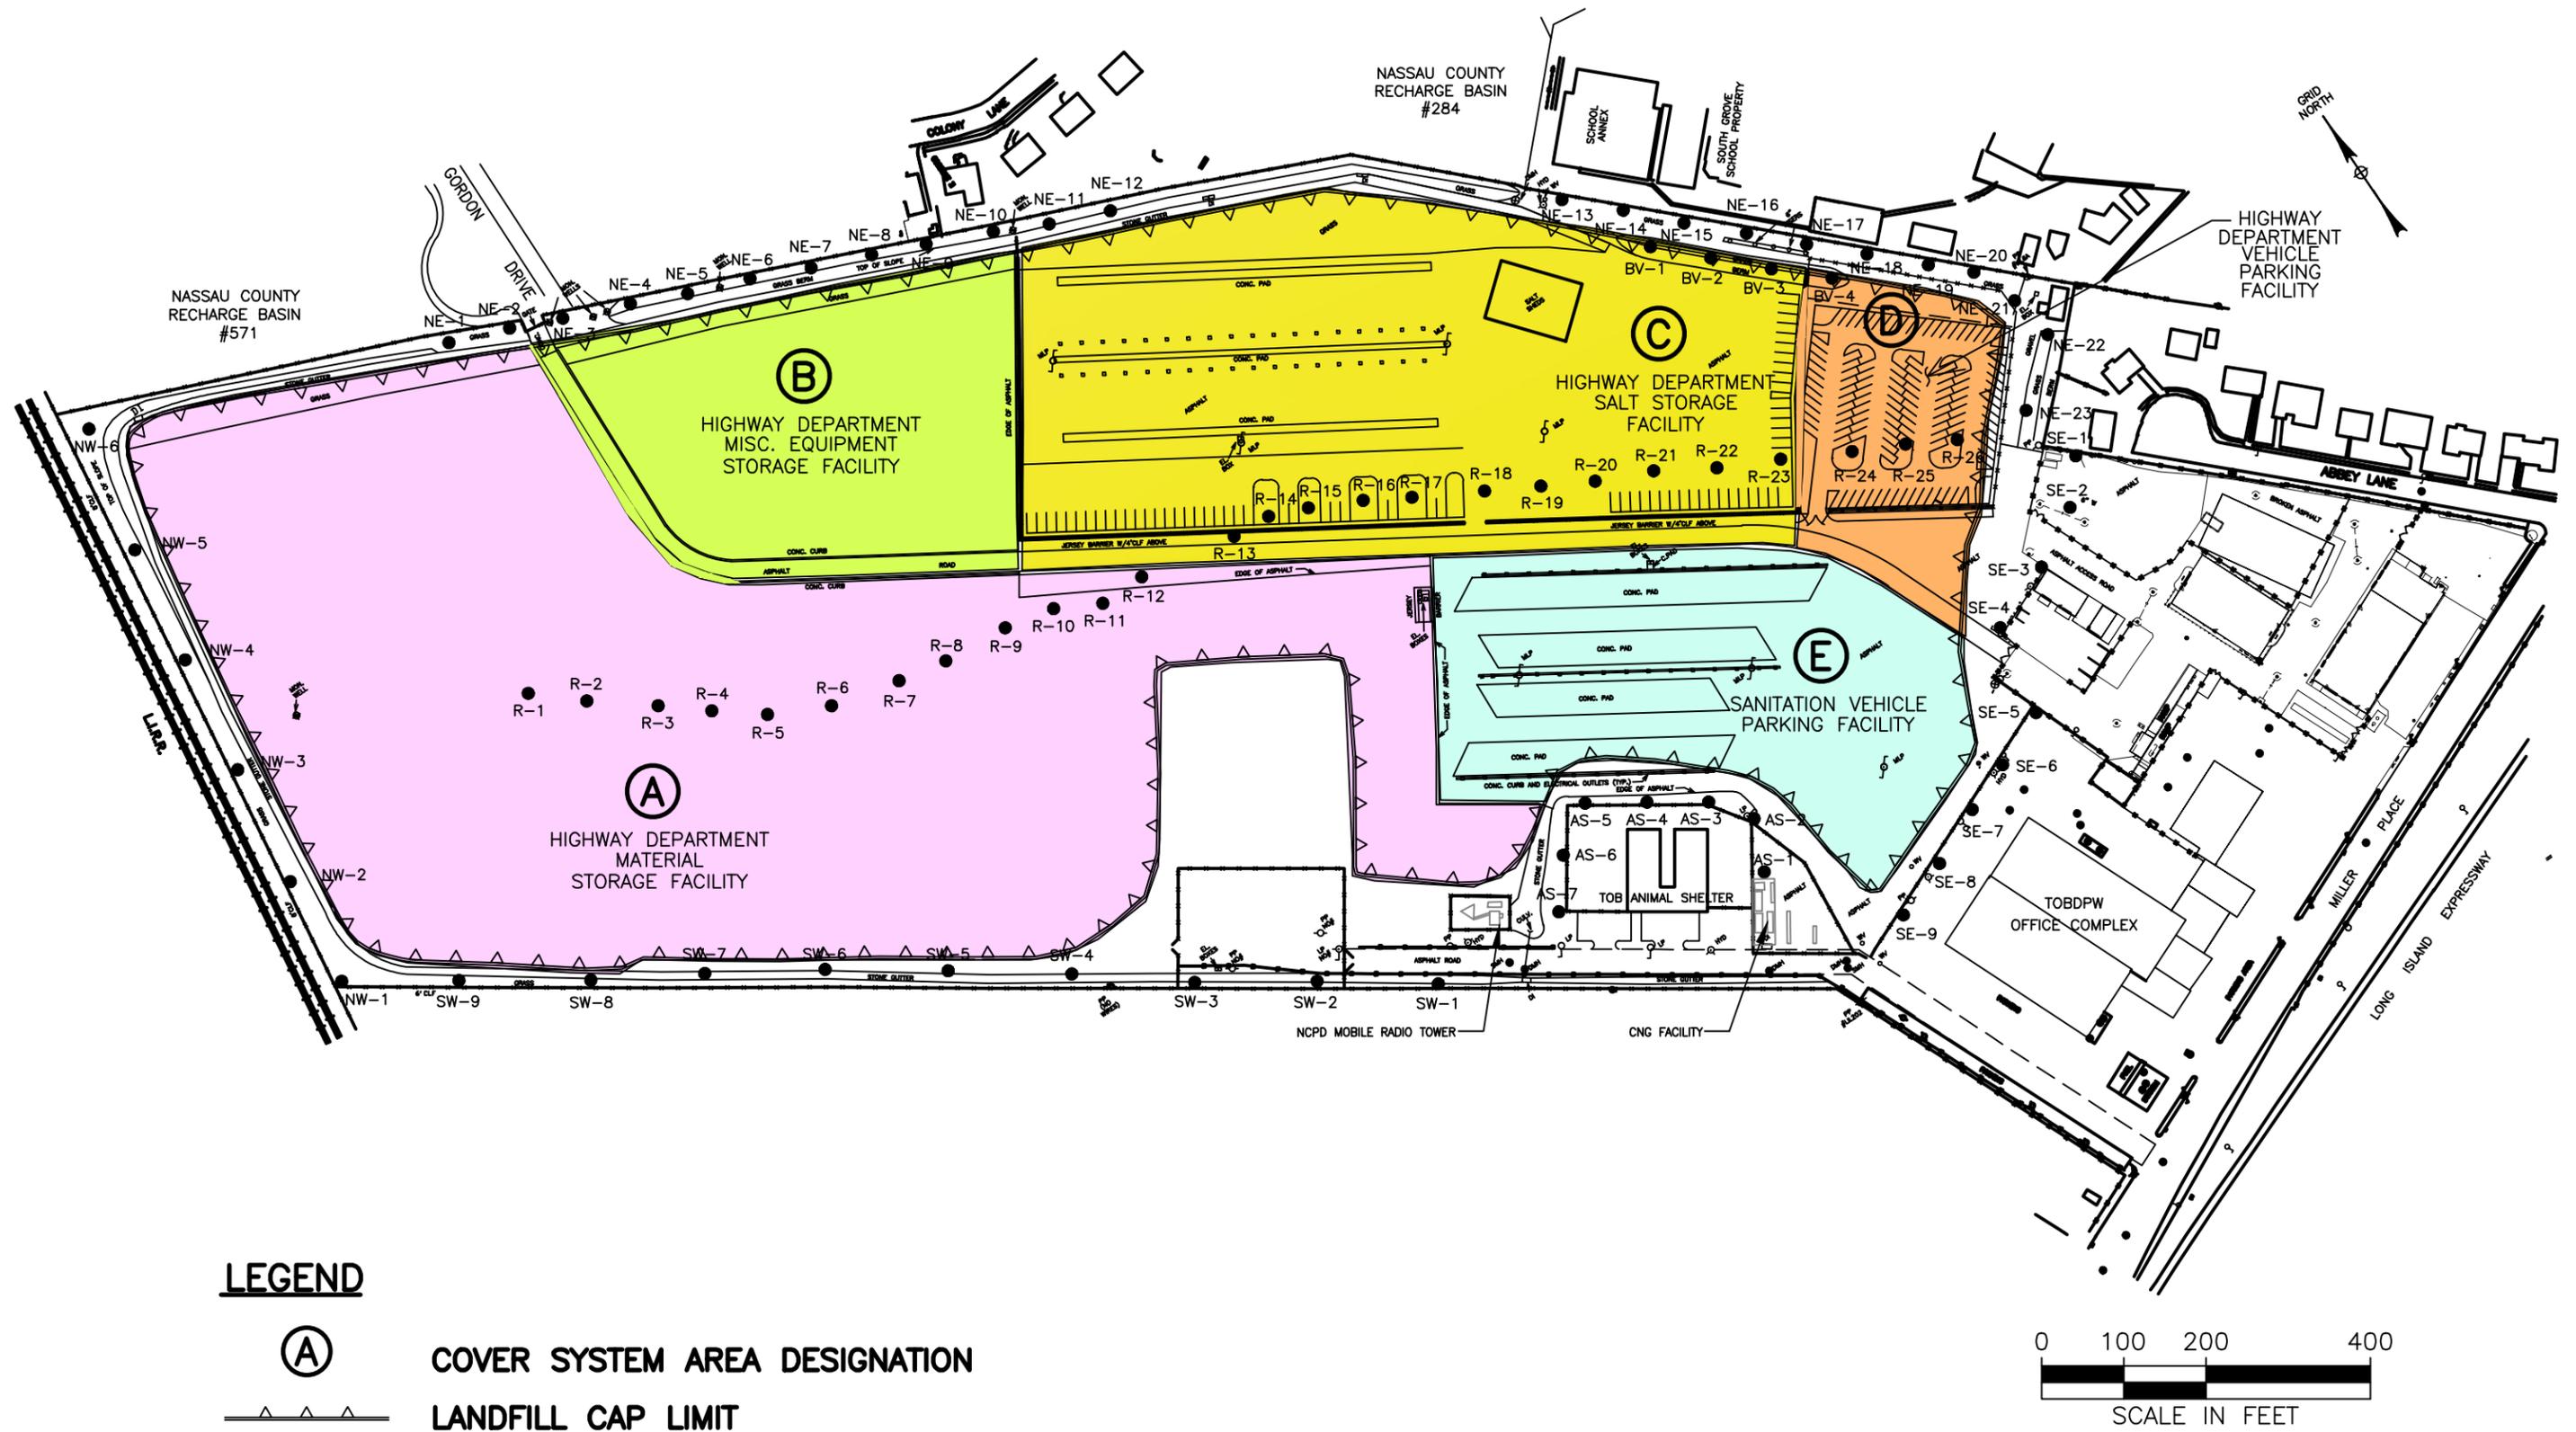
FIGURE 1
SYOSSET LANDFILL
COVER SYSTEM LOCATION PLAN

Three types of surface treatments were designated for use in particular areas of the site based on the anticipated future site uses. The site was divided into five different facilities as shown on Figure 1, Syosset Landfill Cover System Location Plan. The recycled concrete surface treatment was utilized in both the Highway Department's Material Storage Facility and the Miscellaneous Equipment Storage Facility (Areas A and B, respectively, on Figure 1). The asphalt concrete surface treatment was utilized in the Highway Department's Salt Storage Facility and Vehicle Parking Facility as well as the Sanitation Division Vehicle Parking Facility (Areas C, D and E, respectively, on Figure 1). The vegetative cover surface treatment was utilized in a buffer area along the northern property line in Areas A, B and C.

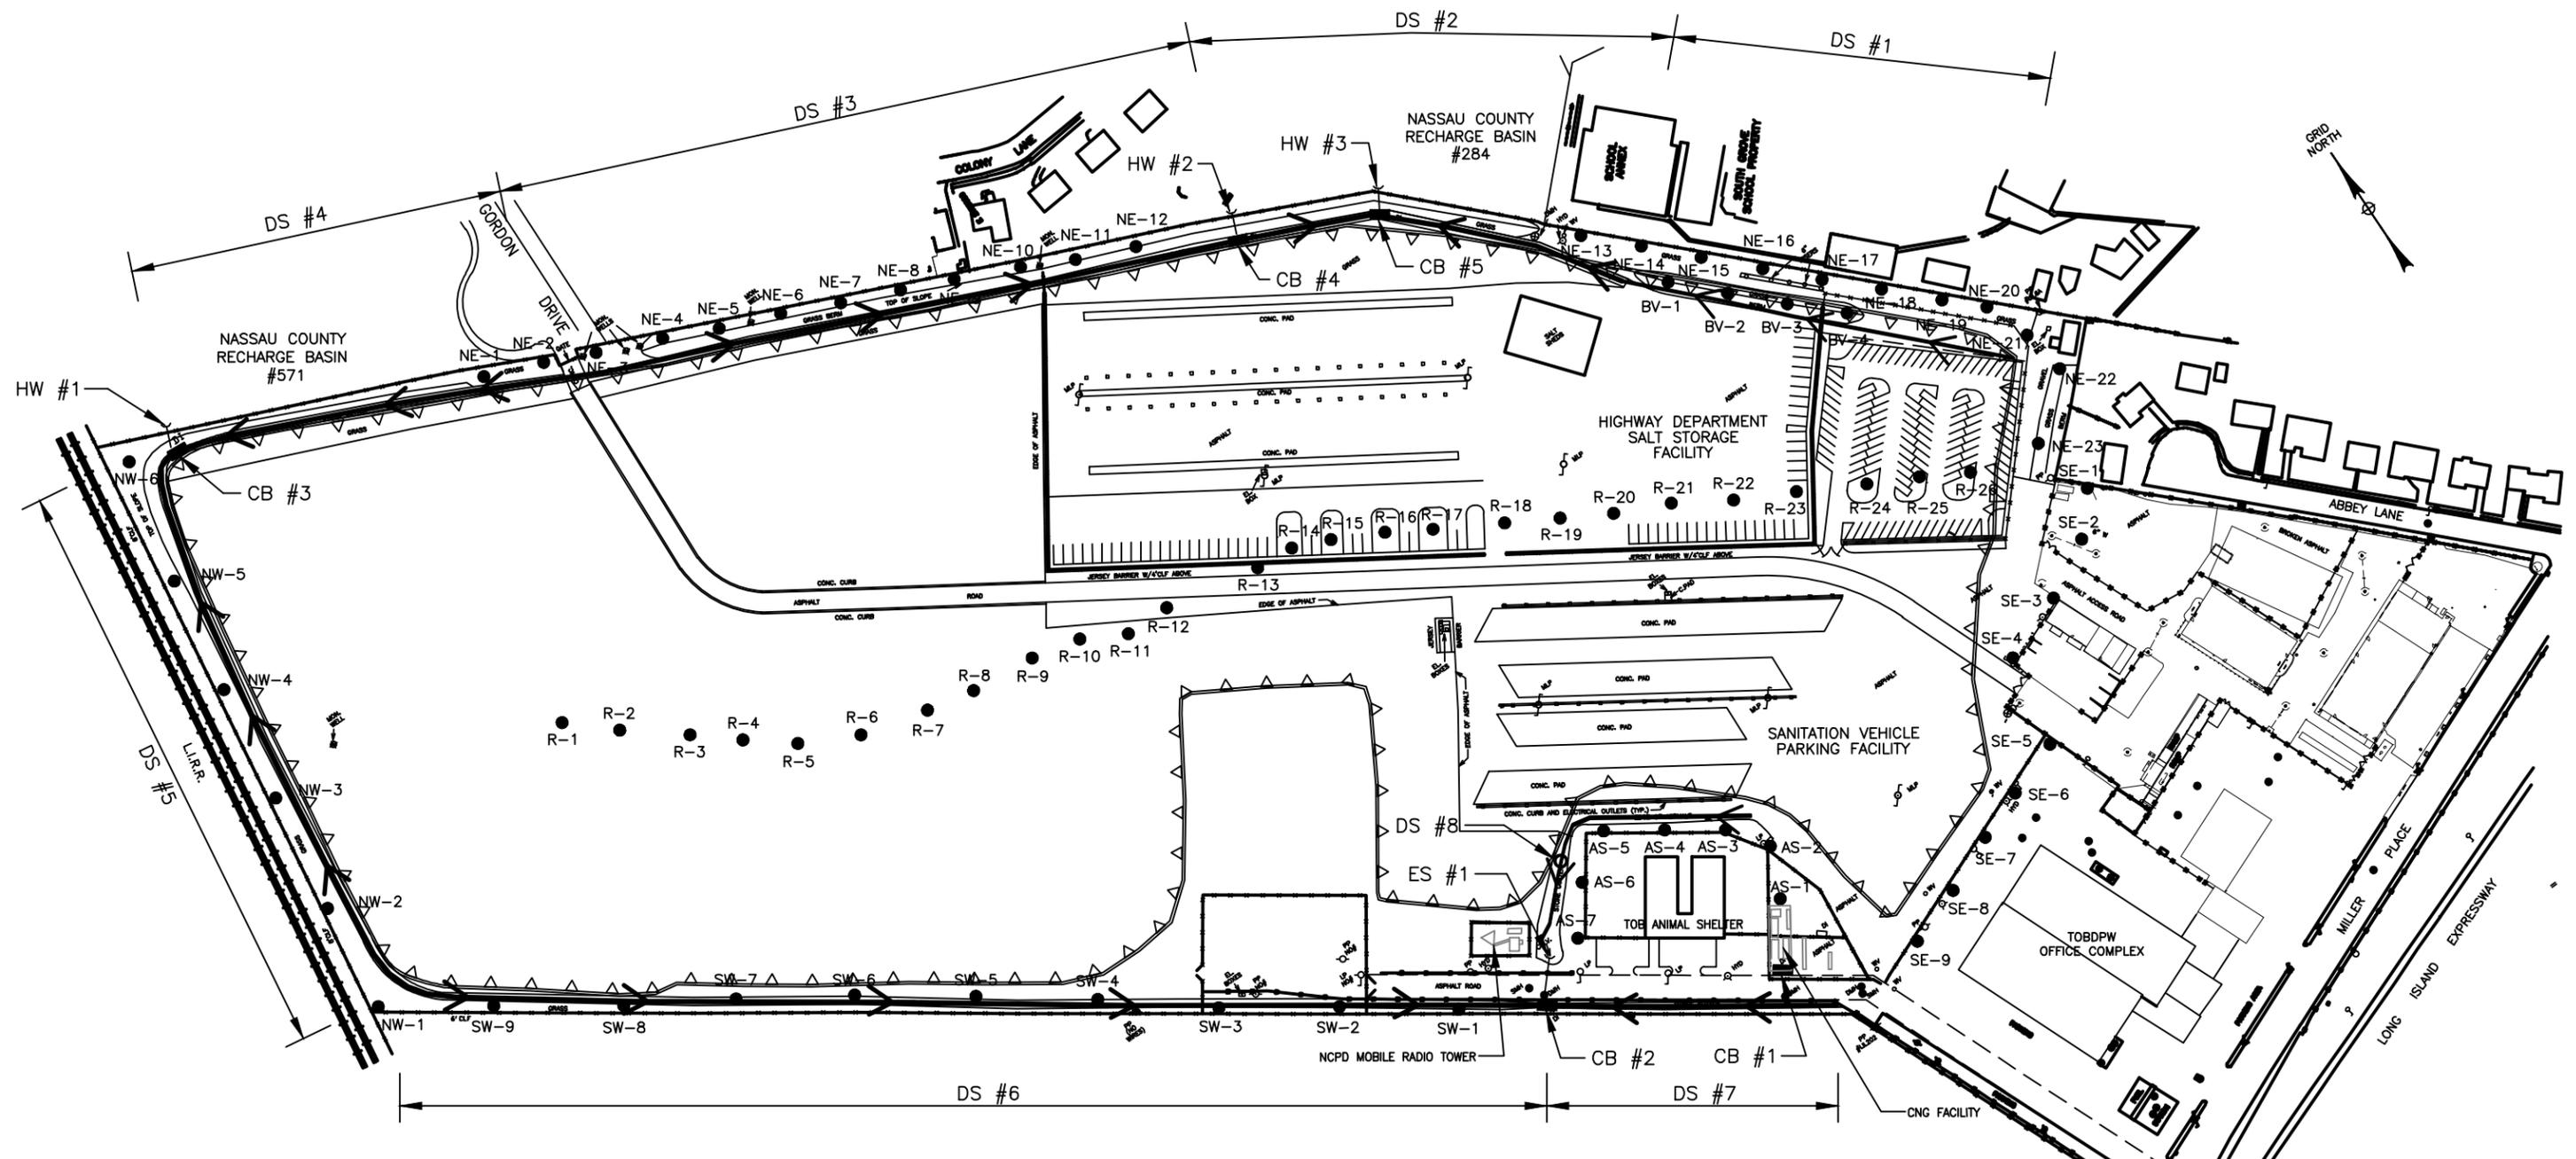
FIGURE 2
SYOSSET LANDFILL
DRAINAGE SYSTEM LOCATION PLAN

The storm drainage pipes were inspected at the some silting and slight debris were detected in the both rounds of inspections at the entrance to the end section located adjacent to the Animal Shelter (ES #1, see Figure 2) during the 2018 reporting period.
