**OPERATIONS & MAINTENANCE STATUS REPORT  
PERIOD: JULY 12, 2006 THROUGH MARCH 22, 2007**

**OPERABLE UNIT I  
FORMER WASTEWATER TREATMENT AREA  
METRO NORTH RAILROAD HARMON YARD  
CROTON-ON-HUDSON, NEW YORK**

**Prepared by:** Day Engineering, P.C.  
40 Commercial Street  
Rochester, New York 14614

**Date:** March 2007

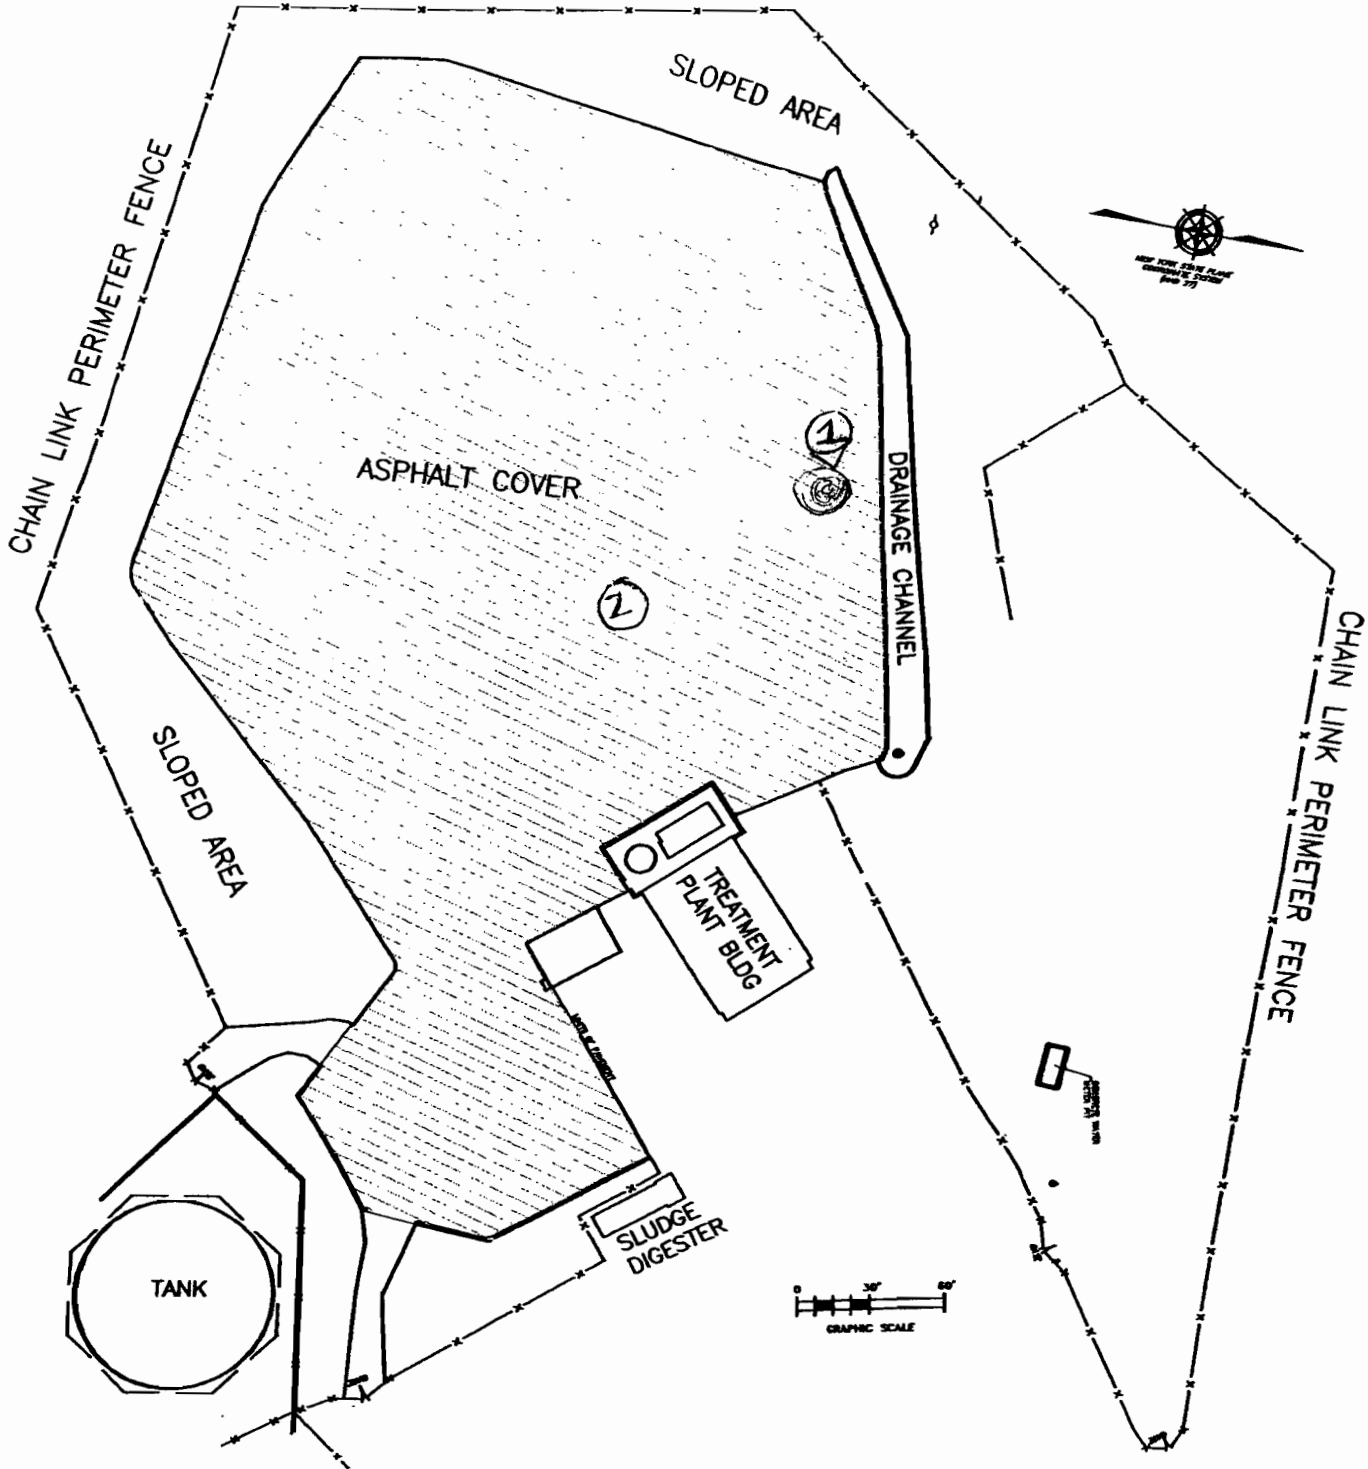
Radial cracks throughout. Minor area of settlement north of new drainage sump. Tentative plans to seal cracks during summer '07.

Snow covered at time of inspection prevents thorough look at all areas. Minor erosion south of LA blower bldg. will be addressed during Spring/Summer. Some trash observed.
