# **Record of Decision (ROD) Implementation Report of Findings**

## **Former C&F Plating Facility**

406 North Pear Street  
Albany  
Albany County, New York  
**NYSDEC Site No.: 401057**

Report Completed:  
October 4, 2016

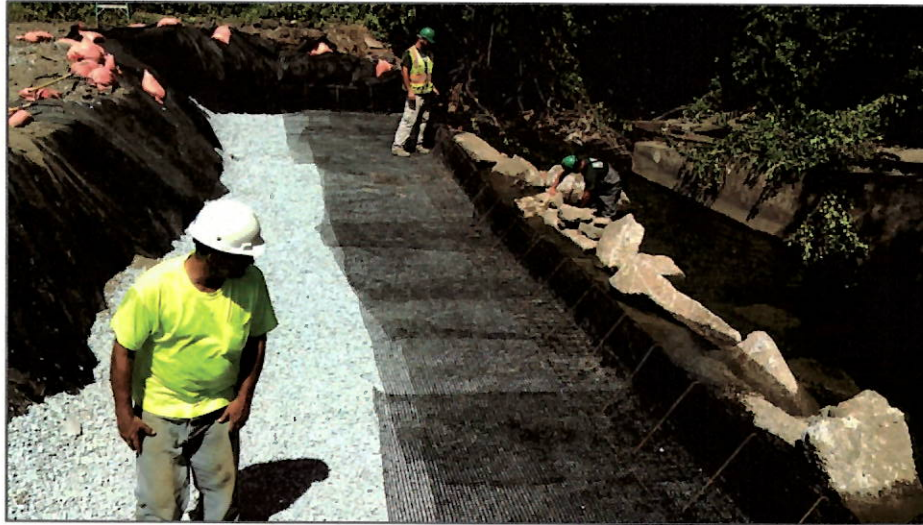
Prior to excavation process, engineering controls were required to facilitate safe and sound excavation and backfill activities occurring immediately adjacent to the Patroon Creek as the water

During the installation phase, large capacity sand bags were strategically placed in Patroon Creek to prevent sediment erosion and loading within the stream. The hydro barriers were left in place until a construction elevation was reached that exceeded the surface elevation of the stream.
