NYS DEC Region 4
Inactive Landfill Post-Closure Inspection Report

Facility Name & Location:	Berlin/Petersburgh Landfill County Route 37 (Jones Hollow Road, Petersburgh/Cold Spring Road, Berlin), Rensselaer County
Date of Site Visit:	April 15, 2016
DEC Staff Present:	Brian Maglienti – R4 DMM, John Weidman – R4 DMM
Others Present:	None
Background Information:	<p>The Berlin/Petersburgh Landfill is located in the Town of Petersburgh just north of the town line between the Towns of Berlin and Petersburgh. After maintaining adjacent disposal facilities for many years, the Towns began joint operation of the site in early 1982. In the early 90s, DEC notified the Towns that the landfill had been operated without a valid Part 360 permit since October 31, 1984 and required that Towns to stop accepting waste at the landfill by July 1, 1991. In 1990, Energy Answers Corporation (EAC) assumed operational responsibilities for the site and agreed to close the landfill in accordance with Part 360. EAC disposed of municipal solid waste in the landfill for approximately two years to establish proper closure grades and to generate revenue to pay for the closure. According to site documents, the landfi

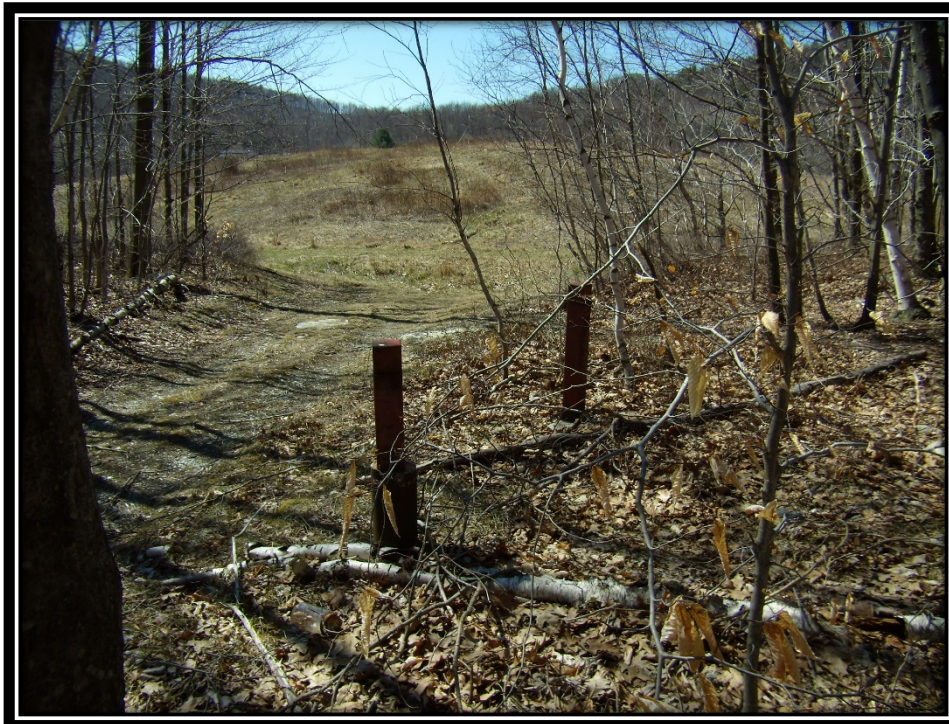
Photo 3: View of the landfill looking south from the location of MW couplet #1/#1A, located in the woods just off the landfill footprint.

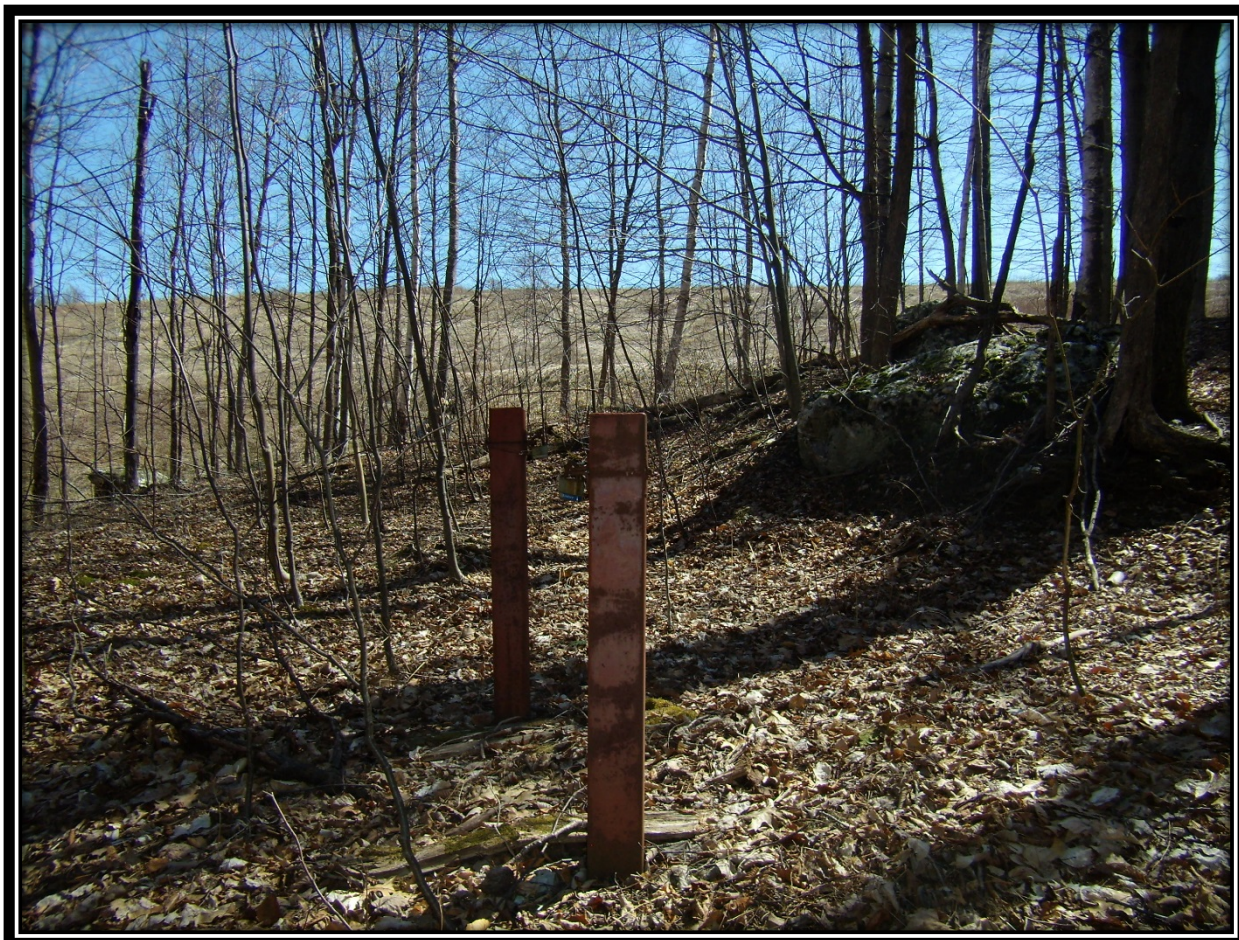
Photo 4: View of the landfill looking east from the location of MW couplet #3/#4 located along top of the southern edge of the ravine leading to Jones Hollow
