Metalico Aluminum Recovery, Inc.

Re: *Former Roth Bros Smelting Corp. Site
6223 Thompson Road, DeWitt, New York
Consent Order C7-0001-94-10*

REPORT

Former Roth Bros. Smelting Corporation Site Corrective Action Management Unit (CAMU) Evaluation of Asphalt Break in Area Adjacent to CAMU

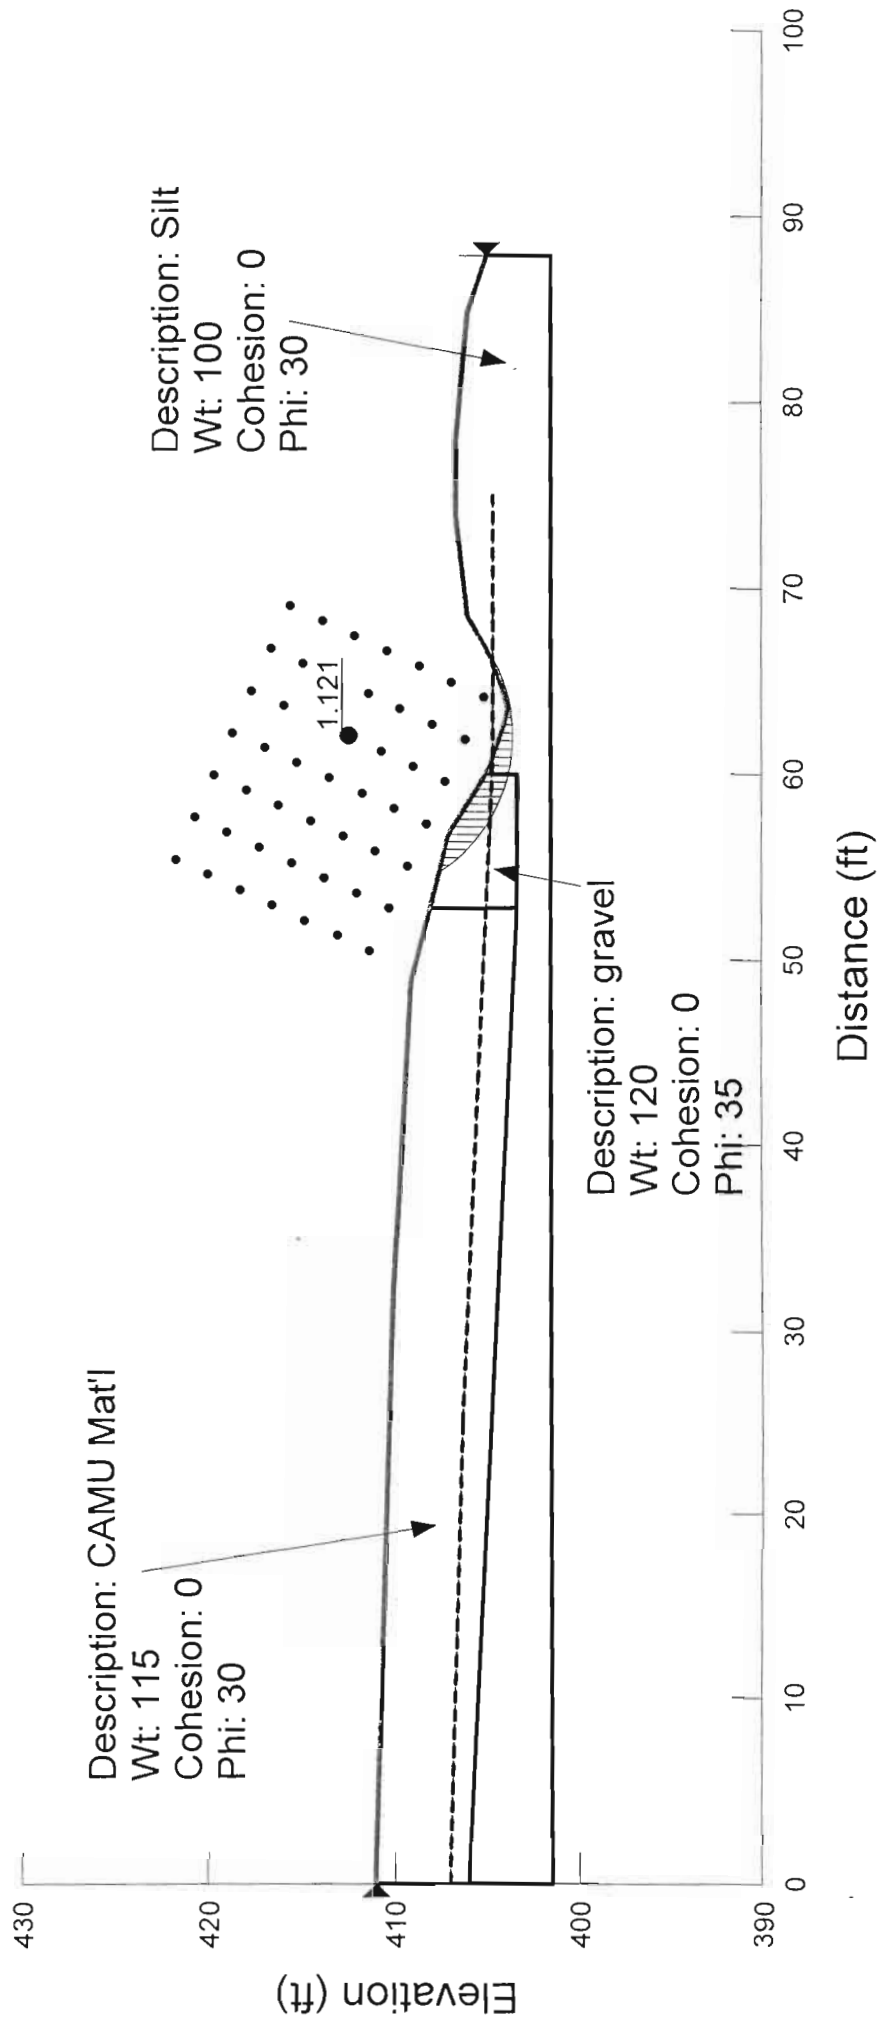
Metalico, Inc.
Slope Stability of CAMU Edge
5/5/08
Low Water Condition

The slope stability analyses calculated that the existing slope is marginally stable (Factor of Safety of 1.0) with low water table conditions, and that failure would be surficial, which is similar to the observed pavement damage. According to the Naval Facilities Engineering Command (NAVFAC), a Factor of Safety of 1.5 is considered stable for static conditions.

The slope stability analyses also showed that the existing slope would have a Factor of Safety less than 1.0 with high water table conditions. Based on these analyses and our visual examination of the area, we believe that the pavement failure is a surficial slope failure. The small section of missing pavement is on the steepest slope adjacent to the CAMU.

The missing asphalt therefore appears to have been caused by the creation of a slope that was too steep to maintain stability of the asphalt.

O'Brien & Gere recommends extending the 21-in storm drain pipe approximately 20 ft north and regrading this slope off the eastern edge of the CAMU over the storm pipe to match grades on the railroad side of the swale. Extending the 21-in storm drain will convey water away from the toe of the slope in the critical area while still providing capacity to transmit surface water flow.

Regrading the slope over the pipe to meet grades on the railroad side of the swale will reduce slope grade to a stable configuration. Slope stability checks of the area calculate a Factor of Safety of 3.4 after regrading, even with high water table conditions.
