REMEDIATION SUMMARY REPORT

VAN DER HORST PLANT NO. 2 SITE
CITY OF OLEAN, CATTARAUGUS COUNTY
CONTRACT NO. D003337
SITE NO. 9-05-022

REMEDIATION SUMMARY REPORT
VAN DER HORST PLANT #2
SOIL CONSOLIDATION AND CAPPING PROJECT

NYSDEC Site No. 9-05-022
Contract No. - D-0003337
Olean, New York

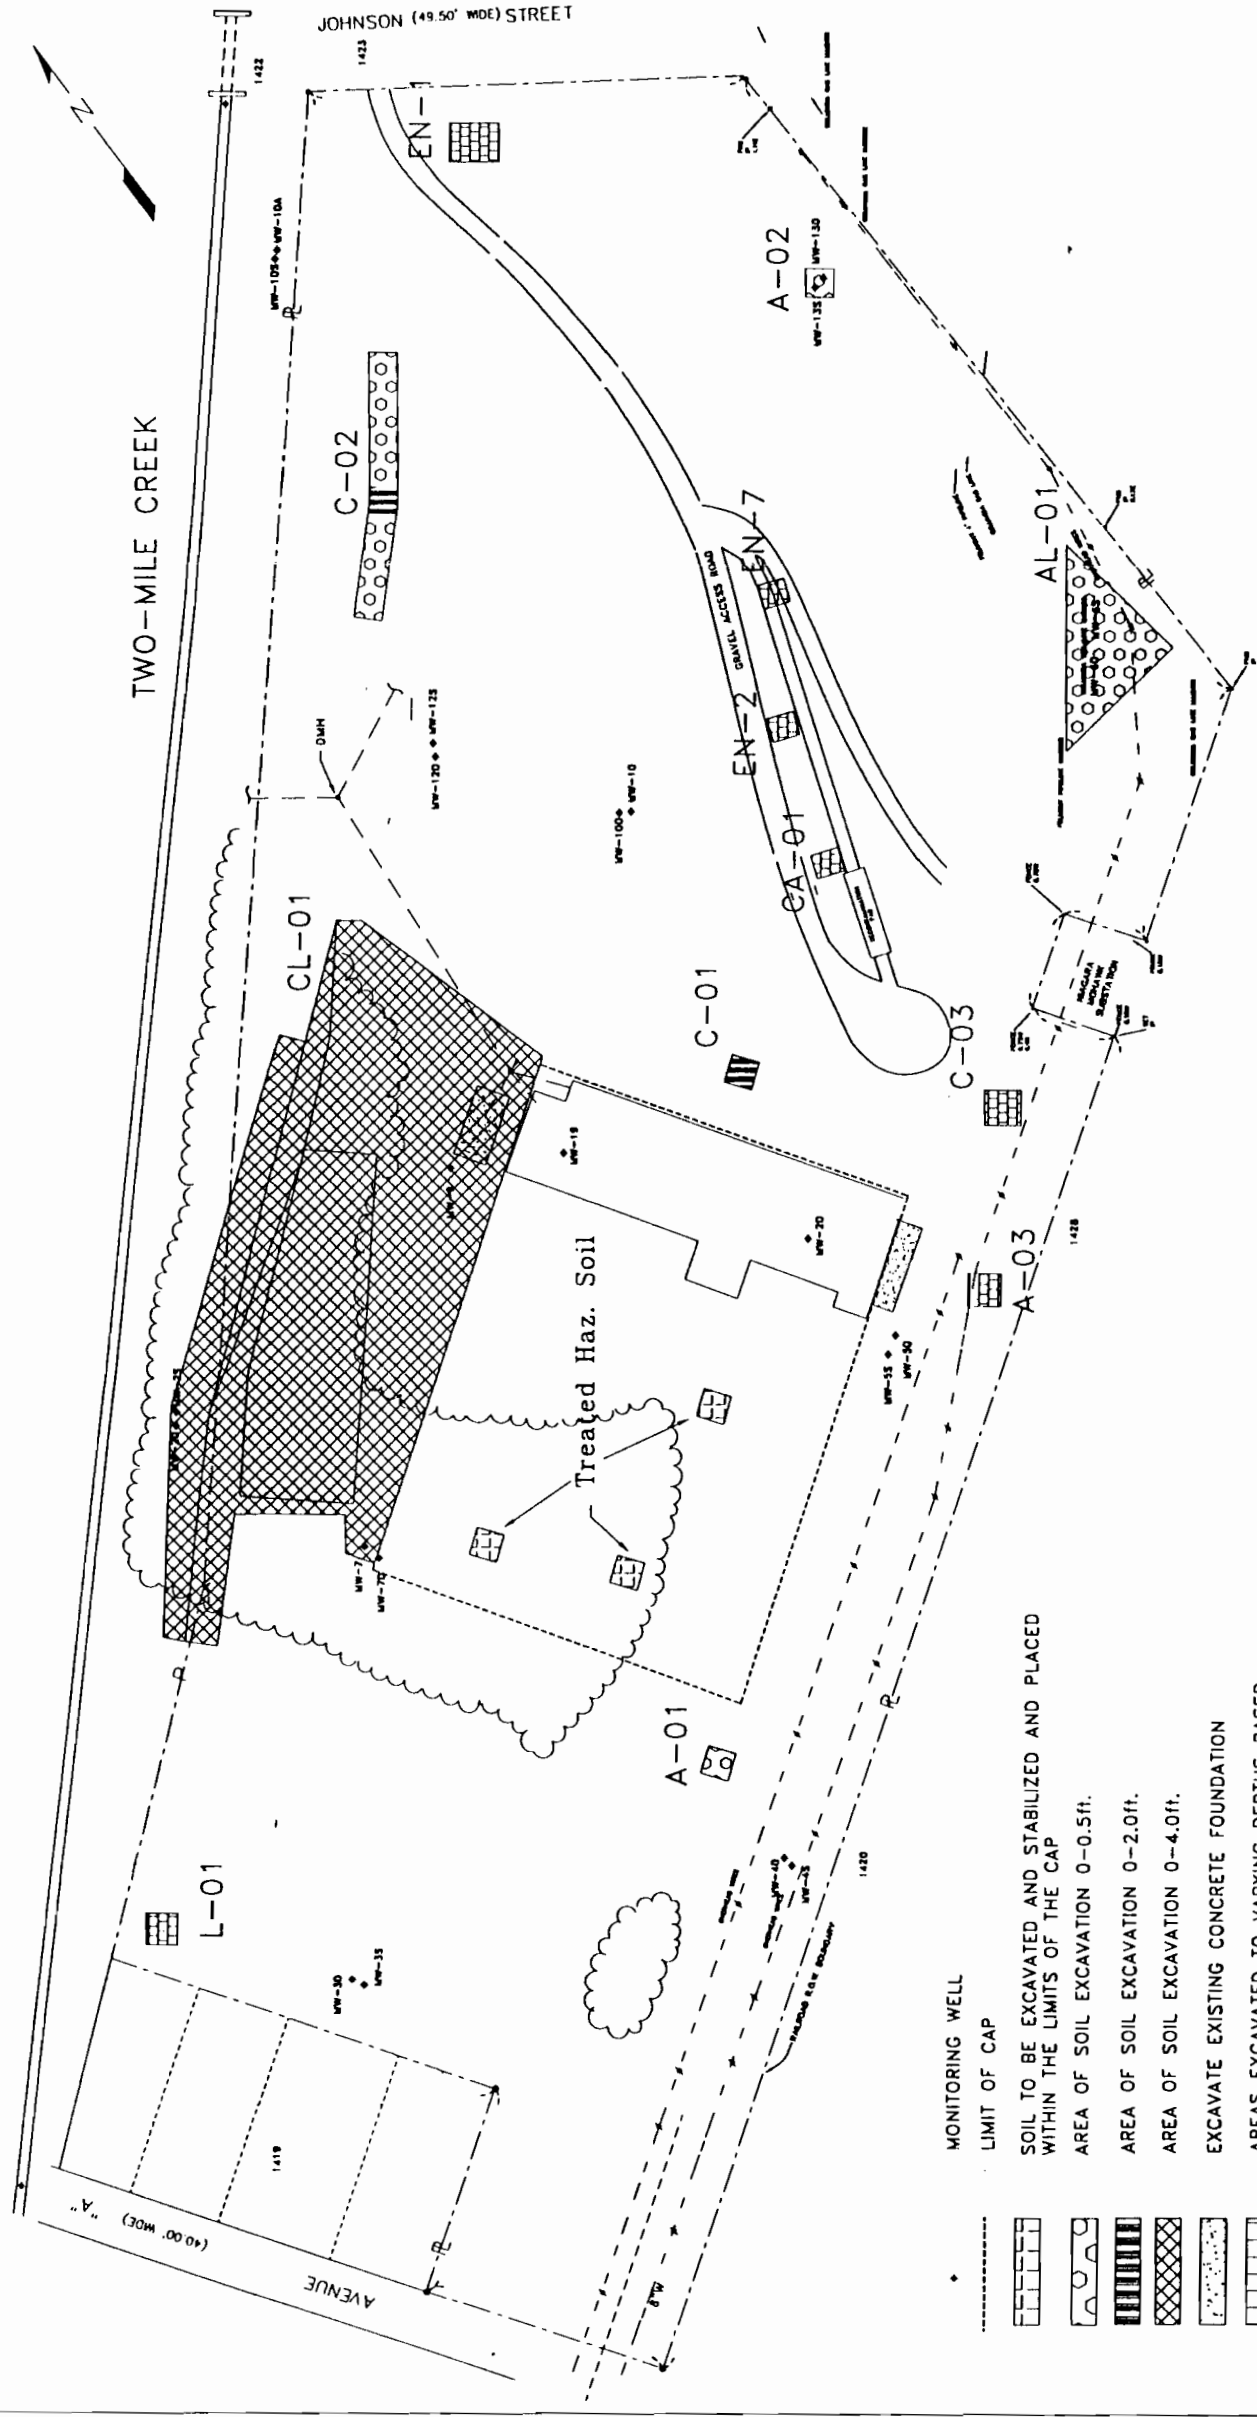
Figure 4

A total of 16 separate site excavations were conducted at the site during the remedial work. The locations of the various excavations are shown in Figure 4. The excavations were located based on samples collected during the remedial investigation of the site. In addition, during the collection of exit samples from the Demolition Project and collection of entrance samples during this project,
