## **2022 PERIODIC REVIEW REPORT SPECIAL METALS CORPORATION DUNKIRK, NEW YORK NYSDEC Site Number 907031**

March 10, 2022

Re: 2022 Periodic Review Report (NYSDEC Site No. 907031)  
Special Metals Corporation  
100 Willowbrook Avenue  
Dunkirk, New York

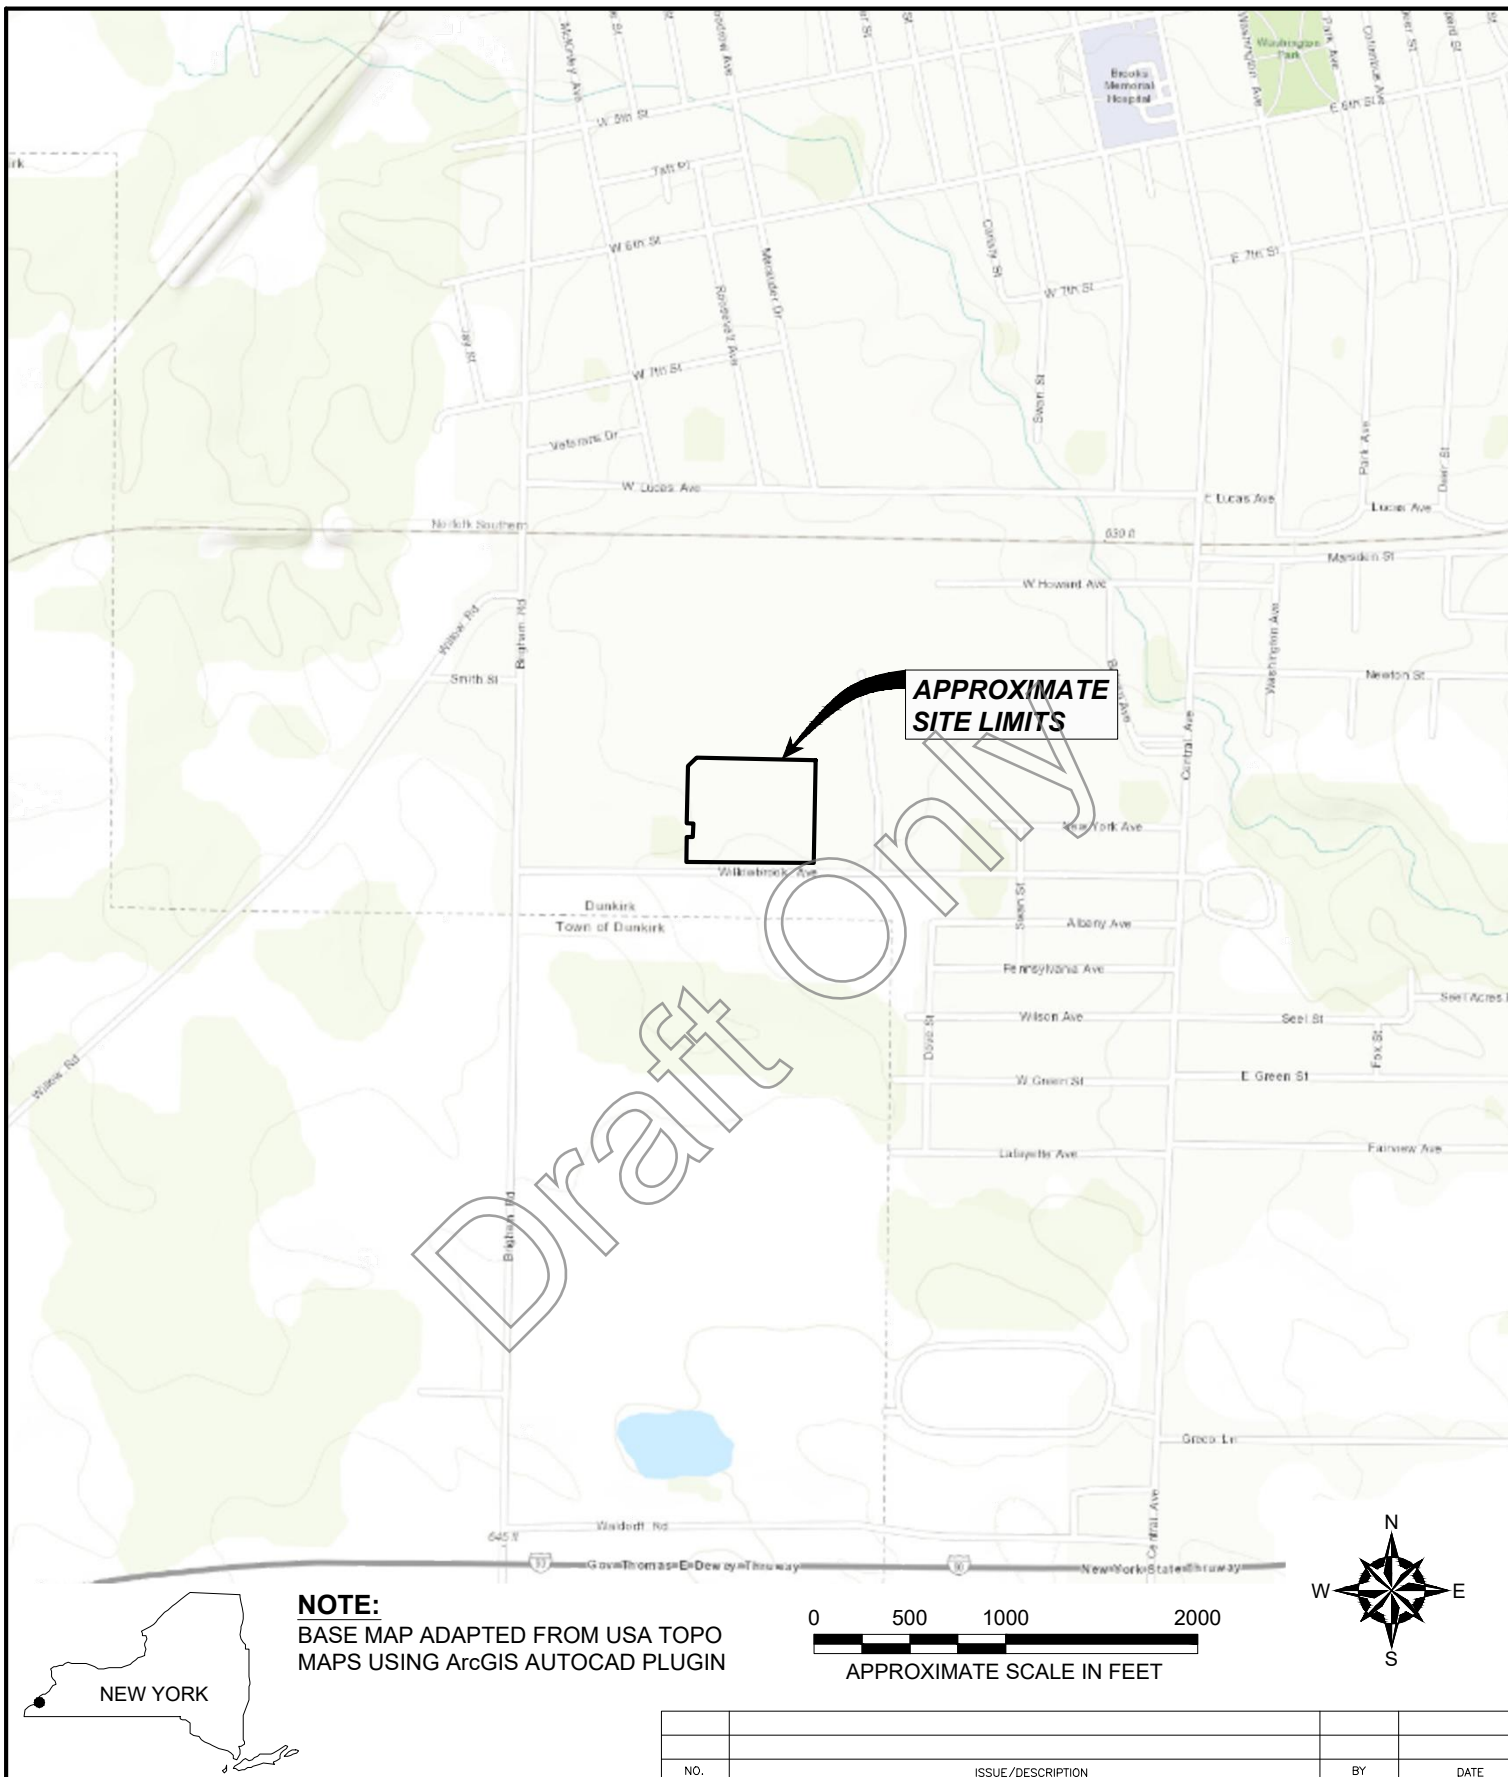
**NOVEMBER 22, 2019**  
**SITE INSPECTION PHOTO LOCATIONS**

<p>One small area of asphalt located approximately 75-feet NNE of the guard house in need of repair.</p> <p style="text-align: center;">See Figure.</p>		
<b>INTRUSIVE ACTIVITIES PLANNED FOR AREA OF CONCERN</b>		
	<b>DATE</b>	<b>LOCATION</b>
None		
<b>ADDITIONAL NOTES &amp; COMMENTS</b>		
<p>Security fence is complete and in good condition.</p> <p>Healthy grass on soil cover system.</p> <p>See photo log.</p>

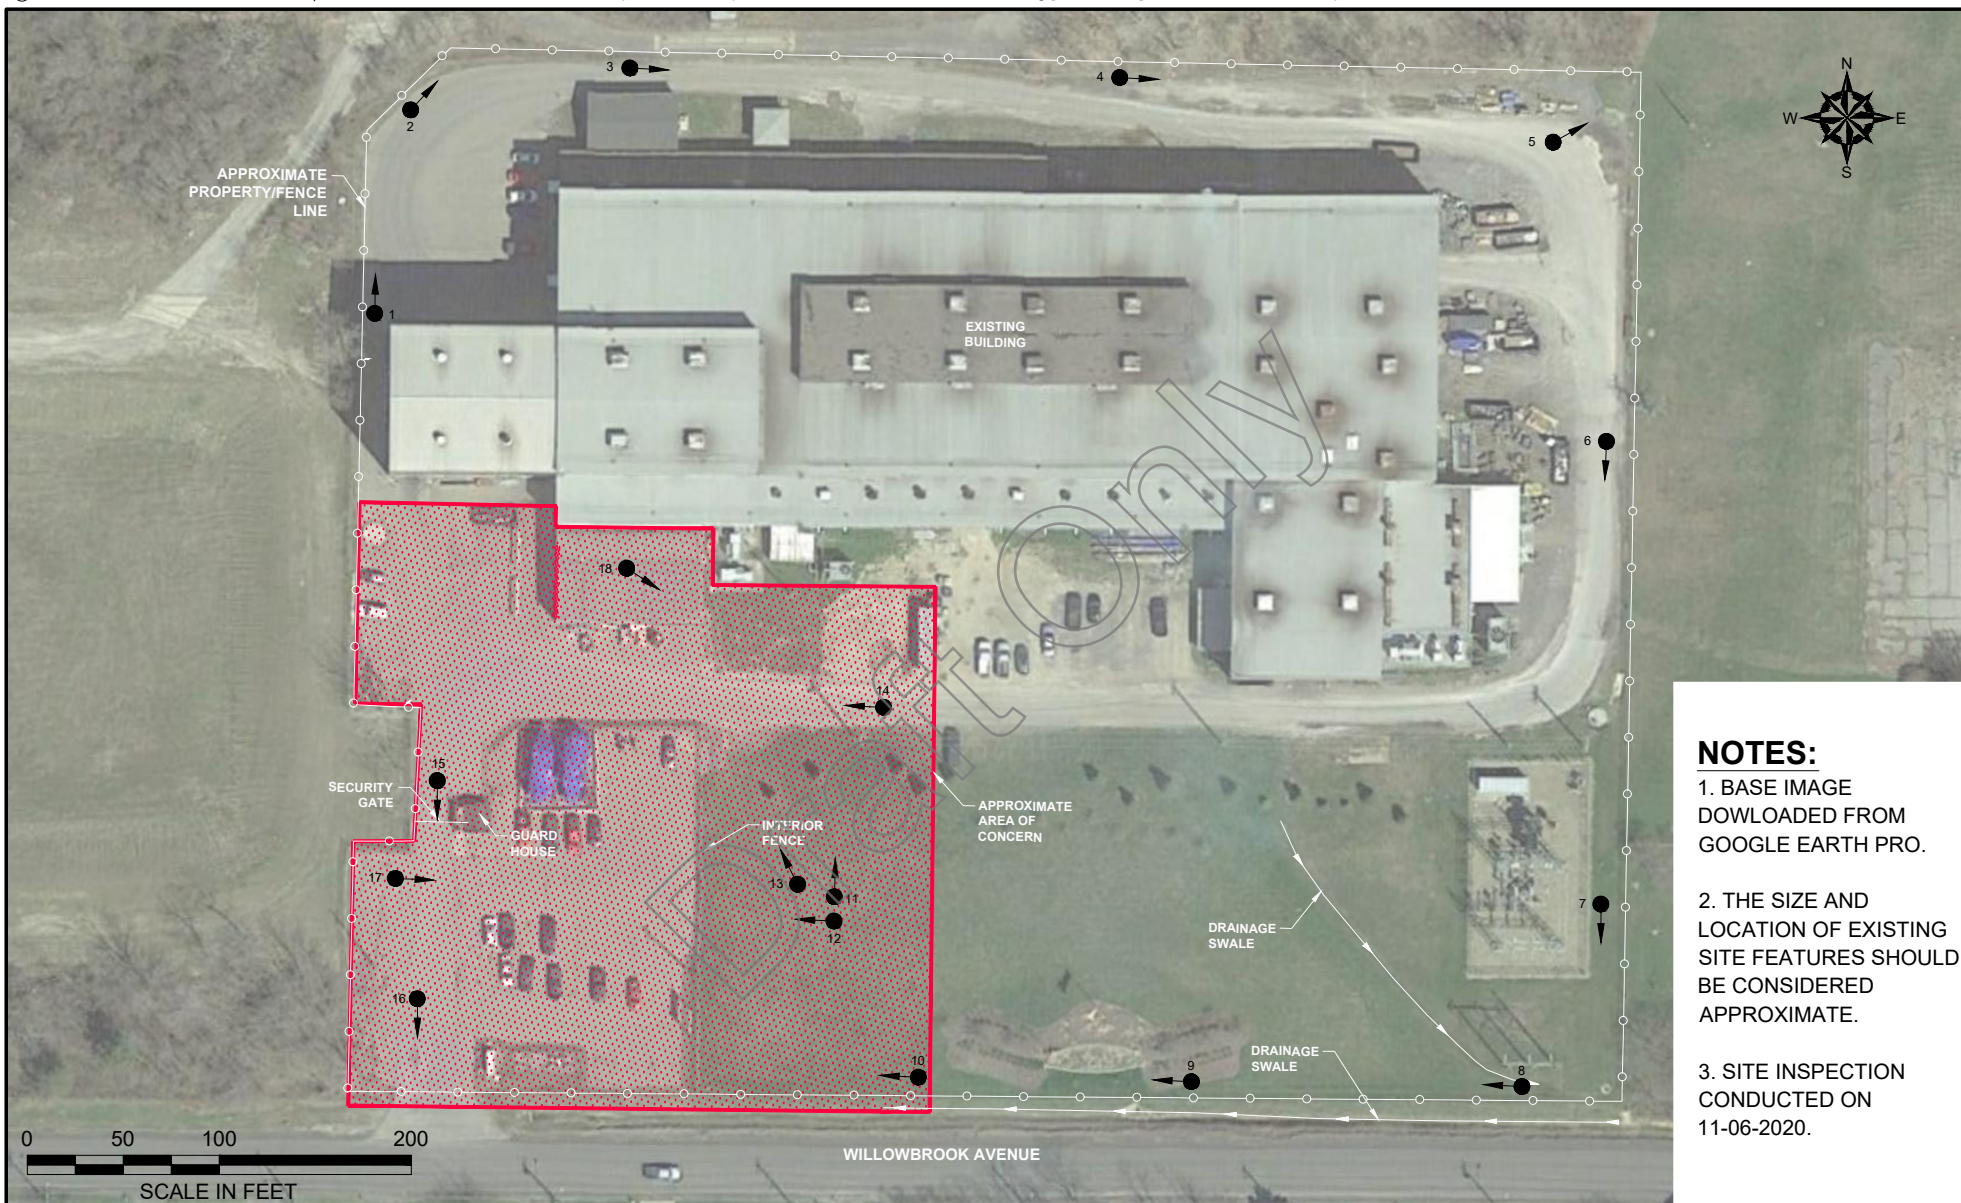
No area in need of repair identified.	
<b>INTRUSIVE ACTIVITIES PLANNED FOR AREA OF CONCERN</b>	<b>DATE</b>
None	
<b>ADDITIONAL NOTES &amp; COMMENTS</b>	
Pavement in good condition.	
Security fence is complete and in good condition.	
Healthy grass on soil cover system.	
See photo log.

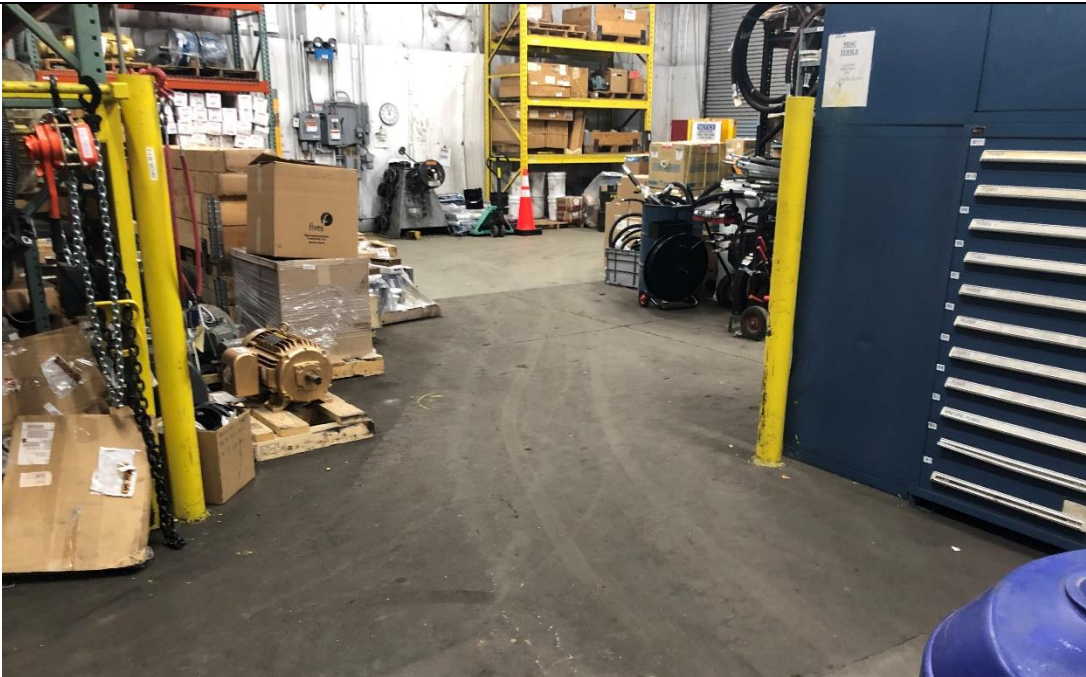
<b>Direction Photo Taken</b> Southeast			
<b>Description:</b>  Concrete floor of the repair shop.

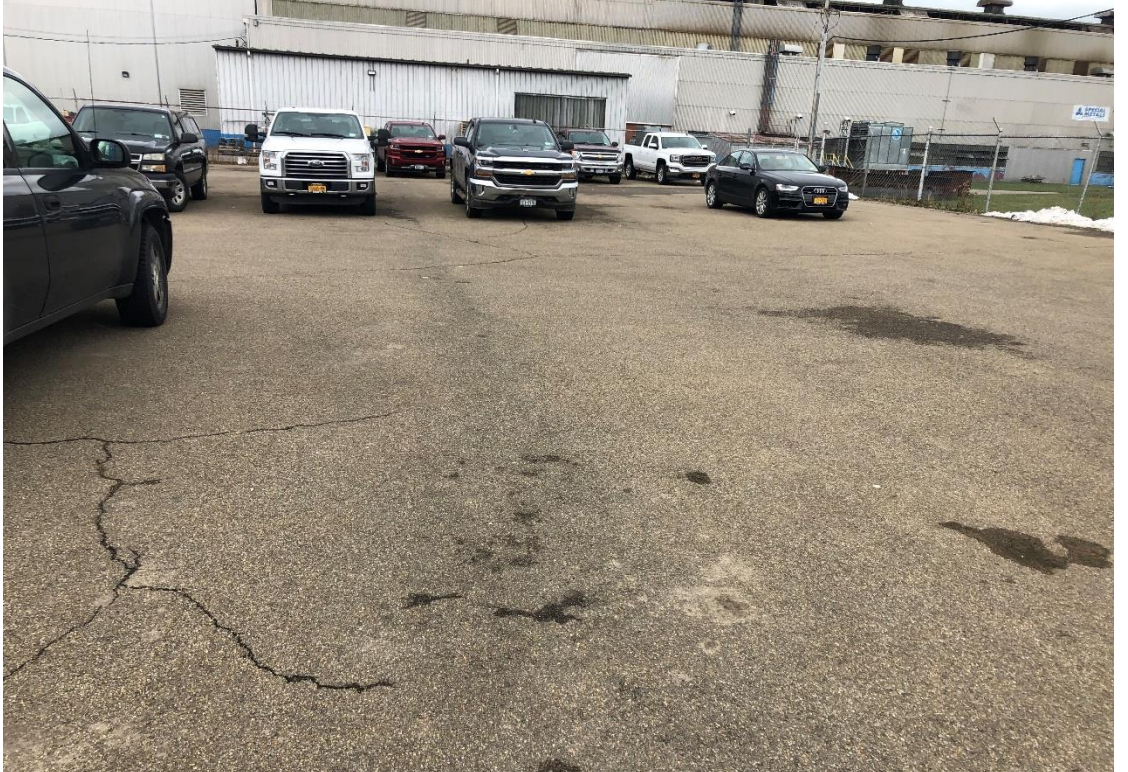
<b>Client Name:</b> Special Metals Corp.		<b>Site Location:</b> SMC Facility, Dunkirk, NY	<b>Project No.</b> 21.0056190.50
<b>Photo No.</b> 17	<b>Date:</b> 11-22-19

<b>Direction Photo Taken:</b>  North			
<b>Description:</b>  Paved Parking Lot.

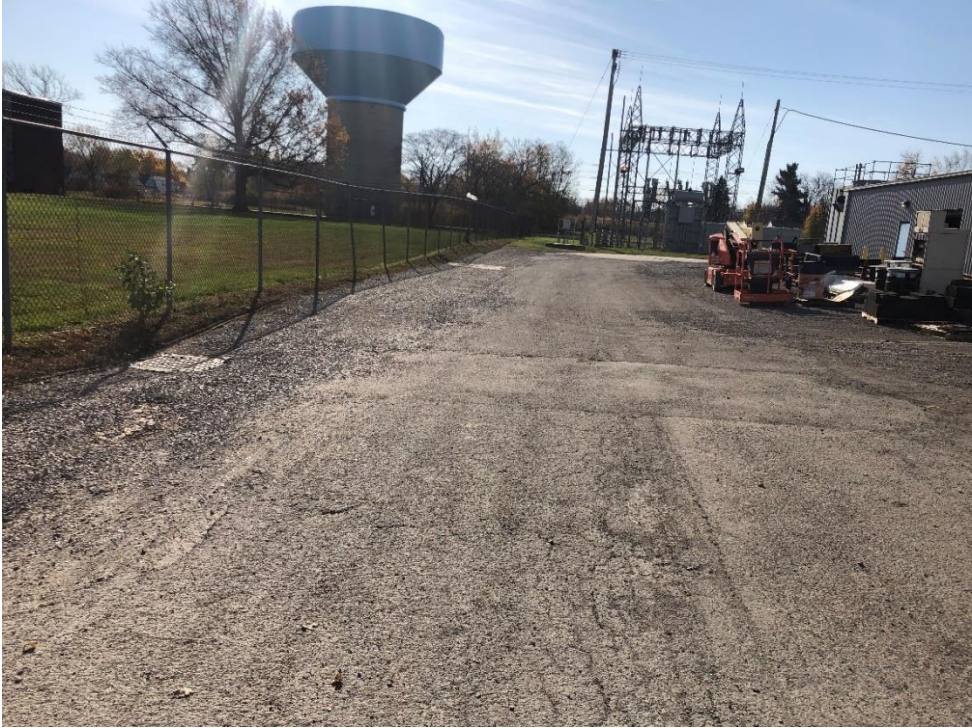
<b>Photo No.</b> 6	<b>Date:</b> 11-6-2020

<b>Direction Photo Taken:</b>  South		
<b>Description:</b>  Northern end of eastern Site perimeter fence.

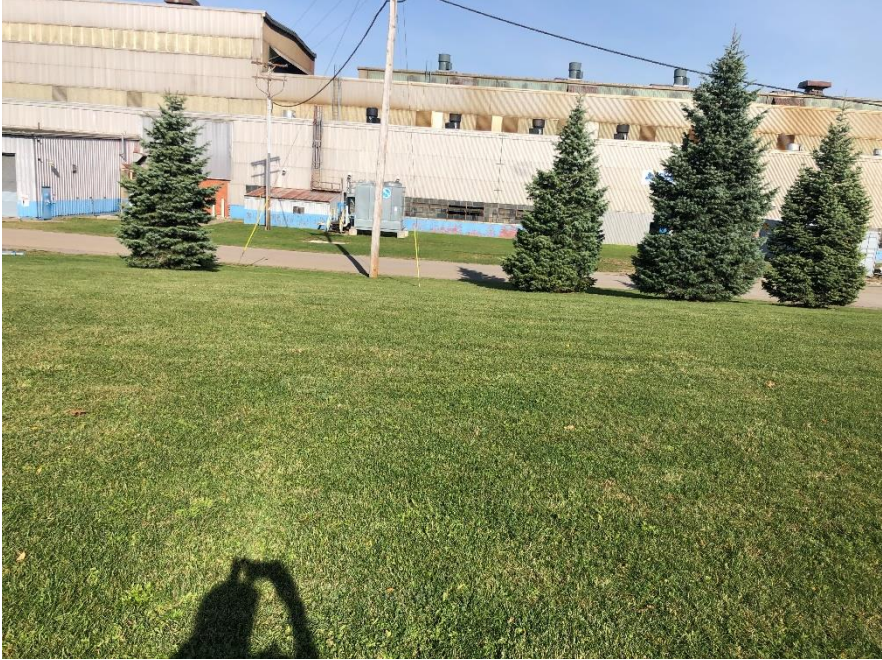
<b>Client Name:</b> Special Metals Corp.		<b>Site Location:</b> SMC Facility, Dunkirk, NY	<b>Project No.</b> 21.0056190.51
<b>Photo No.</b> 11	<b>Date:</b> 11-6-2020

A photograph showing a large, grass-covered mound in the foreground. In the background, there is a large, multi-story industrial building with a corrugated metal roof and several windows. A few evergreen trees are planted in a row in front of the building. The sky is clear and blue.	
<b>Direction Photo Taken:</b>  north			
<b>Description:</b>  Grass-covered mounded area.			
<b>Photo No.</b> 12	<b>Date:</b> 11-6-2020

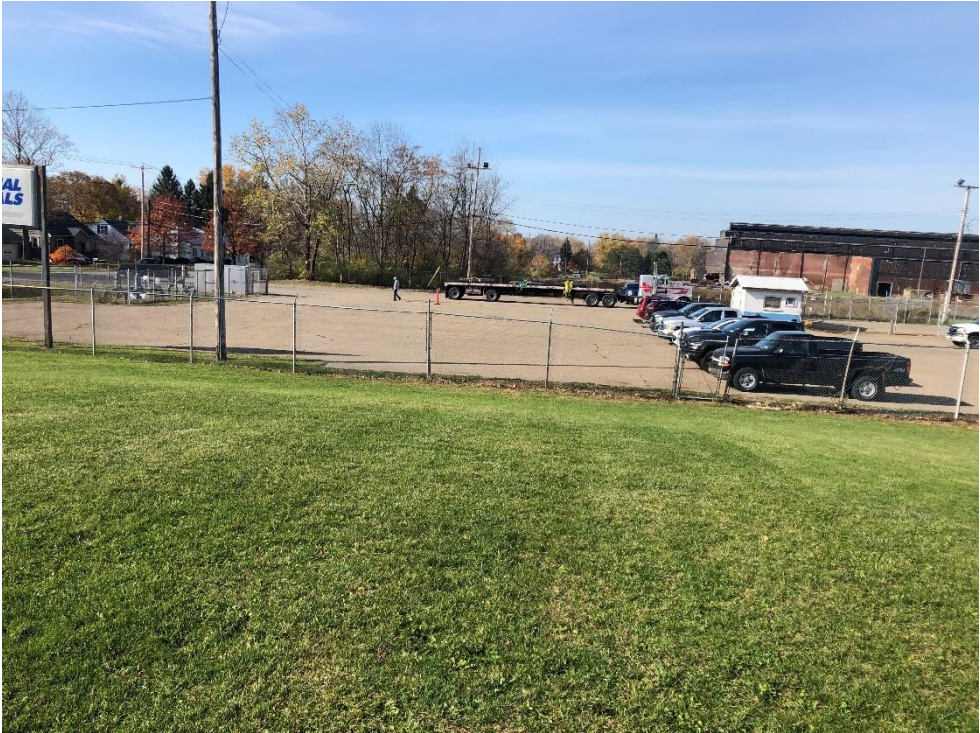
A photograph showing a grass-covered mound in the foreground. In the background, there is a parking lot with several vehicles, including a black pickup truck and a white van. Beyond the parking lot, there are industrial buildings and trees with some autumn-colored leaves. The sky is clear and blue.	
<b>Direction Photo Taken:</b>  west

<b>Description:</b>  Eastern parking lot fence and grass cover on western side of mounded area.

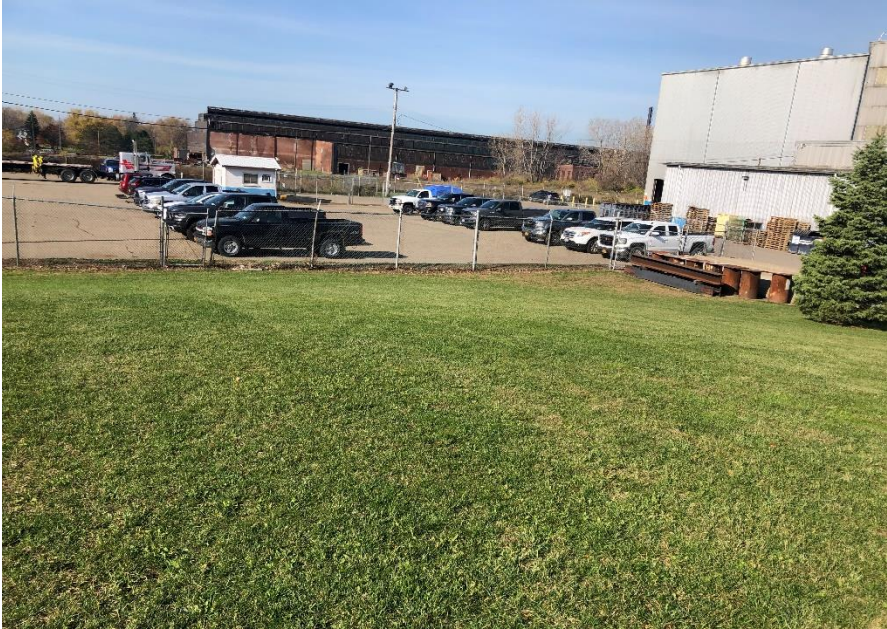
<b>Client Name:</b> Special Metals Corp.		<b>Site Location:</b> SMC Facility, Dunkirk, NY	<b>Project No.</b> 21.0056190.51
<b>Photo No.</b> 13	<b>Date:</b> 11-6-2020

<b>Direction Photo Taken:</b>  northwest			
<b>Description:</b>  Grass-covered mound and NE corner of parking lot fence.			
<b>Photo No.</b> 14	<b>Date:</b> 11-6-2020	 	
<b>Direction Photo Taken</b> west			
<b>Description:</b>  Paved Site road.

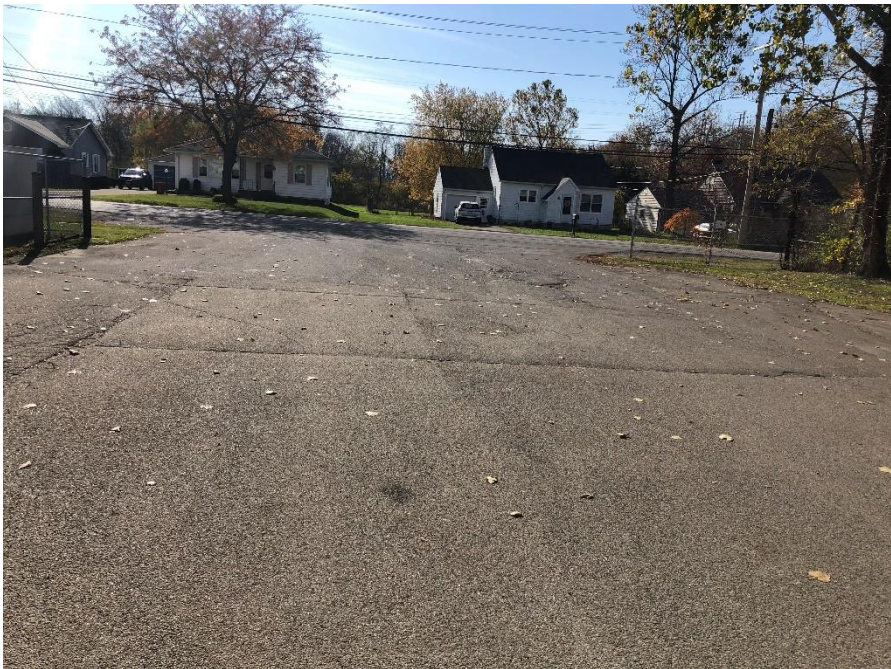
<b>Photo No.</b> 16	<b>Date:</b> 11-6-2020

<b>Direction Photo Taken:</b>  south		
<b>Description:</b>  Paved Site entrance.

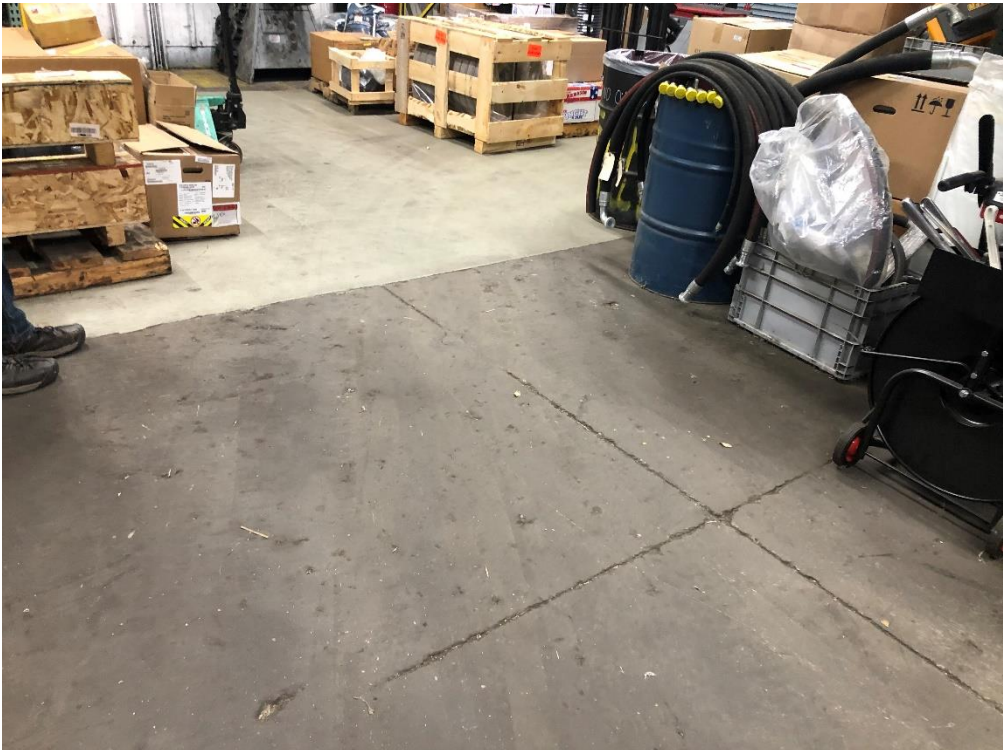
<b>Photo No.</b> 18	<b>Date:</b> 11-6-2020

<b>Direction Photo Taken:</b>  southeast		
<b>Description:</b>  Concrete floor inside of the facility repair shop.

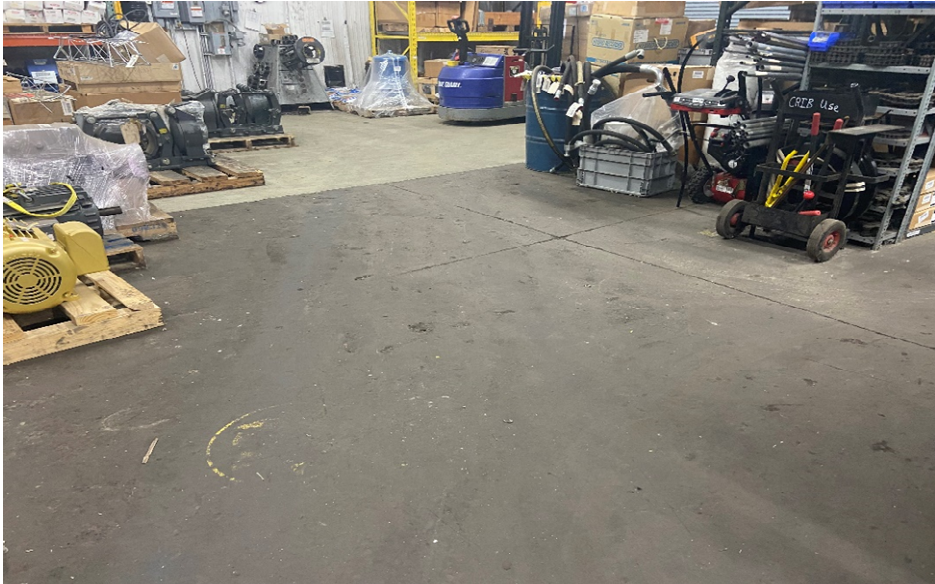
<b>Client Name:</b> Special Metals Corp.		<b>Site Location:</b> SMC Facility, Dunkirk, NY	<b>Project No.</b> 21.0056196.51
<b>Photo No.</b> 1	<b>Date:</b> 10-29-2021

<b>Direction Photo Taken:</b>  Southeast			
<b>Description:</b>  Floor of maintenance shop.

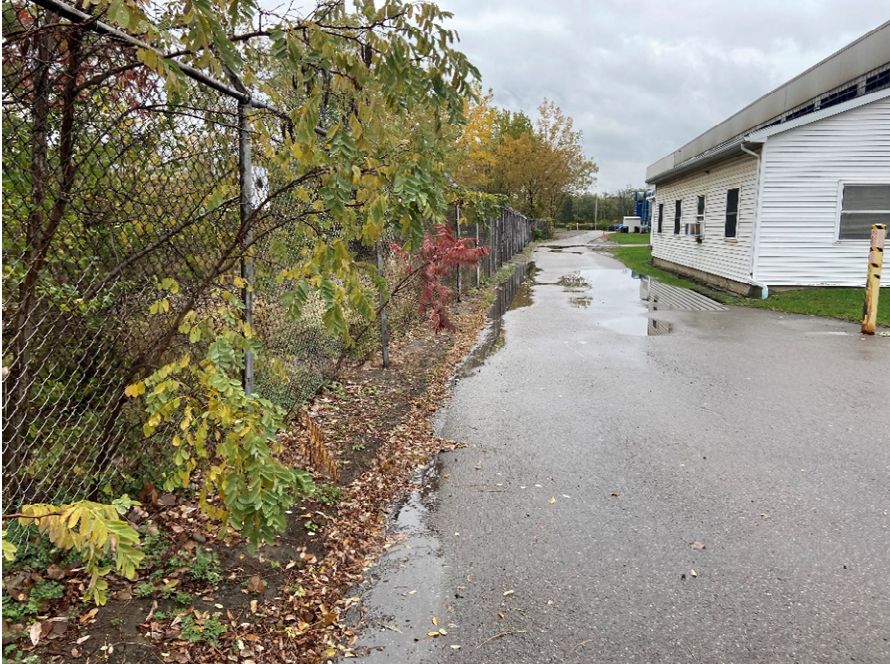
<b>Client Name:</b> Special Metals Corp.		<b>Site Location:</b> SMC Facility, Dunkirk, NY	<b>Project No.</b> 21.0056196.51
<b>Photo No.</b> 5	<b>Date:</b> 10-29-2021

<b>Direction Photo Taken:</b>  East			
<b>Description:</b>  Western extent of the northern site perimeter fence.

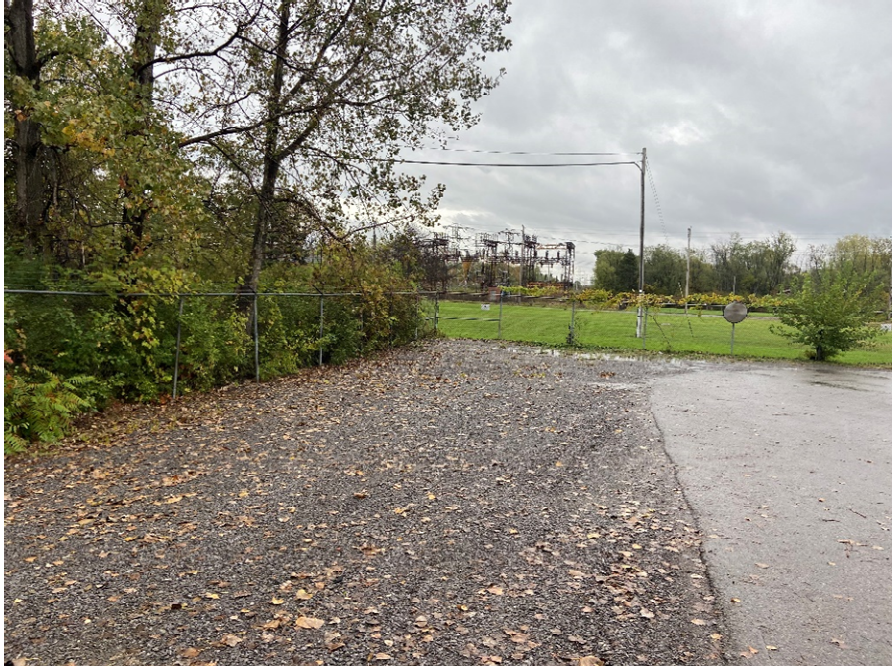
<b>Client Name:</b> Special Metals Corp.		<b>Site Location:</b> SMC Facility, Dunkirk, NY	<b>Project No.</b> 21.0056196.51
<b>Photo No.</b> 7	<b>Date:</b> 10-29-2021

<b>Direction Photo Taken:</b>  East			
<b>Description:</b>  Northeastern corner of the site perimeter fence.

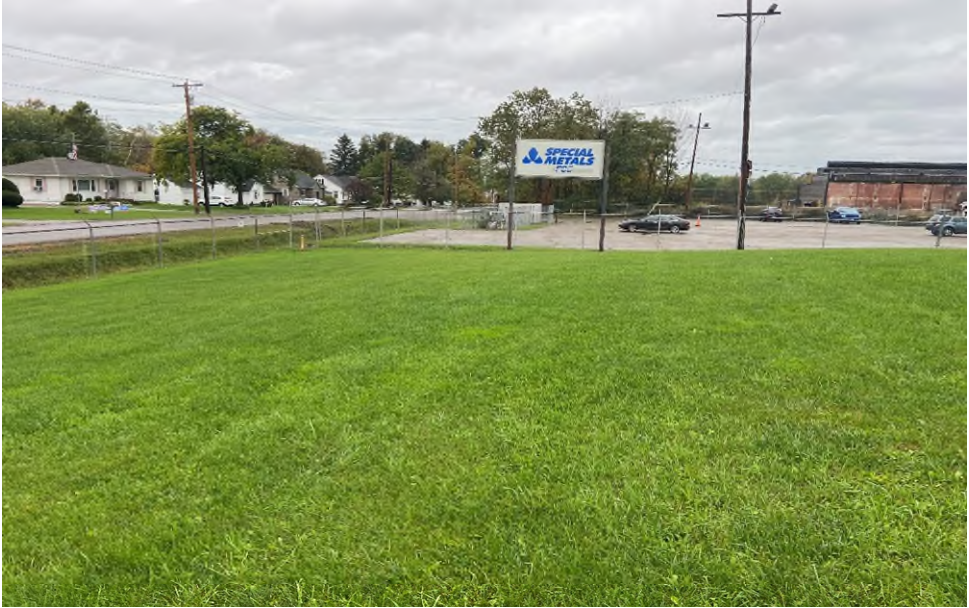
<b>Client Name:</b> Special Metals Corp.		<b>Site Location:</b> SMC Facility, Dunkirk, NY	<b>Project No.</b> 21.0056190.51
<b>Photo No.</b> 11	<b>Date:</b> 10-29-2021

<b>Direction Photo Taken:</b>  Southwest			
<b>Description:</b>  Grass-covered soil mound of the eastern area of concern (AOC) with parking lot in the background.
