ENGINEERING INVESTIGATIONS AT INACTIVE HAZARDOUS WASTE SITES

PRELIMINARY SITE ASSESSMENT

Bisonite Paint Company Site No. 915010

March 1993

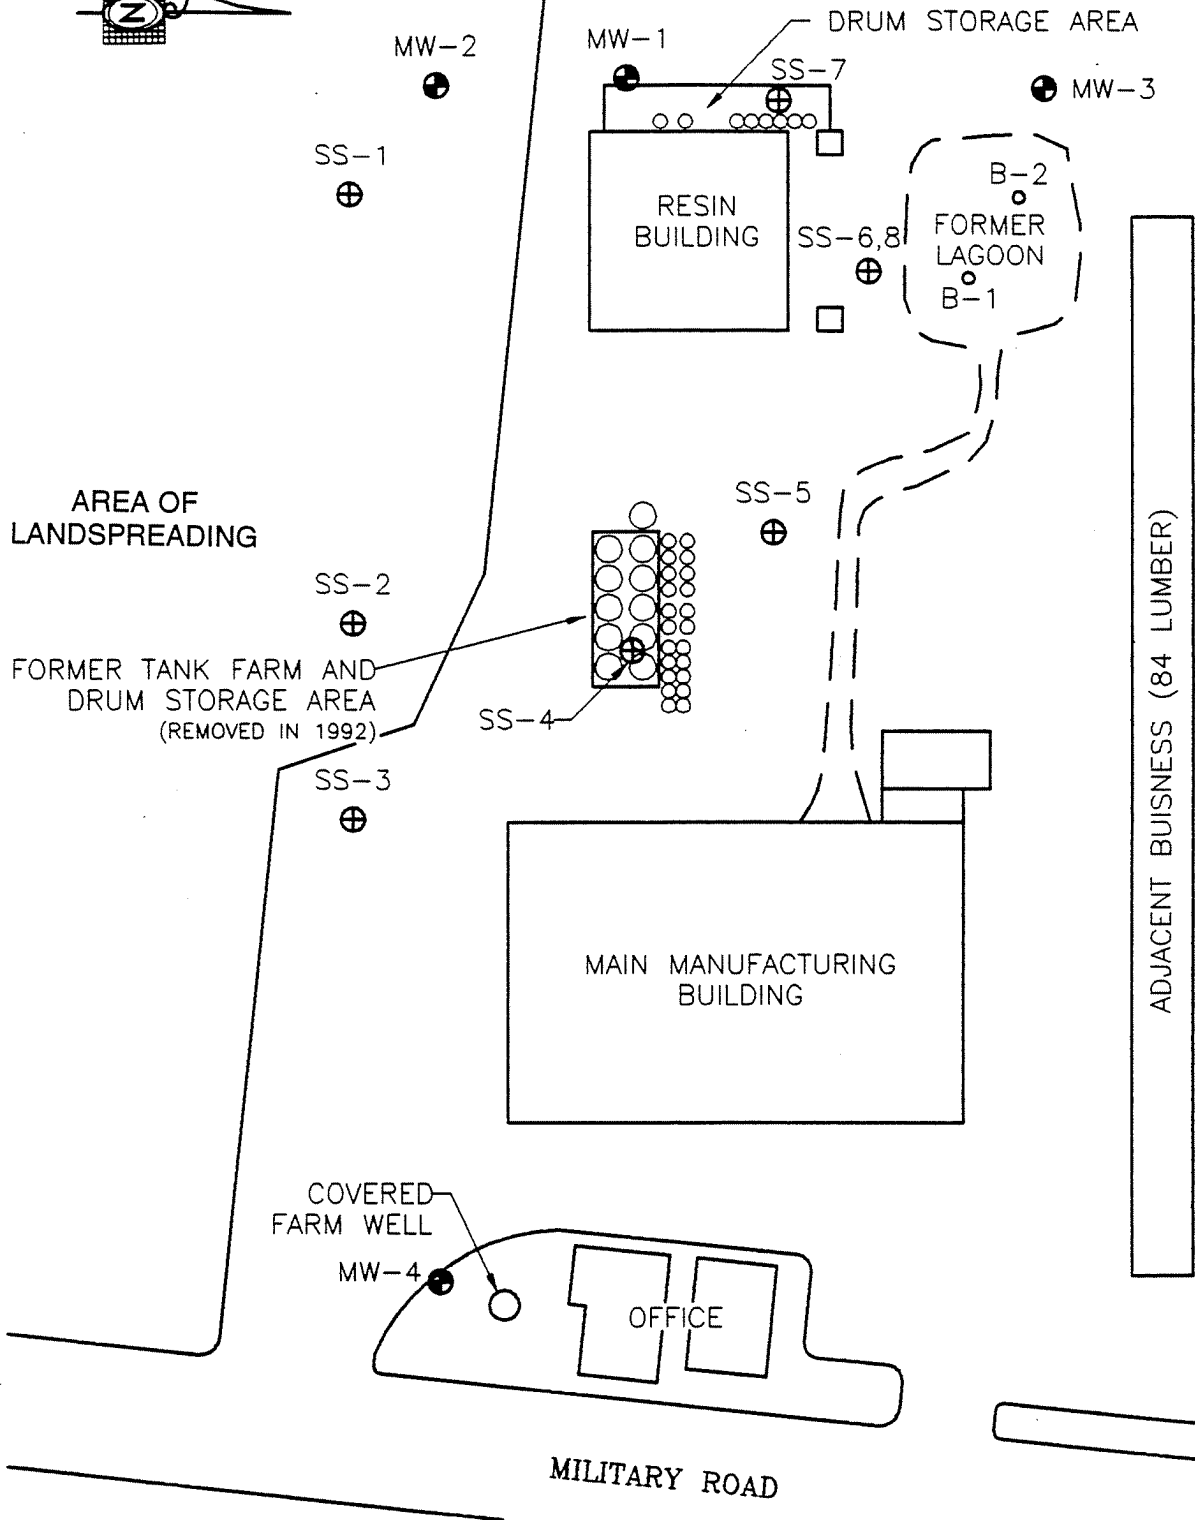
FIGURE NO. 4

The surface soil sampling program consisted of collecting seven surface soils (BIS-SS-1 through BIS-SS-7) and one blind duplicate sample (BIS-SS-8) at the site. The sampling locations were in areas of stressed vegetation and potential source areas as depicted in the 1972 aerial photograph of the site. The approximate soil sampling locations are presented in Figure 4.

Subsurface investigations at the site included the advancement of six soil borings, four of which were converted to groundwater monitoring wells. The two soil borings (BIS-B1 and BIS-B2) not converted to monitoring wells were positioned to determine the absence or presence of residual contamination in the former lagoon. The four remaining soil borings were located at the periphery of the property and converted into monitoring wells to evaluate groundwater quality at the site boundaries. The locations of the soil borings and groundwater monitoring wells are presented in Figure 4.
