ENGINEERING INVESTIGATIONS AT INACTIVE HAZARDOUS WASTE SITES

PHASE I INVESTIGATION

Ernst Steel Site No. 915022
Cheektowaga Erie County

DATE: March 1986

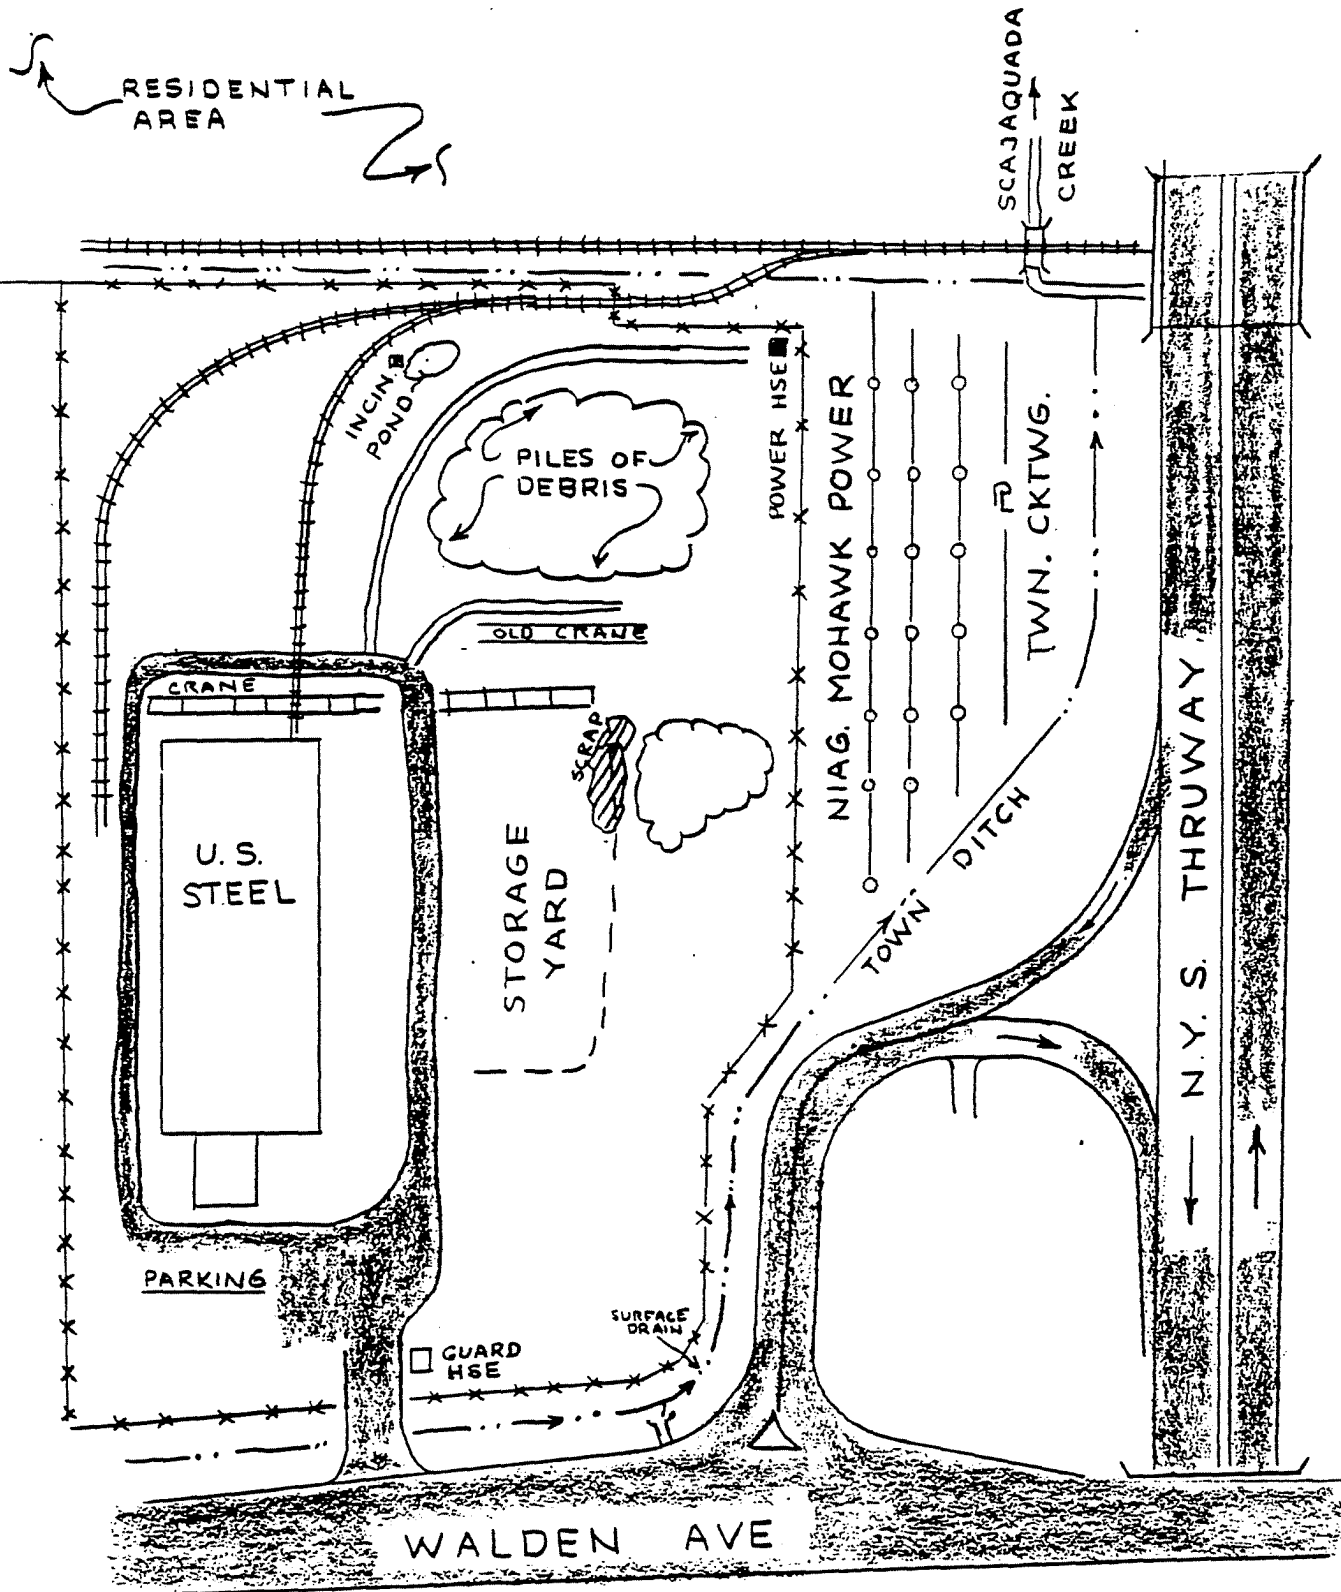
ERNST STEEL
 SITE 915022
 L. CLARE 6/12/86

DISPOSAL ON THE PROPERTY IS EVIDENT IN THE AREA NOTED IN FIGURE 1 (LARRY CLARE 6/12/86). FIGURE 2 REPRESENTS A DETAIL OF THE DISPOSAL AREA. THIS AREA IS A MIXTURE OF FIELD VEGETATION (GRASSES, QUEEN ANN LACE) BRUSHLAND AND WOODED WETLAND. WASTE PILES WERE OBSERVED THROUGHOUT THIS DISPOSAL AREA. TYPES OF WASTE OBSERVED ON-SITE INCLUDE INCINERATOR RESIDUE, SCRAP METAL AND PAINT/DIRT RESIDUES. IN MANY AREAS (PARTICULARLY THE CENTRAL PORTION OF THE DISPOSAL AREA), VEGETATION HAS FIRMLY ESTABLISHED ITSELF ON THE WASTE PILES. MR. ERNST ADVISED THAT HE RECENTLY REMOVED MOST OF THE TIMBER AND EMPTY 55 GALLON DRUMS THAT WERE NOTED IN PREVIOUS INSPECTION REPORTS. AREAS OF DISTURBED EARTH WERE NOTED IN THESE AREAS. ONE 55 GALLON DRUM; WAS NOTED IN A FORMER SWALE AREA THAT AT ONE TIME DIRECTED WATER AWAY FROM THE NORTHEAST ROAD. THE DRUM WAS

- 2) IN 1951, THE RAILROAD WAS NO LONGER IN OPERATION. THE RAILROAD BUILDINGS HAVE EITHER BEEN REMOVED OR ARE COMPLETELY OVERGROWN BY VEGETATION. THE UNDISTURBED LAND TO THE EAST APPEARS DRY.
- 3) THE FILL ACTIVITY TO THE NORTHEAST NOTED IN THE DEP 1983 PROFILE REPORT IS NOT ON THE ERNST PROPERTY.
- 4) DISPOSAL ON THE ERNST STEEL PROPERTY APPEARS TO BE CONFINED TO THE AREA SHOWN IN FIGURE 1.

BEFORE MR. ERNST STARTS A SAMPLING PROGRAM, HE SHOULD MEET WITH DEC TO DISCUSS WHAT WOULD BE ACCEPTABLE TO THEM.

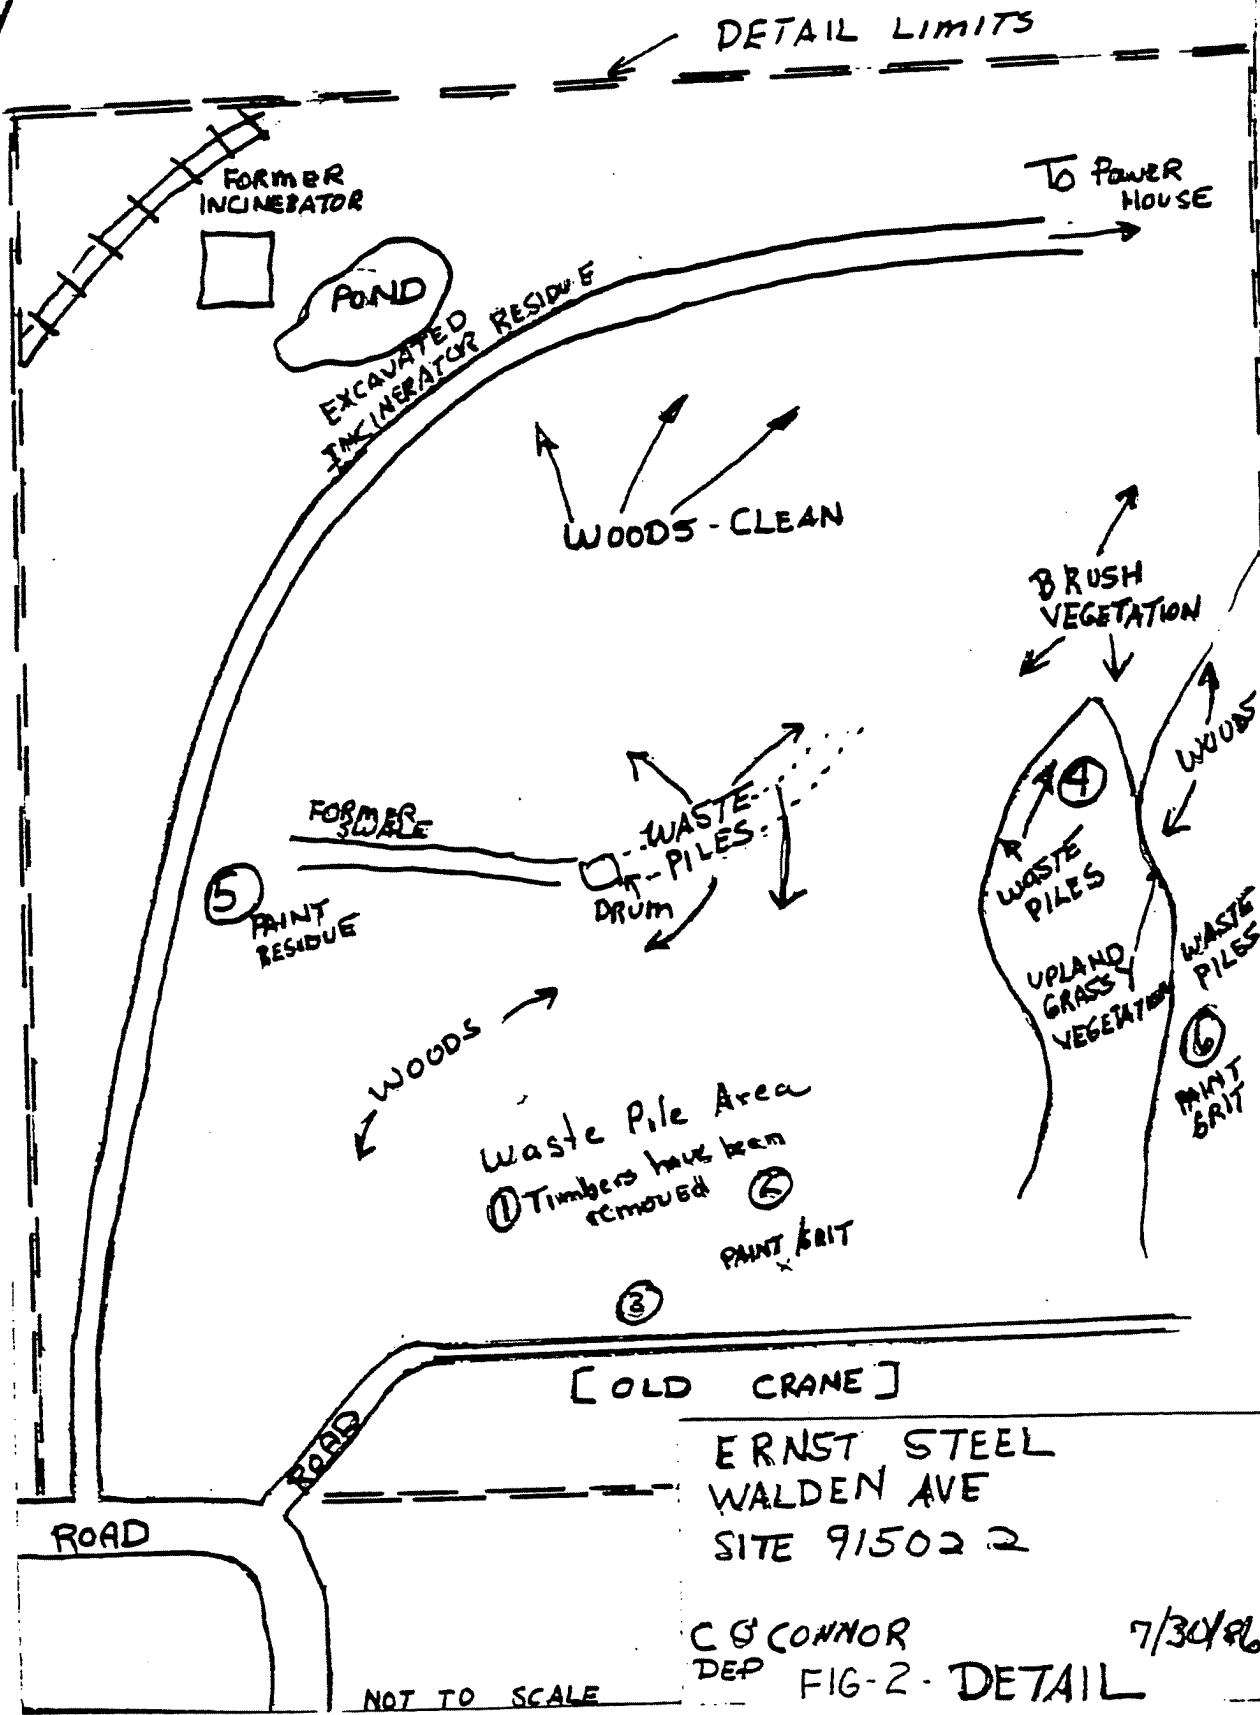
FORMER INCINERATOR

EXCAVATED INCINERATOR RESIDUE
