**SHEET PILE WALL
CONSTRUCTION COMPLETE REPORT**

**IROQUOIS GAS/WESTWOOD PHARMACEUTICAL SITE
BUFFALO, NEW YORK**

RETEC Project No. 1-2700-300

MARCH 1997

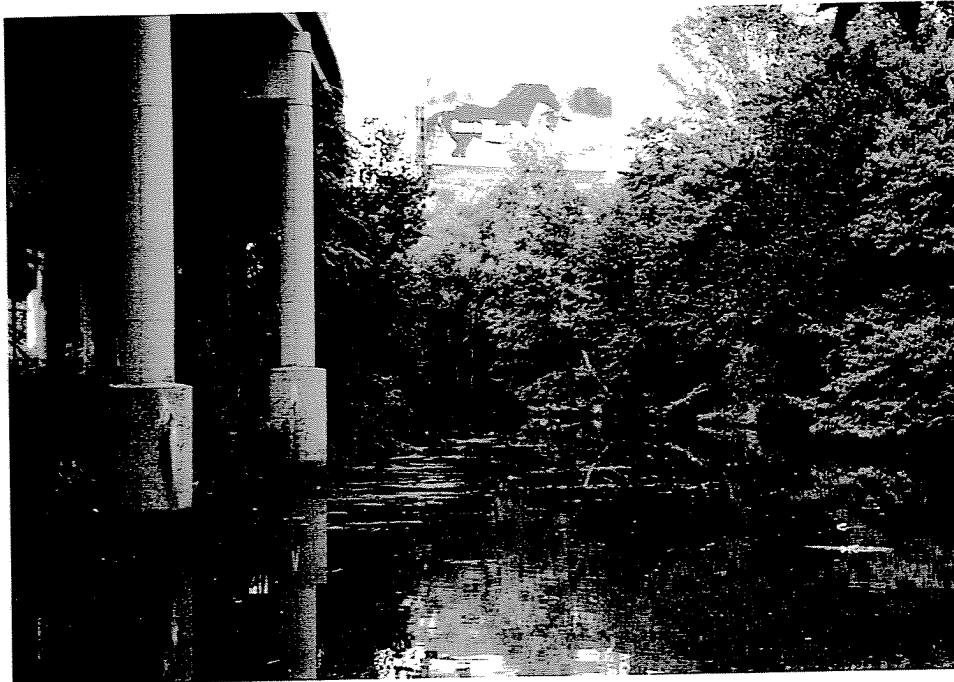
Figure 1
Scajaquada Creek

The IG/WP site lies in a mixed industrial and residential area of Buffalo, New York on the south bank of the Scajaquada Creek (see Figure 1). The creek is approximately 40 to 50 feet wide in the section adjacent to the IG/WP site with a creek level approximately 20 feet below the top of the south bank. The creek drains southwest into the Black Rock Canal of the Niagara River approximately one-half mile down stream. The primary area of concern is a 1600 foot long stretch of the creek running from the West Avenue Bridge to a location 400 feet north of the New York Central Railroad bridge.
