RE: Corrective Measure Completion Final Report
GE Parts and Repair Service Center
Tonawanda, New York
NYSDEC Site ID: 915244
EPA ID: NYD067539940
Permit ID: 9-1464-00044/00001

**PARTS AND REPAIR SERVICE CENTER
GENERAL ELECTRIC INTERNATIONAL, INC.**

**CORRECTIVE MEASURE COMPLETION
FINAL REPORT**

JUNE 3, 2016

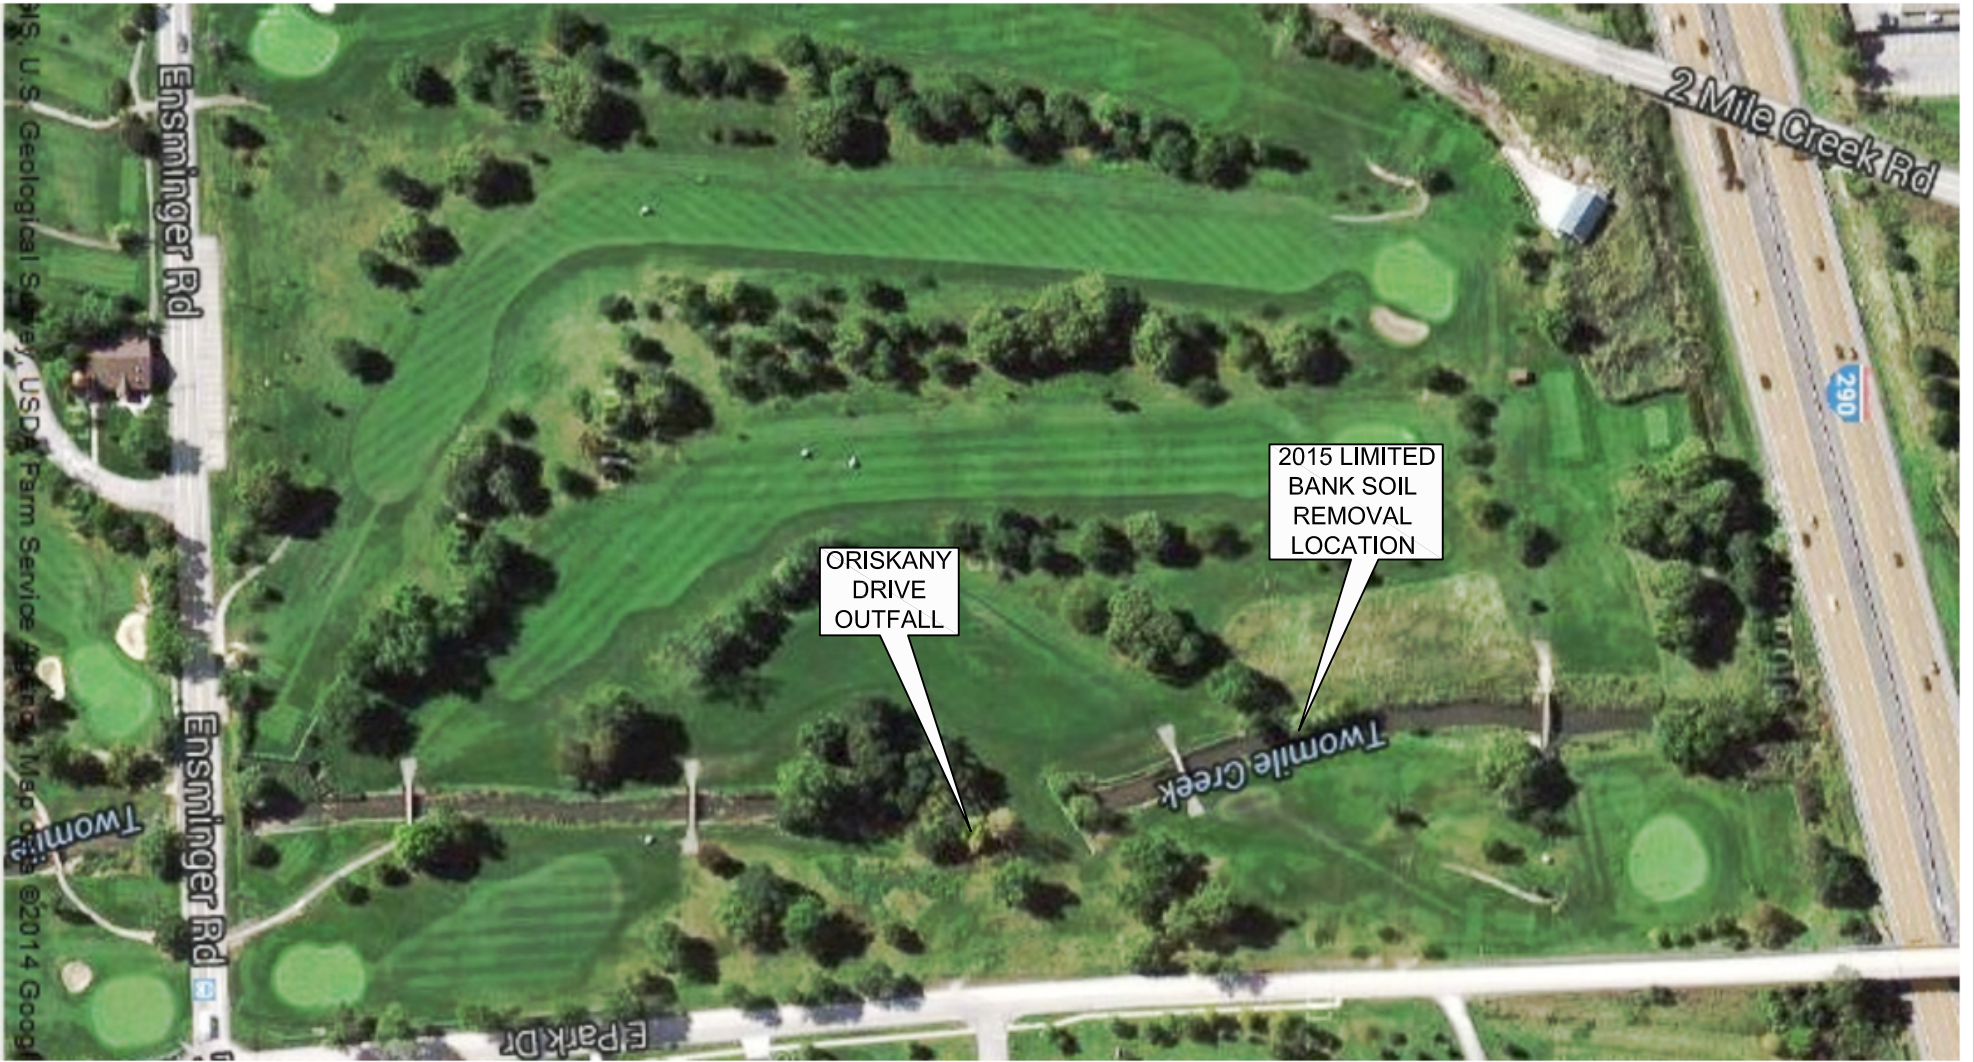
FIGURE 4

Based on the results of the storm sewer investigations, the NYSDEC determined that PCB-impacted sediment might have migrated to Two Mile Creek through the storm sewer outfall at Oriskany Drive. As shown in Figure 4, this portion of the creek runs through the Sheridan Park Golf Course. At the request of NYSDEC, several phases of investigation of creek sediments and bank soils were performed on behalf of GE from 2004 to 2010 by URS and other consultants.

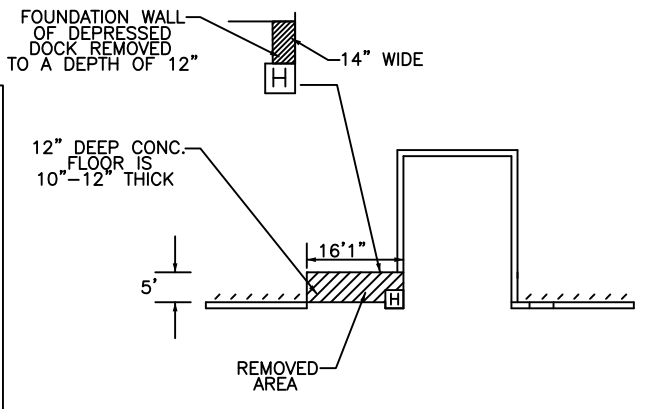
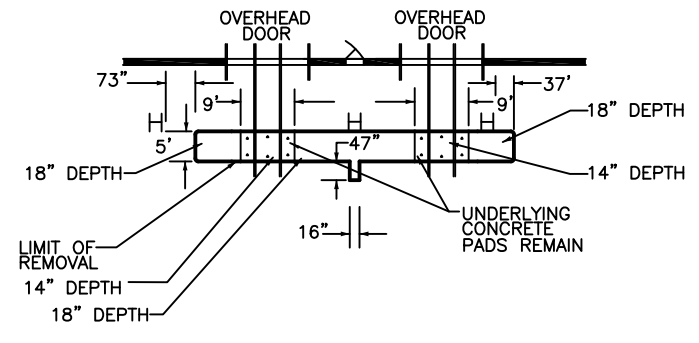
Title: EPOXY COATED AREAS AS OF JUNE 2004	
Location: 175 MILENS ROAD TONAWANDA, NEW YORK	
Client:	GENERAL ELECTRIC INTERNATIONAL, INC.
	Drafter: CLS Date: May 2016
AECOM 40 British American Blvd. Latham, New York 12110	Drg. Size: 11 x 17 Job No.: 60442945
FIGURE 14

hammer. Removed material was placed into a lined roll-off container pending transport and disposal as a PCB-containing nonhazardous waste. The concrete removal area was approximately 18-inches deep, 5 feet wide, and 47 feet long. The rail bay trench drain repair area is shown in Figure 14 and Photographs 51 and 52 (Appendix C).

- **Interior Concrete Floor Slab (Depressed Dock and Truck Bay AOCs):** the depressed dock and truck bay along with most of the concrete shop floor slab with PCBs greater than 1 mg/kg or 10 µg/100 cm², the limits of which are depicted in Figure 14.

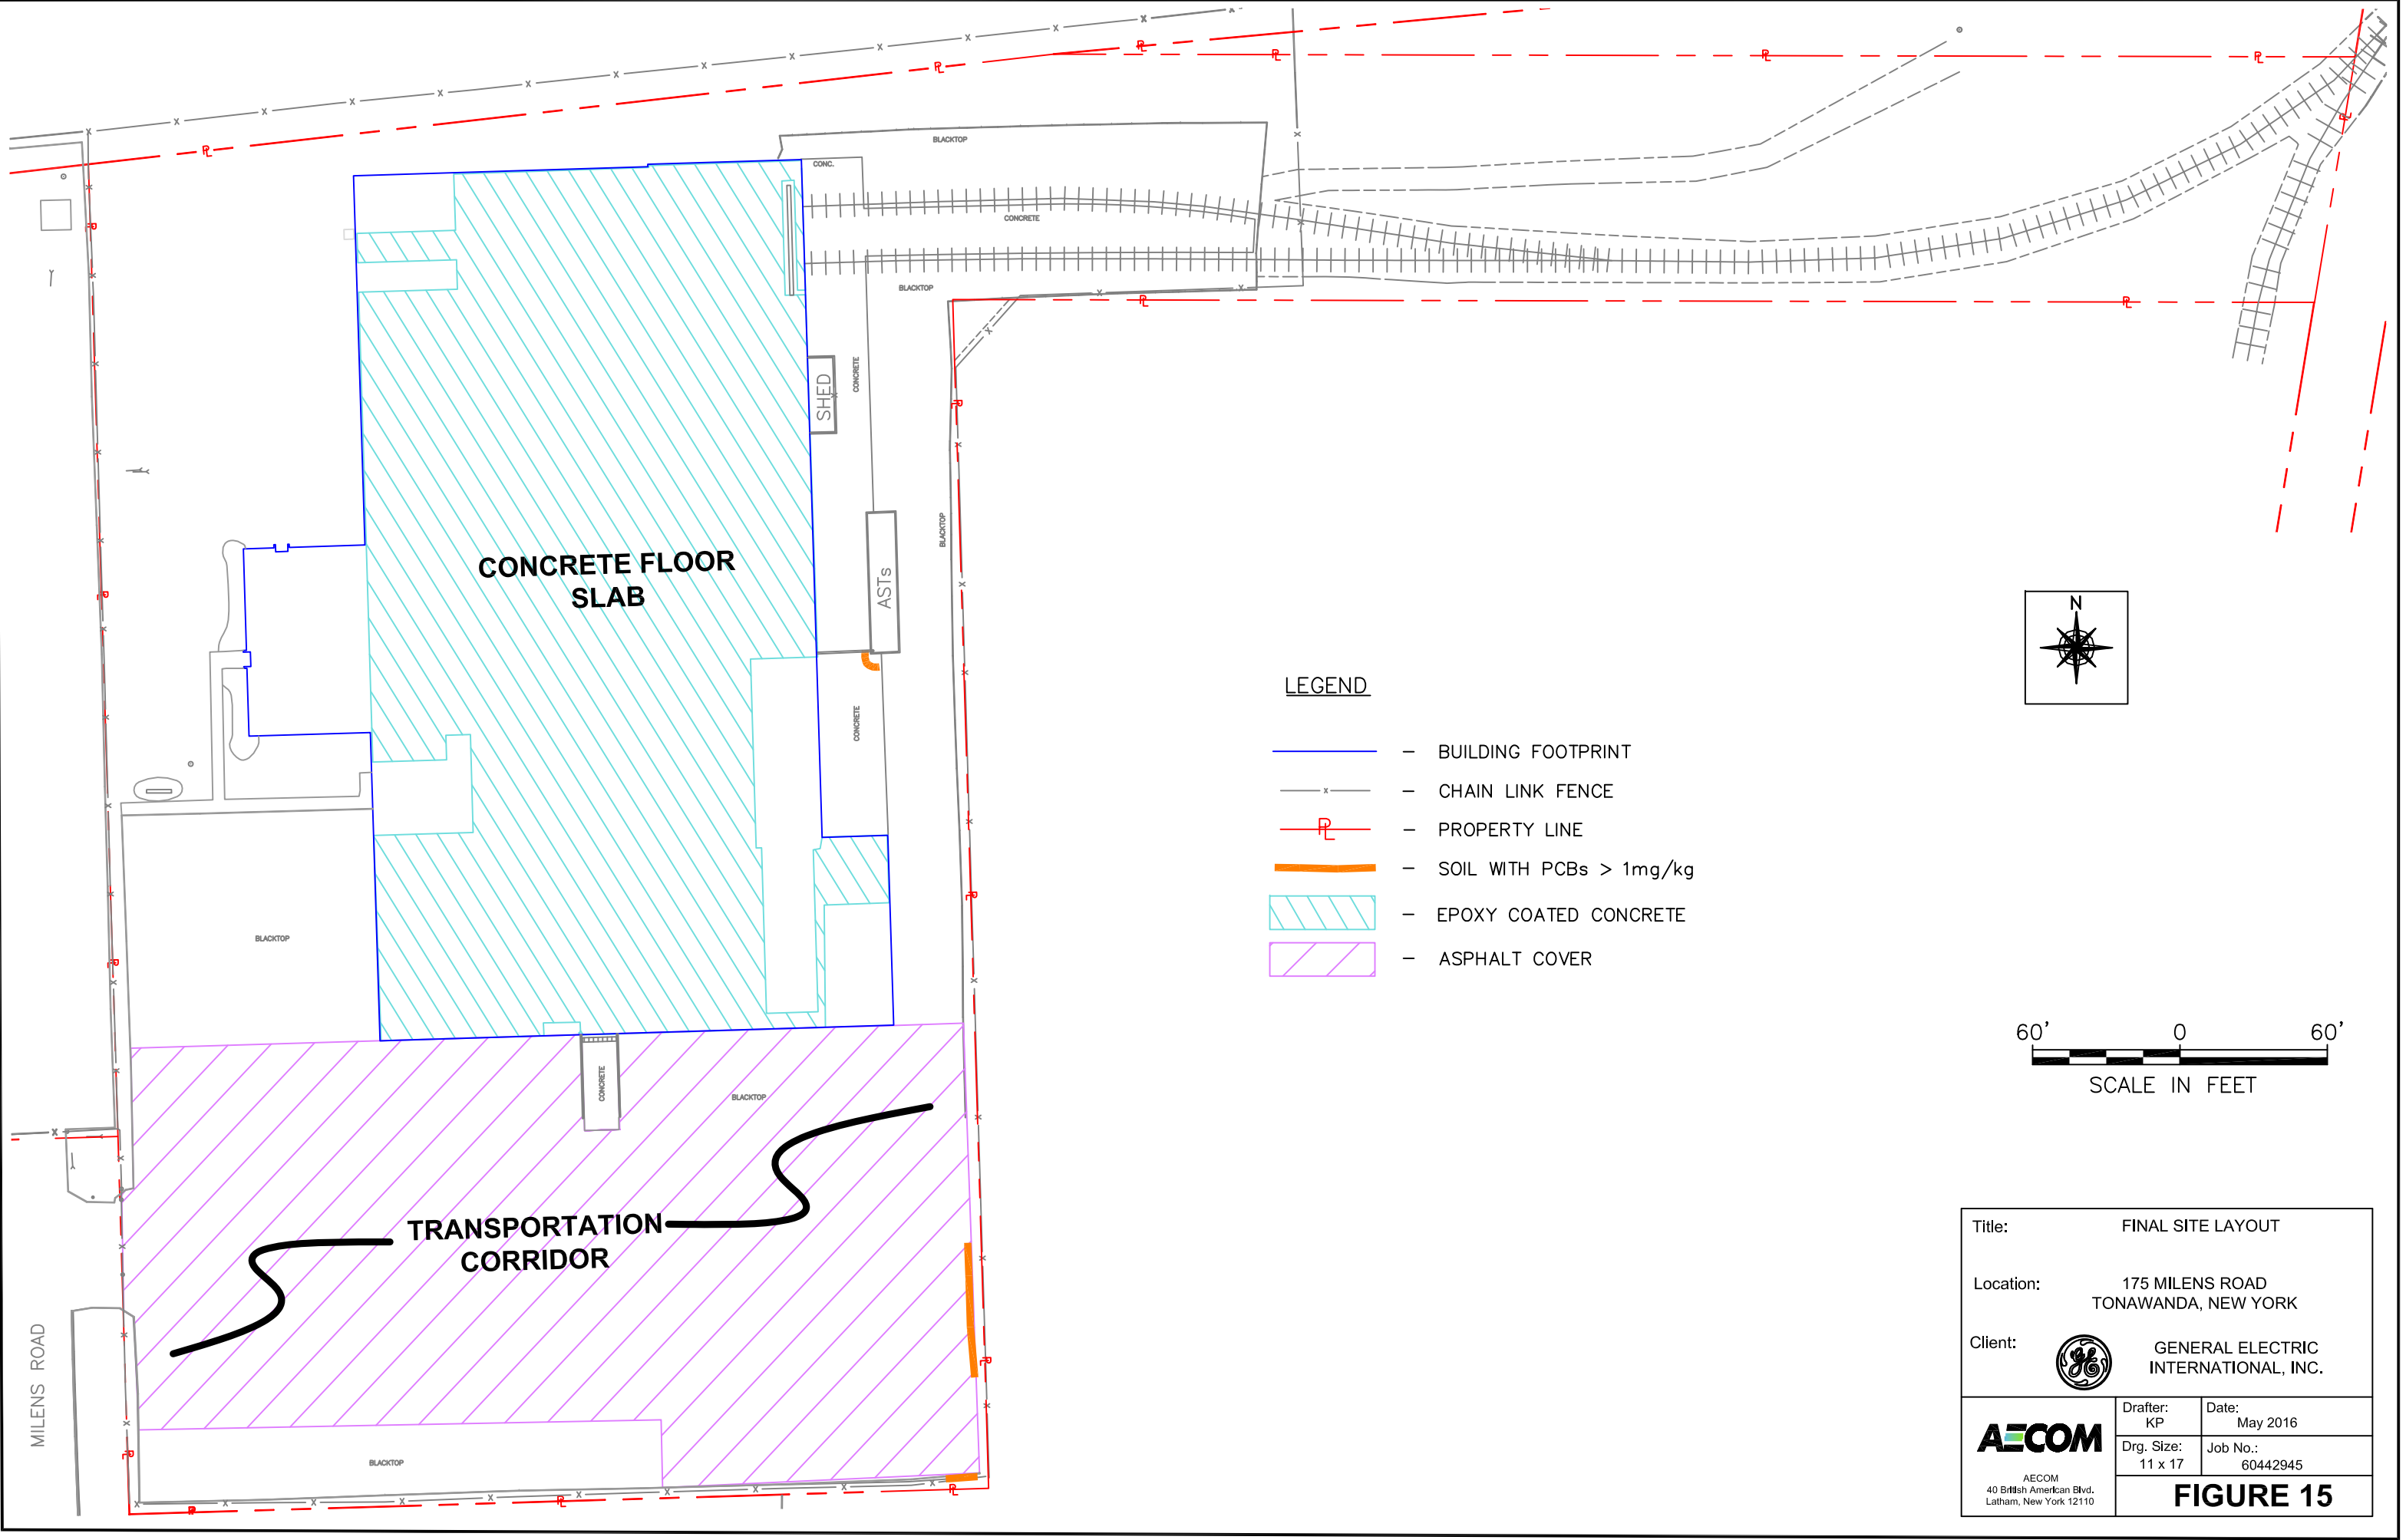
GENERAL ELECTRIC INTERNATIONAL, INC.
Drafter: KP	Date: May 2016
Drg. Size: 11 x 17	Job No.: 60442945
FIGURE 15

PCBs remained at concentrations greater than 1 mg/kg in soils supporting site structures in three areas of the site (see Section 6.8). The confirmatory soil sampling locations for these areas are shown on Figures 11 and 12. In accordance with project design, orange demarcation fabric was placed over the un-excavated soil before these areas were backfilled. The approximate locations of the demarcation fabric for the three areas are shown in Figure 15. Photographs 34, 40, and 41 in Appendix C show the fabric being installed.

- **Exterior Asphalt of Transportation Corridor:** an irregularly shaped area of asphalt with PCBs greater than 1 mg/kg comprising most of the paved area south of the shop, the limits of which are depicted in Figure 15.

Engineering controls to address residual impacts at the site are also shown on Figure 15. The engineering controls include perimeter fencing and cover systems that have been completed and need to be maintained. The cover systems include:
