EFFECTIVENESS OF ADAMS AVE. SEWER SLURRY WALL

August 11, 1988
88C2075B-1

Re: Effectiveness Evaluation
Adams Avenue Sewer Slurry Wall

**EFFECTIVENESS EVALUATION
ADAMS AVENUE SLURRY WALL
NIAGARA PLANT
NIAGARA FALLS, NEW YORK**

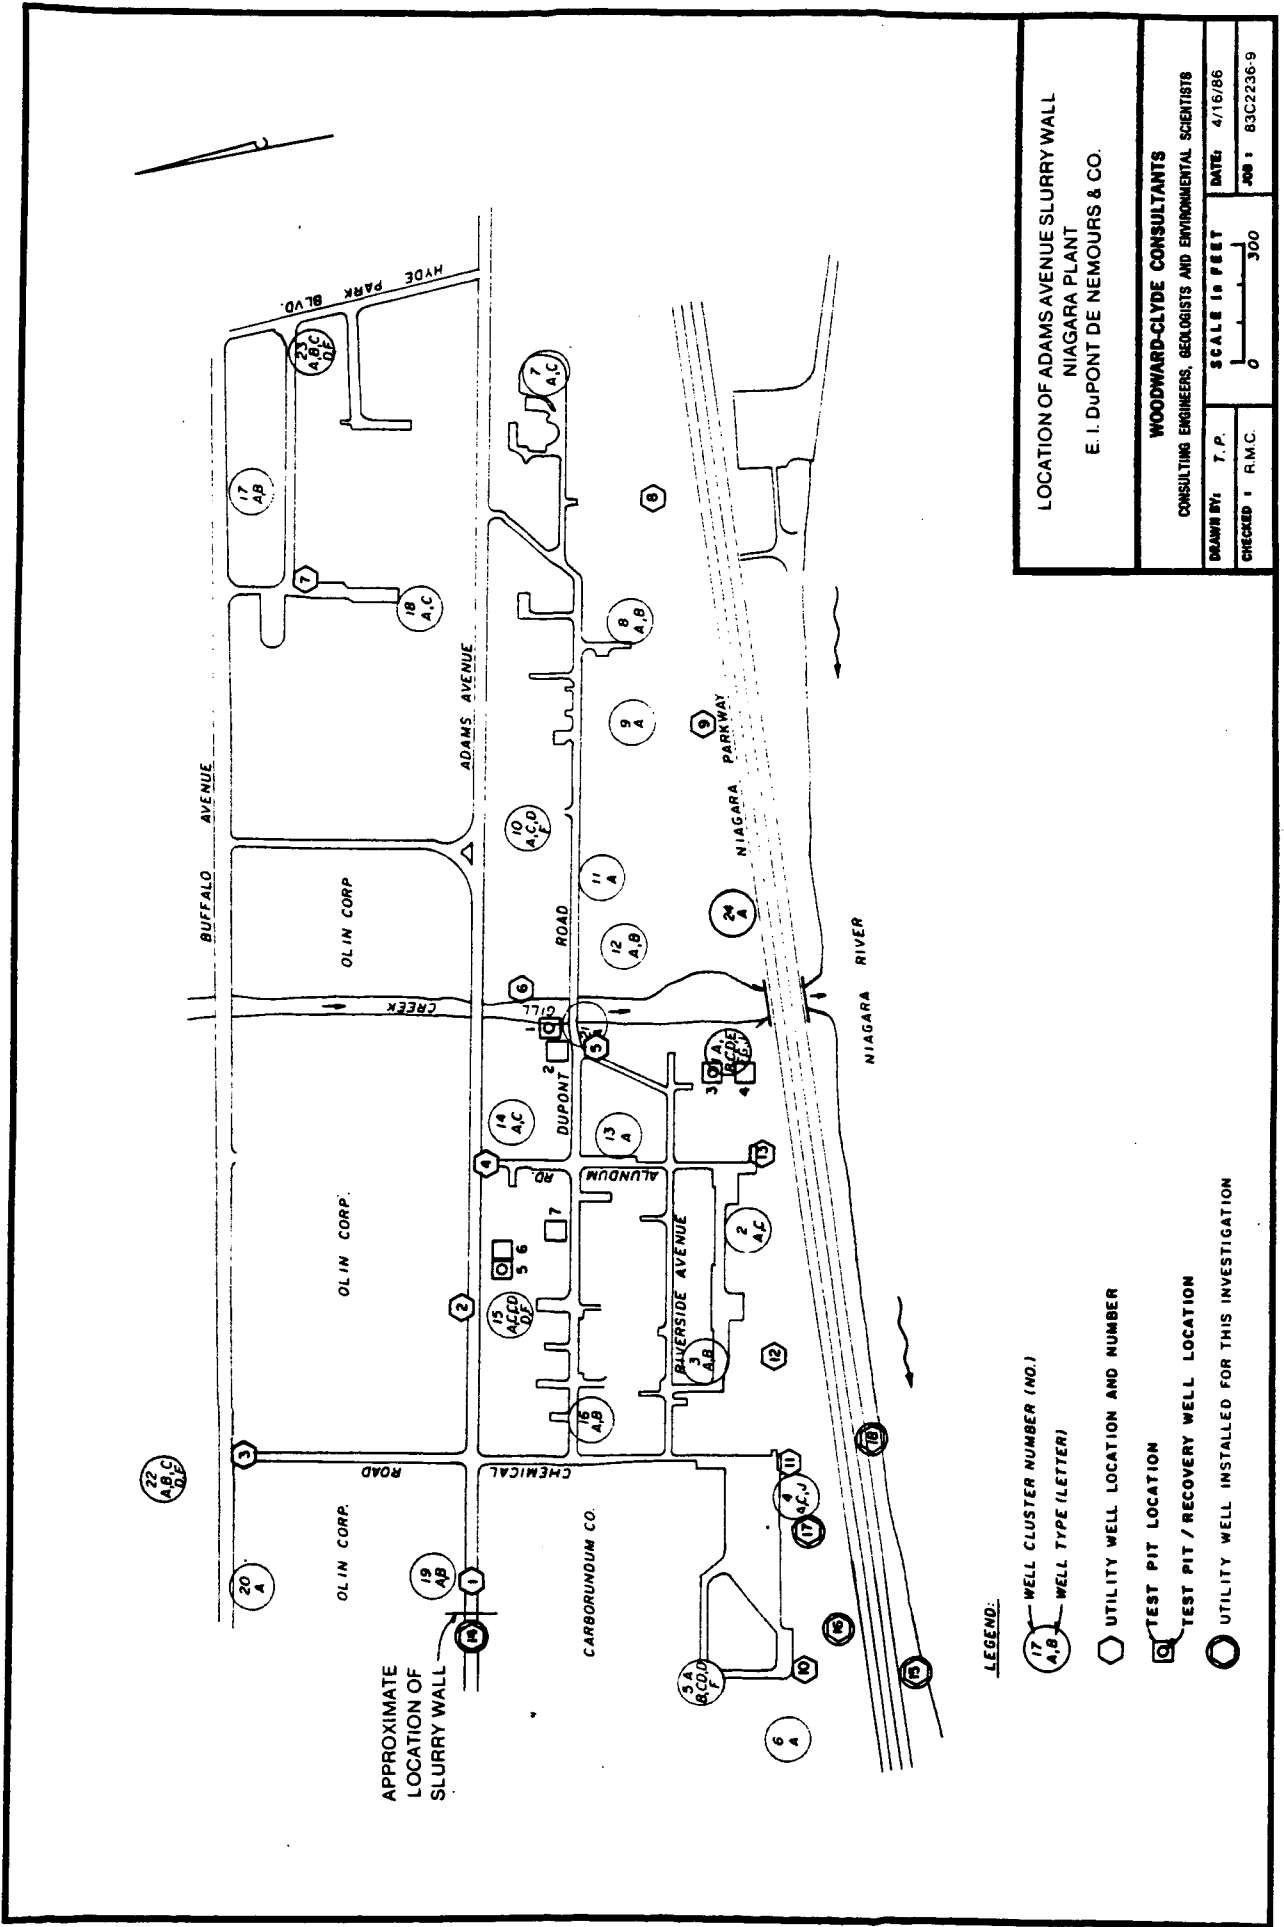
FIGURE 1

Test pits TP-1 and TP-14 were excavated adjacent to the Adams Avenue sewer. A summary of depths of materials encountered in each pit is presented in Table 1. Utility well U-1 was installed in TP-1 and utility well U-14 was installed in TP-4 (Figure 1). Test pit logs and utility well construction diagrams are presented in Attachment A. The test pit logs indicate that the Adams Avenue sewer trench was cut into rock and appears to have been drilled and shot. The sewer pipe bedding was noted as a silty clay/clayey silt with coarse to fine sand and gravel size rock fragments. The pipe trench backfill was noted as predominantly shot rock and more permeable than the surrounding material. The utility wells were screened in the sewer trench backfill since the higher permeability shot rock backfill would be the preferential pathway for groundwater movement and subsequent contaminant transport.

After the test pit excavations were completed and the utility wells allowed to equilibrate, water levels and groundwater samples were obtained. The groundwater elevations observed in utility wells U-1 and U-14 were lower with respect to the nearby monitoring well 19A. This would indicate a hydraulic gradient towards the sewer trench. Groundwater concentrations of C-1 and C-2 compounds in utility wells samples were about two orders of magnitude greater than in groundwater samples from monitoring well 19A. These data suggested that the Adams Avenue sewer may be a pathway for contaminant transport from the site. As a result of the investigation, Du Pont requested that WCC prepare a report on the construction of a low permeability underground barrier (slurry wall) across the Adams Avenue sewer, west of Chemical Road (Figure 1).

Utility well U-1 was damaged in in the winter of 1987 and has since been inaccessible to sampling crews. WCC recommends that U-1 be repaired in order to complement U-14 in monitoring the effectiveness of the Adams Avenue slurry wall. Utility well U-14 should be checked to verify that the casing is intact and the bottom is clear of any obstructions which may cause a dry well reading. Monitoring of groundwater levels and sampling in U-1 and U-14 should continue in order to verify that the slurry wall is maintaining its integrity as a hydraulic and contaminant barrier.
