**REMEDIAL ACTION CONSTRUCTION
IMPLEMENTATION – ADDENDUM NO. 1
REPAIR OF SHORELINE EROSION**

**GRATWICK-RIVERSIDE PARK SITE
NORTH TONAWANDA, NEW YORK**

MARCH 2005

Prepared by:
Conestoga-Rovers
& Associates

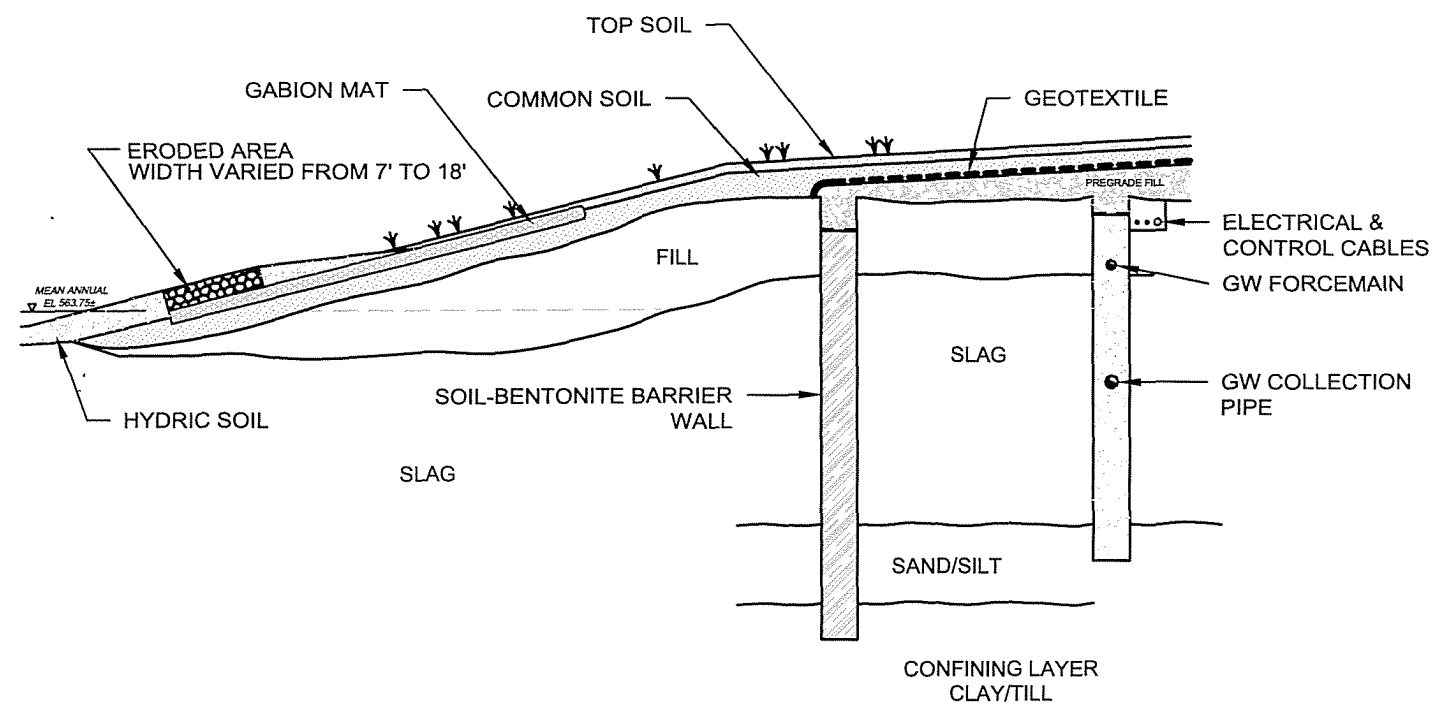
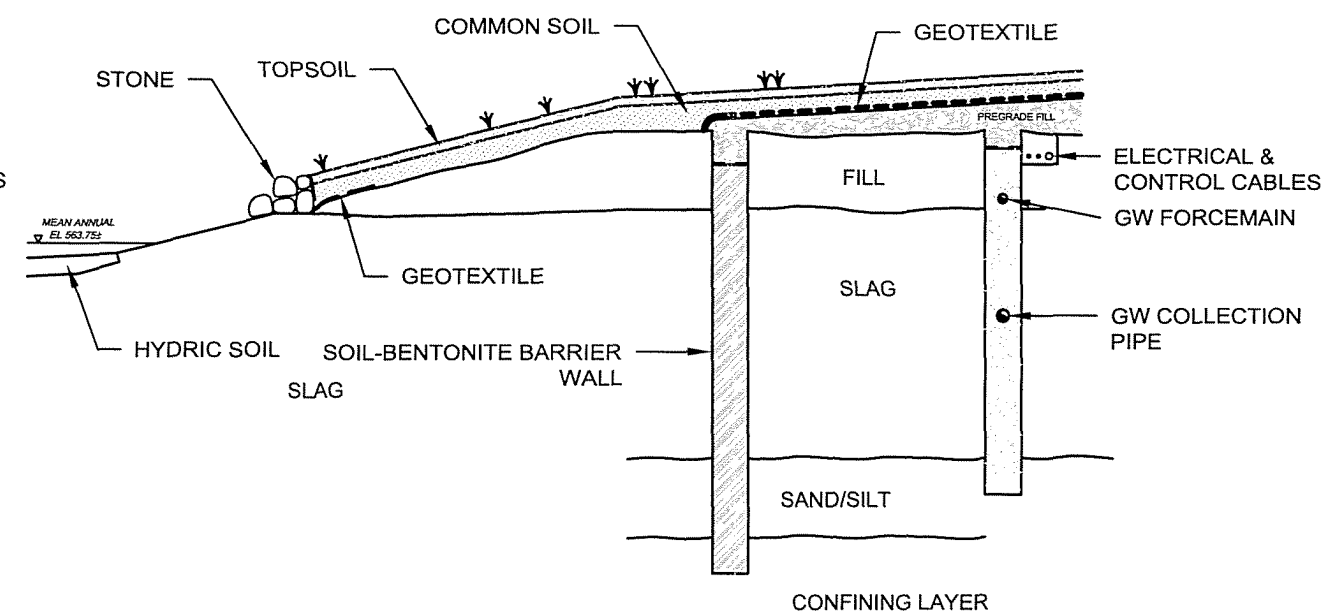
figure 2.1

Cross-sections of the sloped bank stabilization as designed and constructed are shown on Figure 2.1. One cross-section presents the details for the shoreline area which has competent slag along the River's edge and the other where competent slag is not present. A plan view of the layout of the RA, including the sloped bank stabilization, is shown on Figure 2.2. Also shown on Figure 2.2 are the areas where erosion of the overlying topsoil had been eroded and has been repaired. It is noted that, prior to repair, the underlying gabion mat and riprap contained within the gabion mat had not been impacted and continued to prevent erosion of the underlying shoreline soil; thus protecting the constructed remedial components.

TYPICAL BARRIER SYSTEM
WITHOUT COMPETENT SLAG

TYPICAL BARRIER SYSTEM
WITH COMPETENT SLAG
