SITE OBSERVATION REPORT – Remedial Investigation – Day 04

PROJECT No.: 170698601 CLIENT: DATE: Monday, 14 November 2022

PROJECT: 125 3rd Street Third Street WEATHER: Partly Cloudy, 40-46 °F

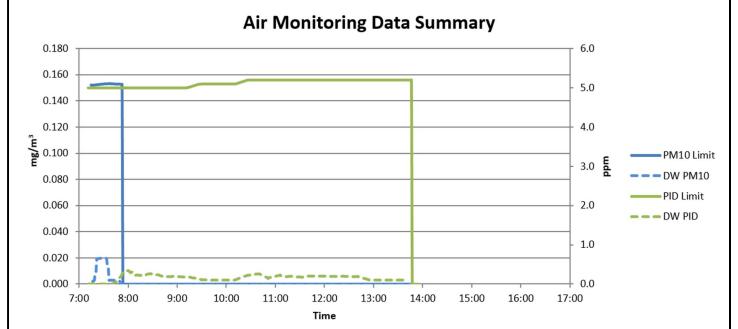
• Langan performed real-time air monitoring during ground-intrusive activities for VOCs and particulate matter less than 10 microns in size (PM10) at the perimeter of the work area at one upwind and one downwind location (depicted on the attached Site Map). 15-minute-average concentrations of VOCs and PM10 were not recorded above the action levels during the monitoring period. PM10 was not recorded by the downwind or upwind stations after 7:52 a.m. due to battery issues in both units. No visible dust emissions were observed leaving the site. Replacement batteries will be installed in both units prior start of work on 15 November 2022. Recorded air monitoring data at the downwind location is presented on the following graph:
