ENGINEERING REPORT

Prepared for
Corporation of the Presiding Bishop of The Church of Jesus Christ of Latter-day Saints
c/o Latham & Watkins LLP
885 Third Ave
New York, NY 10022-4834

December 21, 2012

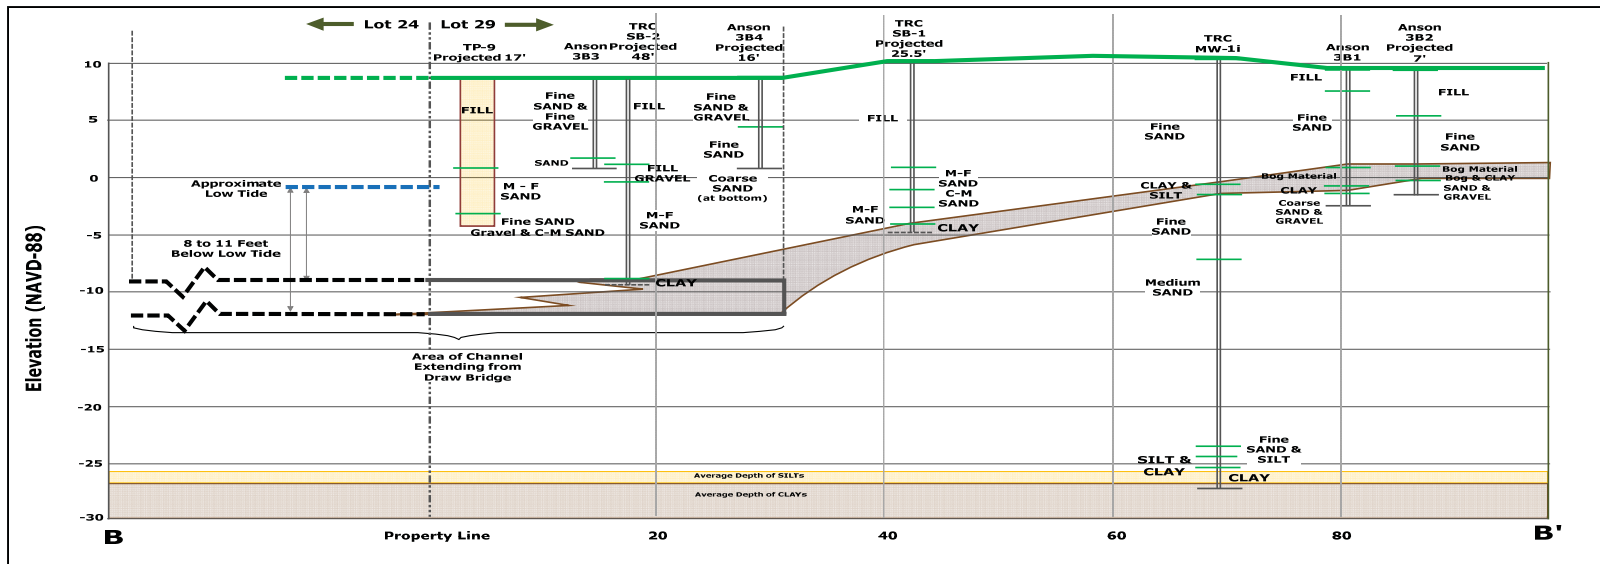
Figure 6 Cross-Section B-B'

The three cross-sections that run from the southwest to the northeast show the effects of sedimentation mechanics that occurred in and near the former Norton Creek channel. Cross-Section B-B' (Figure 6 Cross-Section B-B') runs from the northeast to the center line of the former channel at the point it once passed under the former draw bridge. The draw bridge defines the channel location at this end of the Site as the channel had to have gone under the bridge. As can be seen, the middle clay layer slopes toward the center line of the channel from the area to the northeast that is outside the channel. A variety of coarser grained soils are identified in the section of the cross-section representing the former channel. The location of the former channel is well defined near the former draw bridge and the soils are more permeable due to the larger grain sizes. Note that the other half of the channel in the sloping clay located on Lot 24 cannot be depicted due to the lack of borings and test pits with soil descriptions on Lot 24. Because the conditions on Lot 29 show the effects of the former Norton Creek channel, we can anticipate that the same sloping clay is present on Lot 24 as a mirror image, which is consistent with other data on Lot 24 that shows the clay sloping from high areas to the west to low areas to the east. This is shown by Cross-Section D – D' below.

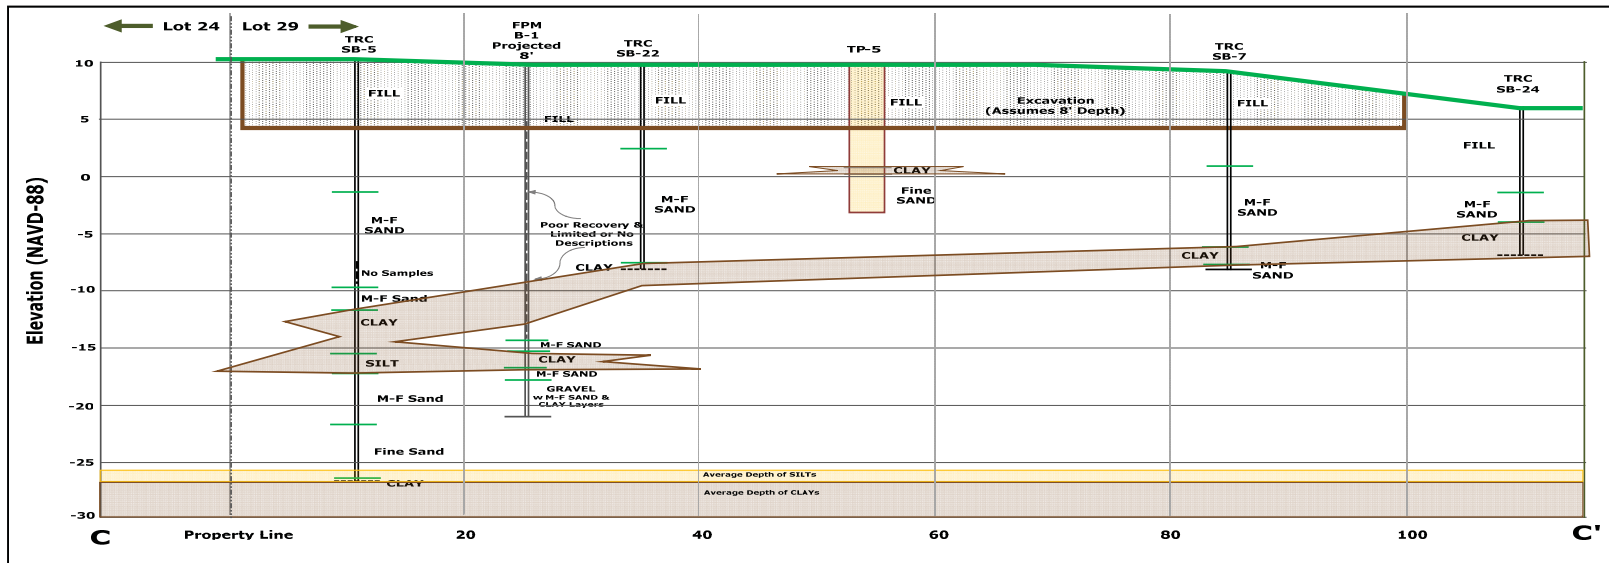
Figure 7 Cross-Section C-C'

Cross-Sections C-C' (Figure 7) and D-D' (Figure 8) are located further from the former draw bridge, however, the slope of the clay is still evident. As with Cross-Section B – B', the information for Cross-Section C – C' is not available for Lot 24. The interpretation of geologic materials on Lot 24 is an extension of the conditions on Lot 29. However, the mirror image is expected as it was for cross-section B – B' for the same reasons.

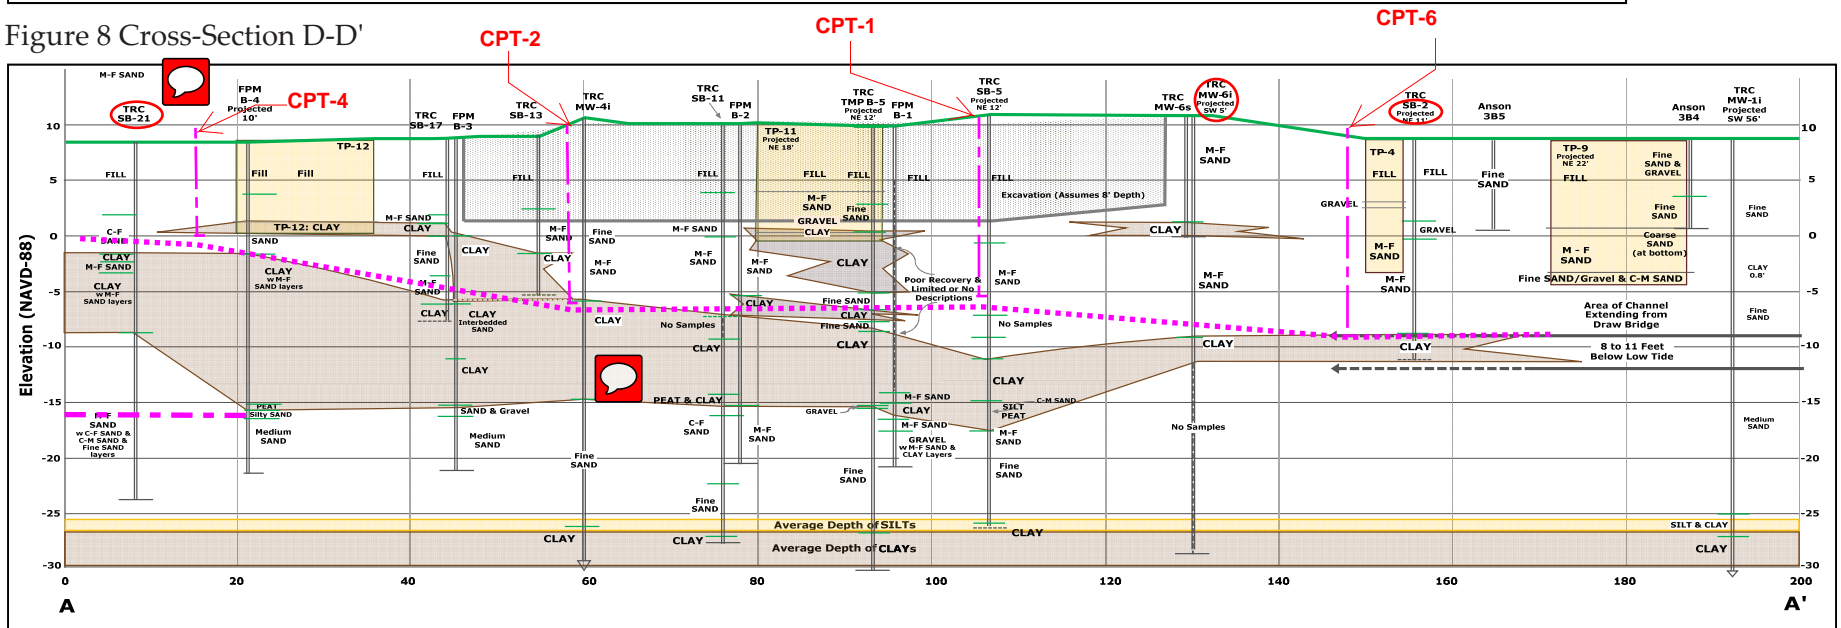
Figure 9 Cross-Section A'A'

Cross-Section A-A' is oriented from south-southeast to north-northwest toward Norton Bay. As can be seen, not only is the clay dipping toward Norton Bay, but it is thinning as well. This is because the areas further from the Bay experience lower velocities for a larger period of time causing the greater deposition of smaller particle sizes as well as the development of marshy areas which, in turn, deposit more silt and clay soils.

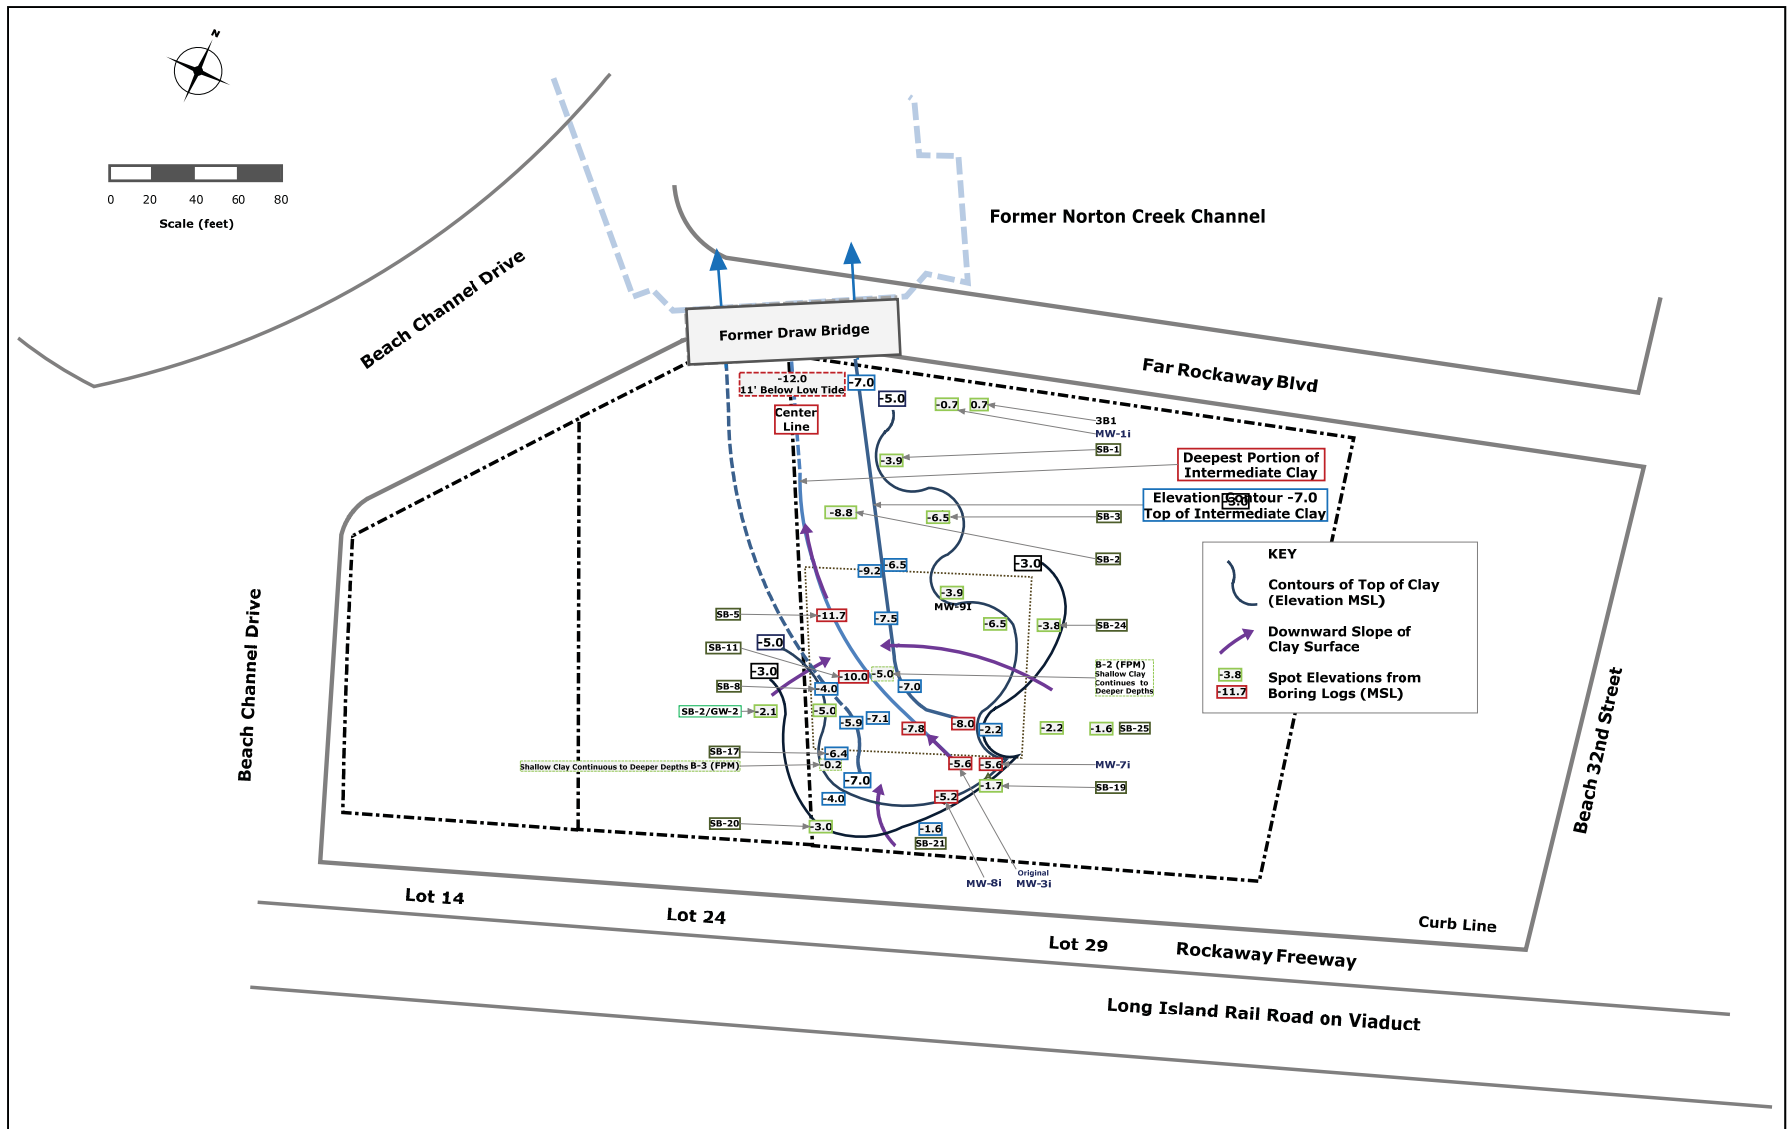
Figure 10 Top of Intermediate Clay Unit

Elevation contours of the top of the intermediate clay layer are shown in Figure 10. The former center line of the channel is indicated where the elevation measurements of the top of the intermediate clay are lower relative to adjacent areas. This former center line is shown on the figure. The center line is in between the two lines representing the elevation of minus seven feet (-0.7 feet) MSL. The figure also shows the elevations of minus five (-5) and minus three (-3) feet MSL, and the gradient of the intermediate clay layer by arrows pointing down slope. These arrows also point in the approximate direction of local groundwater flow and the direction of movement of any other liquids such as petroleum oil that might be influenced by the sloping clay layer. The intermediate clay layer is shaped like a half bowl with the opening towards Norton Bay.

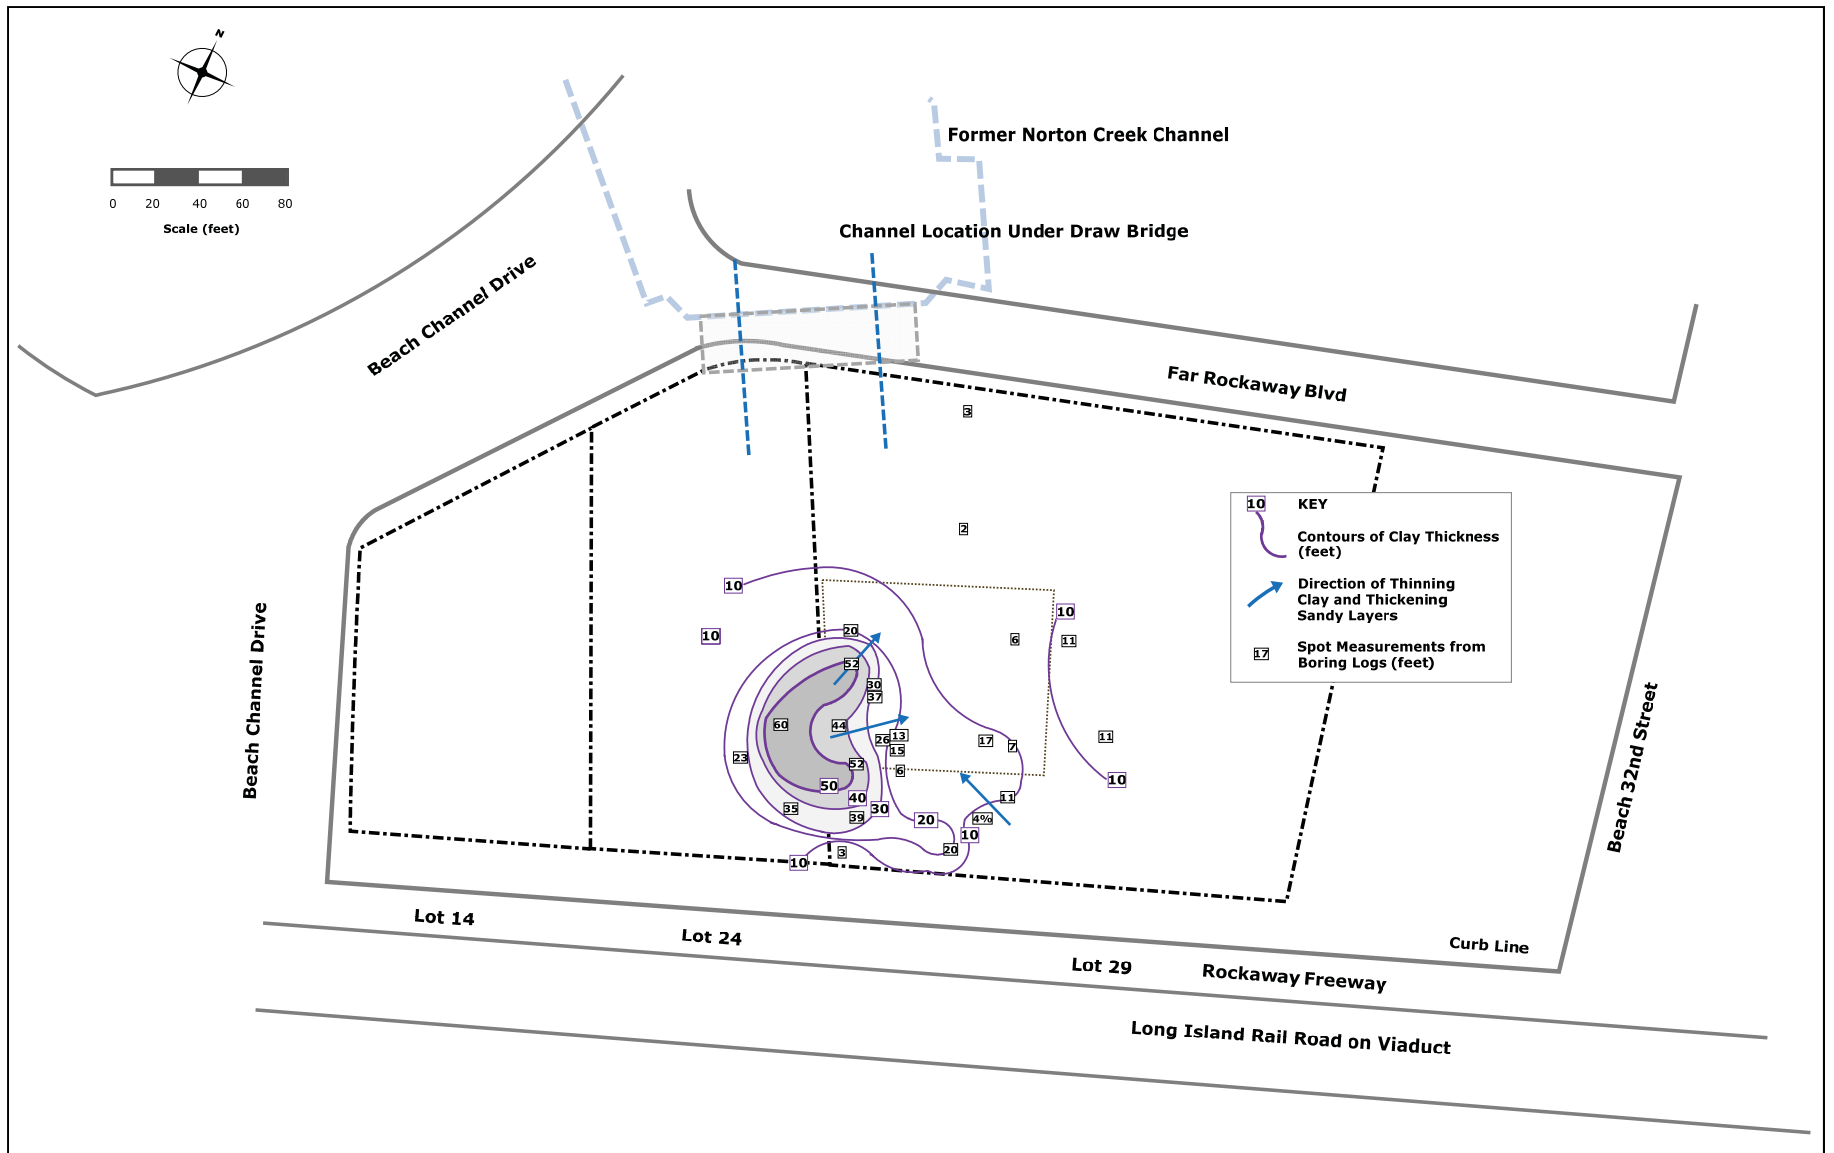
Figure 11 Thickness of Intermediate Clay

Layers conducive to groundwater flow thicken in the downslope direction of the intermediate clay layer creating a path of least resistance. In Figure 11, the percentage of the clay and silty soils in the soil column is plotted with arrows showing the direction in which the intermediate clay thins and the underlying sandy soil thickens as a result. Again, the arrows point in the direction in which groundwater flow is enhanced by the thinning clay layer and thickening layer of sandy soils conducive to the flow of groundwater. Additionally, the thicker portions of the intermediate clay (which bears the shape of the kidney on the figure), provide very strong resistance to the flow of groundwater or other liquids from Lot 29 to Lot 24 in this area.

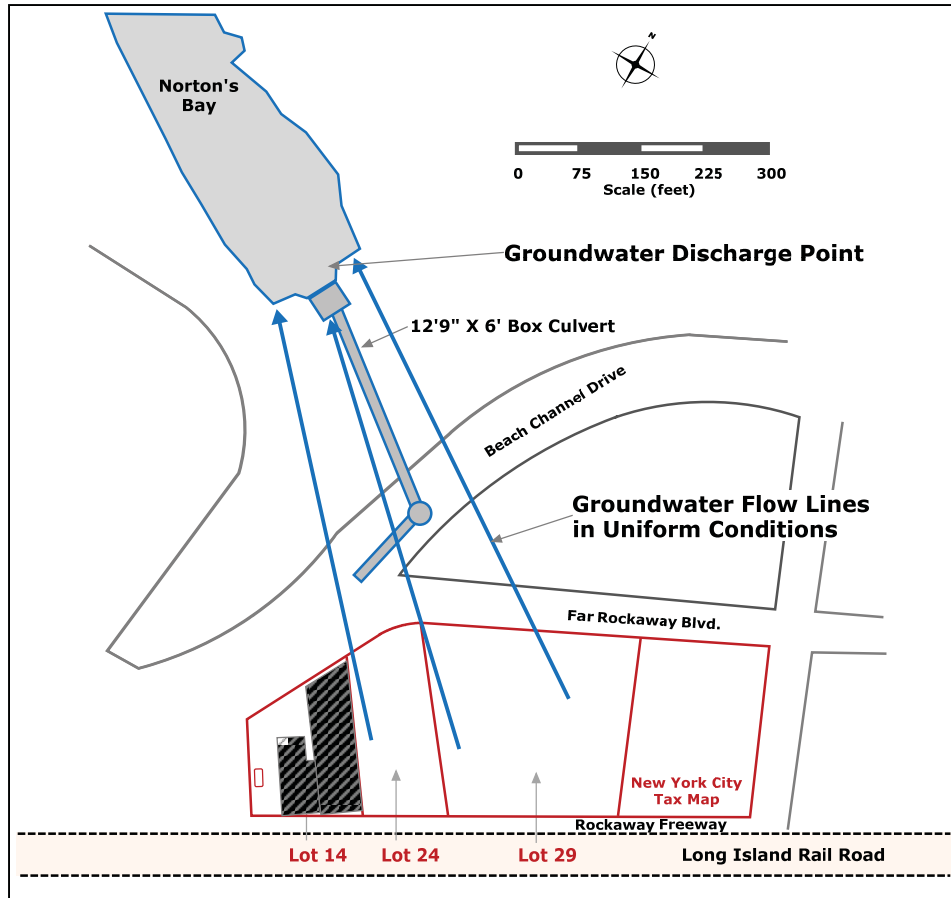
Figure 15 Expectation of Groundwater Flow under Uniform Conditions

The shortest line between a starting point for the groundwater and the point of discharge is the most likely path the groundwater will travel, when hydraulic conductivity, the ability of the soil to transmit water, and the cross-sectional area of flow are equal in all directions. In other words, under uniform conditions and by knowing the discharge point of the groundwater, one can reliably predict the direction of groundwater flow from any point on the land: it is simply a straight line between the starting point and the point of discharge (see Figure 15). The path the groundwater follows (such as this straight line under uniform conditions) is called the groundwater “line of flow” or “flow line.”

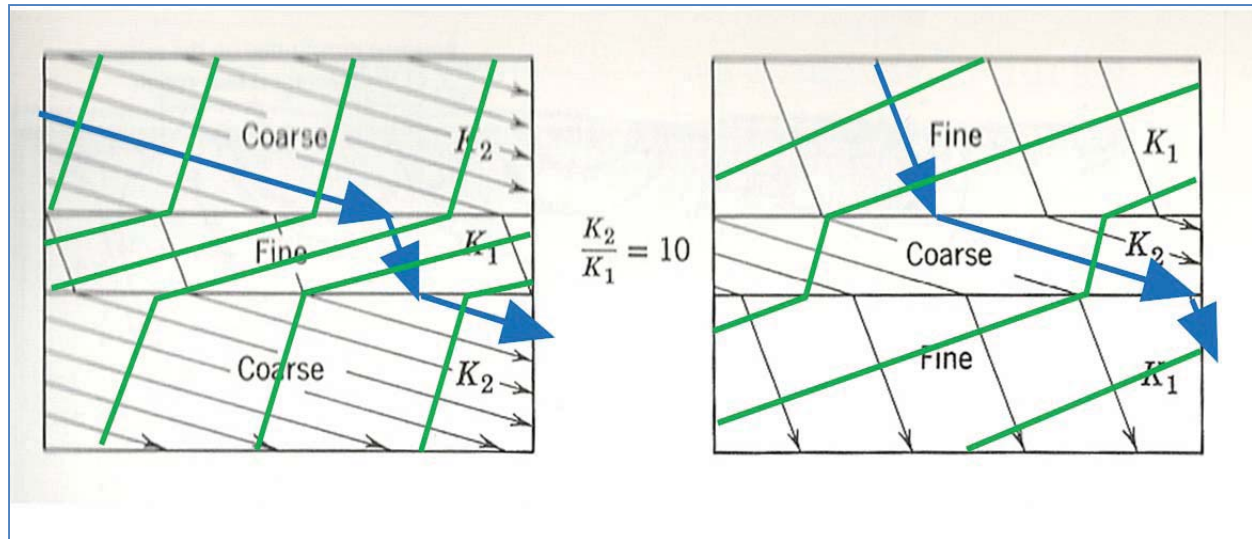
Figure 16 Hydraulic Conductivity Modifying Flow Line

In each image in Todd's figure a flow line has been highlighted for easier viewing. As can be seen, the direction of groundwater flow is altered by a change in hydraulic conductivity. In the image on the right, for example, a higher hydraulic conductivity zone in the middle of the image skews the flow to favor the zone. The opposite is shown in the image on the left where a lower hydraulic conductivity skews flow to favor the outer zones with higher hydraulic conductivity. In the figure the gradient of groundwater flow is also illustrated by contours of "equal potential"; that is, equal groundwater elevations (in a water table aquifer) or equal hydraulic potential in confined aquifers (aquifers with a confining layer above them).
