# C.T. MALE ASSOCIATES

January 8, 2014

RE: *Supplemental Site Investigation  
Old Champlain Mill BCP Site  
Village of Whitehall, Washington County, NY  
BCP Site No. C558036  
CTMA Project No. 06.6448*

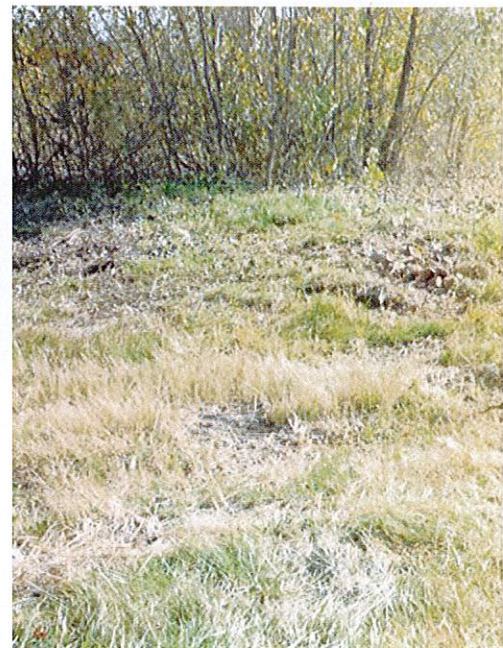
15 Anomaly 5 looking southwest.jpg

**Anomaly 5:** Anomaly 5 was noted in the northeastern portion of the study area. The anomaly extended outside of the study area to the north, within the site's driveway. NYLD indicated the anomaly was associated with the municipal water line as it connected to a hydrant located within the northeastern portion of the site.
