# **STORM-WATER COLLECTION SYSTEM INVESTIGATION REPORT**

**Buffalo Terminal  
Buffalo, New York**

**March 28, 2002**

**ROUX ASSOCIATES, INC.**  
1377 Motor Parkway  
Islandia, New York 11749

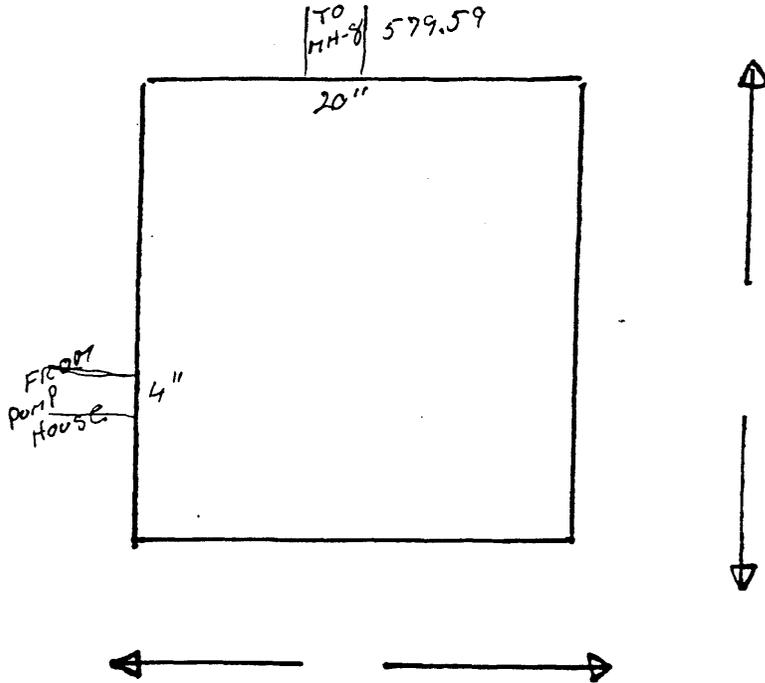
Structure # CB-0

Notes: BE 8/10/00  
- LINES JETTED

Surrounding Area:  
GRAVEL

Flow: NORTH TO MH-8

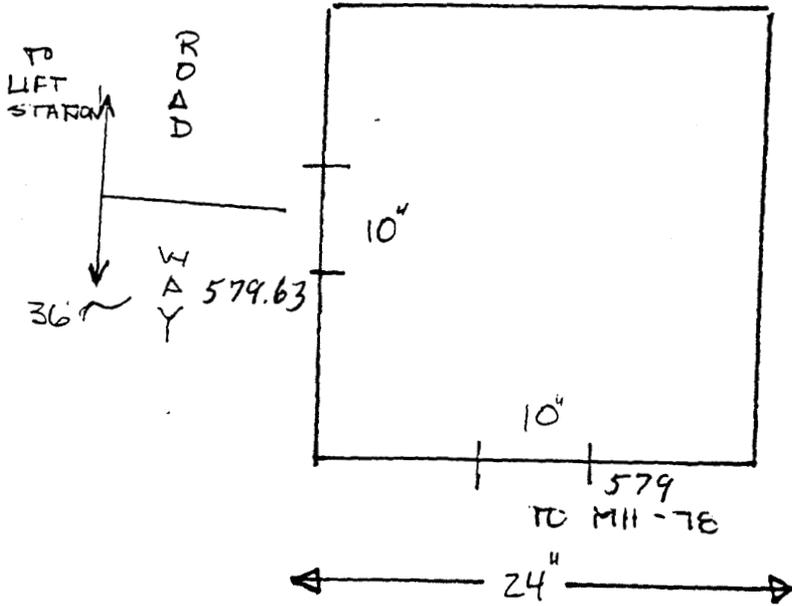
Structure # CB-1

Notes: Be 4/2x10  
formed concrete  
clean water  
clay pipes  
stone cover around car  
basin  
8" riser, Box ABOVE GRADE

Rim Elevation:  
584.2  
Depth to Bottom: 65"

Constructed of:  
concrete  
Sediment: 1"-2"

10" WEST LINE GOES TO  
MIDDLE OF ROADWAY  
THEN NORTH TO  
LIFT STATION

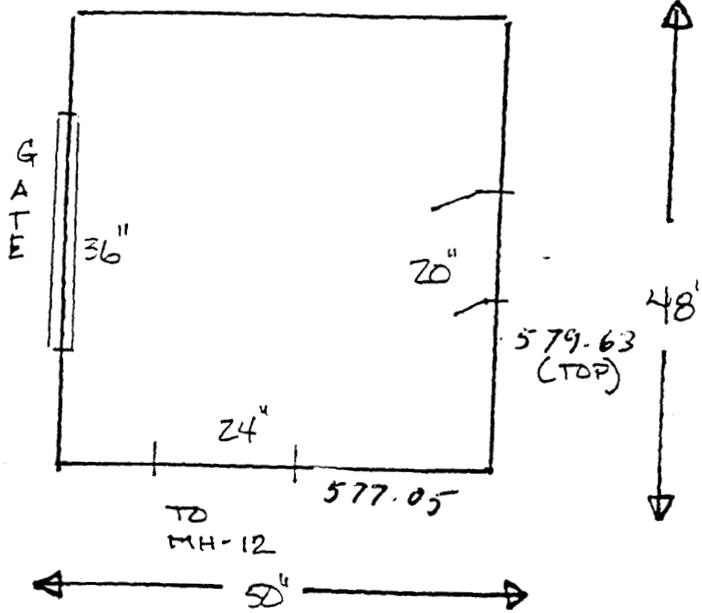
Structure # CB-2

Notes: Be 9/29/00  
 Clay pipes  
 formed concrete  
 Clean water  
 weir door west side  
 to large Separator  
 - 36" RISE TO STEEL CURB  
 TOP  
 Rim Elevation:  
 586.23  
 Depth to Bottom: 11'

Constructed of:  
 CONCRETE  
 Sediment: 11" SAND

Flow:  
 - SOUTH TO MH-12

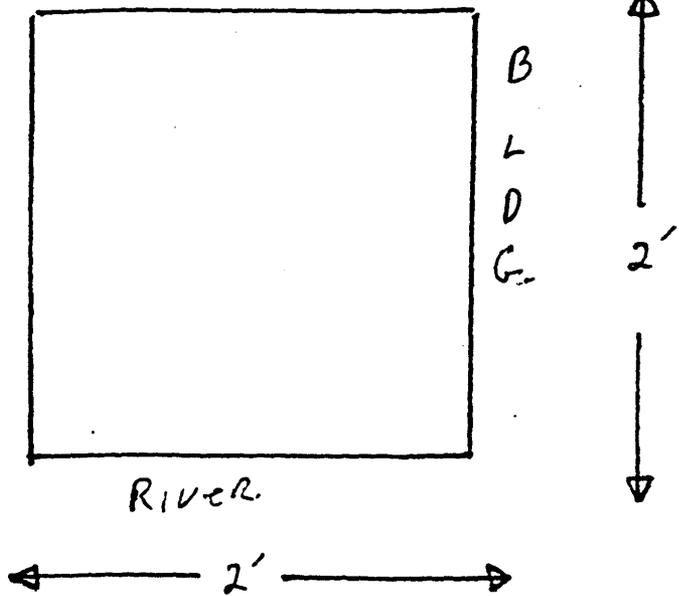
Structure # CB4

Notes: BC 4/19/01  
- APPEARS TO BE  
A CONCRETE SUMP.

Flow: NONE

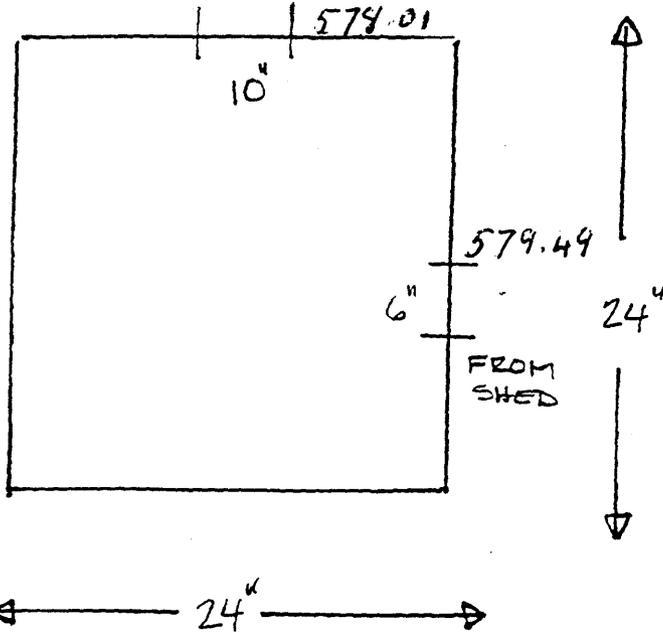
Structure # CB-5

- NOTES: BC 9/2/10
- FORMED CONCRETE CONSTRUCTION
  - CLEAN WATER
  - PVC PIPES
  - STEEL COVER
  - 10" LINE CONNECTS TO A 30" LINE

NORTH TO CB-6

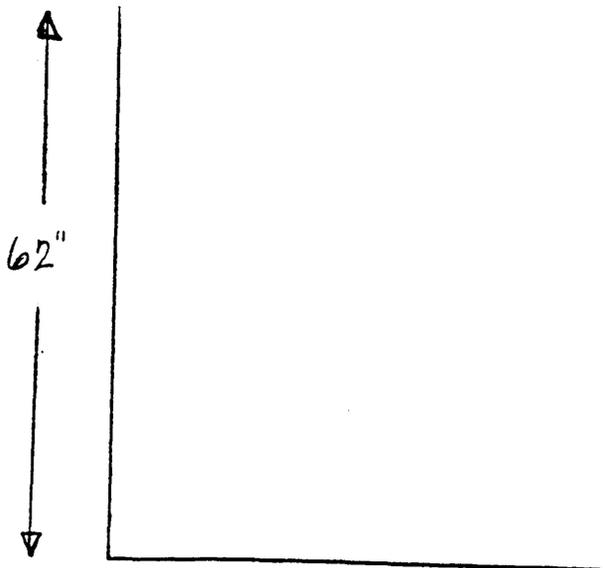
### Structure # CB-7

- NOTES: BC 9/29/00
- BRICK CONSTRUCTION
- HEAVY OIL PRODUCT
- STEEL PLATE COVER
- CLAY LINES
- 30" W LINE BEVELLED
- PRODUCT / WATER  
15 LOCATIONS

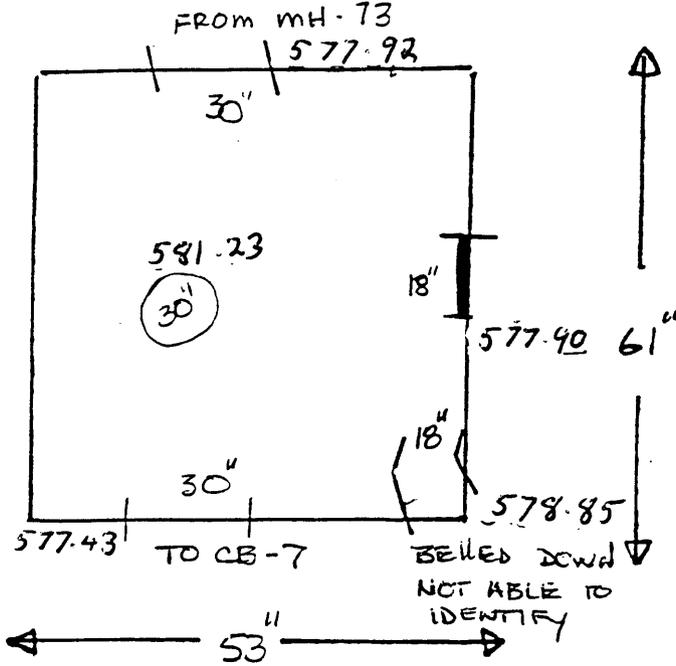
Structure # CB-8

- NOTES: EC 9/28/00
- BRICK CONSTRUCTION
  - HEAVY OILY PRODUCT
  - CLAY LINES
  - 18" E LINE SEALED
  - 18" S/E LINE BELLED
  - PRODUCT / WATER  
1500 GALLONS

Flow:  
NORTH TO SOUTH

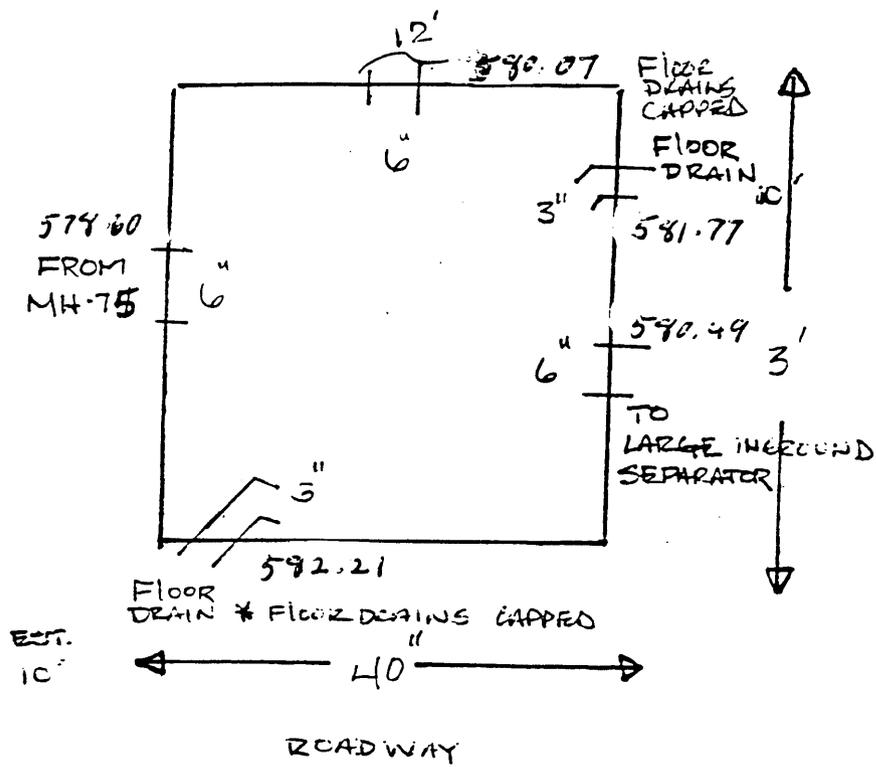
Structure # CB - 10

Notes: BE 12/11/00  
 Block construction  
 Steel lines  
 Clean water  
 NO product  
 Full water  
 - ~~6" N/E LINE~~  
 12' OUT.

Rim Elevation:  
 582.51  
 Depth to Bottom: 4'

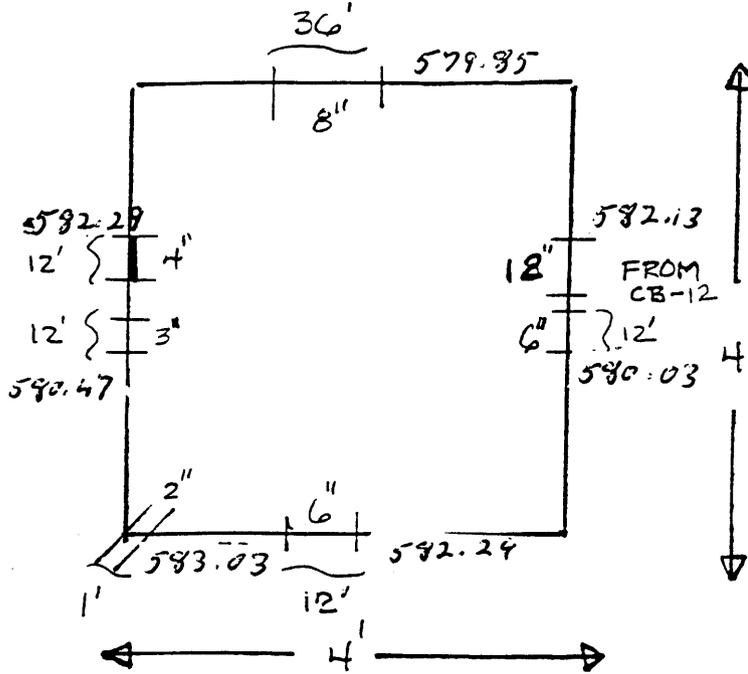
Structure # CB-11

- NOTES: BC 9/25/00
- CONCRETE CONSTRUCTION
  - CLEAR WATER
  - CONCRETE DEBRIS AREA
  - STEEL COVER
  - STEEL LINES
  - 4" WEST LINE CEMENT

EAST TO CB-12

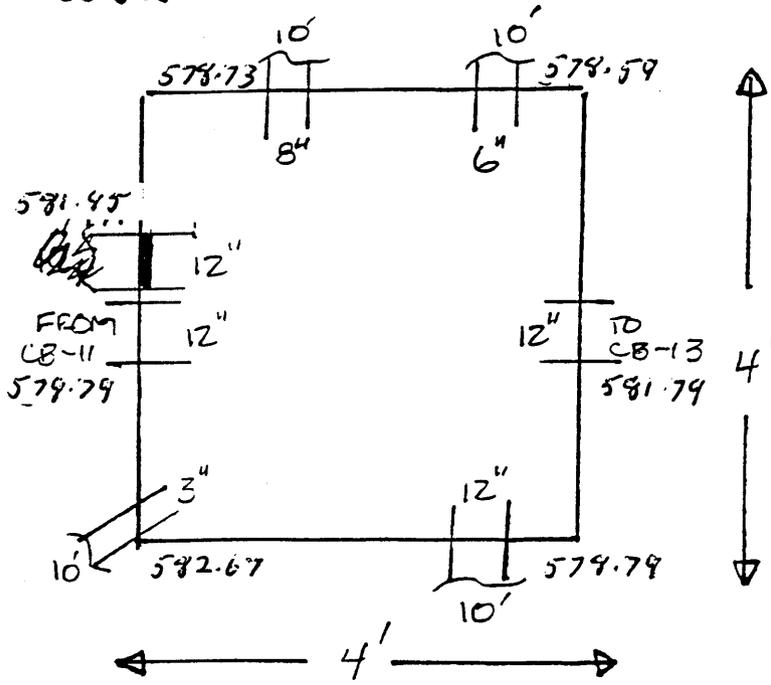
Structure # CB-12

- Notes: BC 9/25/09
- CONCRETE CONSTRUCTION
  - FULL OF RAIN WATER
  - CONCRETE DEBRIS COVER
  - STEEL COVER
  - STEEL PIPES
  - 12" WEST LINE CEMENTITE

EAST TO CB-13

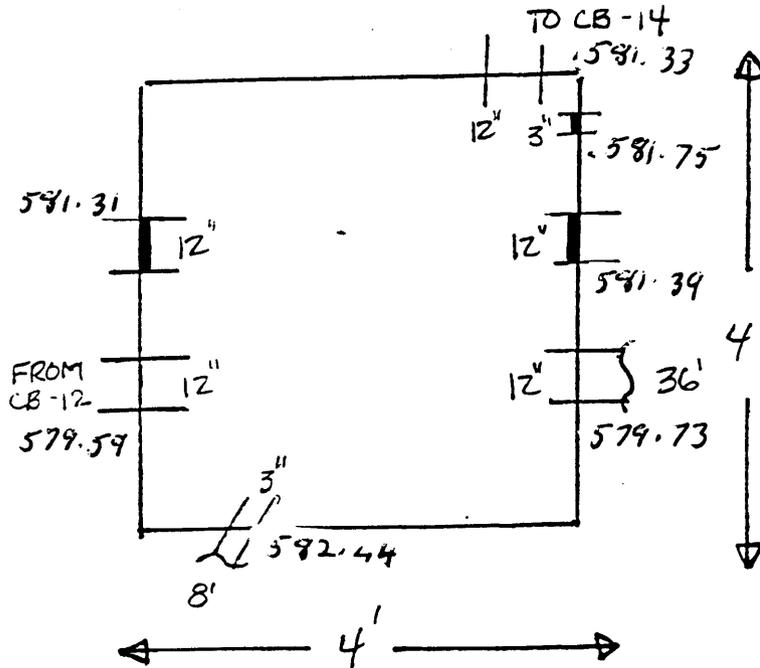
Structure # CB-13

- NOTES: BC 9/25/00
- CONCRETE CONSTRUCTION
  - WEST AND EAST 12" LIN DEBRIS COVERED ELEVAT. QUESTIONABLE.
  - STEEL COVER
  - STEEL PIPES
  - WEST AND EAST 12" CEMENT
  - 3" EAST LINE CEMENTED.
- Rim Elevation: 584.59

Depth to Bottom: 60"  
 \* QUESTIONABLE DUE TO DEBRIS IN BASIN.

Flow:  
 EAST FROM CB-12 TO  
 NORTH CB-14

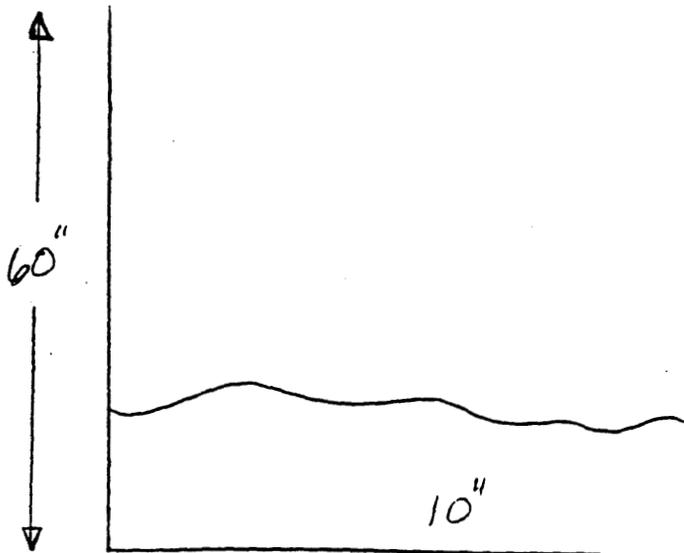
Structure # CB-15

Notes: BE 7/24/00  
Brick Construction  
Slow flow N/W  
very little product  
poor condition on top edges  
- Pipeline runs on top of CC

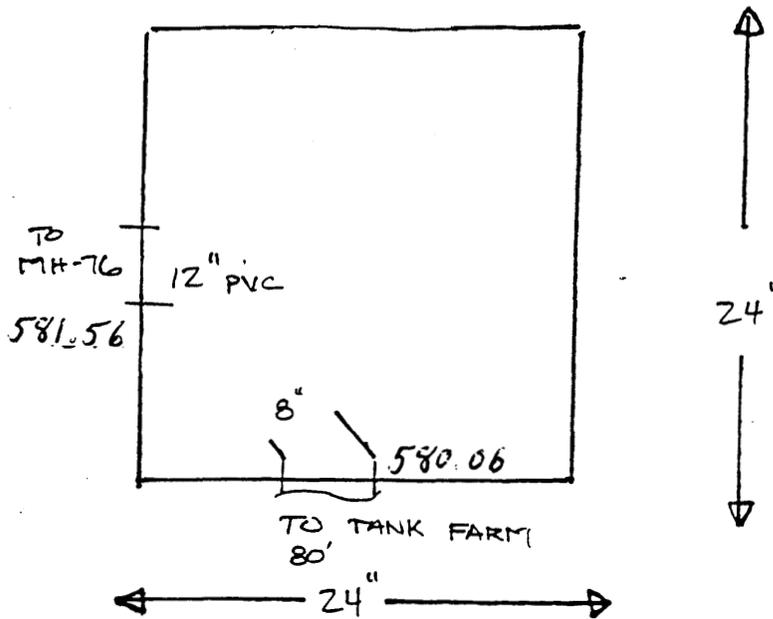
Structure # CB-21

Notes: BC 4/24/00  
formed concrete  
stone cover on ground  
PVC/steel pipes  
Clear water

- WEST TO MH-76
- SOUTH TOWARDS TANKS 97-38

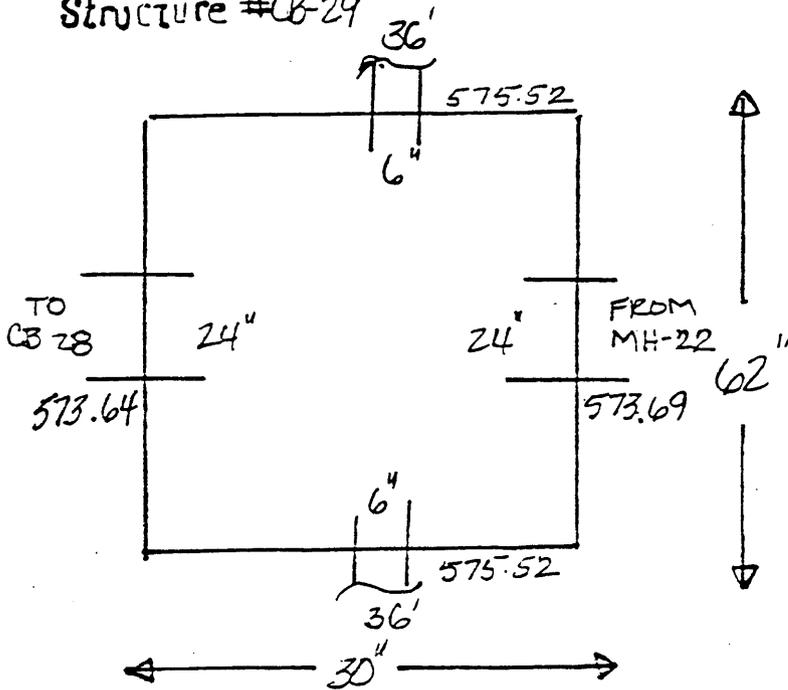
Structure #CB-29

- NOTES: BE 9/25/00
- BRICK CONSTRUCTION
  - MINIMUM PRODUCT FLOW
  - 6" LINES 36" OUT DOWN 3'-6"
  - CLAY LINES
  - STEEL COVER

Flow:  
WEST TO EAST  
FROM MH-22 TO CB-28

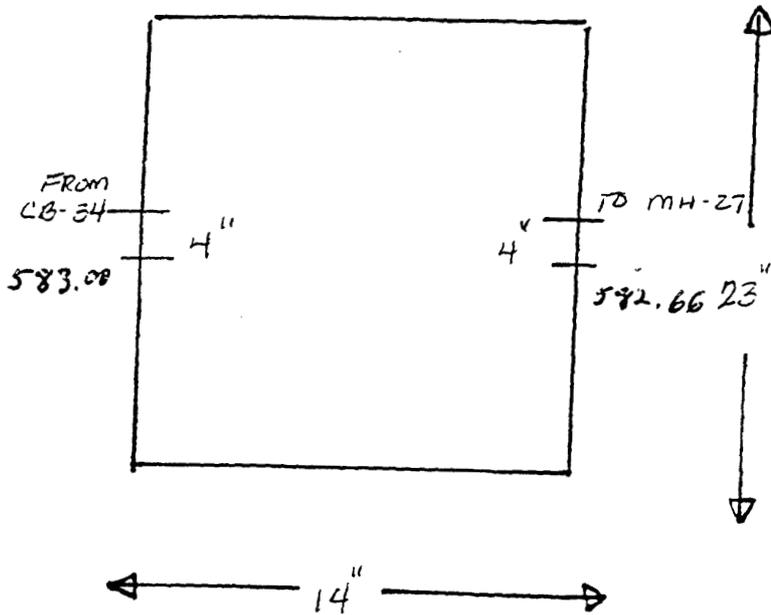
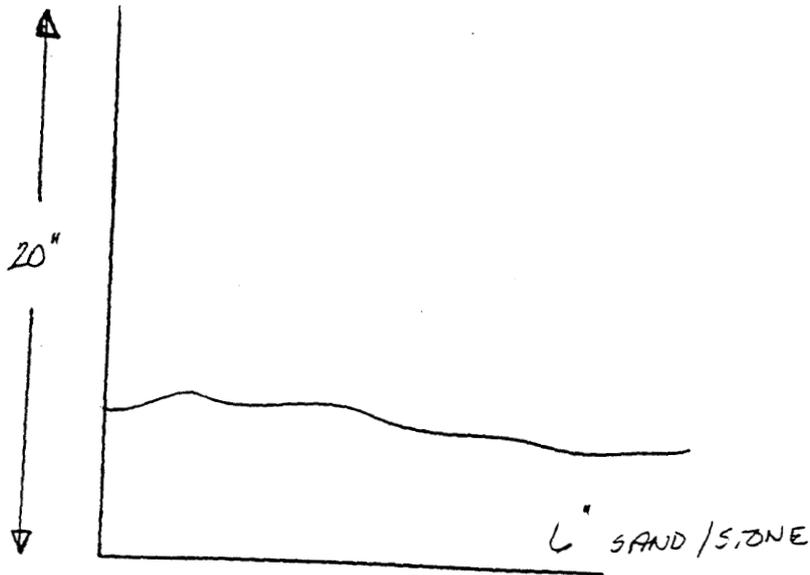
Structure # LB - 33

- NOTES: BC 9/12/00
- CONCRETE CONSTRUCTION
  - ASPHALT ROADWAY
  - WEST LINE FED FROM CB - 34
  - EAST LINE CONNECTS TO MH - 27
  - CLAY LINES
  - Rim Elevation. 584.30

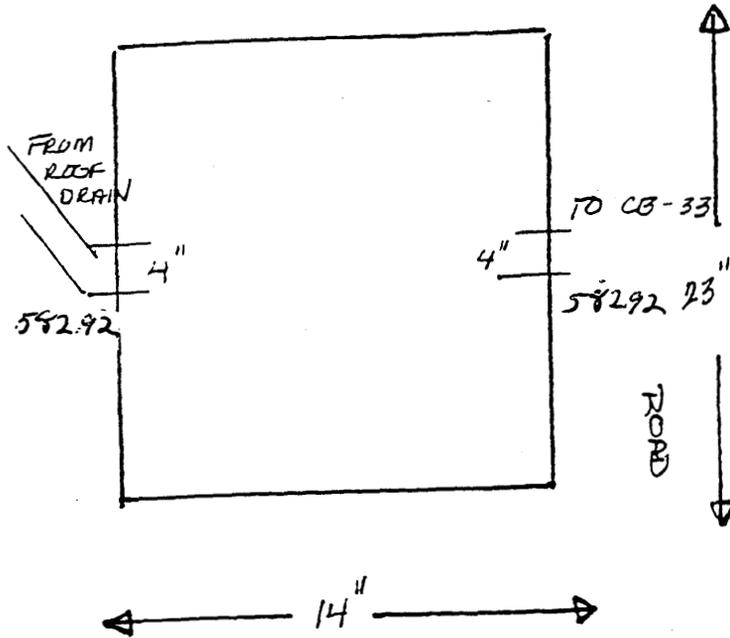
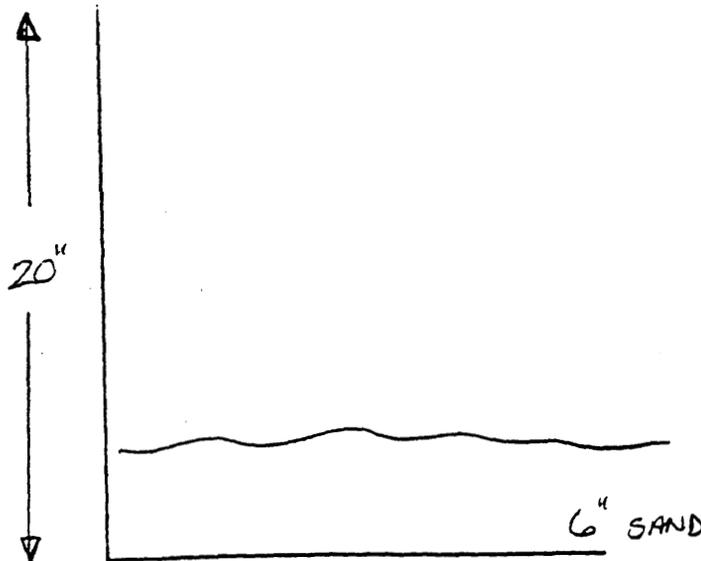
Structure # CB-34

- Notes: BC 9/12/00
- CONCRETE CONSTRUCTION
  - ASPHALT ROADWAY
  - WEST LINE IS FED FROM TBLG ROOF DRAIN
  - EAST LINE CONNECTS TO CB-33
  - CLAY LINE

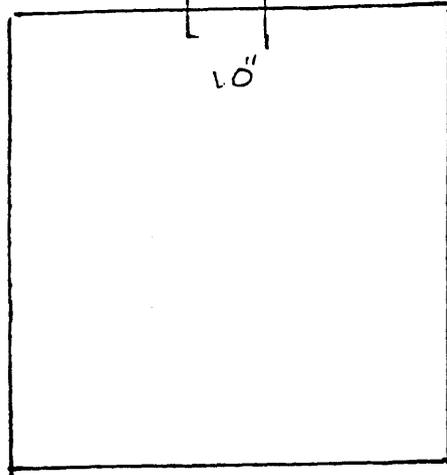
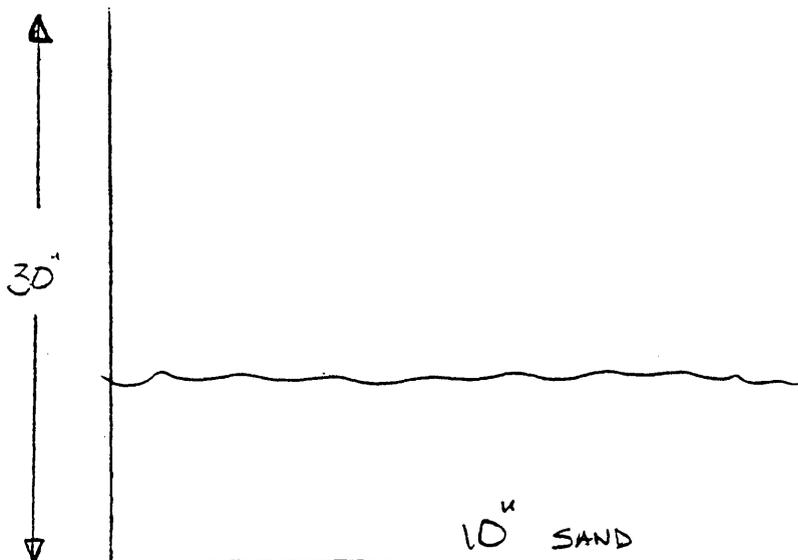
- STEEL FRAME CONSTR.
- SET IN POLICE PARKING LOT, NEXT TO FENCE
- CAST LINES
- DRY, NO WATER

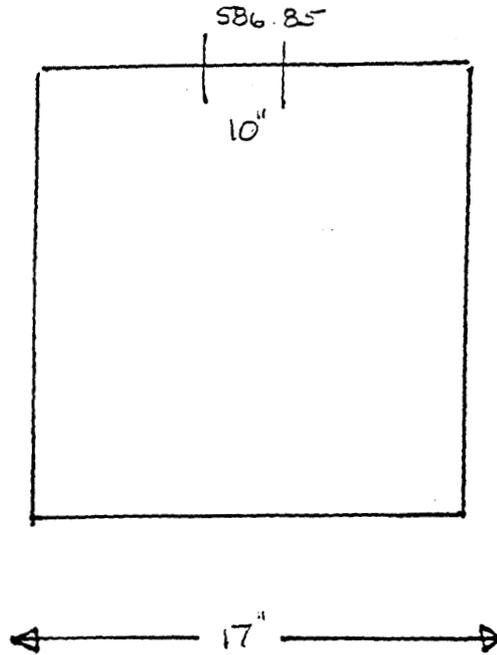
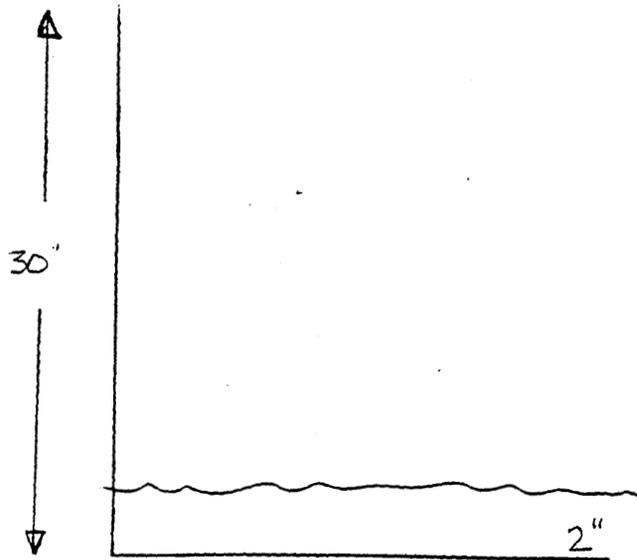
Structure # CB - 36

- STEEL FRAME CONSTRUCT
- SET IN POLICE PARKIN LOT, NEXT TO FENCE.
- DRY, NOT WATER
- CAST LINES

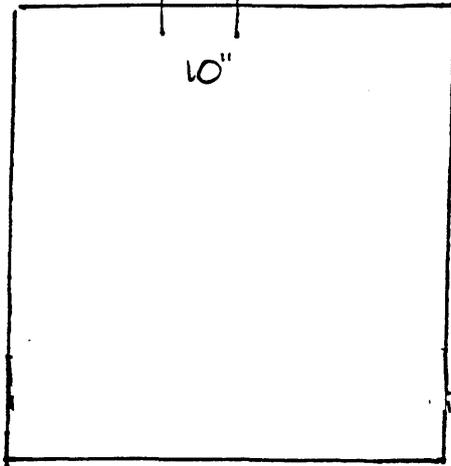
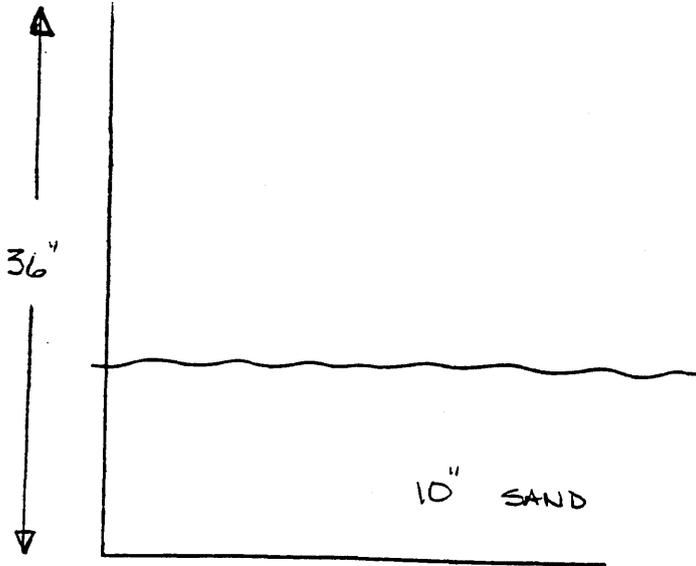
Structure # CB-37

- STEEL FRAME CONSTRUCTION
- SET IN POLICE PARKING LOT NEXT FENCE
- CAST LINES
- DRY, NO WATER

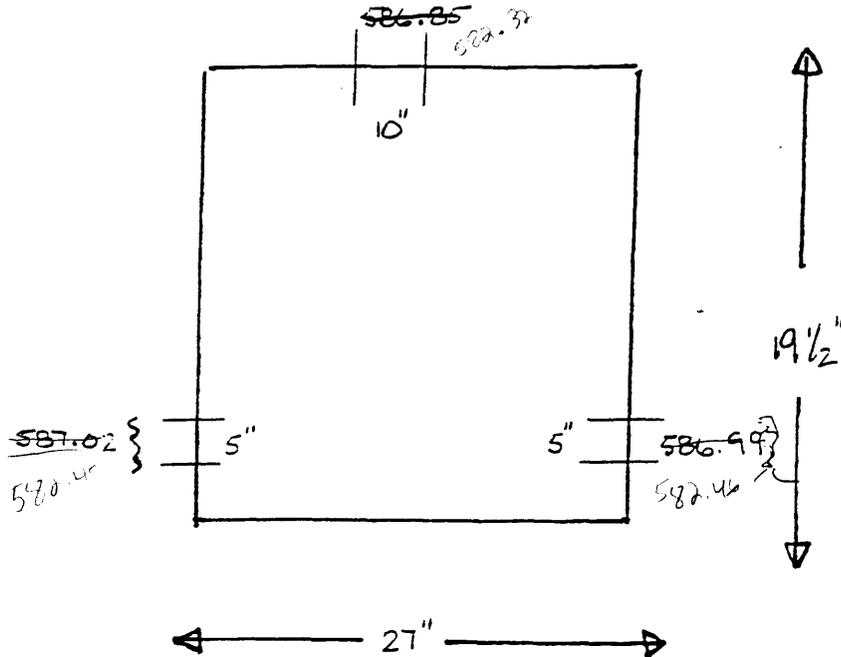
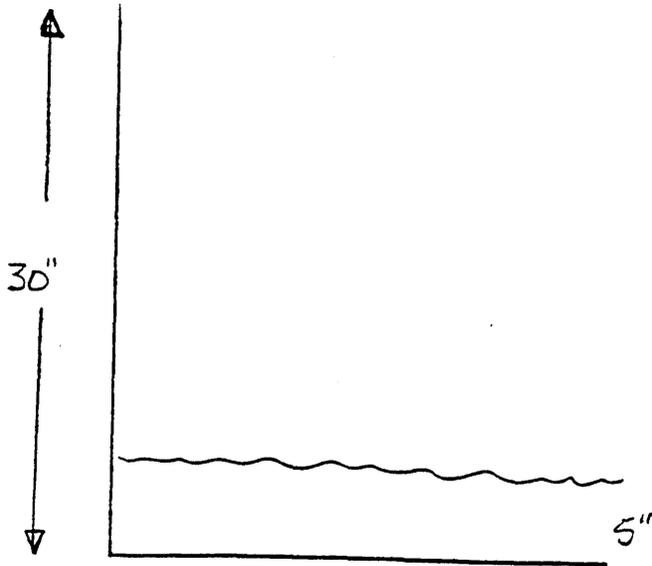
Structure # CB-38

Notes: BE 9/6/00

- STEEL FRAME CONSTRUCTION
- EAST LINE PLUGGED 1" IN.
- SET IN POLICE PARK LOT NEXT TO FENCE
- CAST LINES

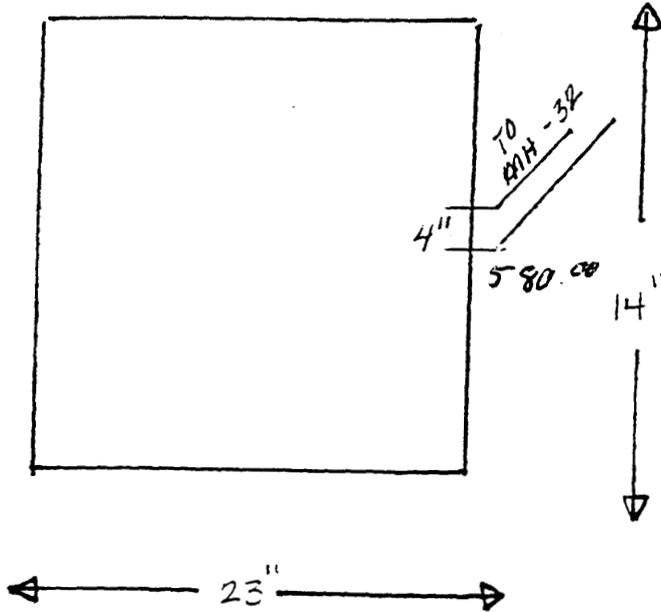
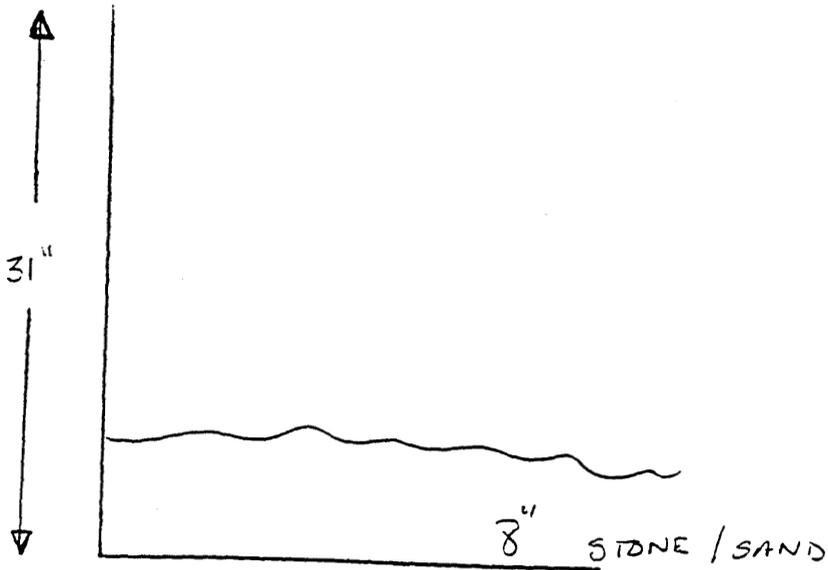
Structure # LB-39

- Notes: BC 7/12/00
- CONCRETE CONSTRUCTION
  - ASPHALT / STONE COVER
  - STEEL COVER
  - CB FILLED W/ STONE
  - CLAY LINE

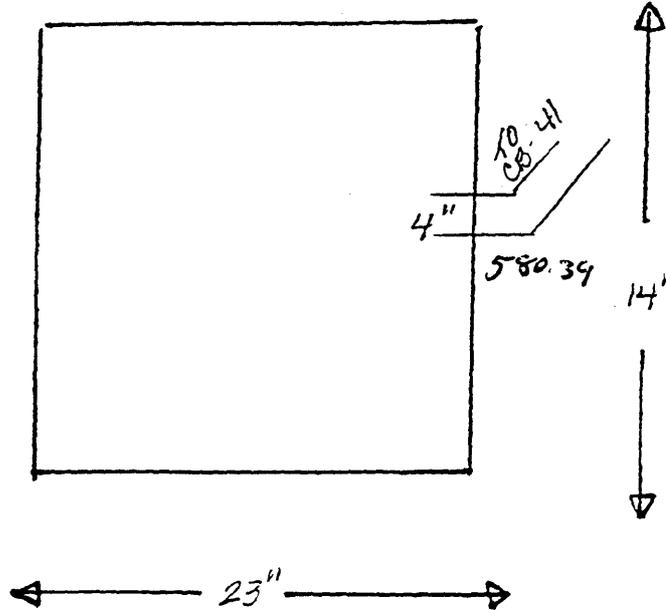
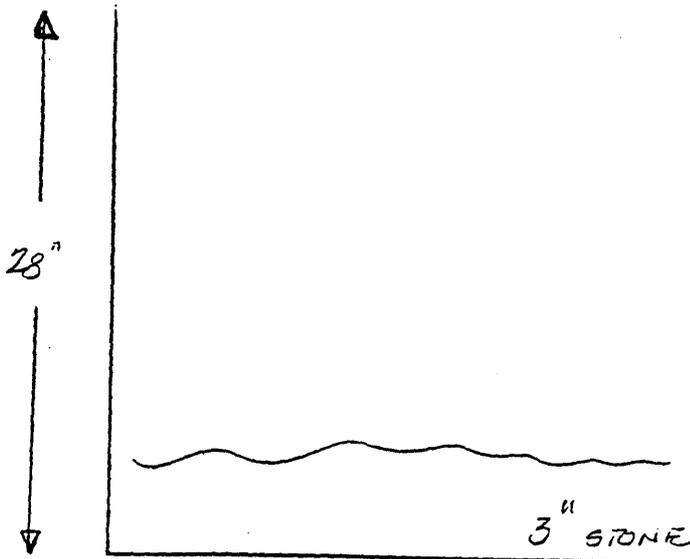
Structure # CB-40

- Notes: BC 9/12/00
- CONCRETE CONSTRUCTION
  - STEEL COVER
  - ASPHALT ROADWAY
  - 4" LINE MAKES 2 45° BENDS TO CB-41
  - CLAY LINE

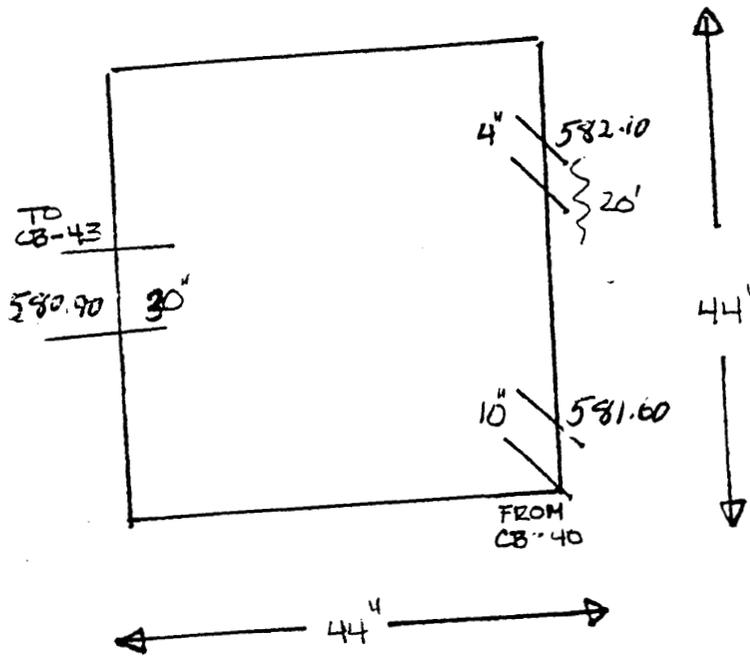
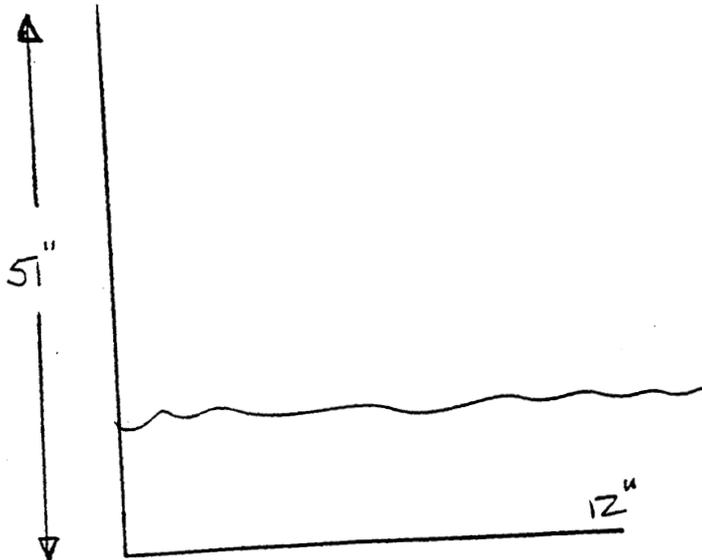
Structure # CB-41

- NOTES: BE 7/11/00
- CONCRETE CONSTRUCTION
  - 12" SAND DEBRIS REMOVED
  - 4" LINE DEAD S/E 20'
  - 10" LINE CONNECTS TO CB-40
  - 20" LINE CONNECTS TO CB-43
  - CLAY LINES
- Rim Elevation: 584.54

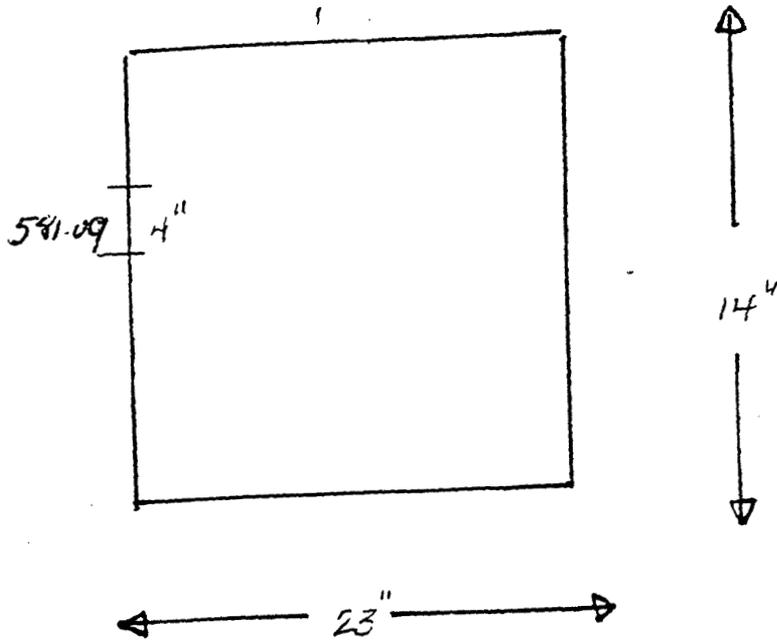
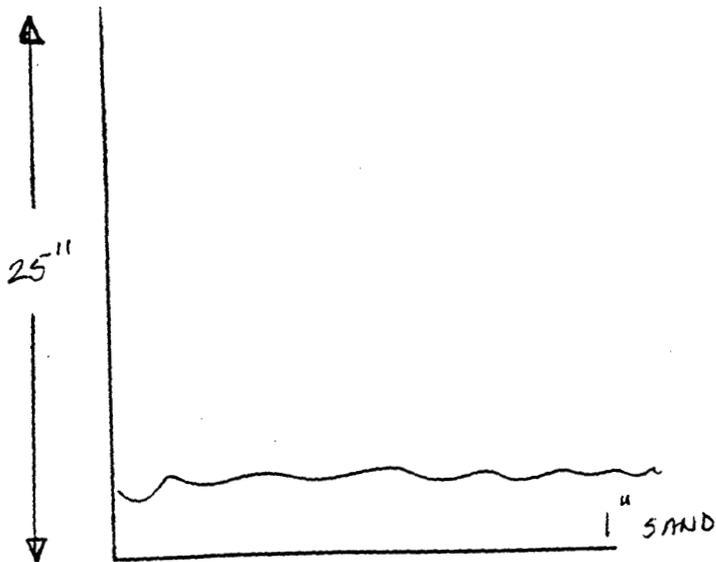
Structure # CB-42

- CONCRETE CONSTRUCTION
- 4" LINE CONNECTS TO MAIN LINE TO CB-43
- STEEL COVER
- ASPHALT ROADWAY
- CLAY LINE

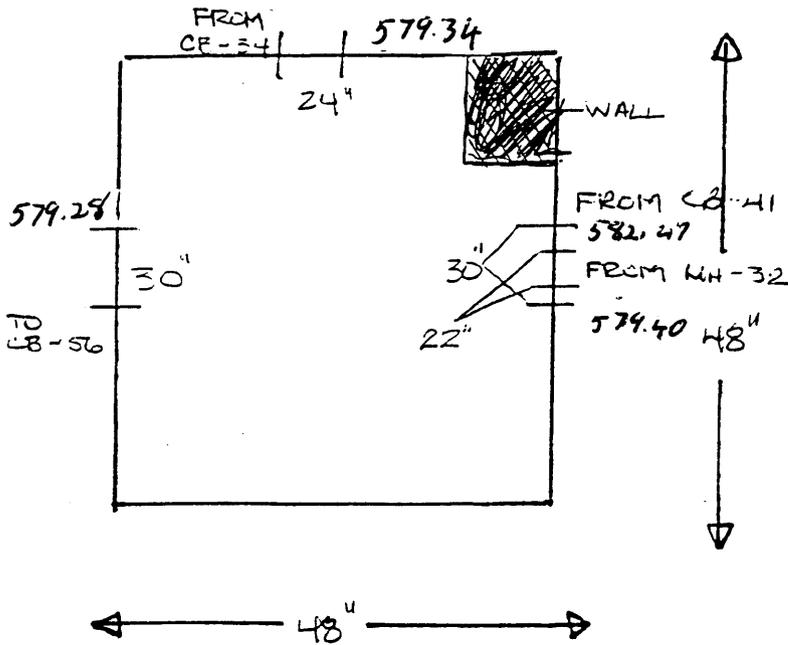
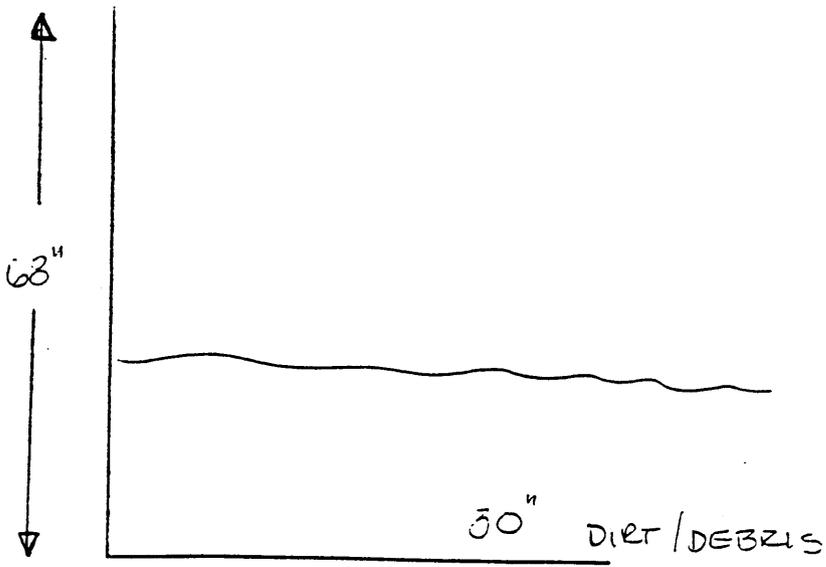
Structure # CB-43

- Notes: BC 9/11/00
- BRICK CONSTRUCTION
  - ASPHALT ROADWAY
  - 2' DEBRIS REMOVED
  - 6" REMAINING DEBRIS ON BASE.
  - CLAY LINES
- Rim Elevation. 585.43
- Depth to Bottom:
- Constructed of:  
BRICK
- Sediment: 30"
- Product: 2" REMOVED
- Surrounding Area:  
- ASPHALT ROADWAY
- Flow:  
WEST TO CB-56

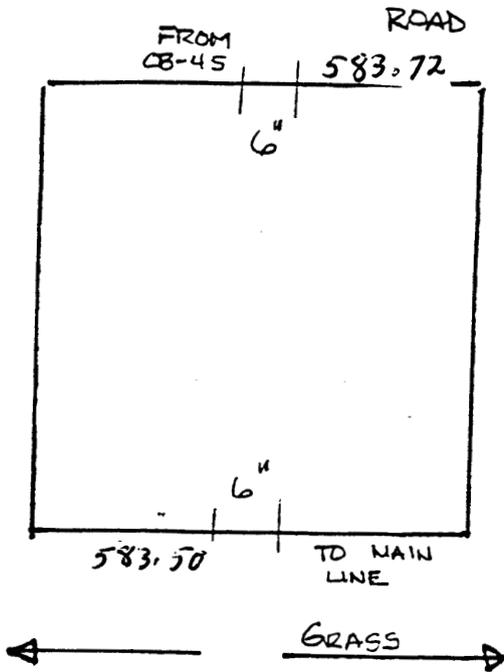
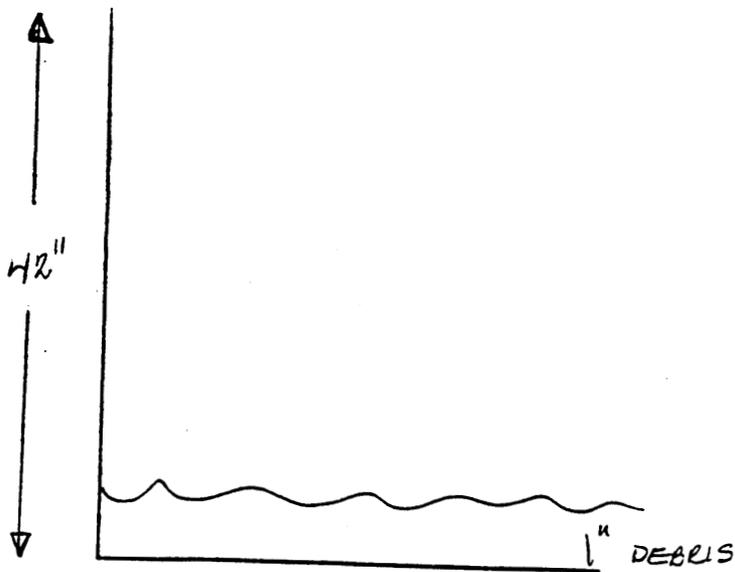
Structure # CB-44

- NOTES: BC 9/9/00
- CONCRETE CONSTRUCTION
  - STEEL COVER
  - ON ROADWAY EDGE
  - CLAY LINE

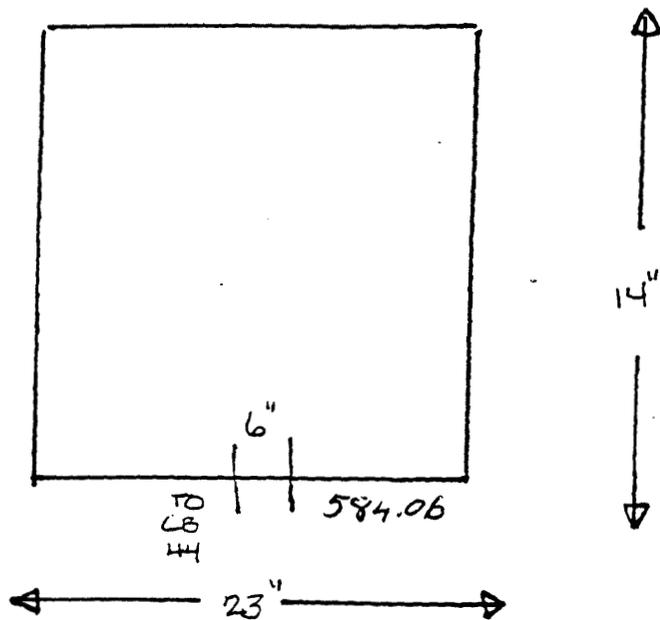
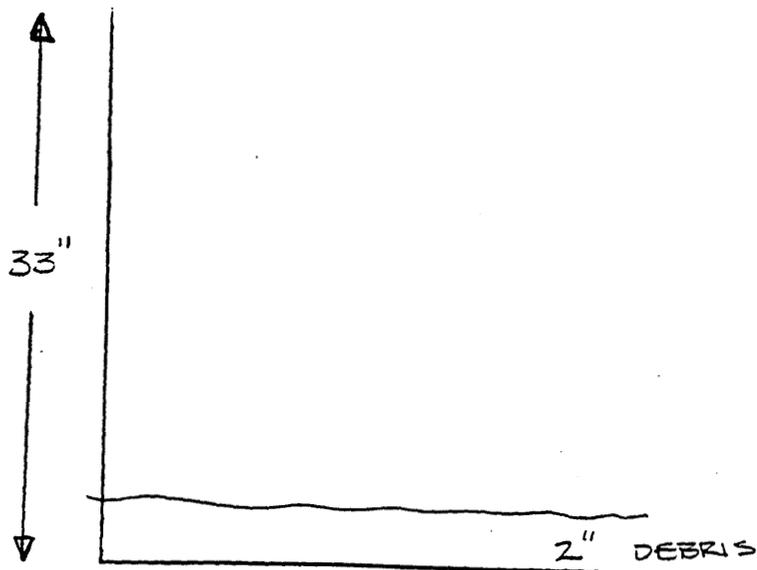
Structure # CB-45

- NOTES: CE 1/3/00
- CONCRETE CONSTRUCTION
  - STEEL COVER
  - ON ROADWAY EDGE
  - CLAY LINE

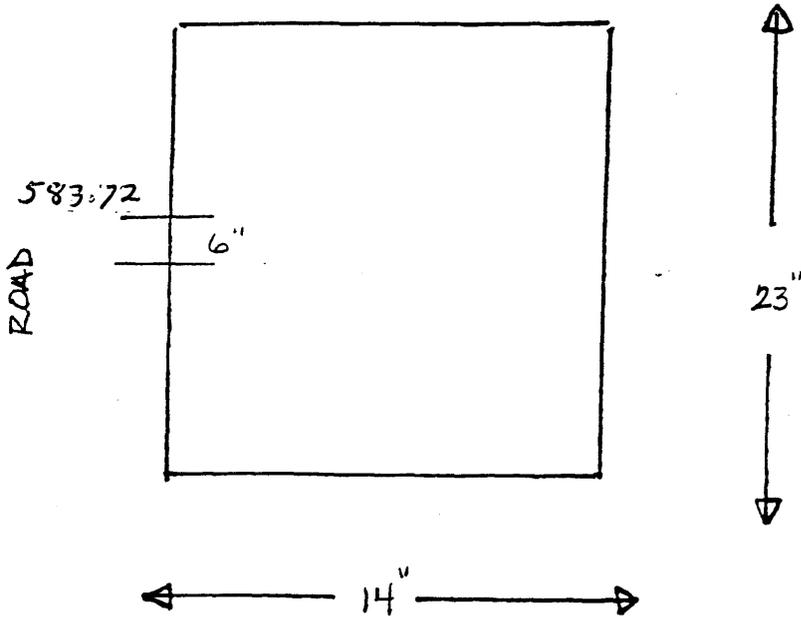
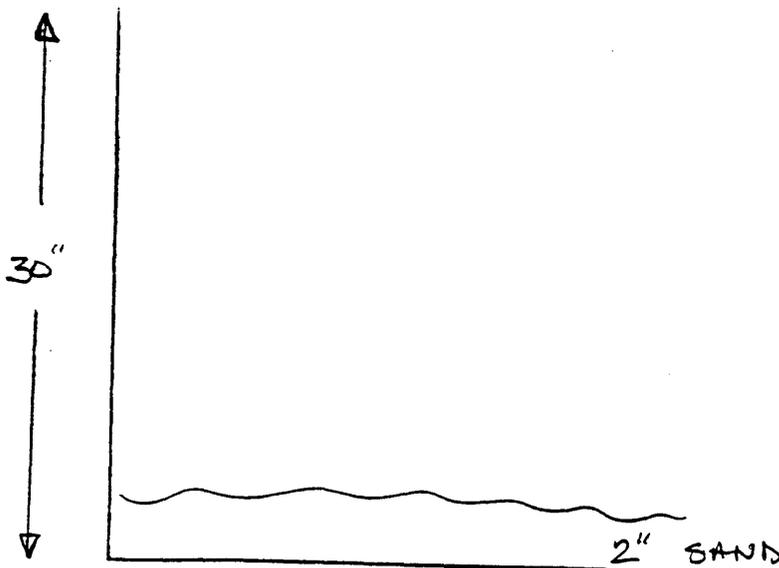
Structure # CB-46

- NOTES: BC 7/8/00.
- CONCRETE STRUCTURE
  - ON ROADWAY EDGE
  - CLAY LINE
  - STEEL COVER.

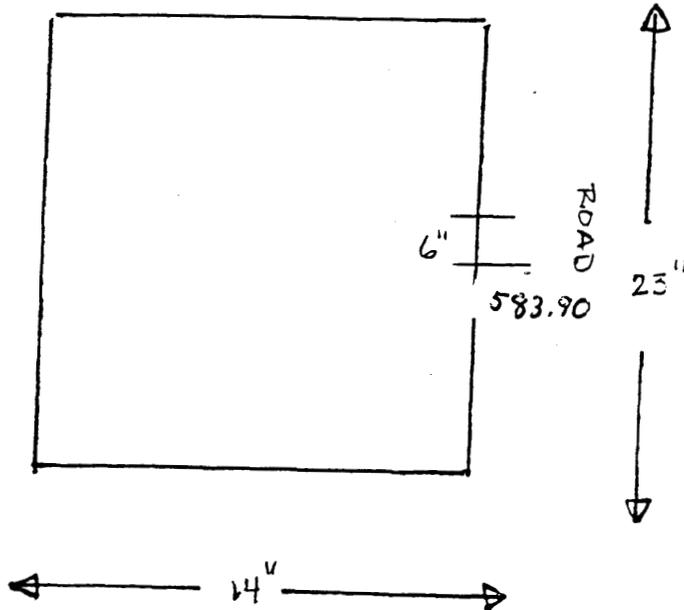
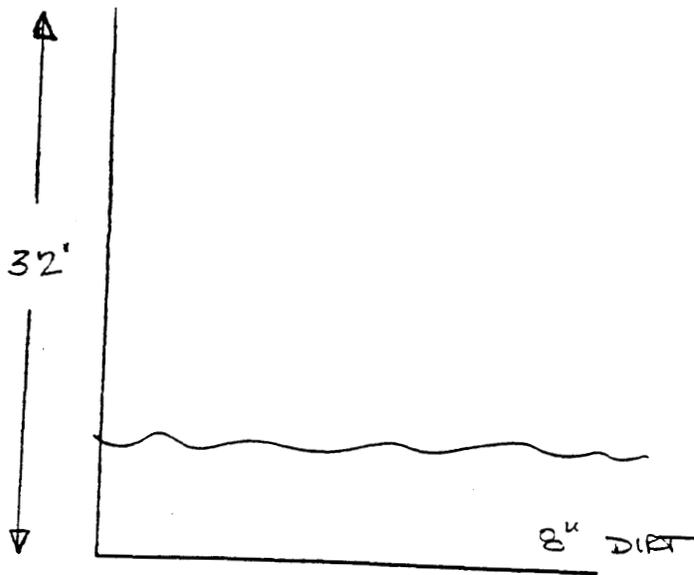
Structure # CB-47

- NOTES: BC 4/9/00
- CONCRETE STRUCTURE
  - ON ROADWAY EDGE
  - CLAY LINE
  - STEEL COVER

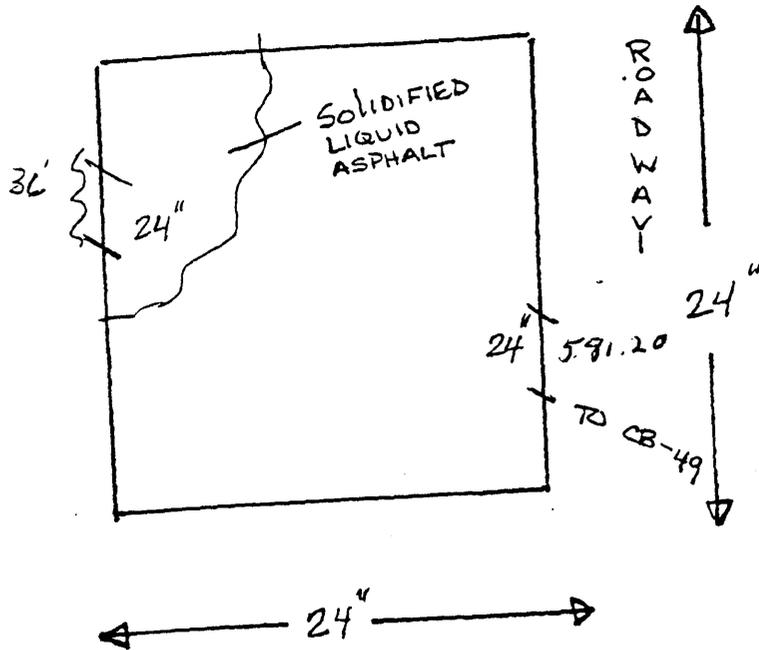
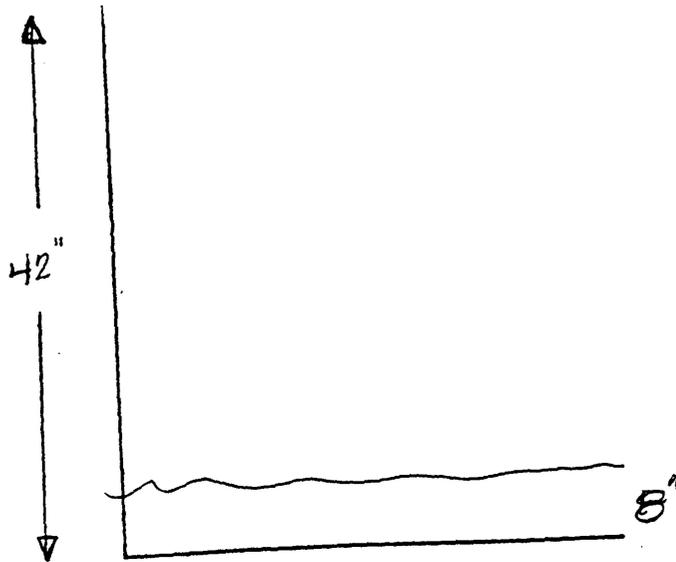
Structure # CB-48

- NOTES: BC 7/11/01
- WOOD FRAME CONSTRUCTED
  - FORMED CONCRETE BACK
  - ONLY ONE PIPE COULD BE READ, HARDENED PRODUCT COVERING PIPE
  - CLAY LINES

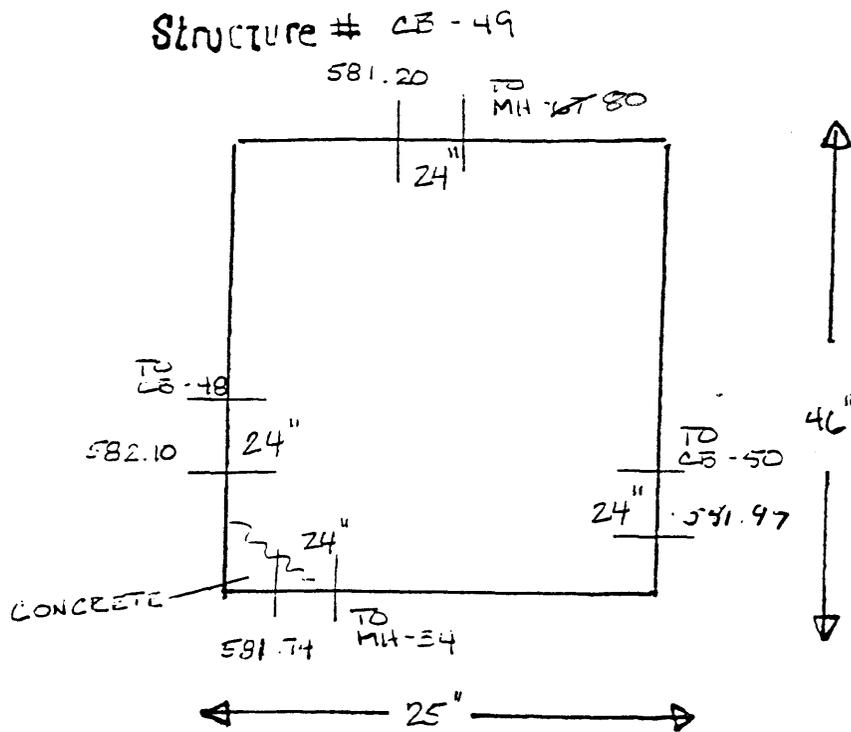
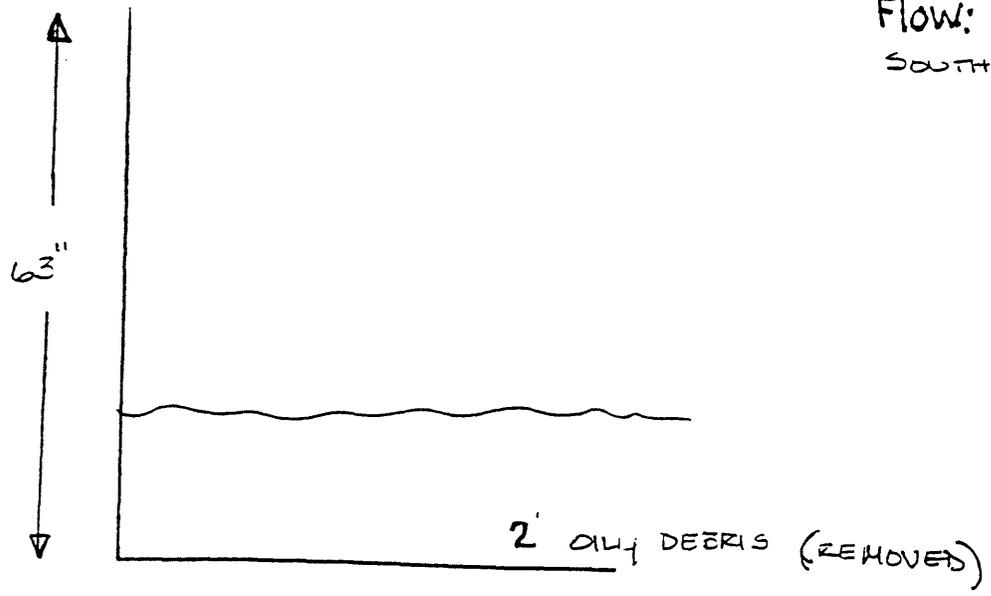
- NOTES: BC 7/100
- BRICK / CONCRETE CONSTRUCTION
  - CONCRETE PIECE ON SW CORNER
  - EFFLUENT LINE TO SO. 1/2 FULL W/ CONCRETE REMOVED
  - IN ROADWAY
- Rim Elevation. 586.37
