# **STORM-WATER COLLECTION SYSTEM INVESTIGATION REPORT**

**Buffalo Terminal  
Buffalo, New York**

**March 28, 2002**

**ROUX ASSOCIATES, INC.**  
1377 Motor Parkway  
Islandia, New York 11749

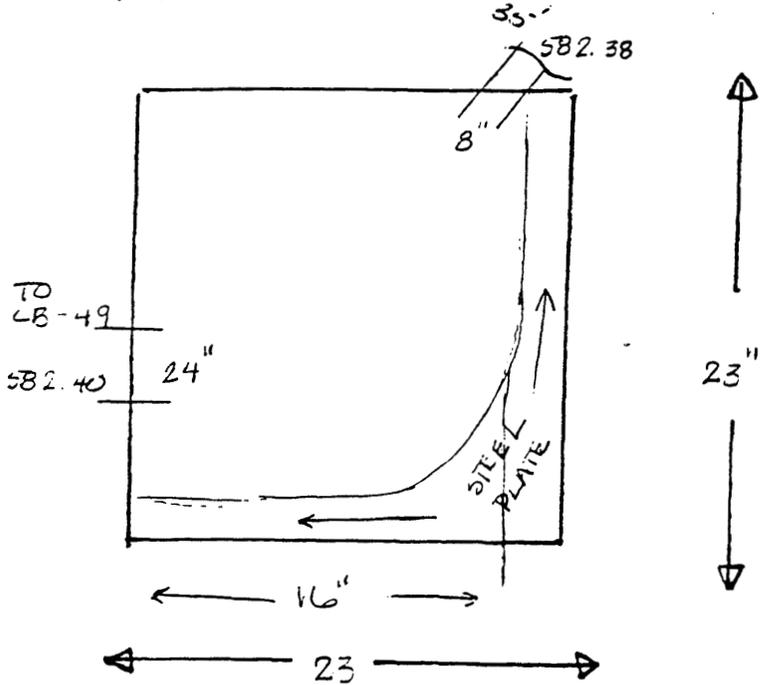
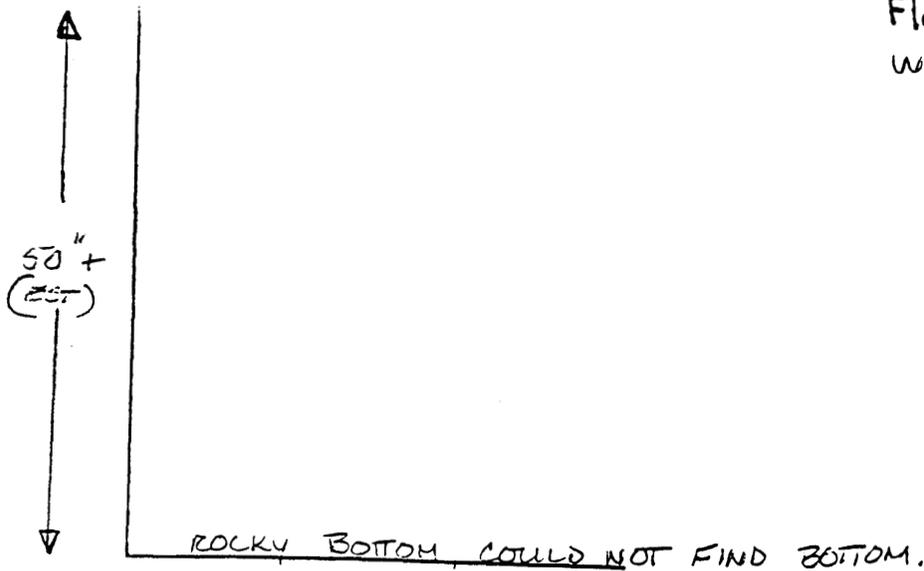
Structure # CB-50

- NOTES: BC 9/4/00
- CONCRETE / BRICK CONSTRUCTION
  - TAIN SHEET METAL PLATE USED FOR FLOW DEVERTER

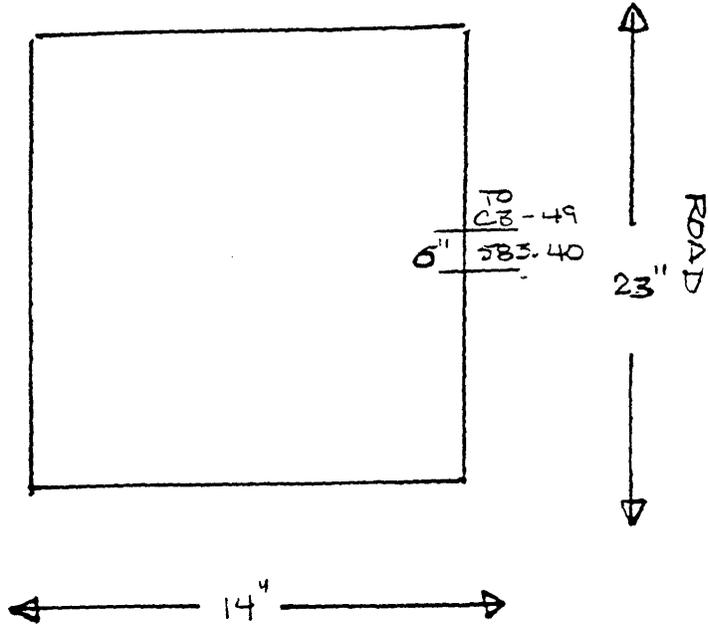
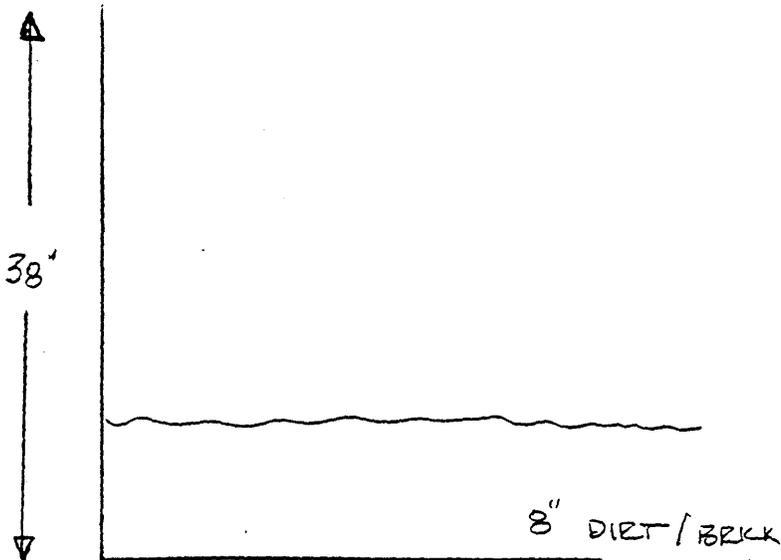
Structure # CB-51

- NOTES: BC 9/9/00
- CONCRETE STRUCTURE
  - ON ROADWAY EDGE
  - CLAY LINE
  - STEEL COVER

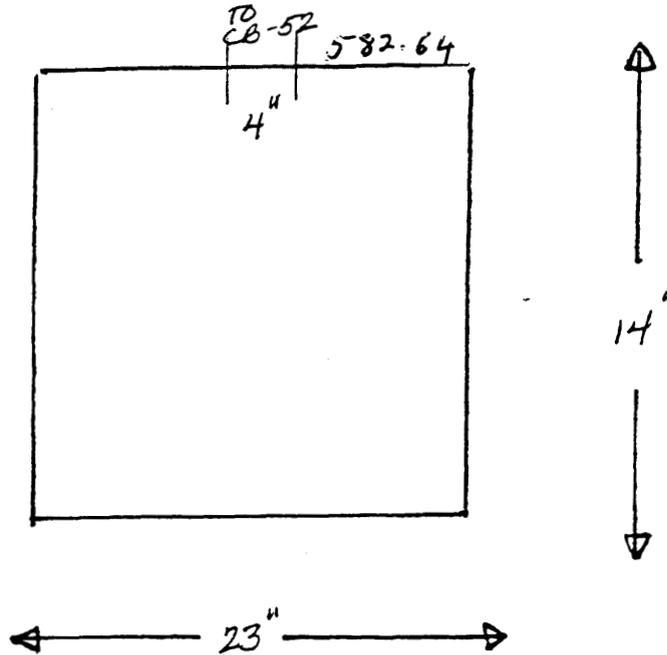
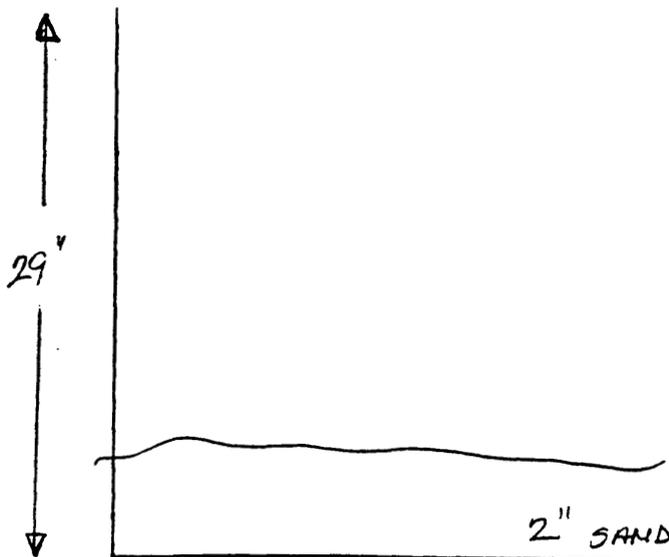
Structure # CB-53

- NOTES: BC 7/11/00
- CONCRETE CONSTRUCTION
  - CLAY LINE
  - STEEL COVER
  - CONNECTS TO CB-52

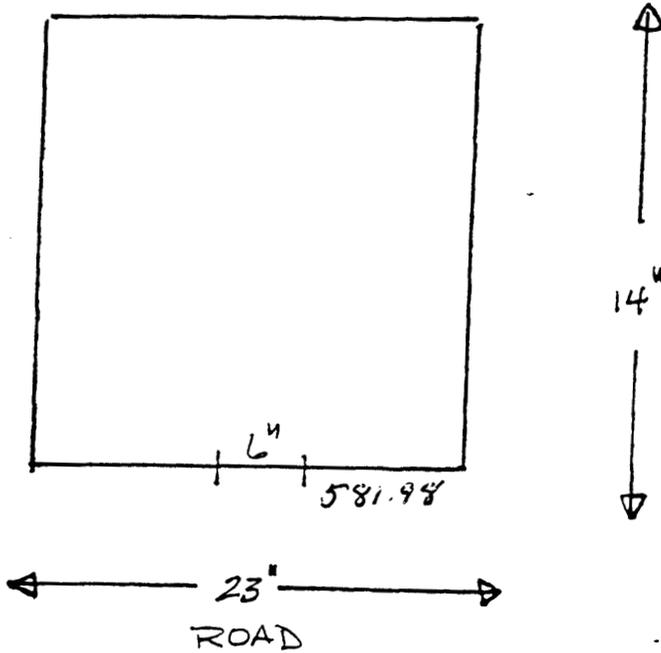
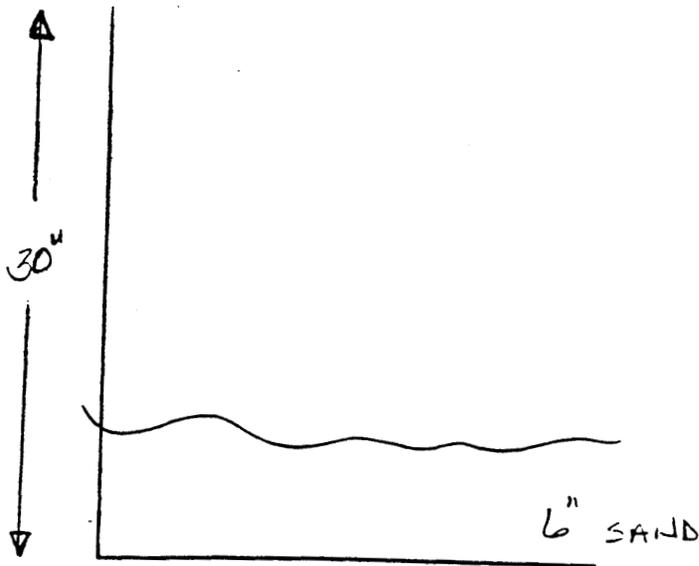
Structure # CB-54

- NOTES: BC 9/11/0
- CONCRETE CONSTRUCTION
  - STEEL COVER
  - ASPHALT ROADWAY

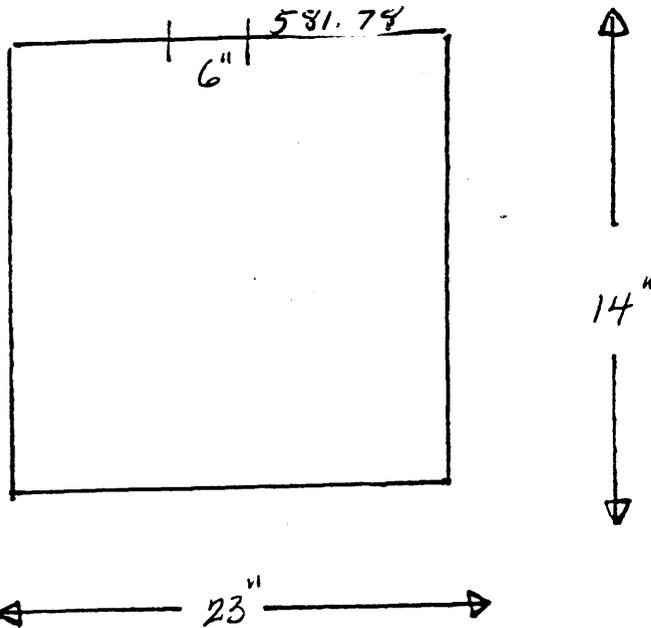
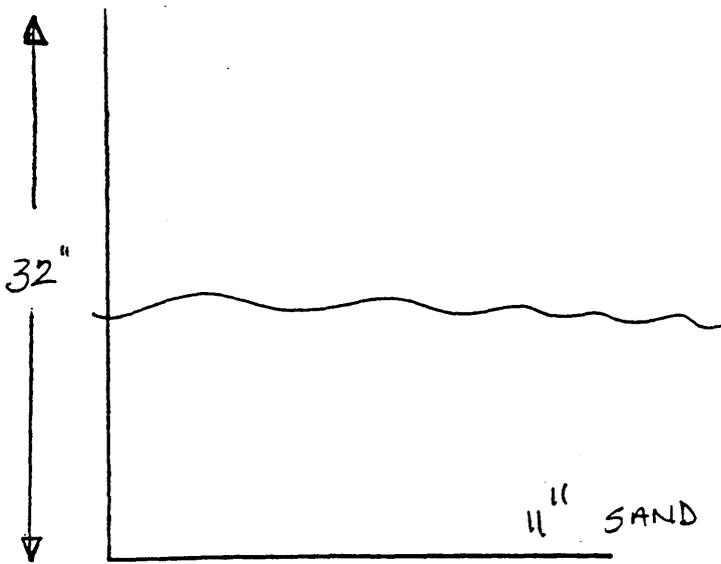
Structure # CB-55  
ROAD

- NOTES: BC 9/18/21
- CONCRETE CONSTRUCTIVE
  - STEEL COVER
  - ASPHALT ROADWAY

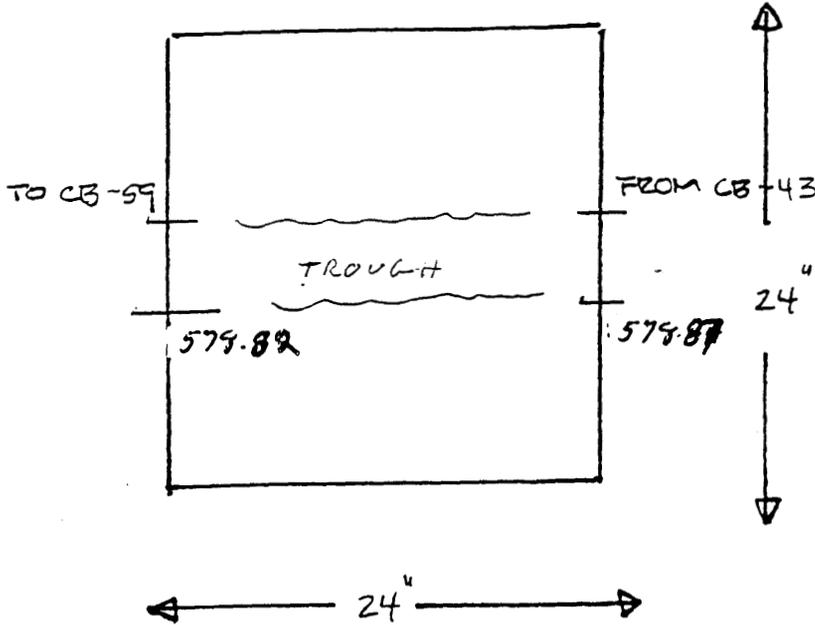
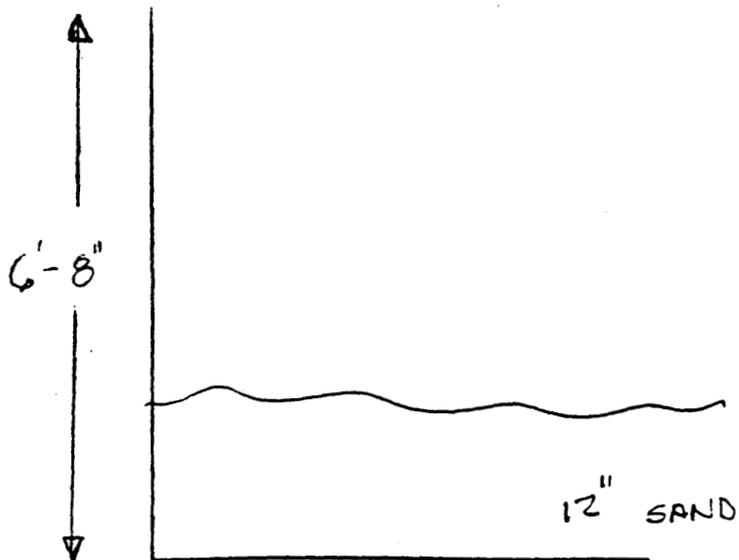
Structure # CB-56

- NOTES: BC 7/20/00
- CONCRETE CONSTRUCTION
- FLOWS EAST TO WEST
- GRASS ON EAST / SOUTH SIDE
- ASPHALT ROADWAY ON NORTH SIDE
- STEEL COVER

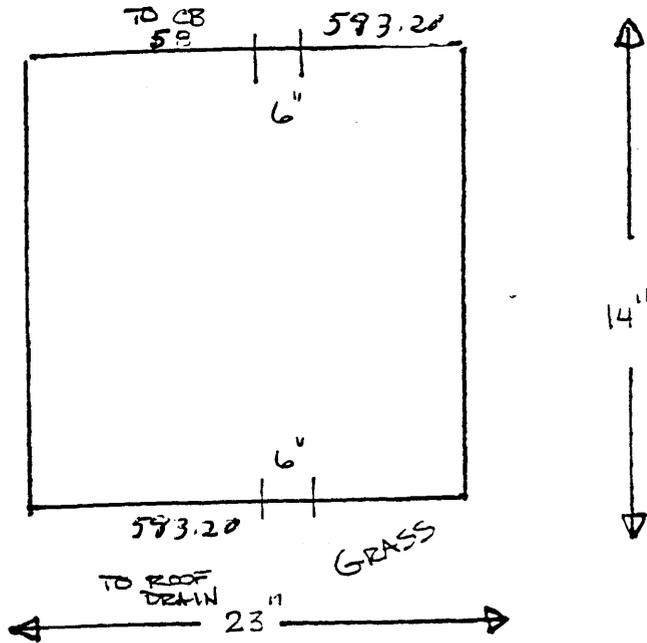
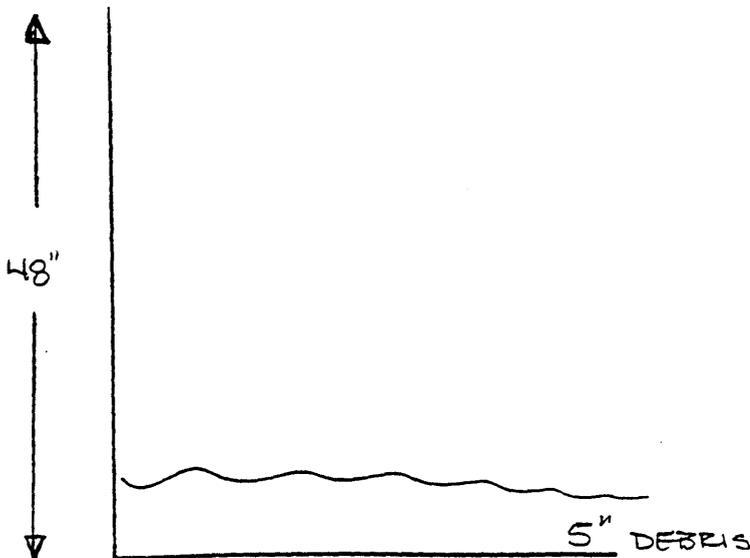
Structure # CB - 57 ROAD

- NOTES: BC 9/11/00
- CONCRETE CONSTRUCTION
  - ASPHALT ROADWAY
  - FAIR CONDITION
  - STEEL COVER
  - CLAY LINE
  - SIE LINE CONNECTS TO ROOF DRAIN

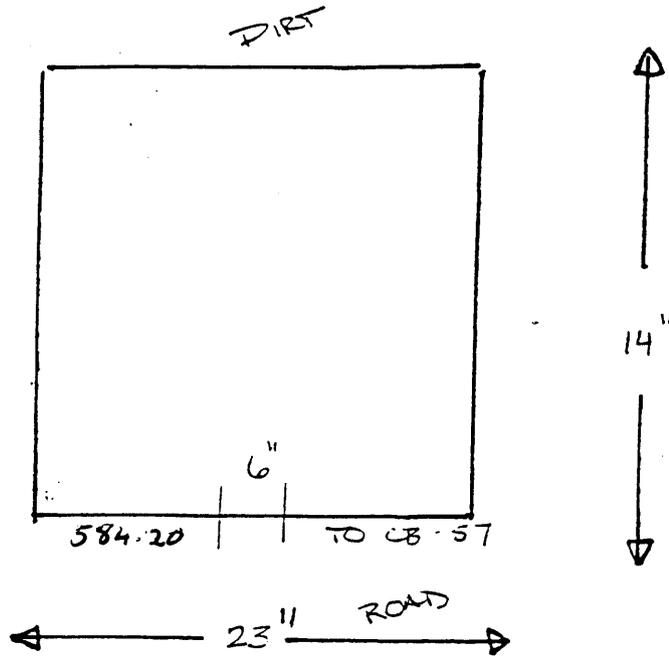
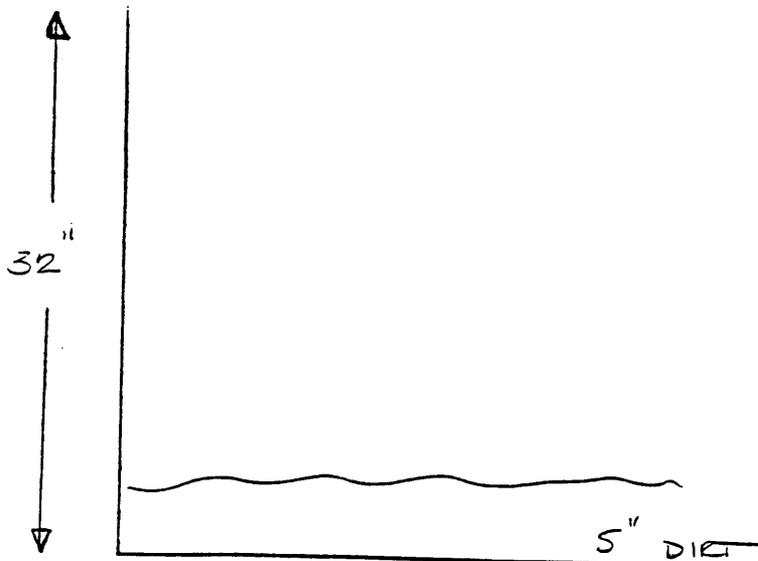
Structure # CB-58

- NOTES: BE 9/11/07
- CONCRETE CONSTRUCTION
  - ASPHALT ROADWAY
  - STEEL COVER
  - CLAY LINE

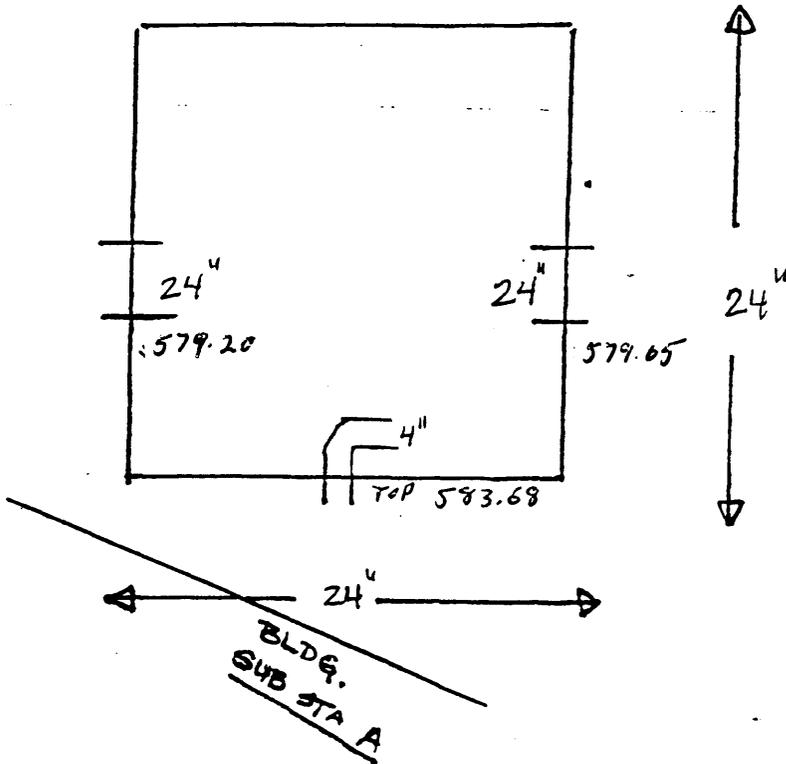
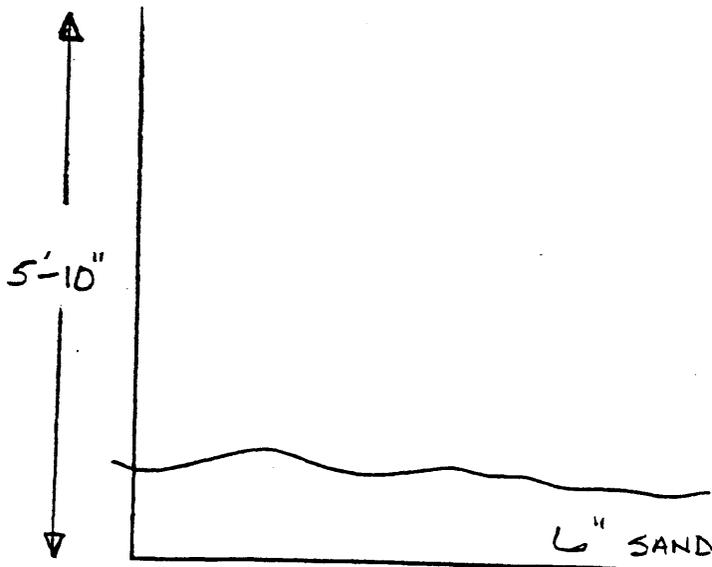
Structure # CB-59

- Notes: 8/29/19/00
- CONCRETE CONSTRUCTION
  - FLOW GOES EAST TO WEST
  - TROFF LINE LINE (NOT VISABLE)
  - 4" STEEL LINE

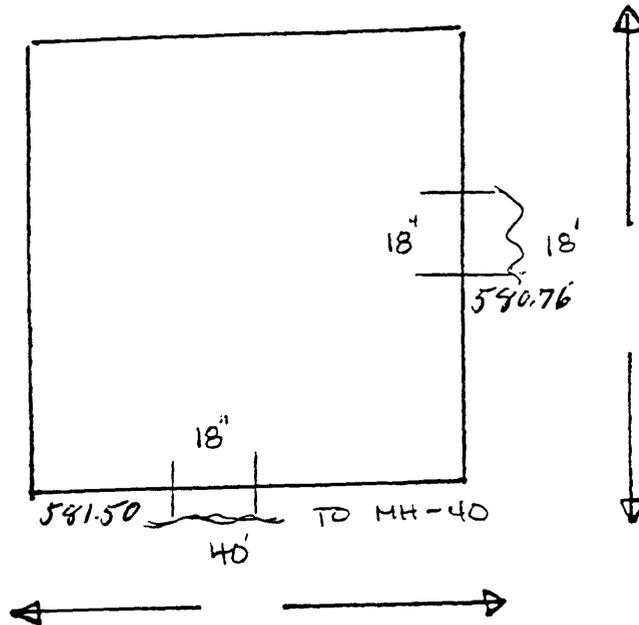
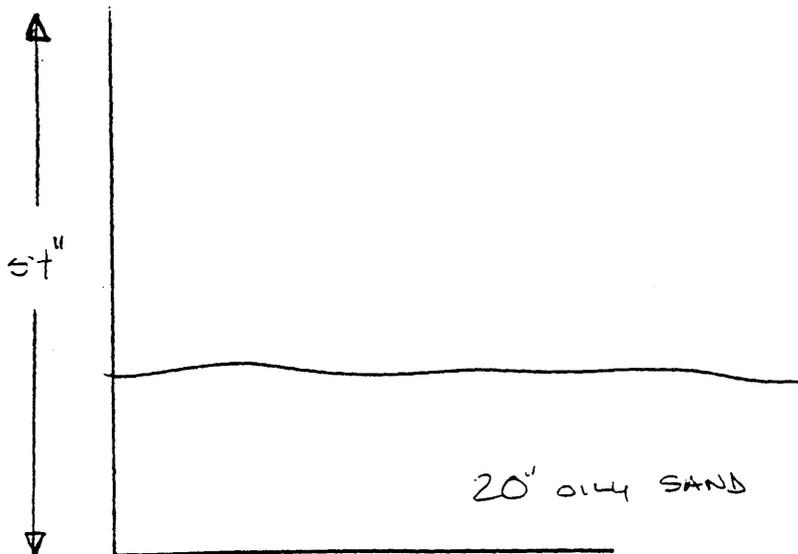
Structure # CB-60

- NOTES: EC 1/20/00
- CONCRETE CONSTRUCTED
  - WATER ENTERING FROM SOUTH LINE, UNDERNEATH
  - EAST LINE 18' OUT, 2' DOWN
  - SOUTH LINE 40' OUT TO MH-40
  - STEEL COVER
- Rim Elevation. 544.55

Flow:  
SOUTH TO MH-40

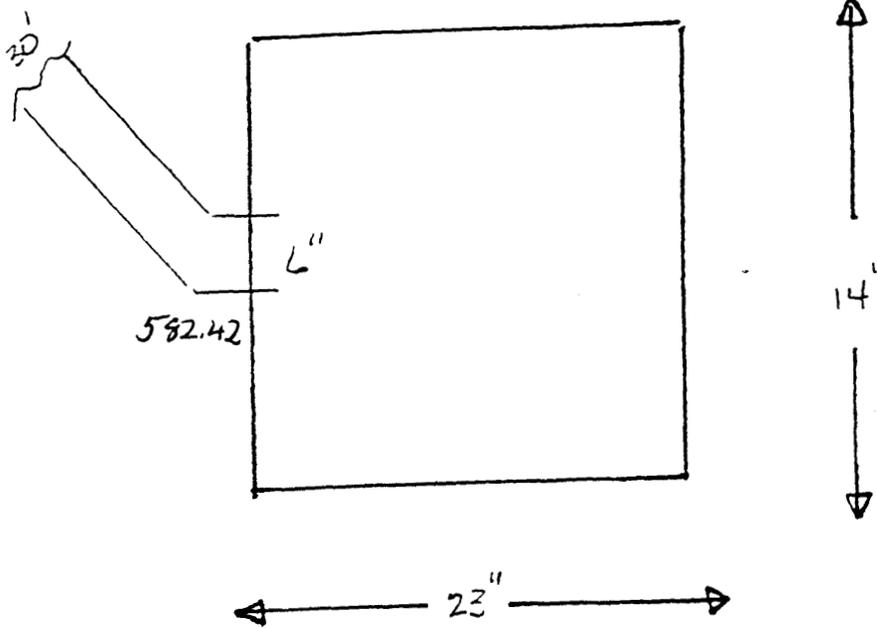
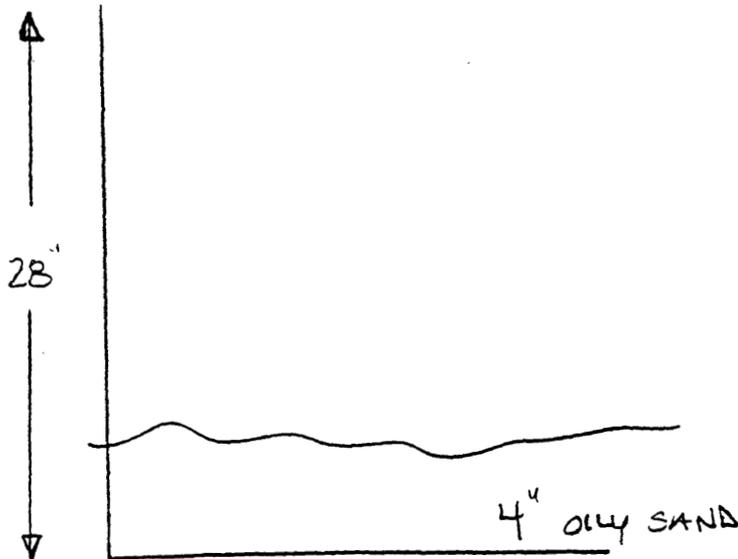
Structure # CB-61

- Notes: BC 7/1/77
- CONCRETE CONSTRUCTION
  - LINE OUT N/W 30' STOPPED.
  - STEEL COVER
  - ASPHALT ROADWAY
  - CLAY LINES

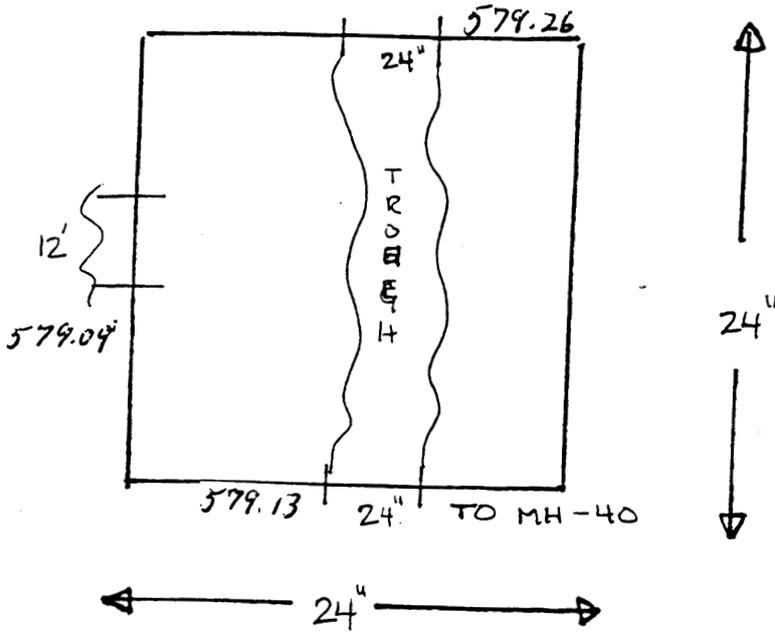
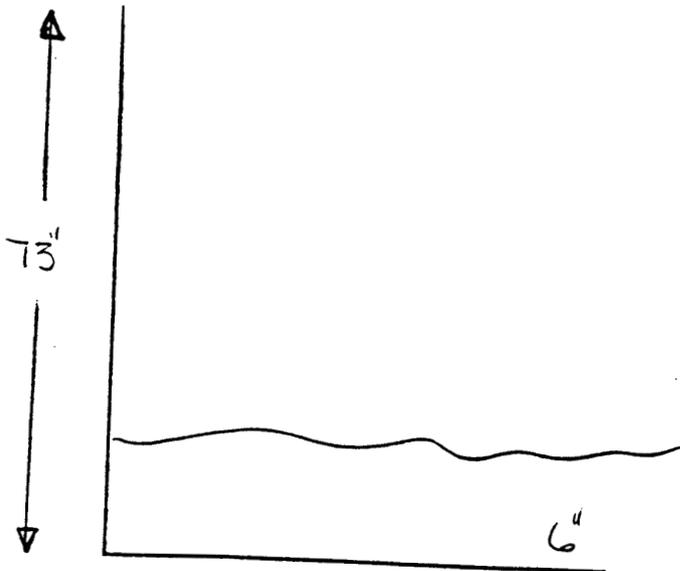
Structure # CB-62

- NOTES: BC 4/21/00
- ASPHALT LIKE MATER
  - WEST LINE OUT 12' STOPPED.
  - STEEL COVER
  - CLAY LINE

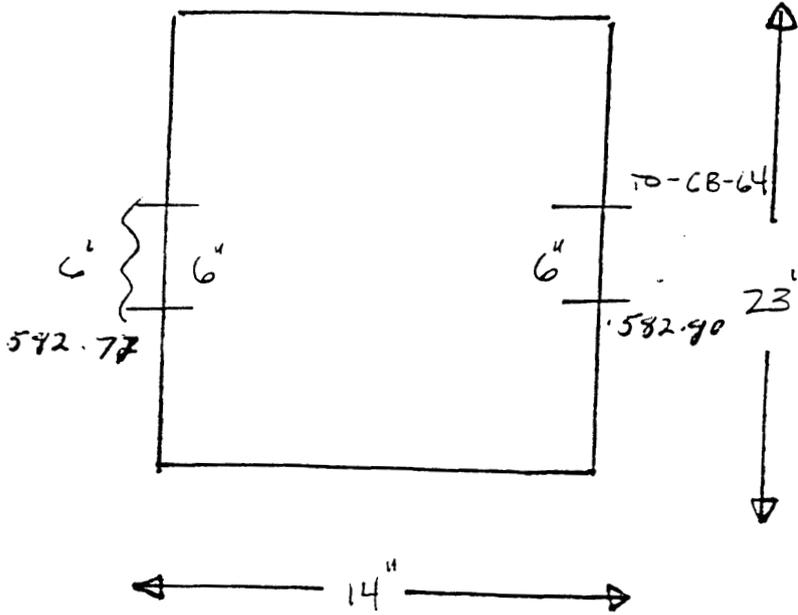
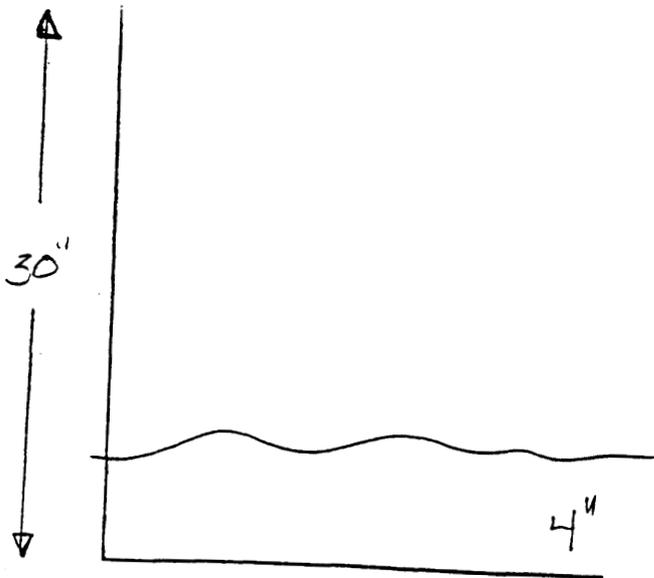
Structure # CB-63

- NOTES: EC 7/21/00
- CONCRETE CONSTRUCTION
  - ON ASPHALT ROADWAY
  - STEEL ~~PA~~ COVER
  - WEST LINE OUT C' STOPPED.

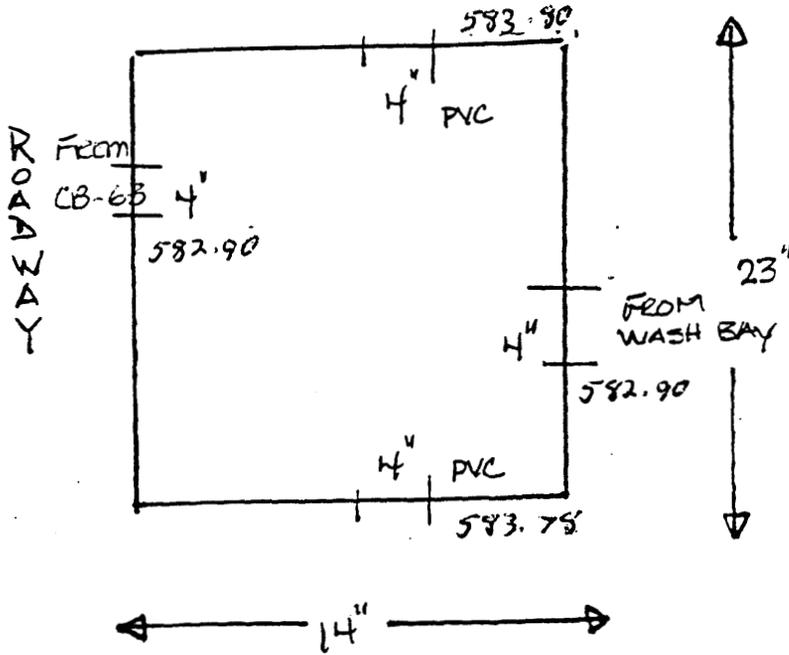
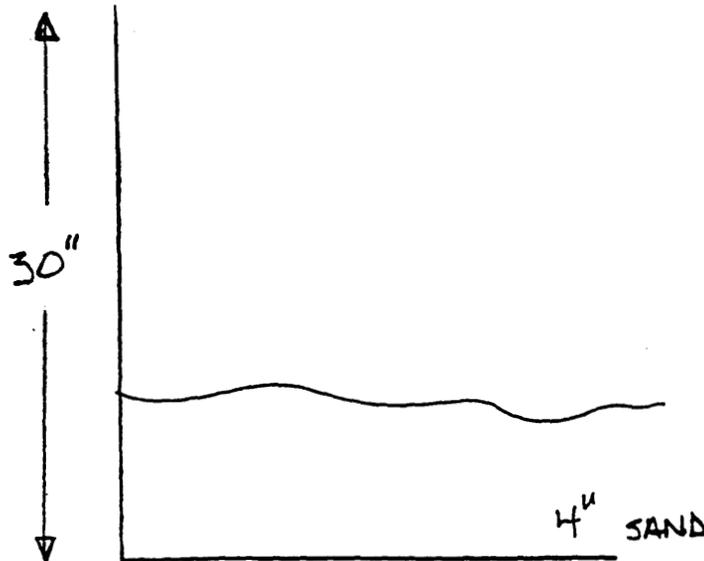
Structure # CB-64

- Notes: BC 9/1/00
- CONCRETE CONSTRUCTION
  - ASPHALT ROADWAY
  - NORTH AND SOUTH LINES PVC
  - EAST AND WEST LINES CLAY

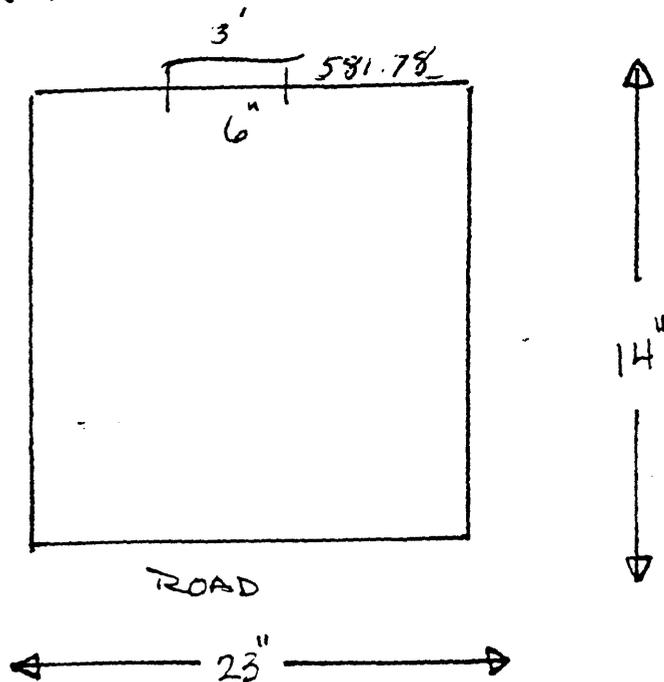
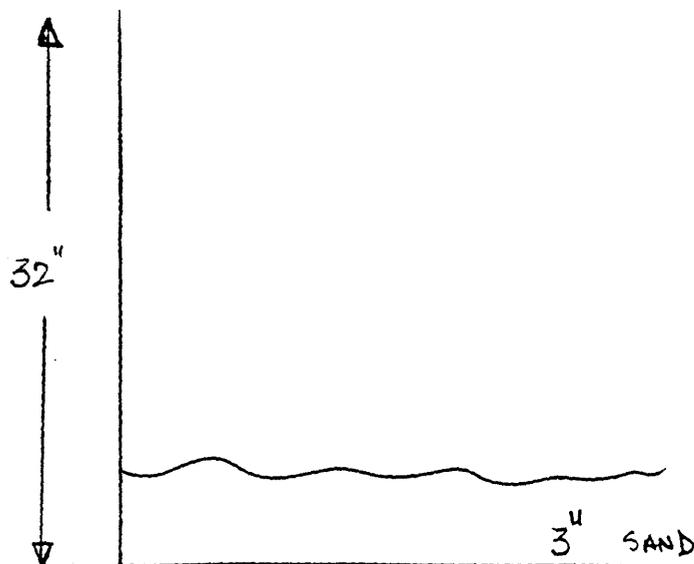
Structure # CB-65

- NOTES: BC 7/24/00
- CONCRETE CONSTRUCTION
  - STEEL COVER
  - CLAY LINE
  - ASPHALT ROADWAY

- 6" LINE STEPPED 3' OUT.

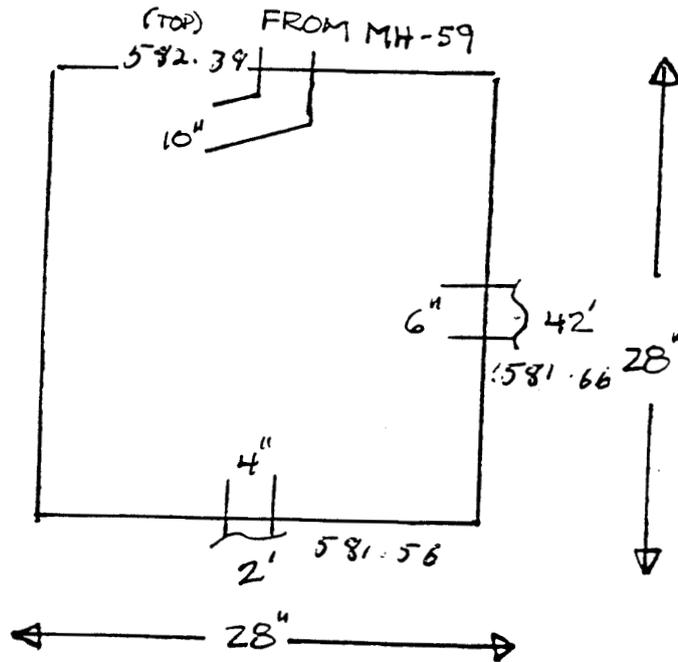
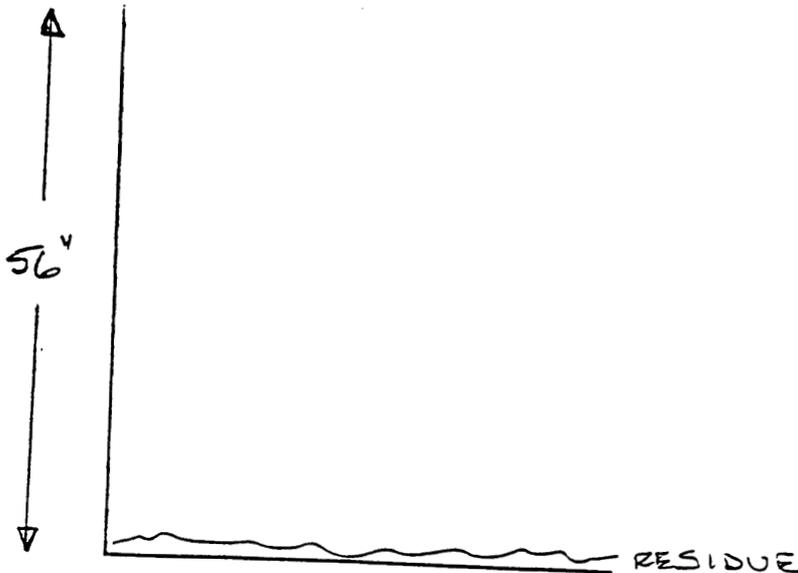
Structure # CB-66

- NOTES: BE 1/2, 100
- CONCRETE CONSTRUCTION
  - STEEL COVER
  - CONCRETE PAD
  - 10" STEEL
  - 4" / 6" CAST
  - 6" OUT 42' TO PAD DEAL
  - 4" OUT 2' DEAD

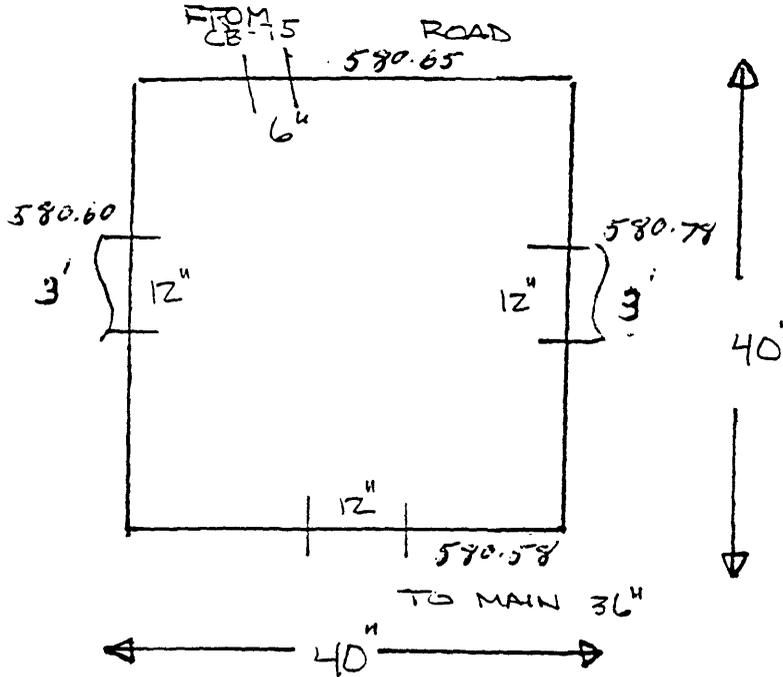
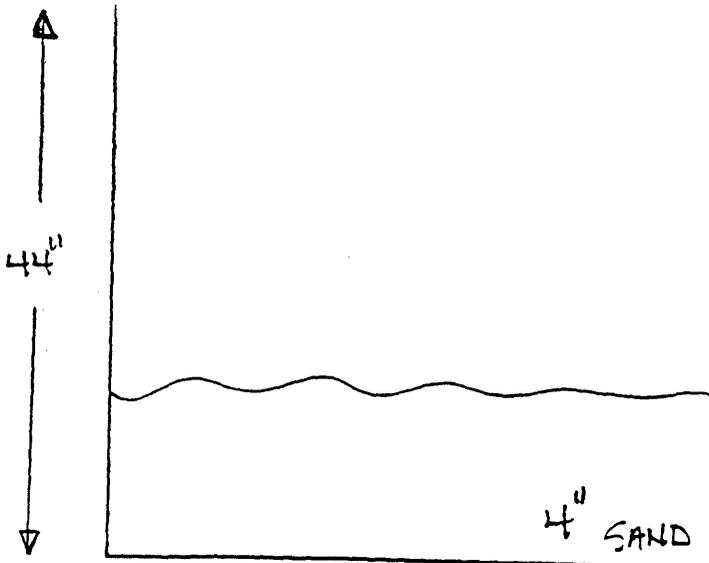
Structure # CB-67

- NOTES: BC 9/25/00
- CONCRETE / BRICK CONSTRUCTION
  - STEEL PLATE COVER
  - IN GRAVEL COVERED AREA
  - CLAY LINES

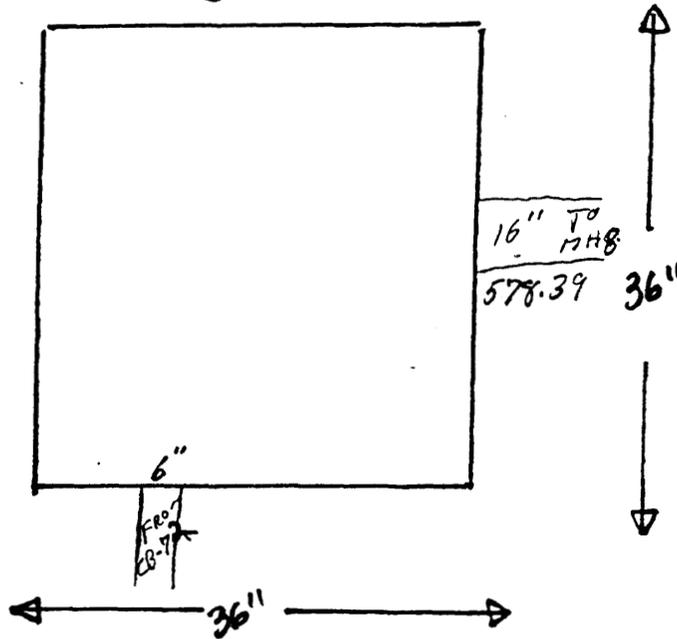
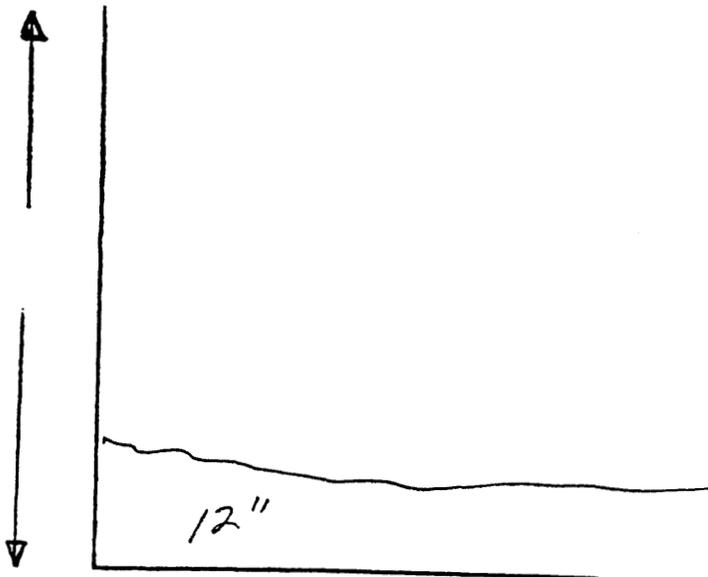
Structure # ~~CB-71B~~<sup>A</sup>  
CB-71

- Notes: Be 8/10/00
- Concrete Construction
  - Lines JETTED CLEAN
  - GOOD Flow FROM CB-72 AND GOOD Flow TO MH-8.

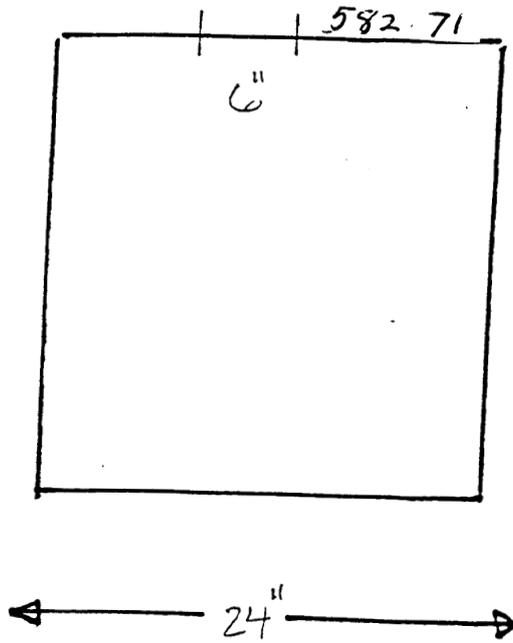
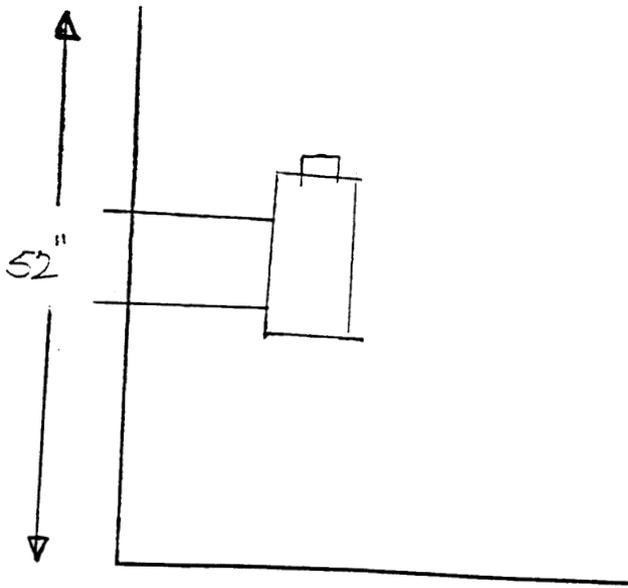
Structure # CB-73

Notes: BE 10/2/00  
- formed concrete const.  
- inside asphalt parking lot - discharges to BSA  
- line in CB. runs north to EIK ST. cast const. w/te. and top clean-out

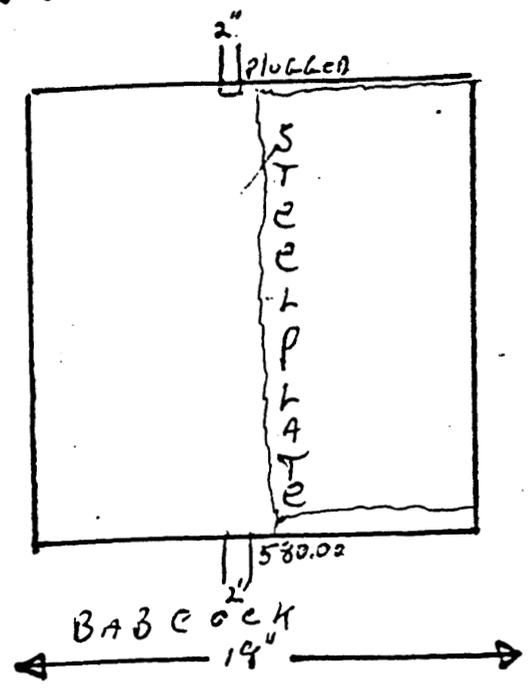
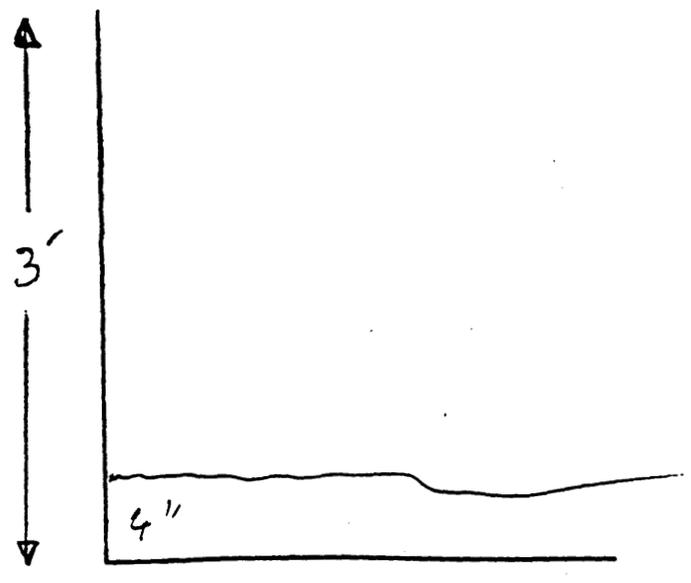
Structure # CB75

- Notes: BC 4/14/01
- Could NOT Remove Steel Plate
  - 2" TO EAST PLUG
  - 2" TO WEST TO SHALL TO JCT.

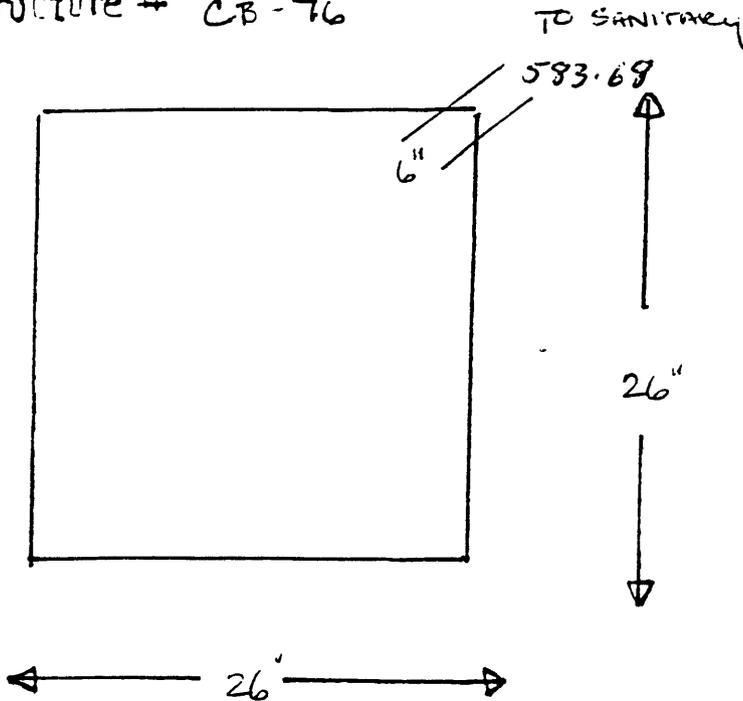
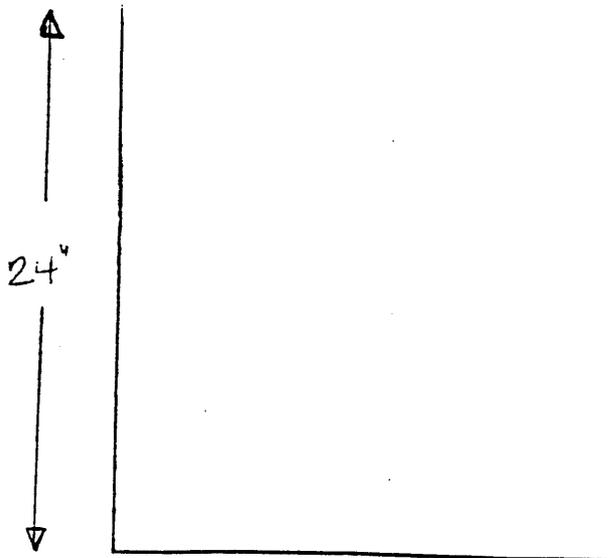
Structure # CB-76

- NOTES: BE 4/8/00
- CONCRETE CONSTRUCTION
  - AT MAIN GATE
  - PIPE BELLS TO BOTTOM
  - CAST LINE

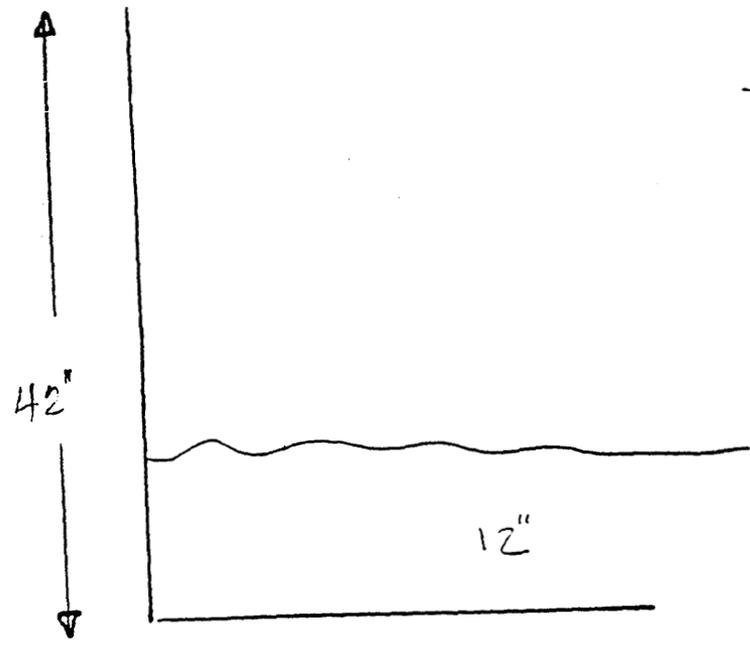
- Notes: BC 9/29/01
- STEEL COVER
  - IN PARKING LOT
  - BRICK CONSTRUCTION
  - POOR SHAPE
  - WATER FLOW INCOMING FROM MISSING BRICKS
  - CLAY PIPE

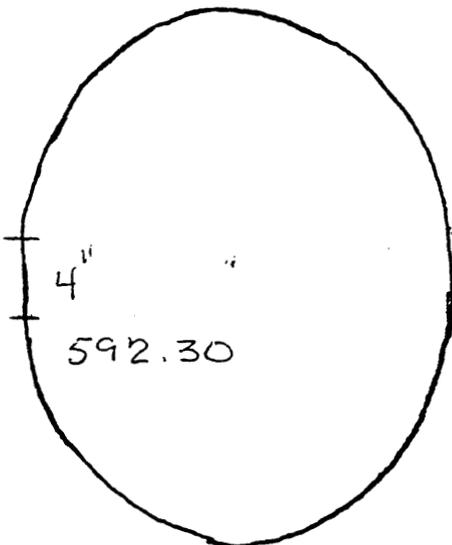
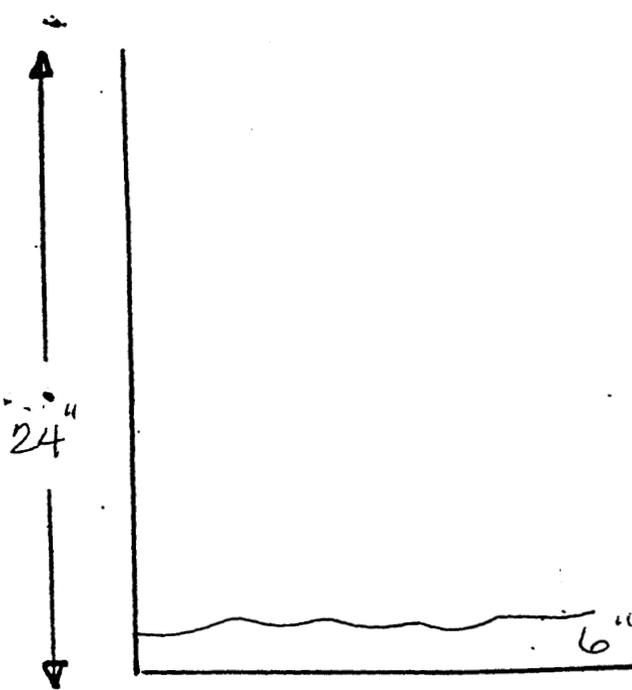
Structure # CB-78

- 4" PVC LINE
- IN WASH BAY
- STEEL COVER
- FORMED CONCRETE

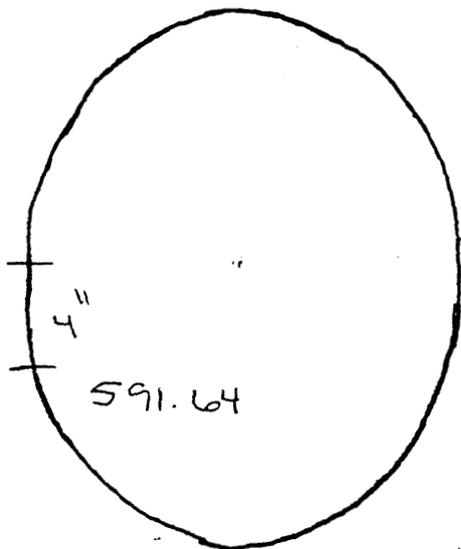
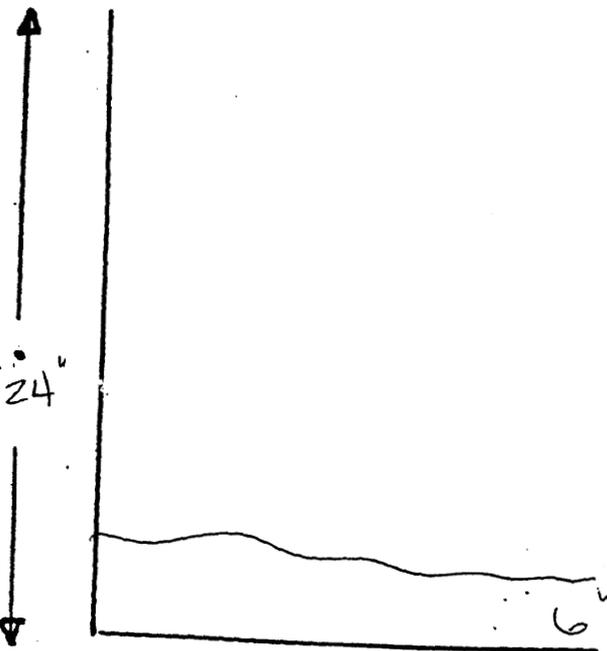
Structure # CB-79

- 4" PVC
- IN WASHBAY
- STEEL COVER
- FORMED CONCRETE

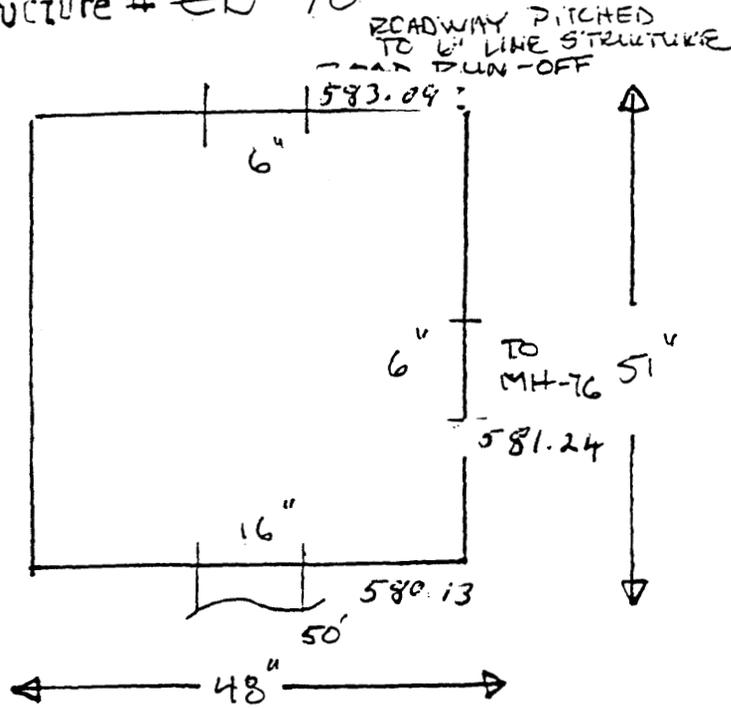
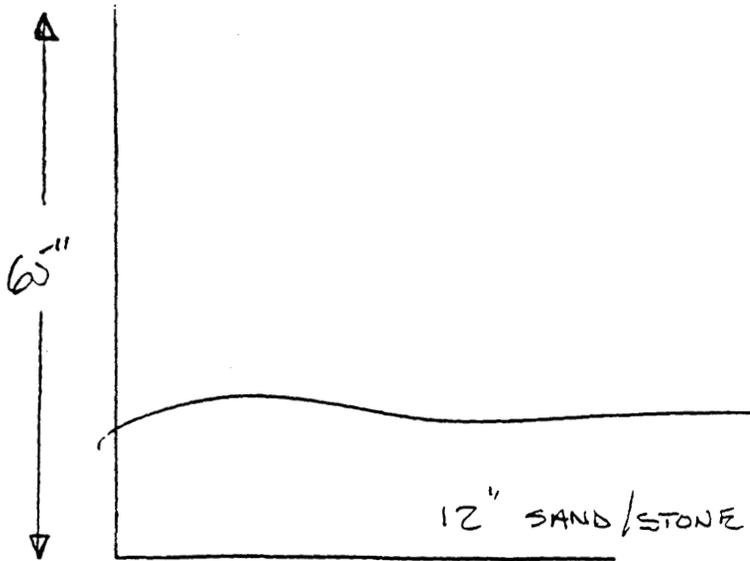
Structure # ~~CB-70~~

NOTES: BC 1/29/00  
 Concrete Const.  
 Clay Pipes  
 Stone cover on surrounding Sur-

6" NORTH LINE ROAD  
 RUN-OFF  
 6" EAST LINE PVC

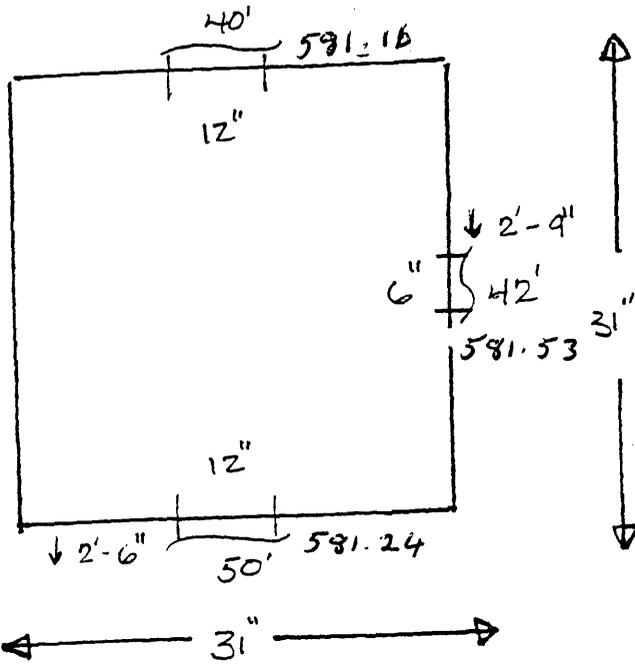
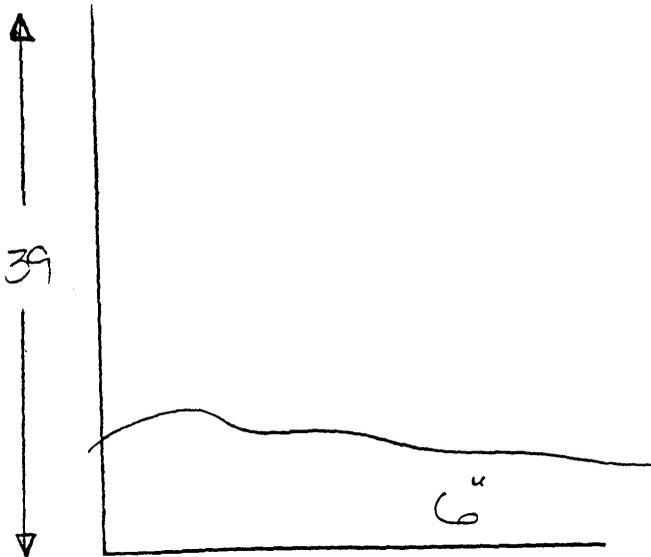
Structure # ~~CB-71~~

Notes: BC 4/29/00  
Steel construction w/ concrete behind steel

12" N LINE STOPPED AT CONCRETE DEBRIS AREA (POSSIBLE BURIED STRUCTURE)  
12" S LINE STOPPED AT CONCRETE DEBRIS AREA
