# **STORM-WATER COLLECTION SYSTEM INVESTIGATION REPORT**

**Buffalo Terminal  
Buffalo, New York**

**March 28, 2002**

**ROUX ASSOCIATES, INC.**  
1377 Motor Parkway  
Islandia, New York 11749

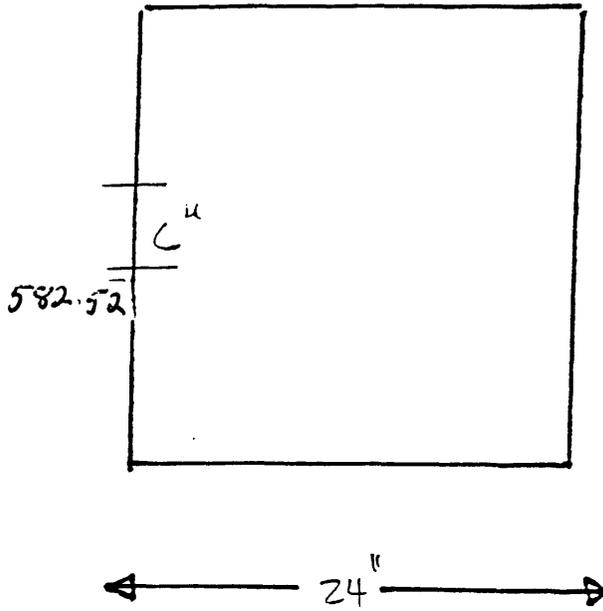
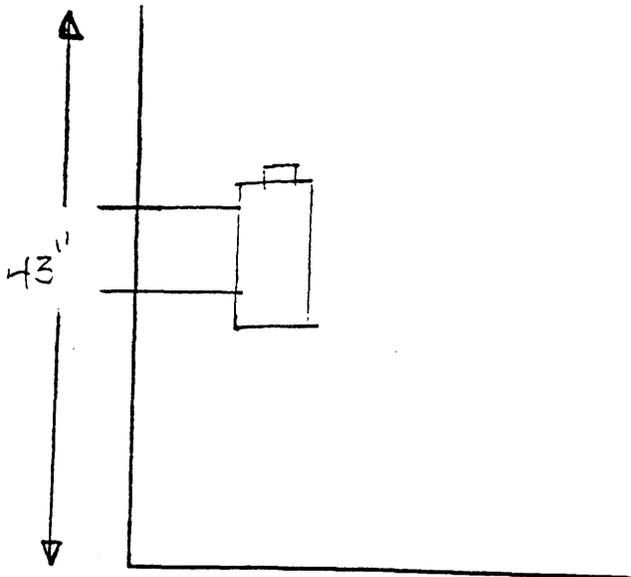
Structure # ~~CB-77~~

Notes: BE 10/2/00  
 formed concrete const.  
 in side of asphalt parking lot  
 discharge to BSA  
 line in CB runs west, east  
 const. w/tee end and a top  
 clean-out

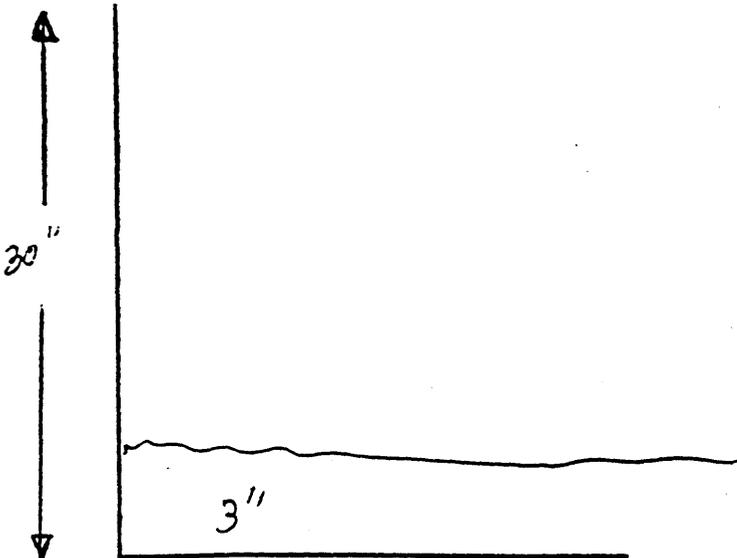
Structure # CB 85 TO MH44

Notes: B2 465/01  
GOOD SHAPE  
6" STEEL PIPE TO MH44  
LOCATED ON EDGE OF ROAD

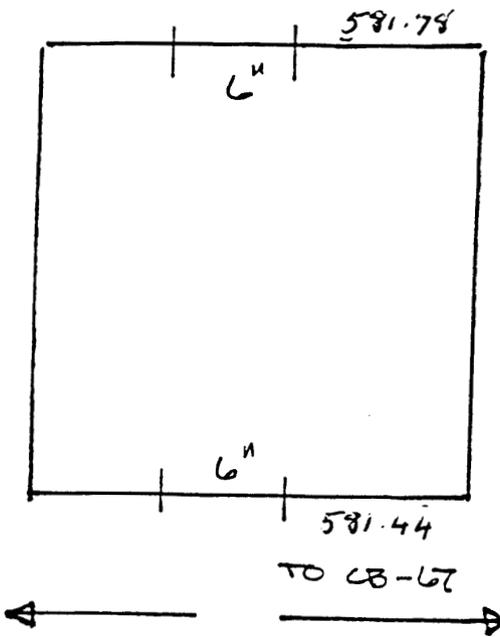
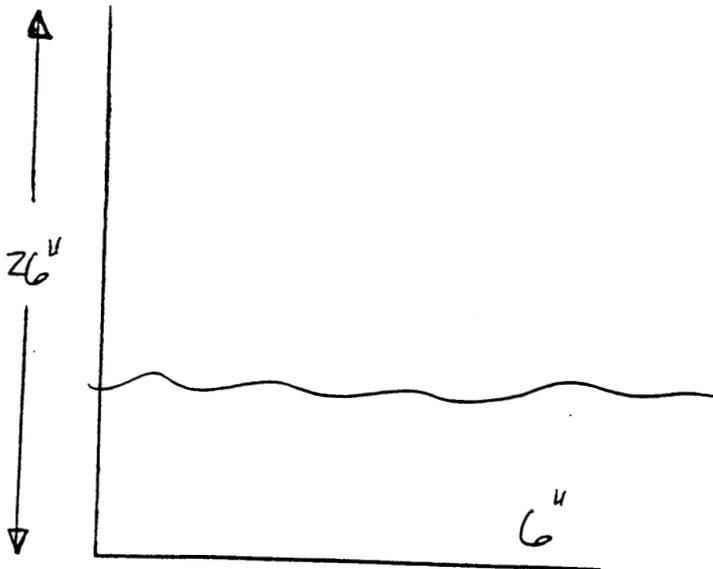
Structure # 10' CB-75<sup>86</sup>

- NOTES: BE 9/15/20
- CONCRETE CONSTRUCTION
  - ASPHALT ROADWAY
  - STEEL COVER
  - CLAY LINES

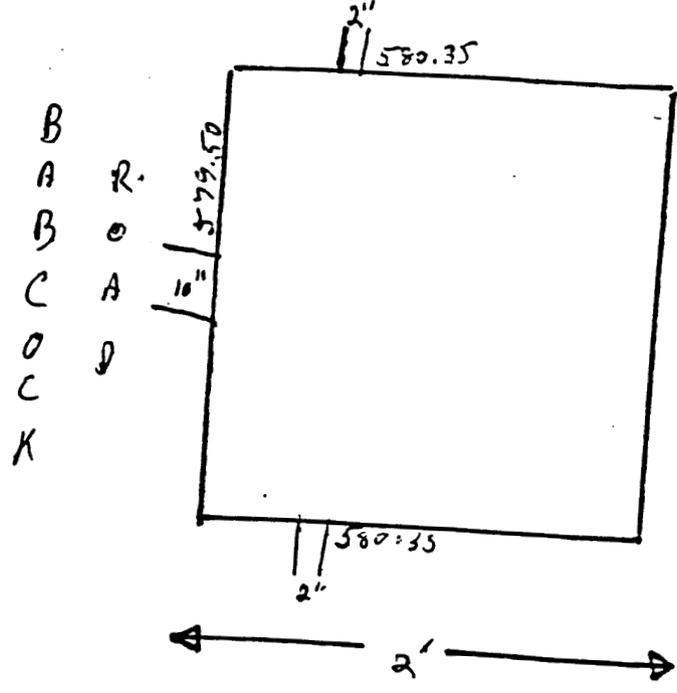
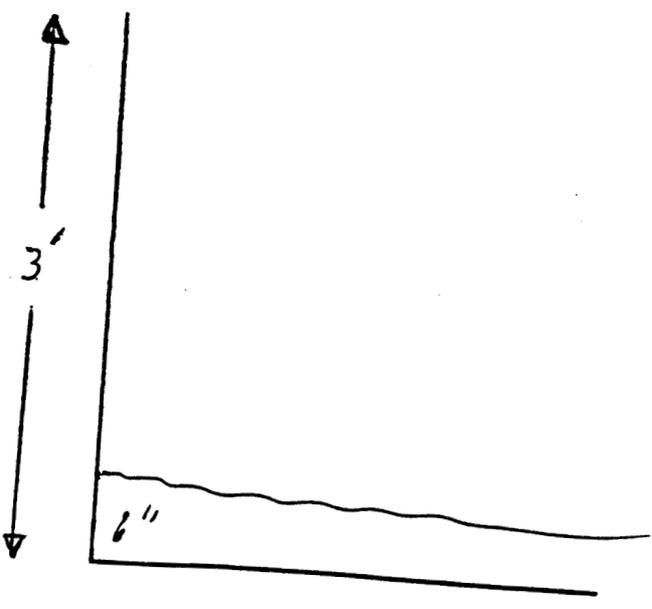
Structure # ~~NO~~ CB-87

Notes: BE 4/19/06  
 2" PIPE NORTH COULD NOT  
 TEST  
 2" PIPE SOUTH COULD NOT  
 TEST  
 10" PIPE WEST TO 6" DRAINAGE  
 TUNNEL

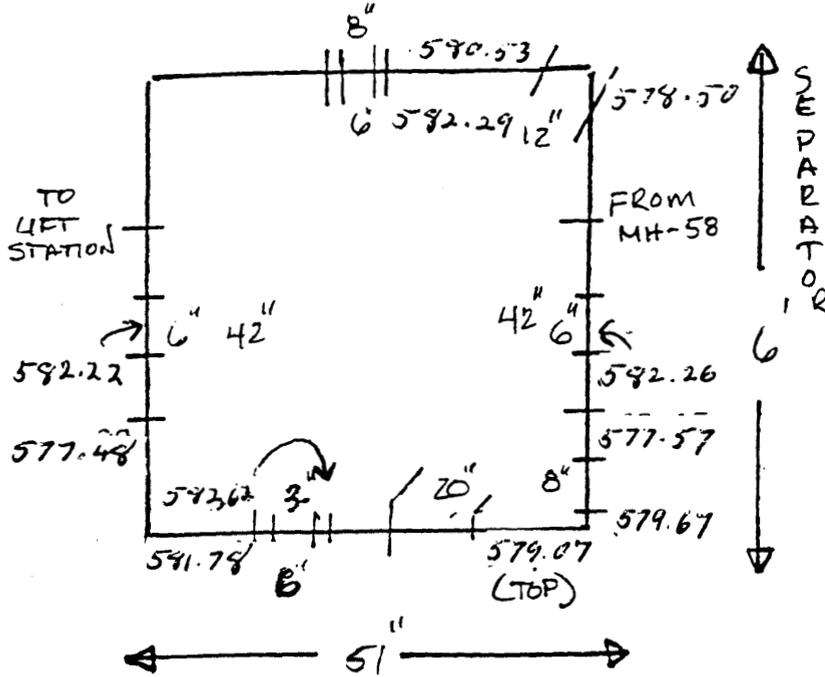
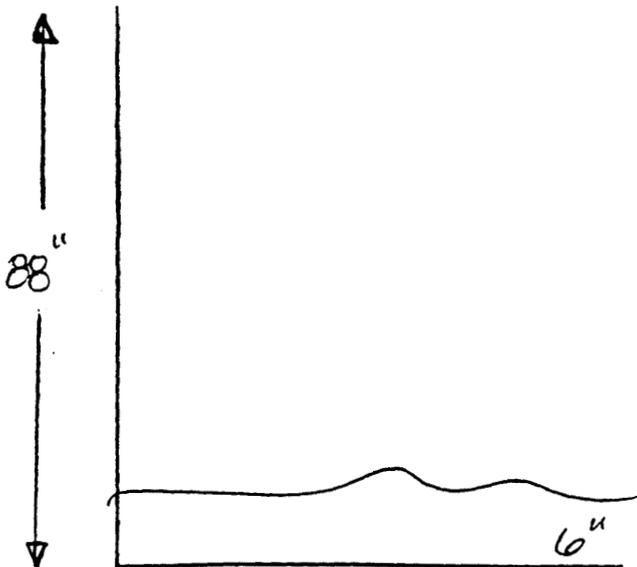
Structure # MH-1

Notes: Be 10/10w  
 formed concrete cons  
 mild product  
 good flow  
 3" line SE top of racks the 57.  
 all 6" line blocked 21-31 out.  
 8" NW line out of 36' stop  
 12" line 60' out stop  
 8" NE line  
 Rini Elevation:  
 584.48  
 Depth to Bottom:  
 Constructed of:  
 concrete  
 Sediment: 6"  
 Product:  
 SWEEN  
 Surrounding Area:  
 STONE  
 Flow:  
 ALL INCOMING LINES  
 GO TO LIFT STATION

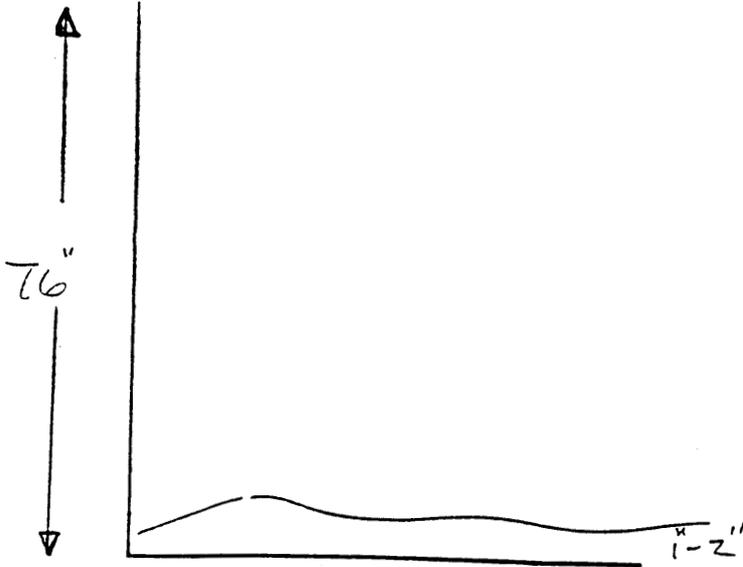
Structure # MH-2

Notes: BC 10/1/00  
 Clean water  
 formed concrete cor  
 clay pipes  
 stone rock cover

- 12" RISER
- STEEL PLATE COVER
- 2 x 27" DIA. TUBES

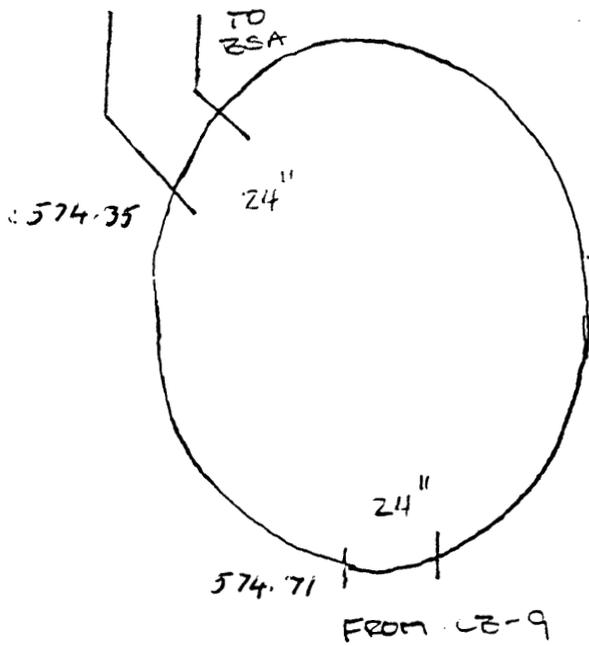
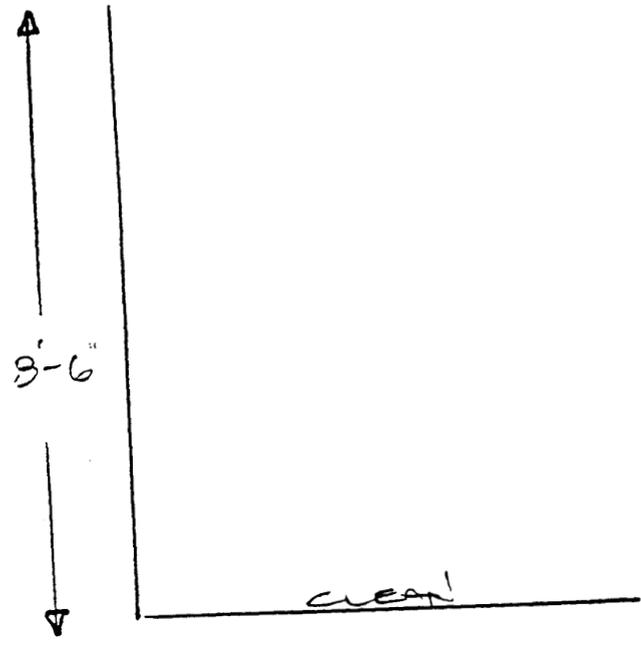
Structure # MH-3 (BSA) LINE

- Notes: BC 10/1/02
- FORMED CONCRETE CONSTRUCTION
  - DISCHARGES TO B.S.A
  - DUE TO LIQUID, COULD NO VERIFY LINE SIZE.

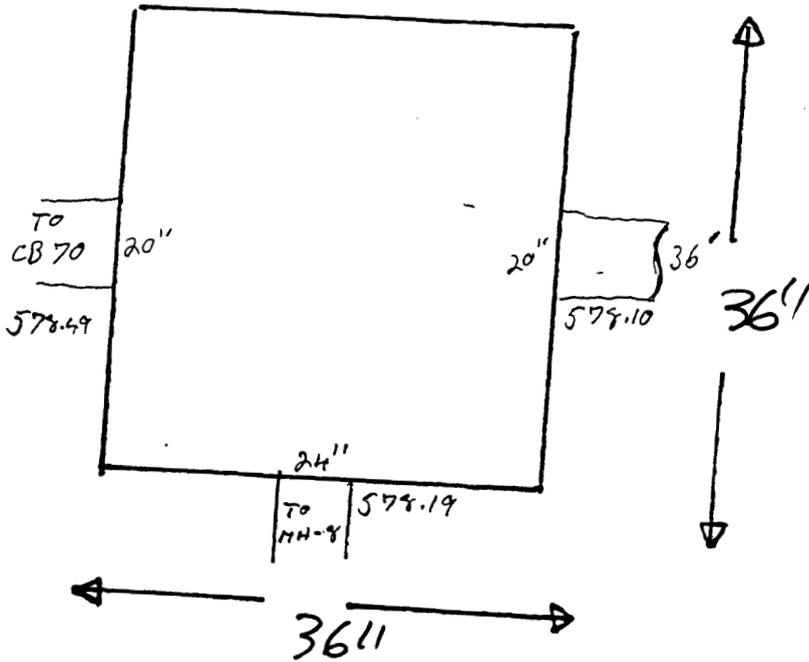
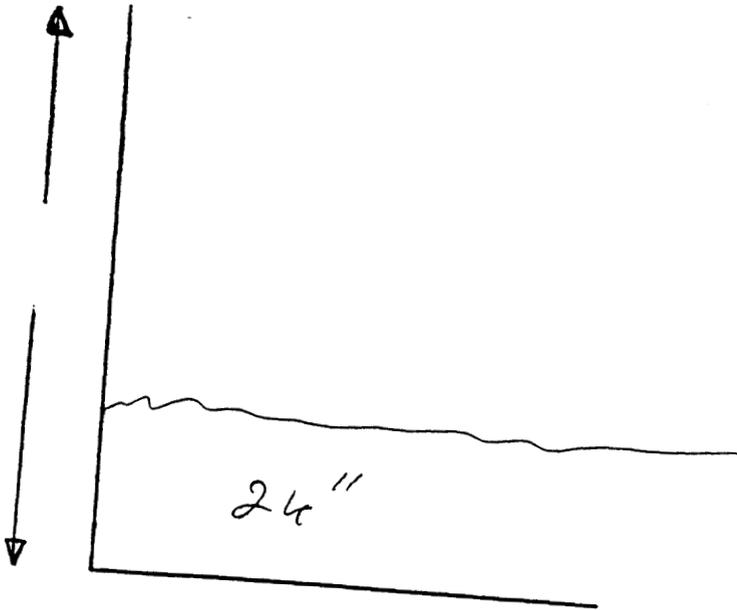
Structure # MH-4

- Notes: 8/10/00 BC
- Lines JETTED
  - Good Flow BTWN. MH-4 & MH-8
  - PIPE TO EAST PLUGGED 9/30/00 ~~Removed~~
  - VALVE ~~OPENED~~ IN CB-70 TO ALLOW FLOW FROM CB-70
  - well screen & pump INSTALLED
  - ? INVERTION WEST PIPE DUE TO ANGLE OF PIPE COMING INTO MH-4

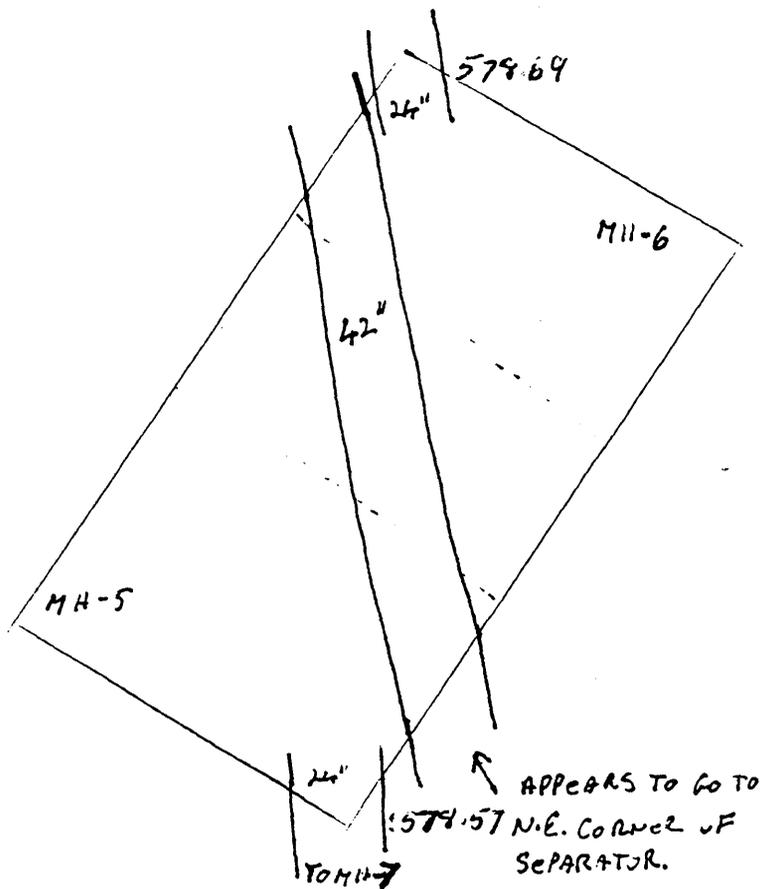
NOW MH-5  
MH-6

NOTES: BC 10/1/00

FORMED CONCRETE, AIR RUN  
4" ABOVE GRADE. AREA  
COVERED w/ STONE. MH-5 & 6  
APPEAR TO BE 1 STRUCTURE  
BELOW GRADE.

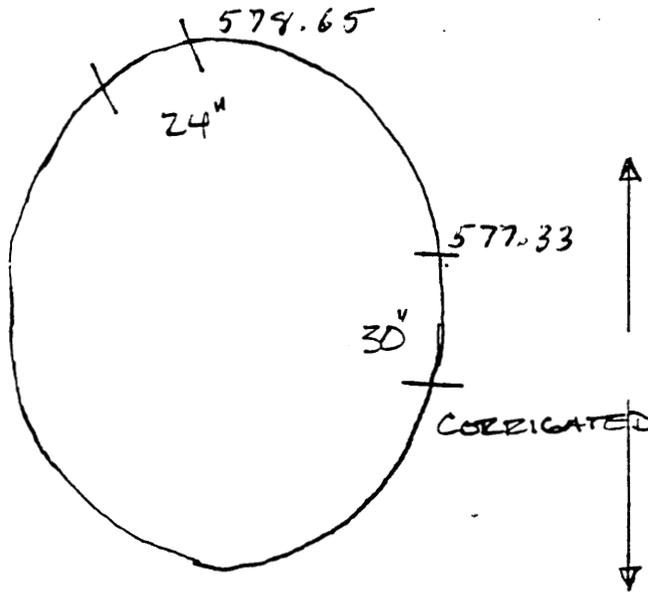
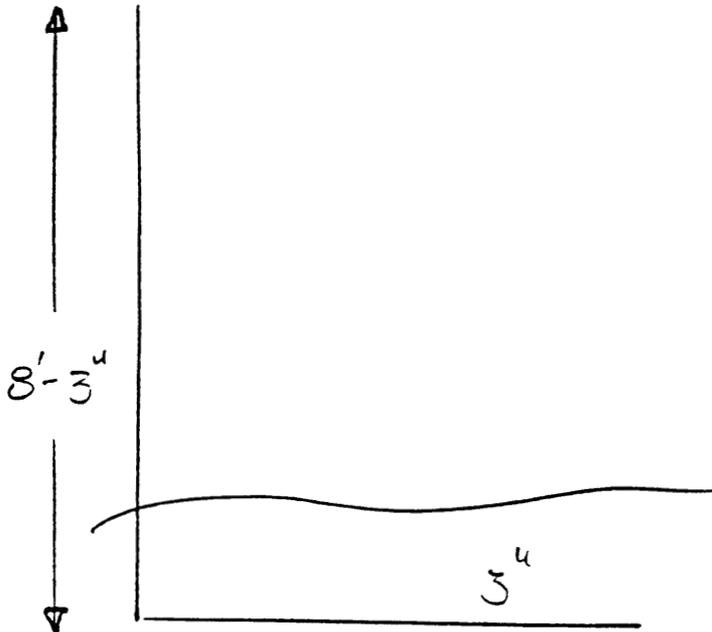
Structure # MH-7

Notes: BC 7/20/00  
FORMED CONCRETE  
CLEAN  
GOOD SHAPE  
HIGH RISE STRUCTURE  
STONE COVERED AREA  
- 30" CORRUGATED  
24" CHAN  
Rim Elevation: 584.37

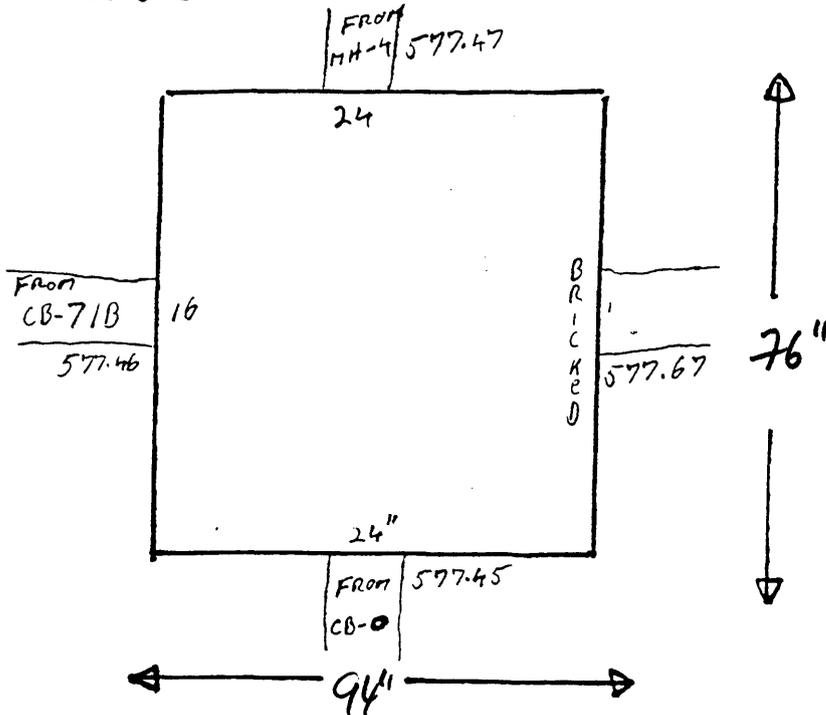
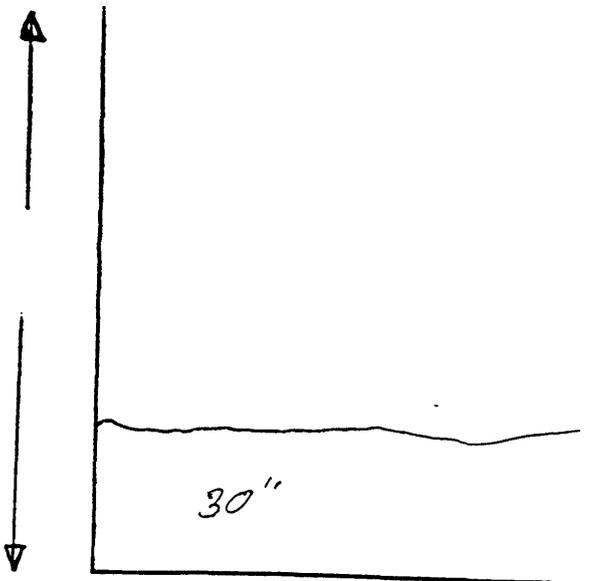
Structure # MH-8

Notes: 8/10/00 BCR

- LINES JETTED.
- INVERTS ARE NOT 100% ACCURATE ON NORTH & SOUTH PIPES, ARE BELLED INTO MH-8. CONFIRE SPACE ENTR; WAS MADE TO OBTAIN INVERTS.

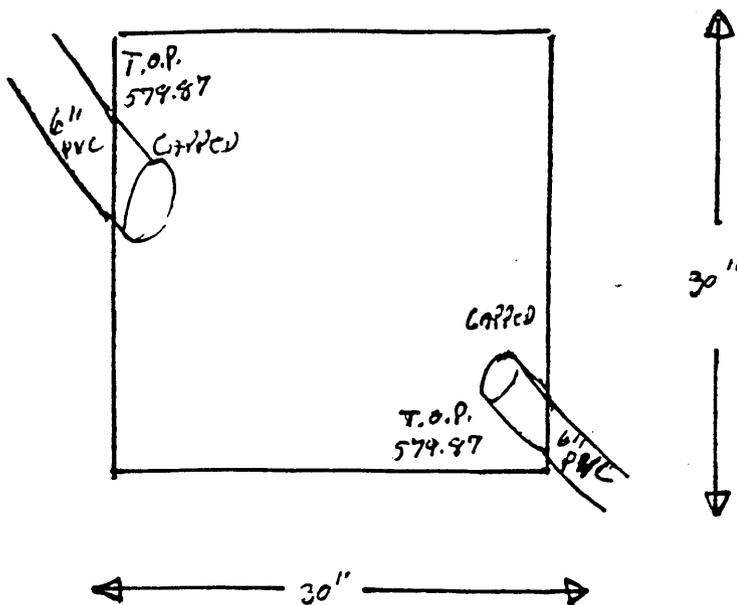
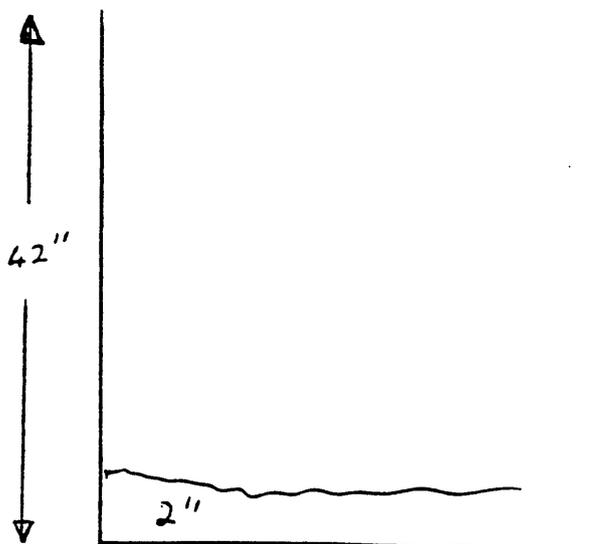
Structure # MH 9

Notes: DE 4/19/01  
- APPEARS TO BE PART OF WESTERN WELL POINT SYSTEM.

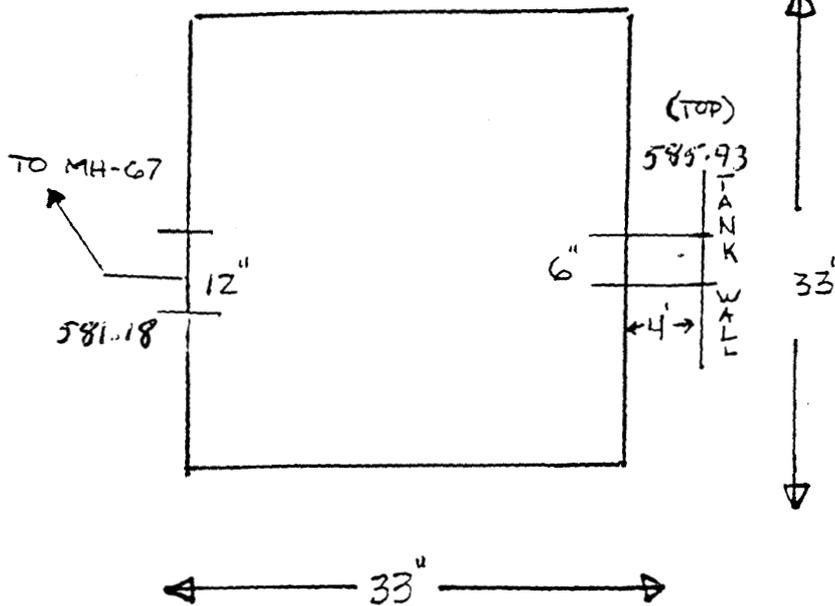
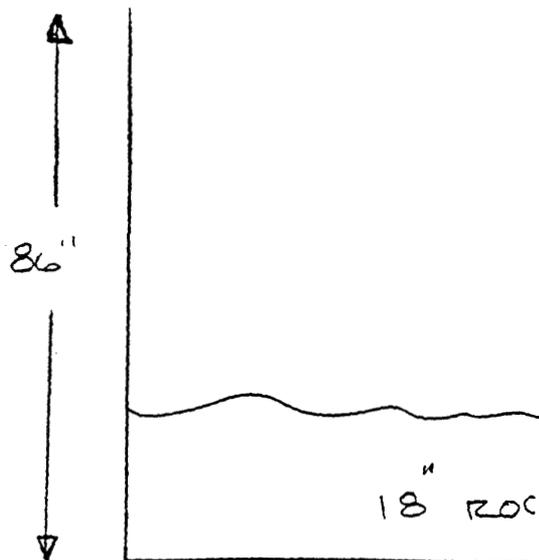
Structure # MH-10

- ALL LINE STEEL
- NOTES: BC 1/27/00
- FORMED CONCRETE CONSTRUCTION 4"
- CINDER BLOCK 38"
- NO COVER
- WOOD DEBRIS
- 6" LINES GOES TO OLD FARM

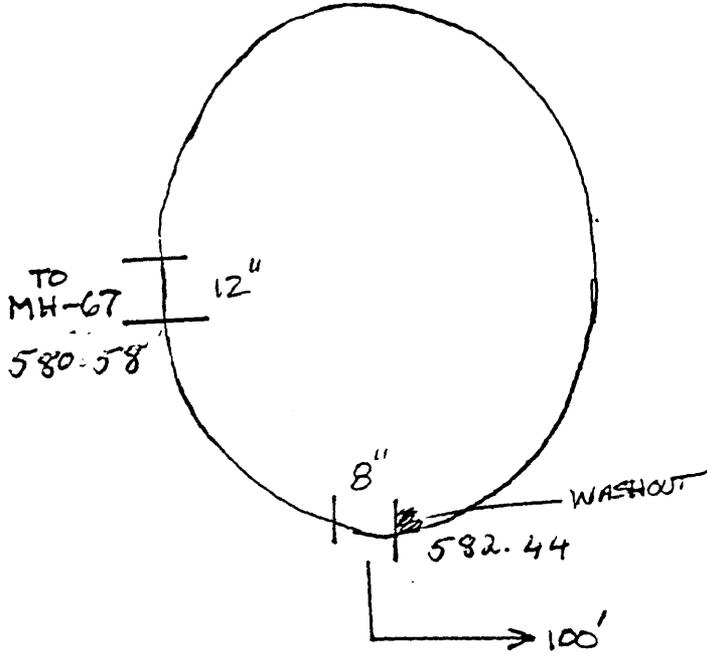
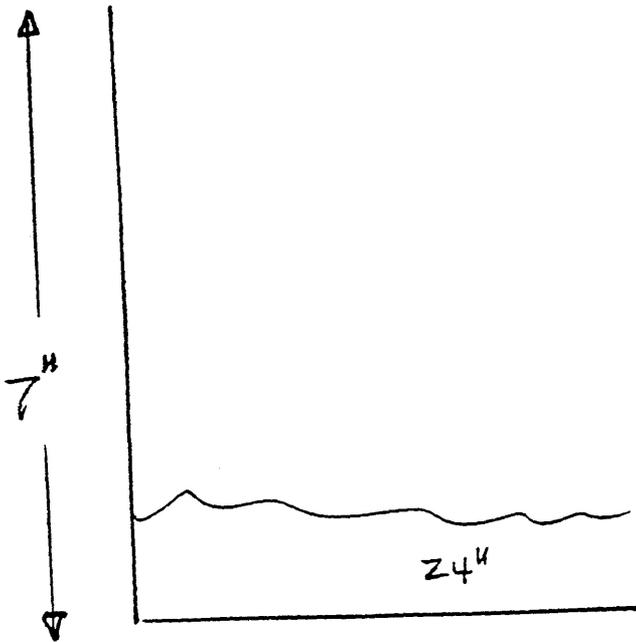
Structure # MH-11  
ROADWAY

- Notes: BC 4/27/00
- ROUND FORMED CONCRETE
  - PRODUCT FLOW WEST IN 12" PIPE.
  - STEEL LINES
  - STEEL COVER
  - SOME WASHOUT ON RIGHT SIDE OF 8" PIPE
  - 8" LINES GOES INTO TANK FAR
- Rim Elevation: 584.75

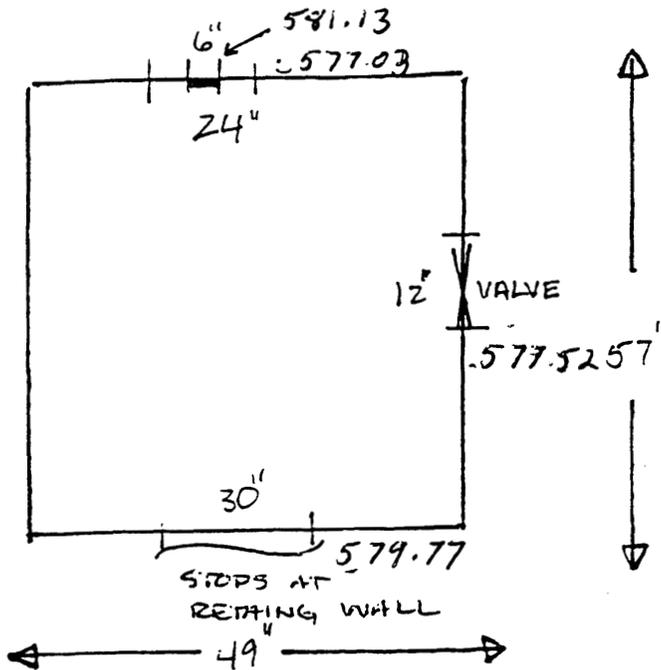
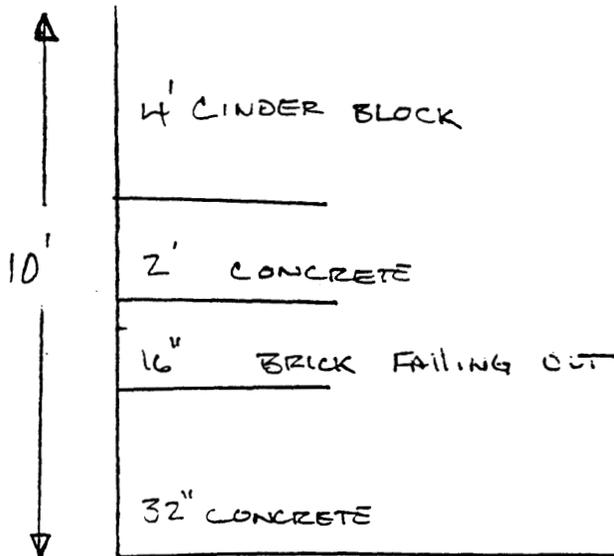
Structure # MH-12

NOTES: BC 7/20/00  
mixed form structure  
bricks in poor shape  
falling out

30" LINE CORRUGATED  
STEEL

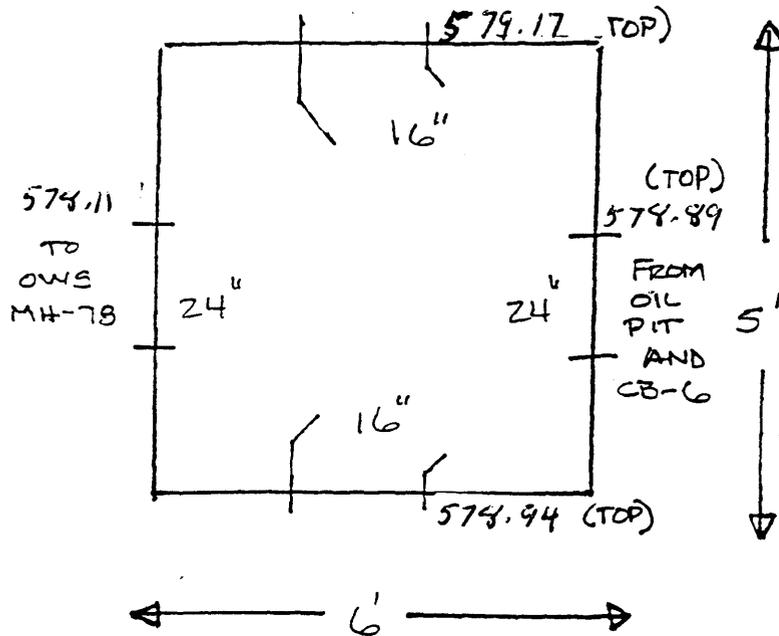
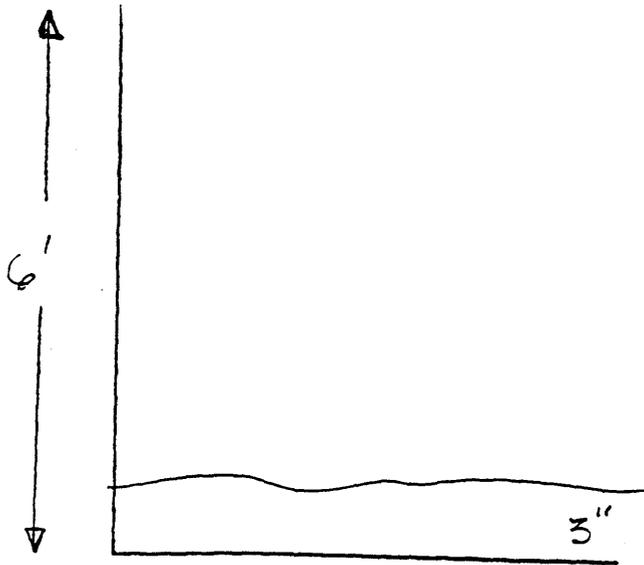
Structure # MH-13

Notes: BC 4/30/00  
Brick construction  
pool shape  
heavy product on site  
ALL PIPES CAST

HEAVY PRODUCT STAINING

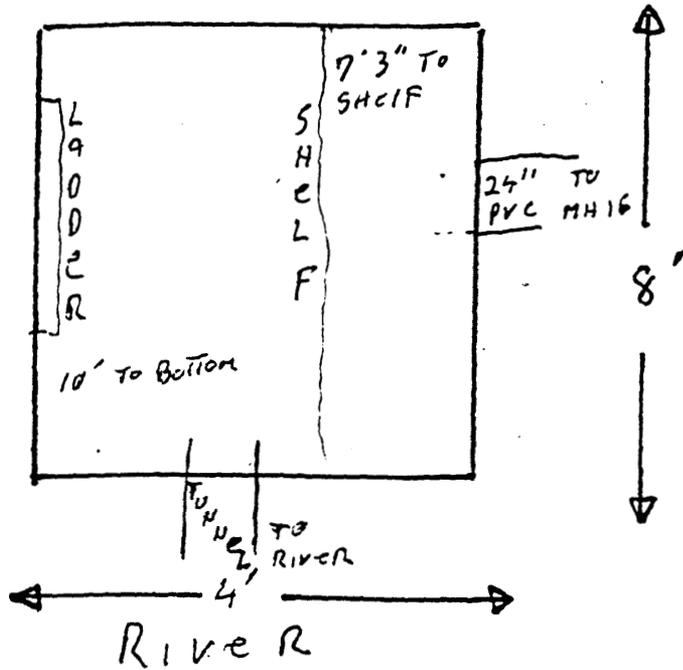
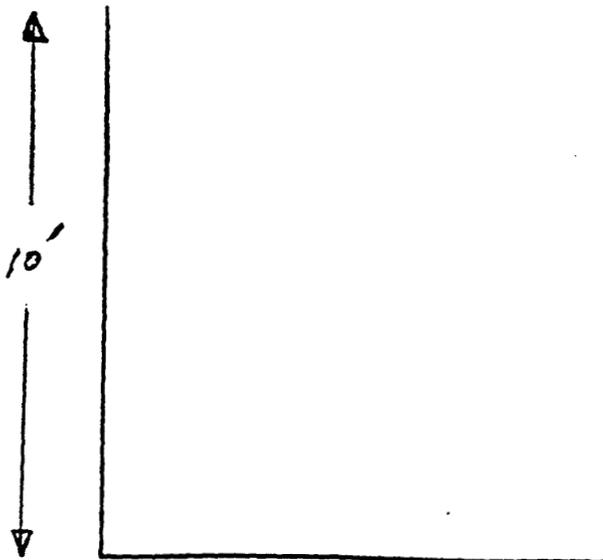
Structure # MH 15

Flow: EAST TO SOUTH

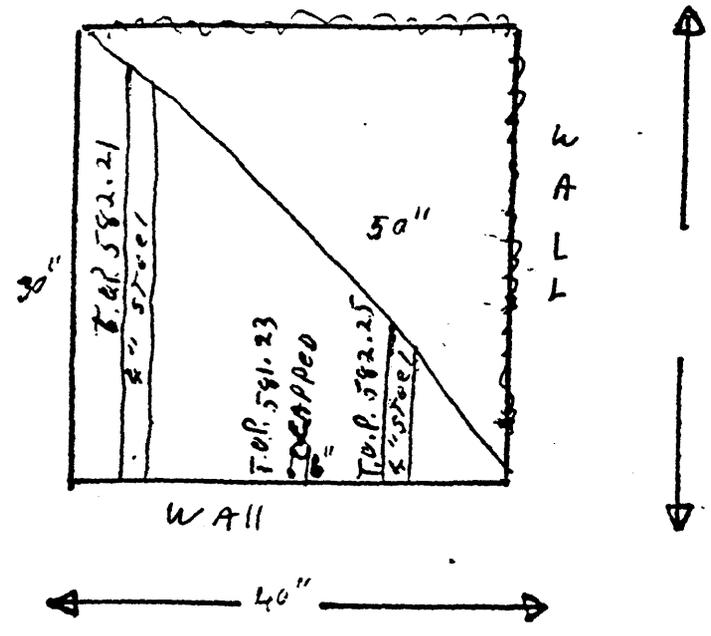
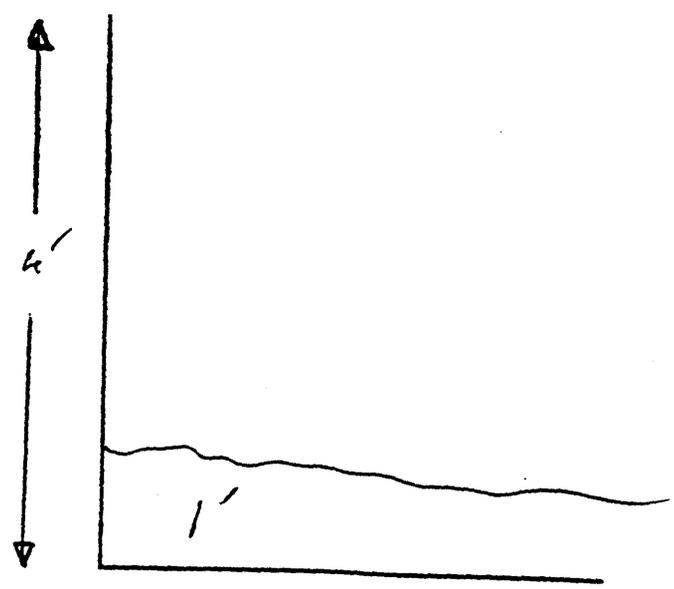
Structure # MH 21

- Notes: BC 4/25/01
- ACTUAL LOCATION IS IN S.E. CORNER OF CONCRETE WALL BERM FOR TANKS 25-26
  - 6" PIPE CAPPED
  - STRUCTURE IN POOR SHAPE

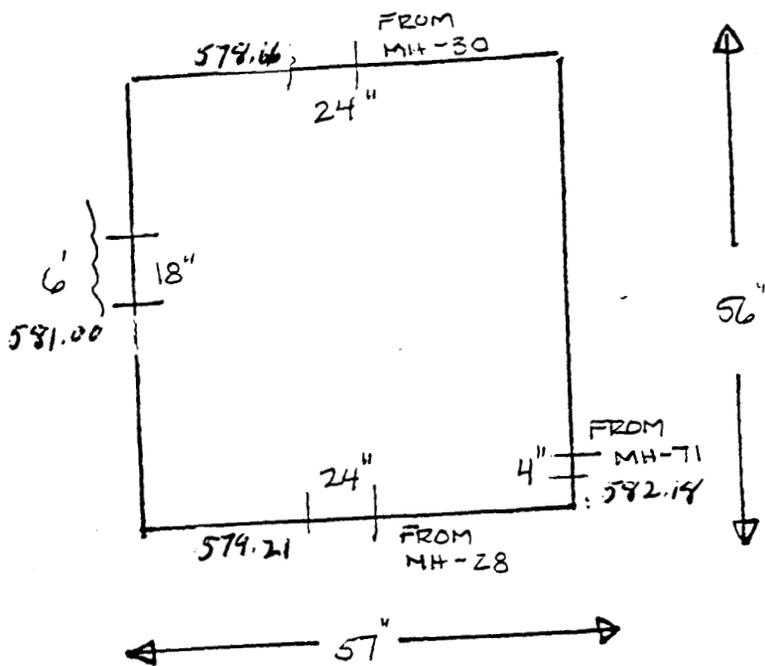
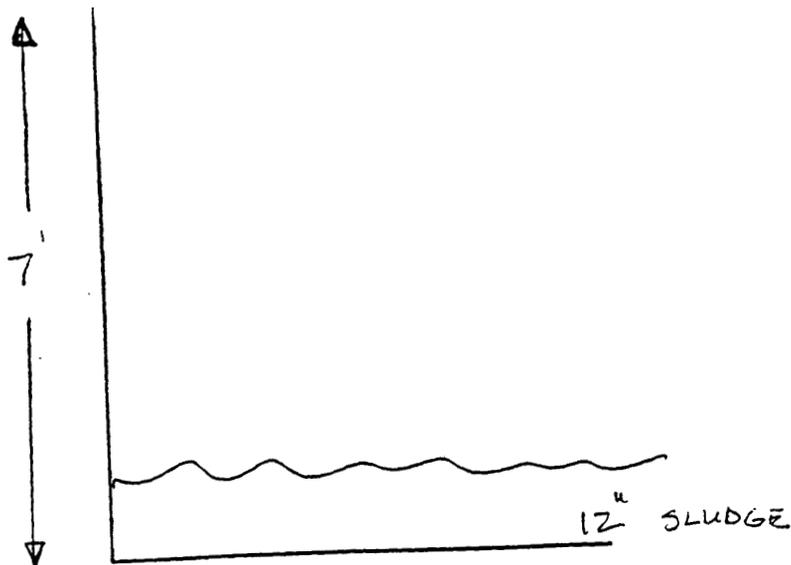
Structure # MH-29

- NOTES: BC 7/12/01
- BRICK CONSTRUCTION
  - 24" CONCRETE RISER
  - CLAY PIPES
  - 18" WEST LINE BLOCK
  - 24" NORTH LINE CONNECTS TO MH-30
  - 24" SOUTH LINE CONNECTS TO MH-28

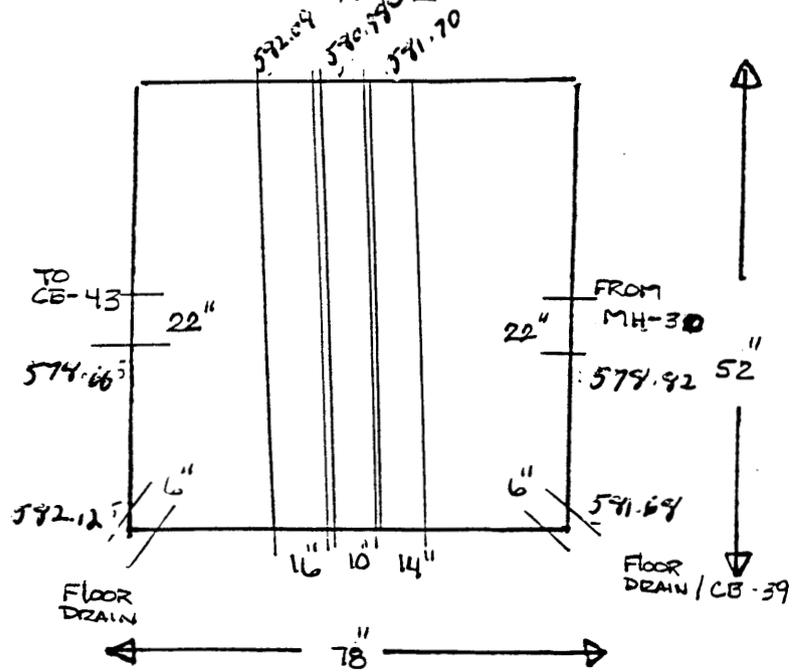
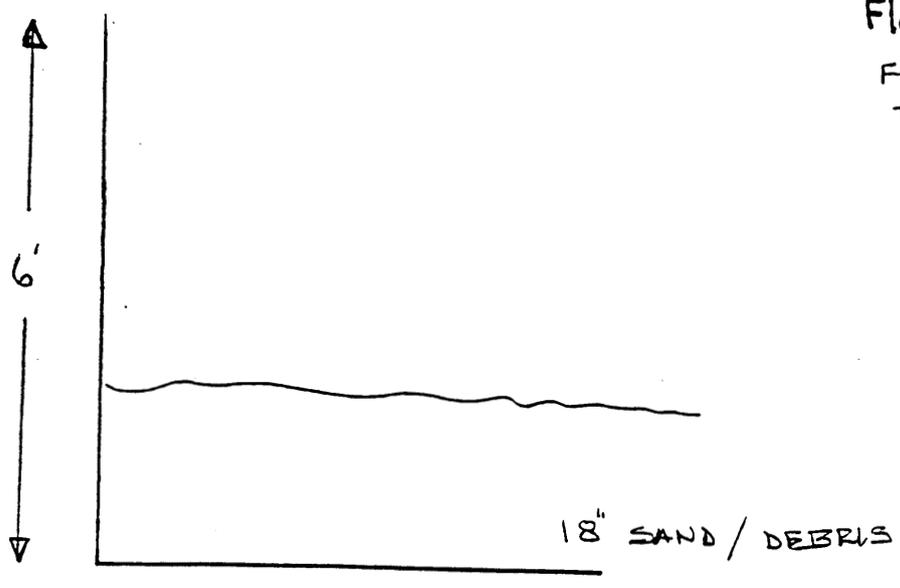
Structure # MH-32

- NOTES: BC 1/15/00
- BRICK / CONCRETE CONSTRUCTION
  - REMOVED SAND FOR PIPES TO FLOW FROM MH-30 TO CB-34
  - NO ACCESS TO 10", 14", AND 16" LINES. (STEEL)
  - CLAY PIPES

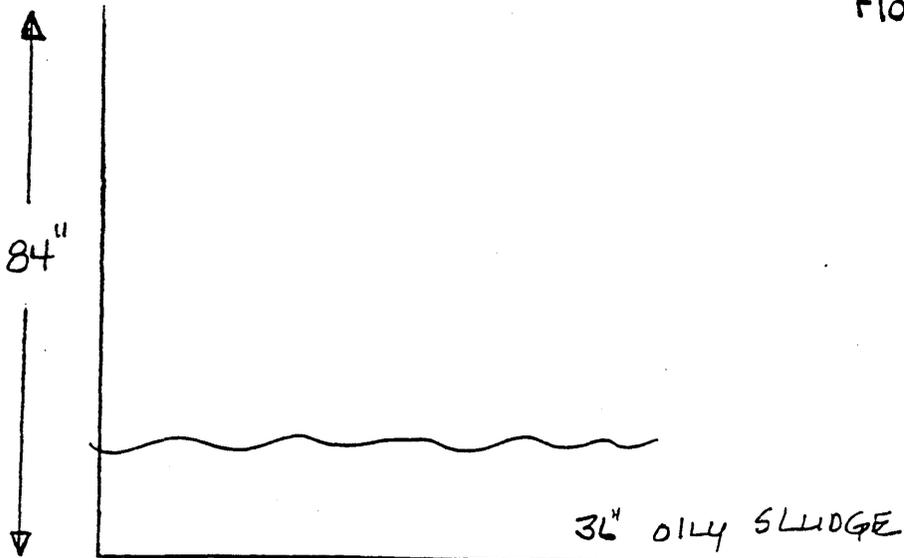
Structure # MH-36

- Notes: BC 9/18/00
- BRICK CONSTRUCTION W/ 20' CONCRETE RISER.
  - HEAVY OILY SLUDGE.
  - STEEL PLATE COVER
  - ASPHALT ROADWAY

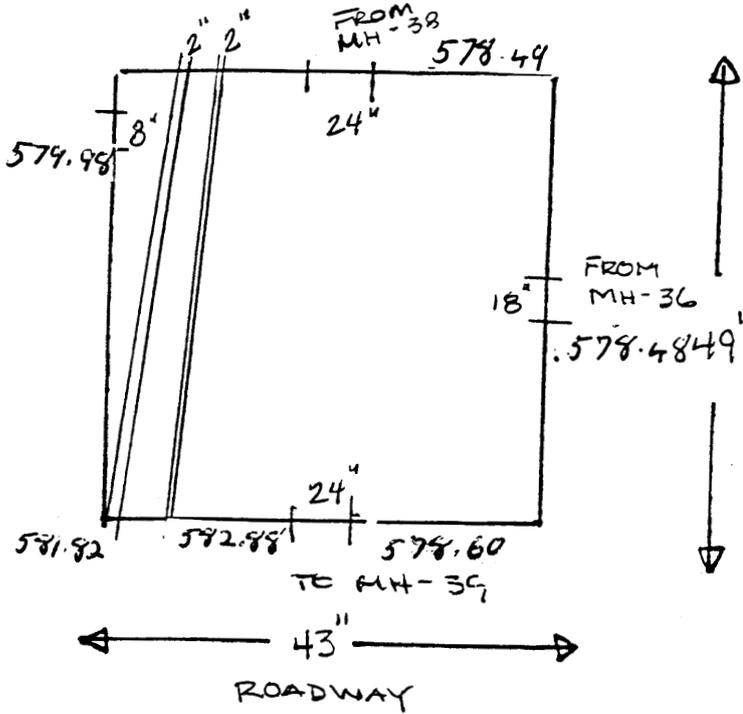
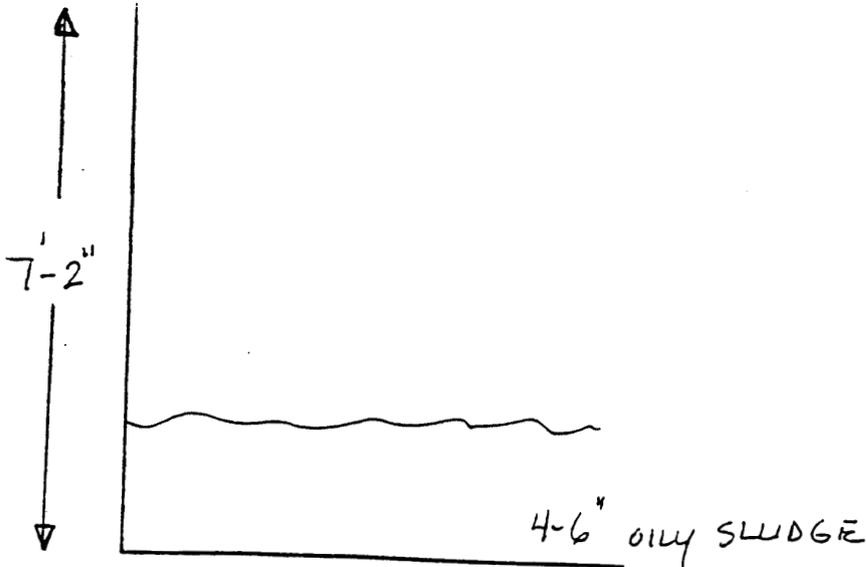
Structure # MH-37

- Notes: BC 1/17/00
- 24" N LINE FED FROM MH 37
  - 18" E LINE FED FROM MH-36
  - 2" LINES NOT TRACED

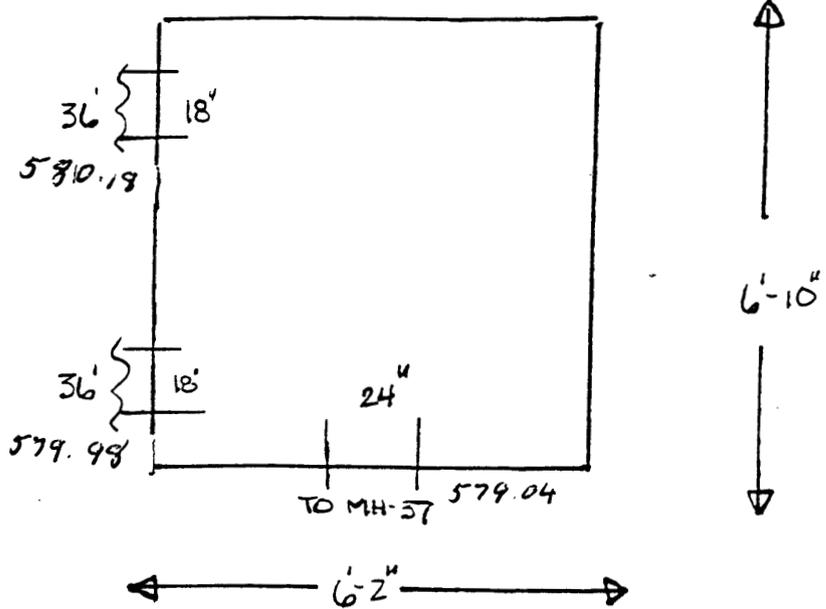
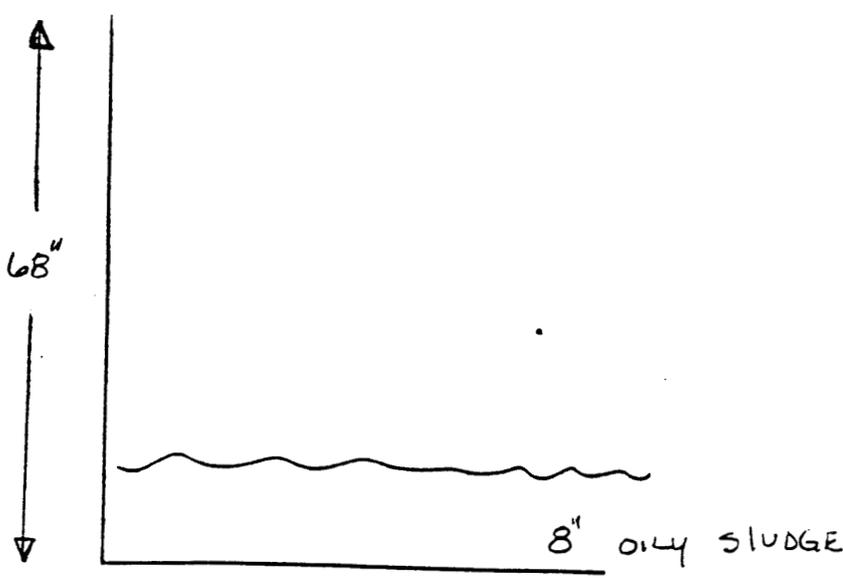
Structure # MH-38

- Notes: BC 7/15/00
- 24" LINE CONNECTS TO MH-37
  - 18" LINES HAVE Baffle "T" GO WEST 36"
  - CONCRETE CONSTRUCTION
  - STEEL PLATE COVER

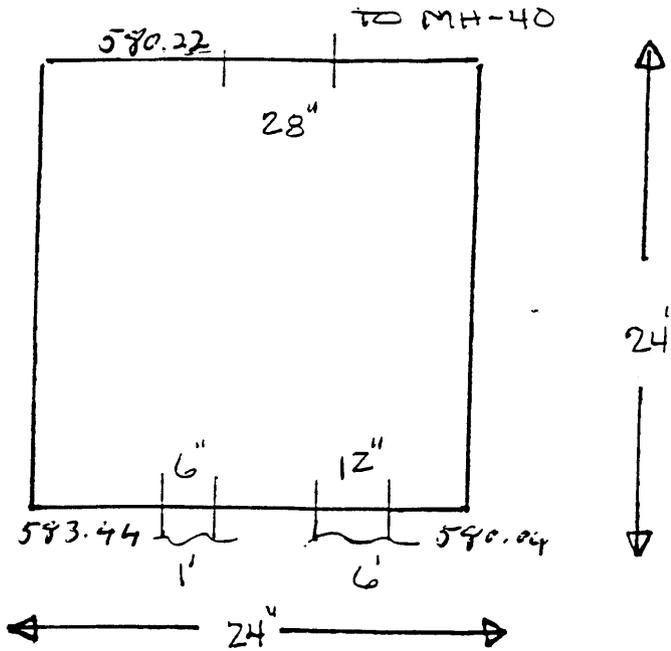
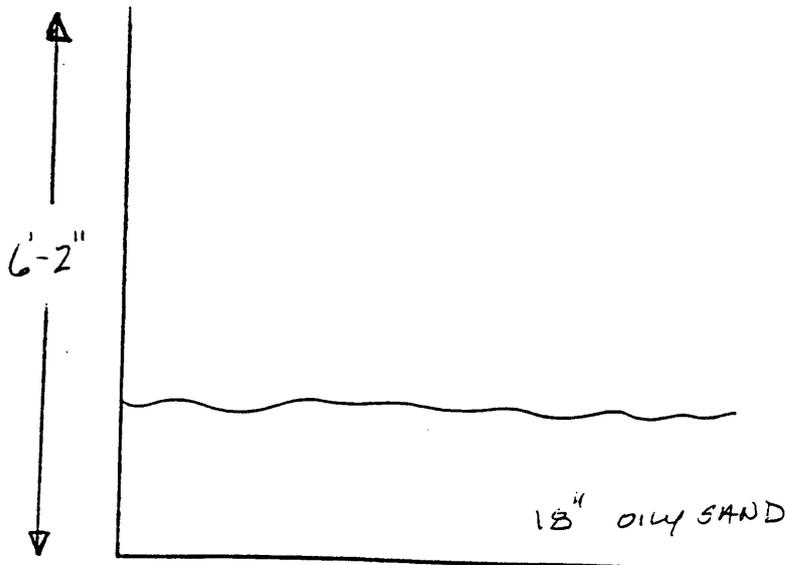
Structure # MH-41

- NOTES: PC 7/20/00
- POOR CONCRETE CONSTR.
  - BOTTOM UNDERMINED
  - 6" SOUTH LINE PLUGGE 1' OUT
  - 12" SOUTH LINE PLUGGE 6' OUT
  - STEEL COVER
- FLAY. LINES  
Rim Elevation: 585.96

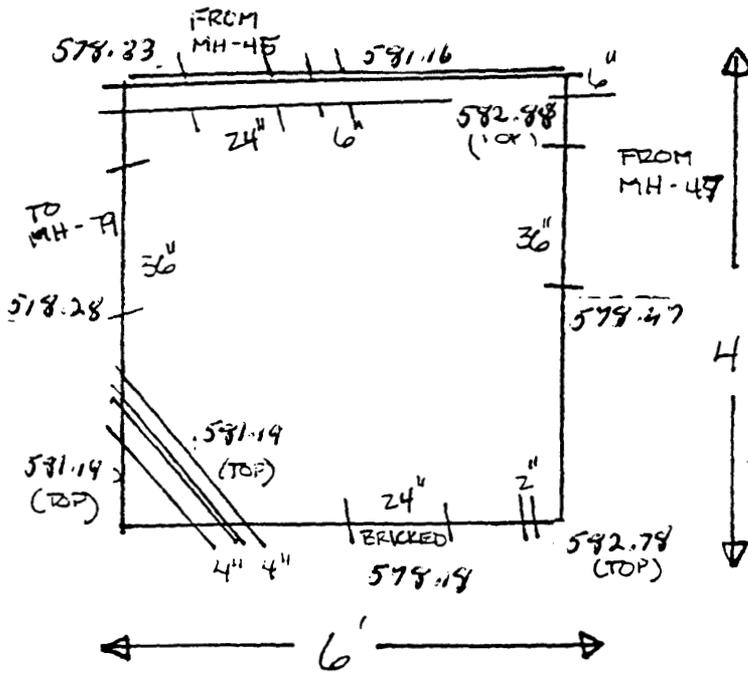
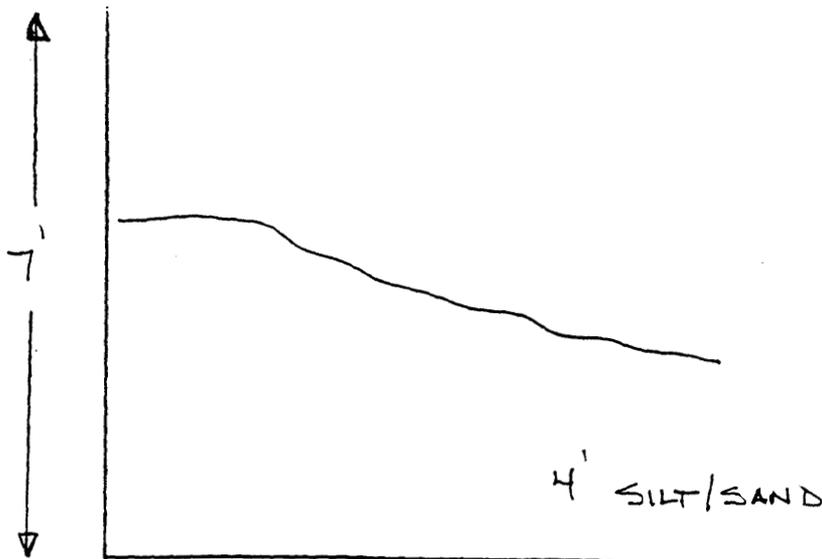
Structure # MH-44

- NOTES: BC 7/22/00
- CONCRETE / BRICK CONSTRUCTION
  - WEEDS / BRUSH COVERED
  - LINES FULL SILT / SAND
  - STEEL PLATE COVER
  - 24" SOUTH LINE BRICK
  - 6" RISER ON CONCRETE

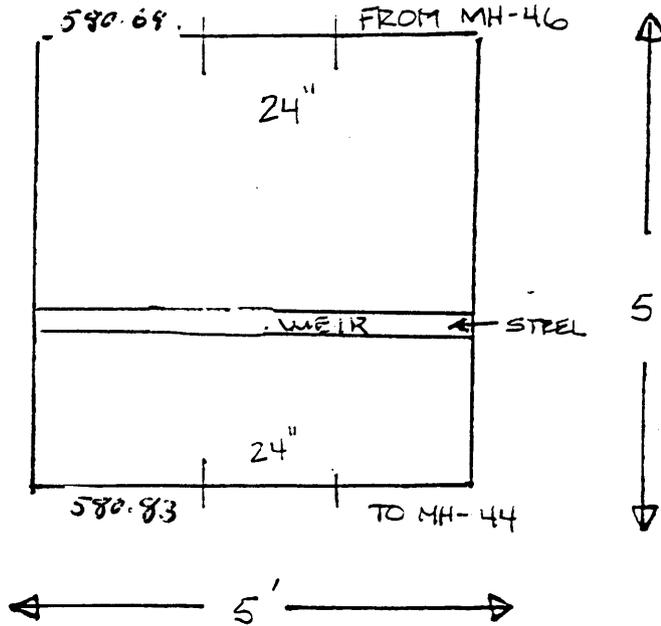
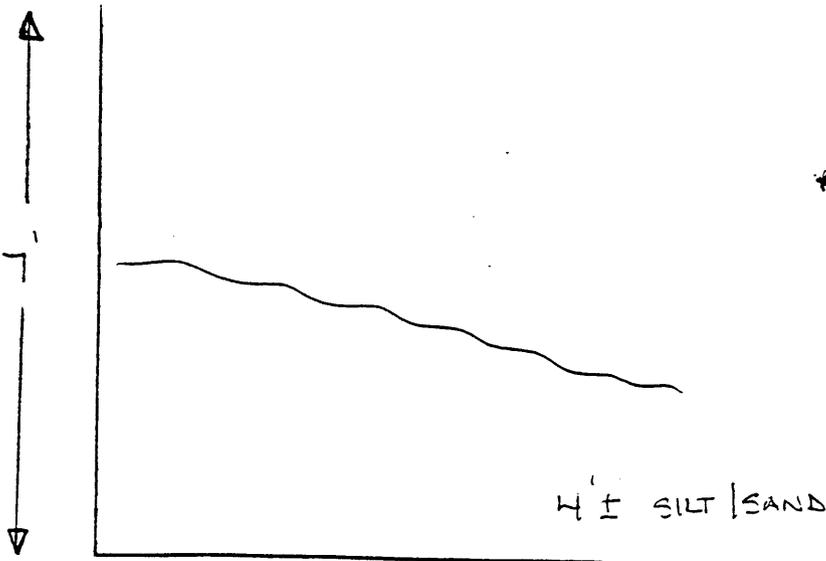
Structure # MH-45

- NOTES: BC 4/22/20
- CONCRETE / BRICK CONSTRUCTION
  - WEIR ON SOUTH SIDE
  - STEEL PLATE COVER
  - FENCE ON WEST SIDE
  - STEEL WARE

\* UNABLE TO REMOVE  
STEEL WEIR
