# **STORM-WATER COLLECTION SYSTEM INVESTIGATION REPORT**

**Buffalo Terminal  
Buffalo, New York**

**March 28, 2002**

**ROUX ASSOCIATES, INC.**  
1377 Motor Parkway  
Islandia, New York 11749

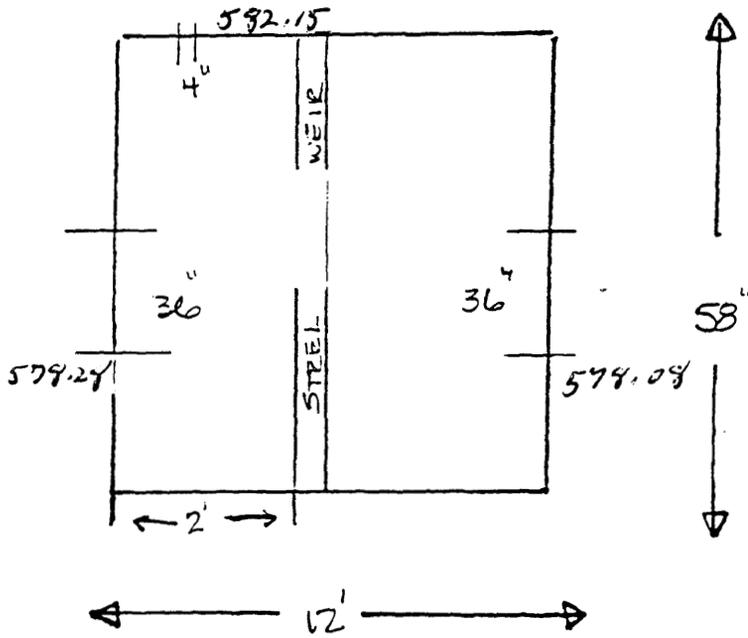
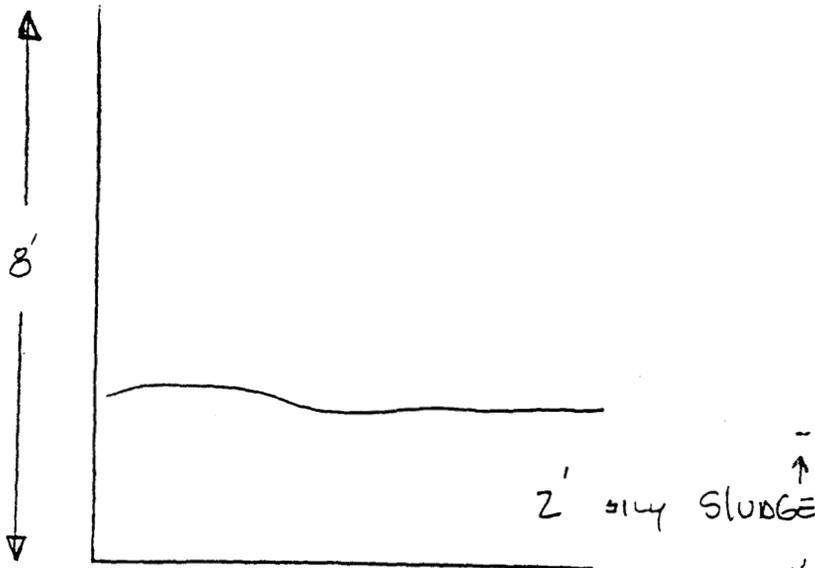
Structure # NH-47

- NOTES: BC 7/22/20
- CONCRETE CONSTRUCTION
  - FLOW IS EAST TO WEST
  - WEEDS / BRUSH COVER
  - DIRT / GRAVEL WILL WA IN DURING HEAVY RAIN
  - STEEL PLATE COVER
  - HIDDEN BY TREES
  - CLAY LINES
- Rim Elevation: 584.46

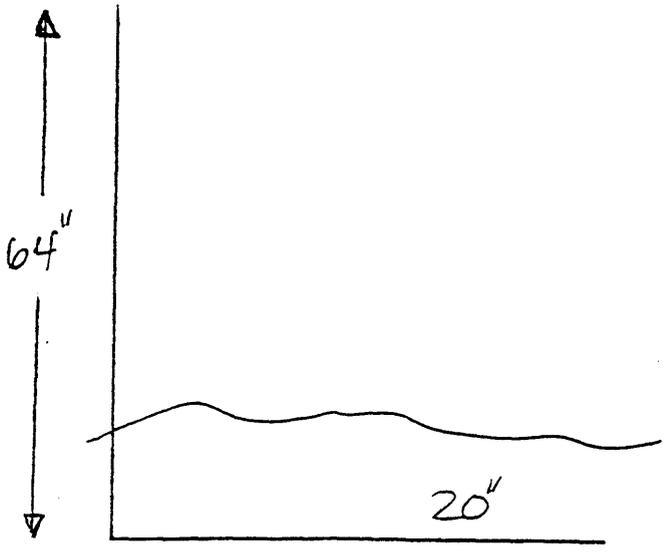
Structure # MH-48

- NOTES: BC 9/26/00
- BRICK CONSTRUCTION
  - CONCRETE RISER
  - 3" LINE STEEL, PLUGGED
  - STEEL PLATE COVER
  - POOR SHAPE
  - JOINTS SEPERATED
  - GROUNDWATER INFILTRATED
  - CONCRETE DEBRIS
  - CLAY LINES
- Rim Elevation: 585.44

Surrounding Area:  
CONCRETE DEBRIS

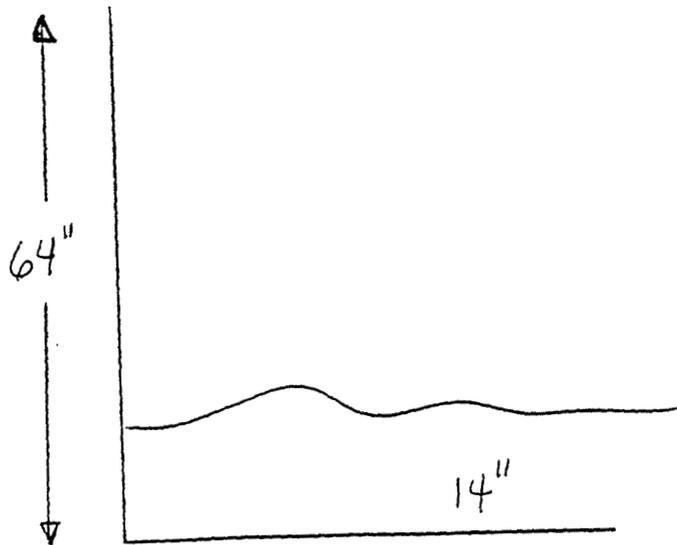
Structure # MH-49

- NOTES: BC 9/26/00
- BRICK CONSTRUCTION
  - CONCRETE RISER
  - STEEL PLATE COVER
  - CONCRETE DEBRIS
  - GROUNDWATER INFILTRATED
  - CLAY LINES

Surrounding Area:  
CONCRETE DEBRIS

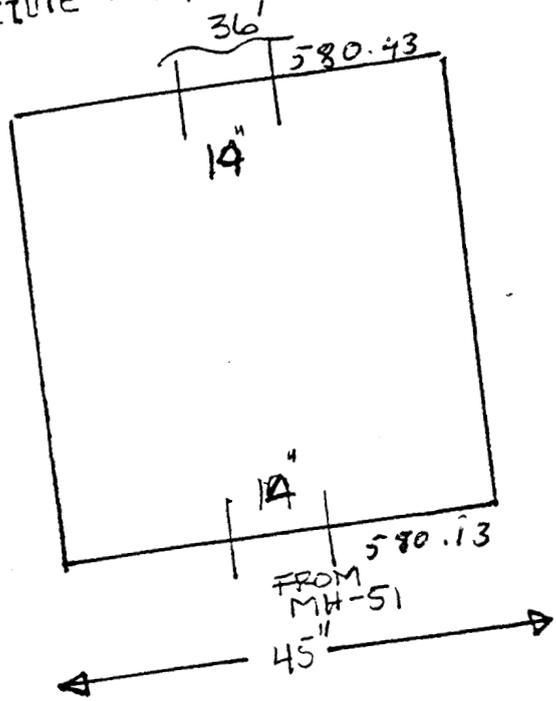
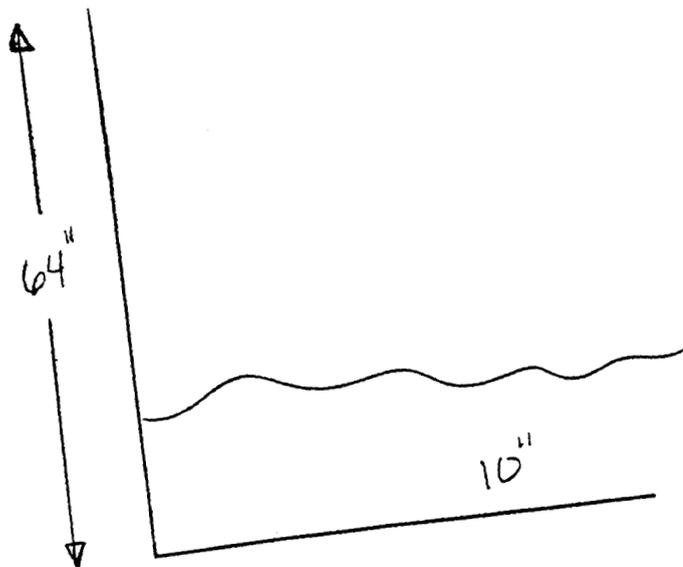
Structure # MH-50

- NOTES: 02 9/20/03
- BRICK CONSTRUCTION
  - CONCRETE RISER
  - STEEL PLATE COVER
  - CLAY LINES
  - GROUNDWATER INFILTRATED
  - NORTH LINE STOPS OUT 36'

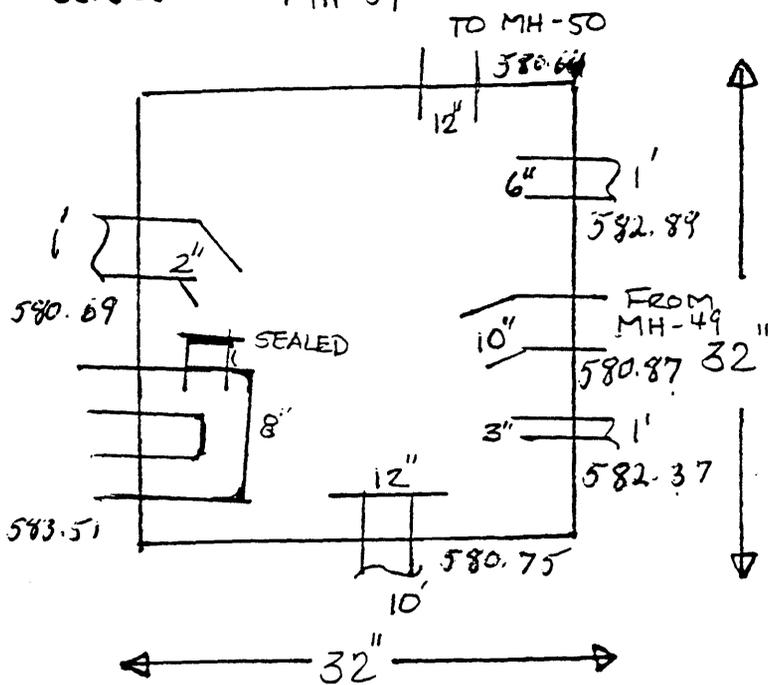
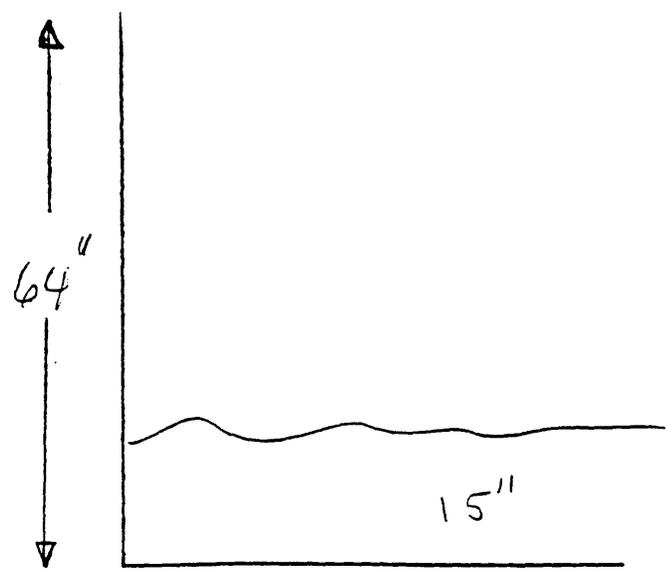
Structure # MH-51

- Notes: BC 9/26/01
- CONCRETE RISER, BRICK CONSTRUCTION
  - CONCRETE DEBRIS
  - STEEL PLATE COVER
  - EAST 6", 3" LINE STEEL
  - WEST 8" T" PLUGGED
  - CLAY LINES
  - 12" SOUTH LINE "T"

Surrounding Area:  
CONCRETE DEBRIS

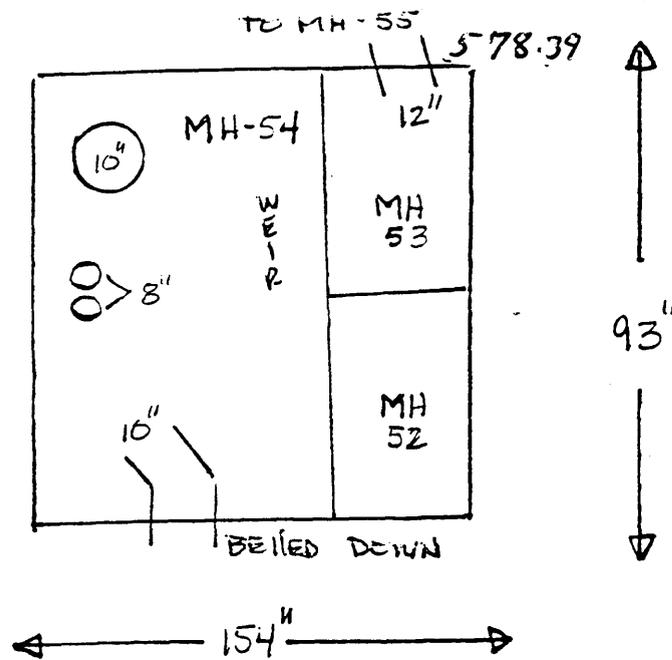
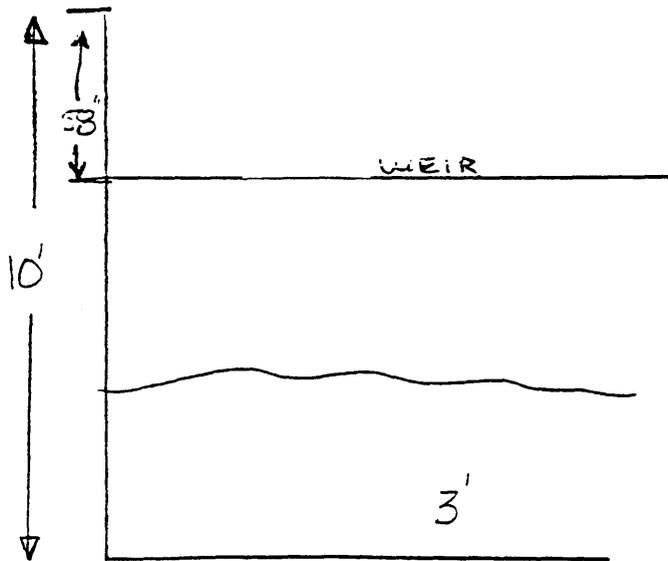
Structure # MH-52/53/54 (TANK)

- 10" SOUTH LINE NO READING
- NOTES: BC 4/27/00
- CONCRETE CONSTRUCTION
- STEEL LINES
- ONE TANK W/CONNECTING WEIR
- MH-52 TANK W/NO PIPES
- WEIR: SEPARATING MH-52/MH-53
- LADDER IN MH-54/MH-53
- 1 10" LINE FEEDS DOWN (VEN)
- 2 8" LINES FEEDS DOWN
- Rim Elevation: 584.97

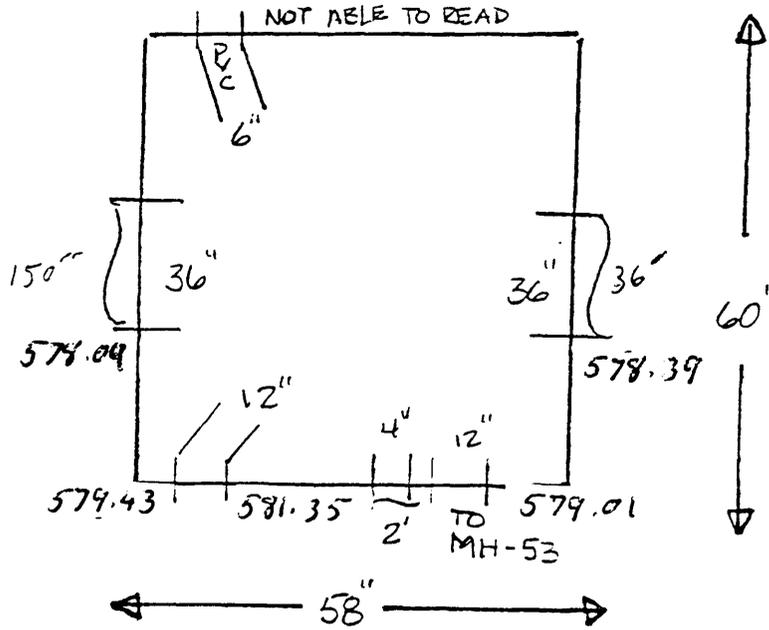
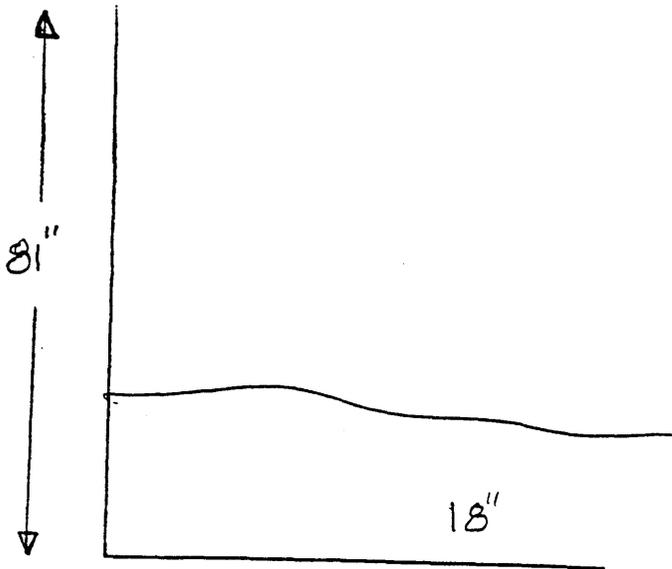
Structure # MH-55

- Notes: BC 7/28/00
- CONCRETE CONSTRUCTION
  - 6" PVC OUT 40' STOPPED
  - 4" STEEL LINE OUT 2' STOPPED
  - 12" S/E LINE CLAY TO MH-53
  - STEEL PLATE COVER
  - 36" LINES FLOW EAST TO W

WEST 36" LINE STOPPED  
150' OUT

EAST 36" LINE GOES  
N/E THEN WEST 36'

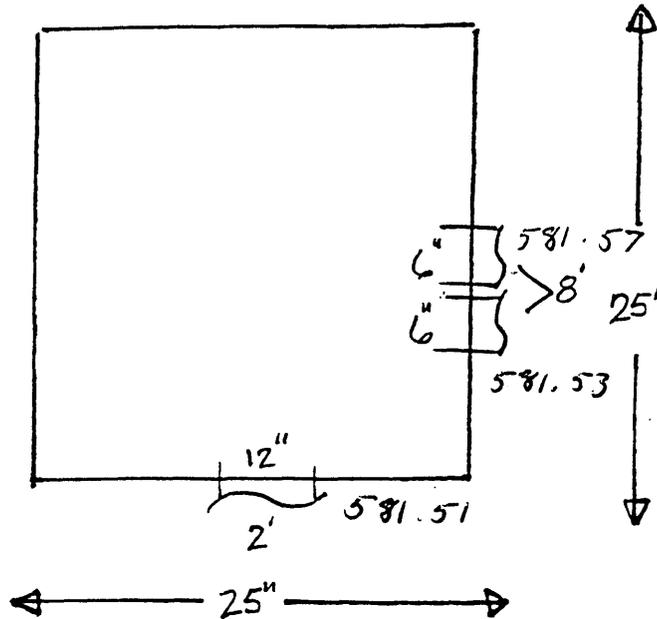
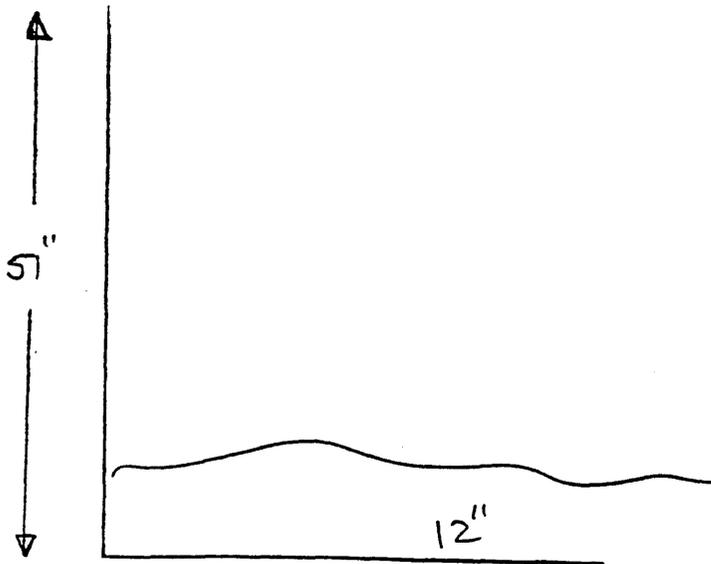
Structure # MH-56

- Notes: BC 4/27/20
- CONCRETE CONSTRUCTION
  - CLAY PIPES
  - PRODUCT FLOW SOUTH 12" LINE
  - 12" LINE STOPPED 2' OUT (POSSIBLE GROUNDWATER) ENTERING
  - STEEL PLATE COVER
- Rim Elevation: 585.49

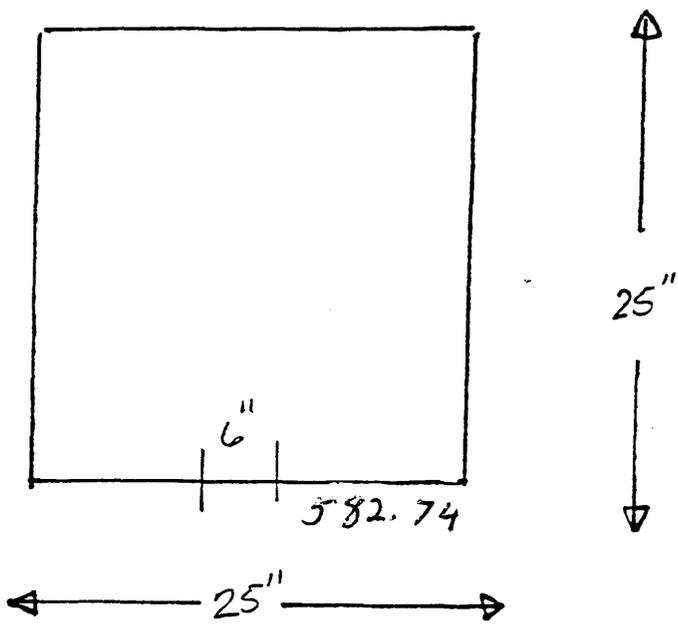
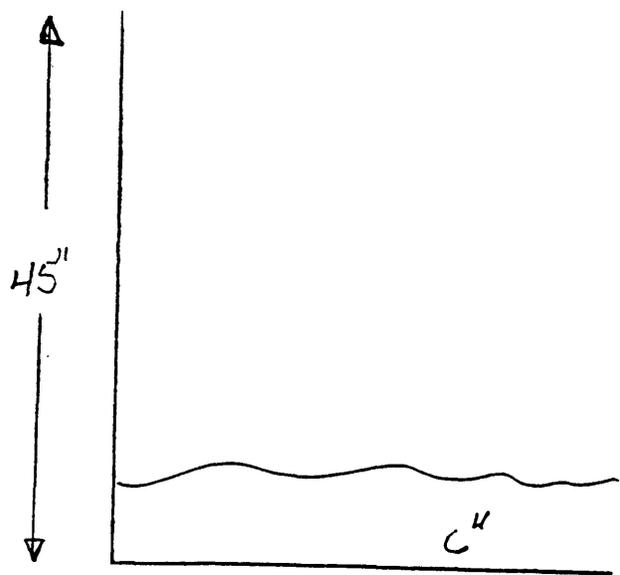
Structure # MH-57

- NOTES: BC 4/27/00
- CONCRETE CONSTRUCTION
  - CLEAN
  - CLAY PIPE
  - STEEL PLATE COVER

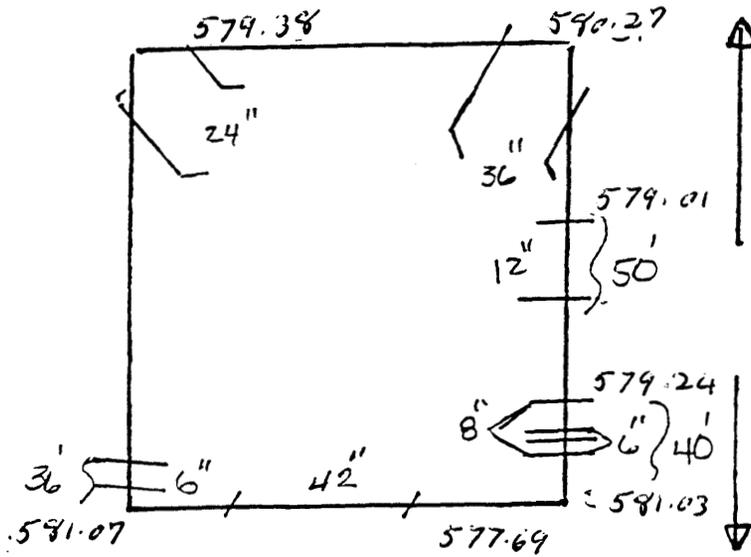
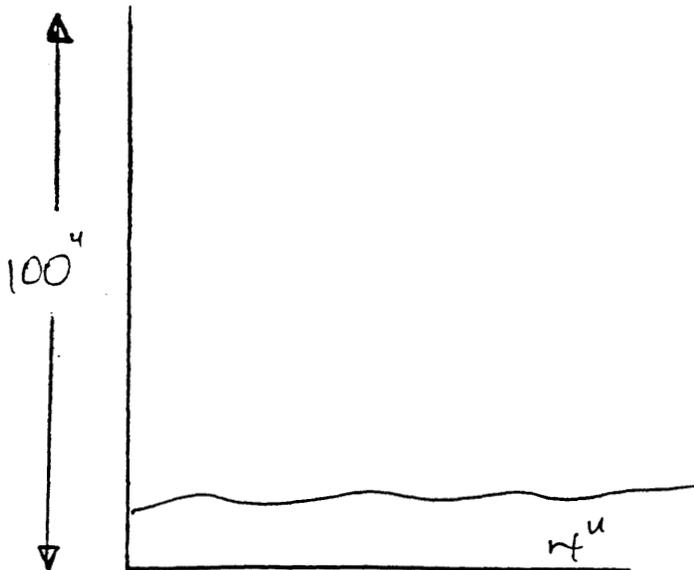
Structure # MH-58

Notes: Be 10/2/00  
formed concrete const.  
riser w/ brick const.

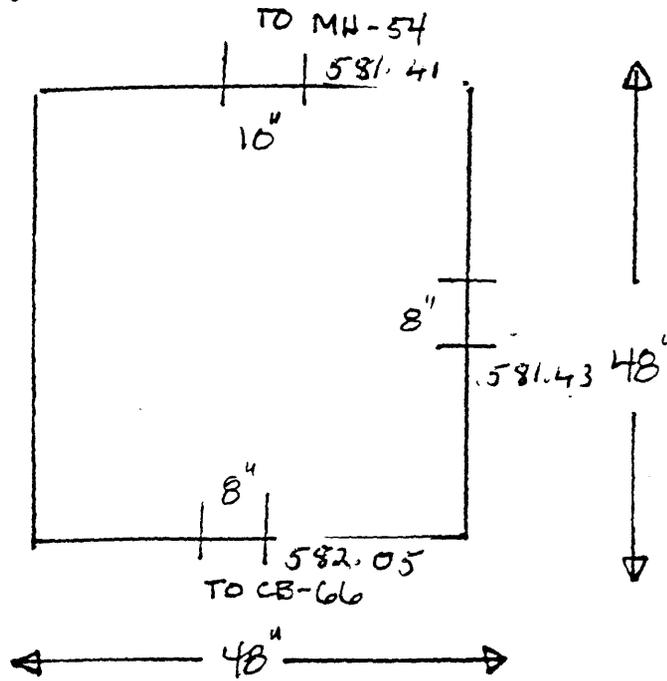
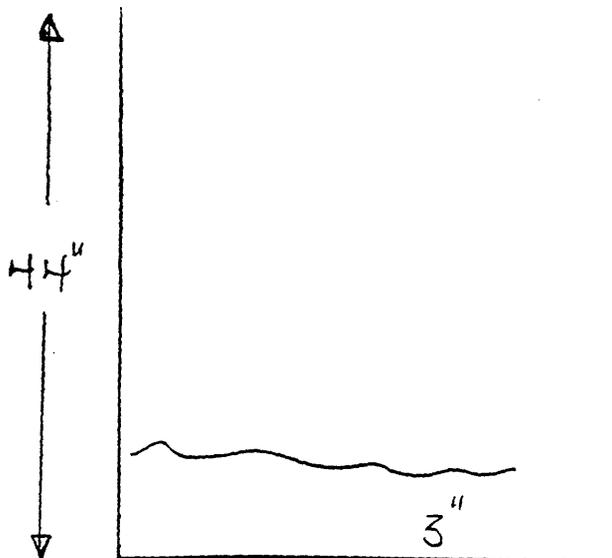
Structure # MH-59

- NOTES: 02/12/00
- CONCRETE CONSTRUCTION
  - CAST LINES
  - CLEAN
  - 8" EAST LINE 90' TO PAD PER
  - 8" SOUTH LINE TO CB-66
  - STEEL COVER
  - ON CONCRETE PAD
- Rim Elevation: 585.02

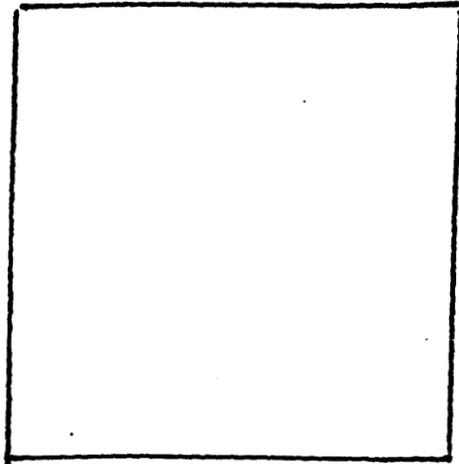
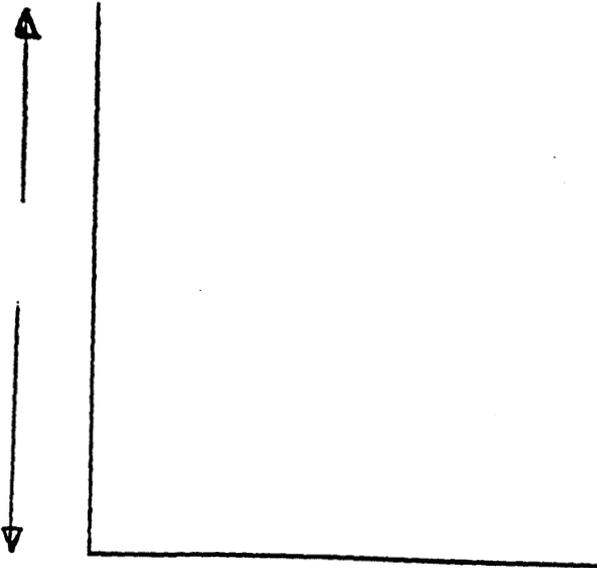
Structure # MH 60

Notes: BC 4/19/01  
- STRUCTURE INSTALLED  
BY CES FOR WESTERN  
WELL POINT SYSTEM.

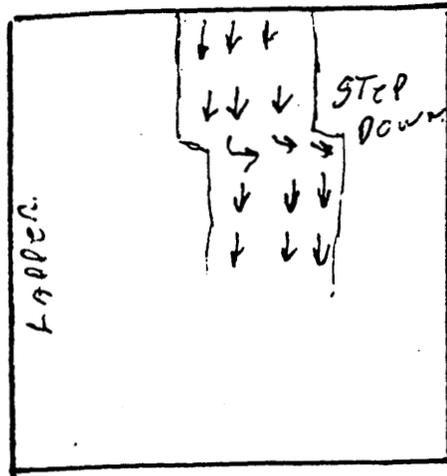
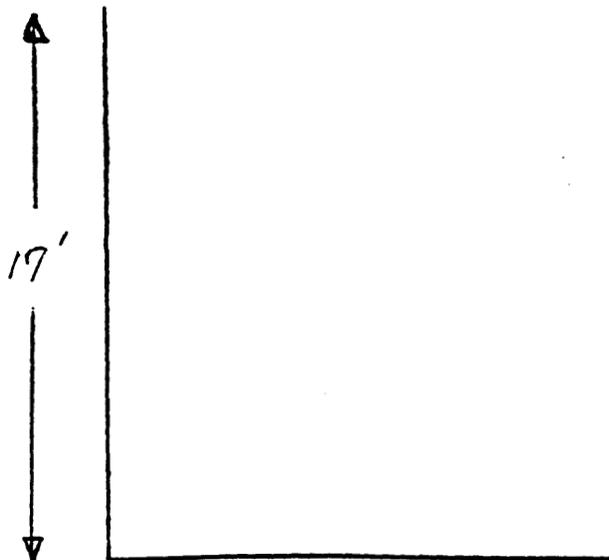
Structure # MH 65

Notes: BC 4/19/01  
• Does NOT MAKE SENSE  
WATER FLOWING AWAY FROM  
TUNNEL.  
• COULD NOT LOCATE  
6" PIPE FROM CB 74

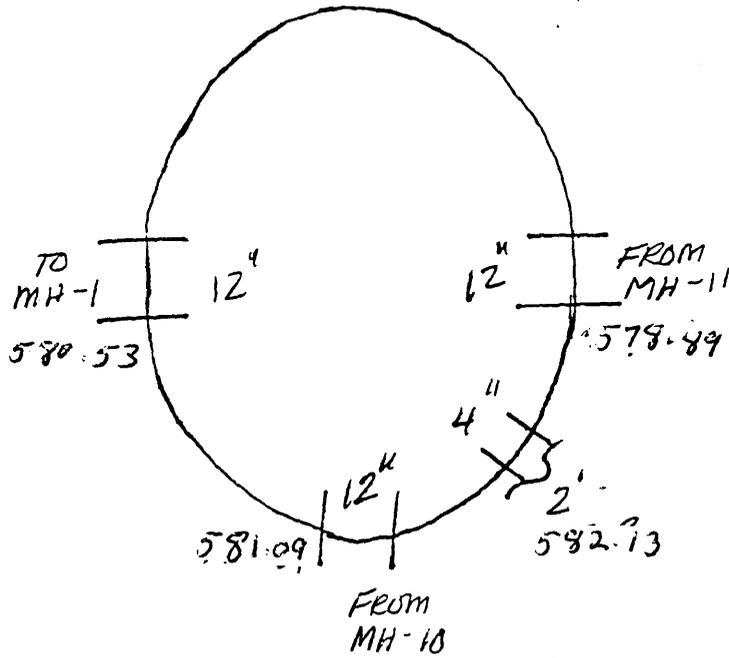
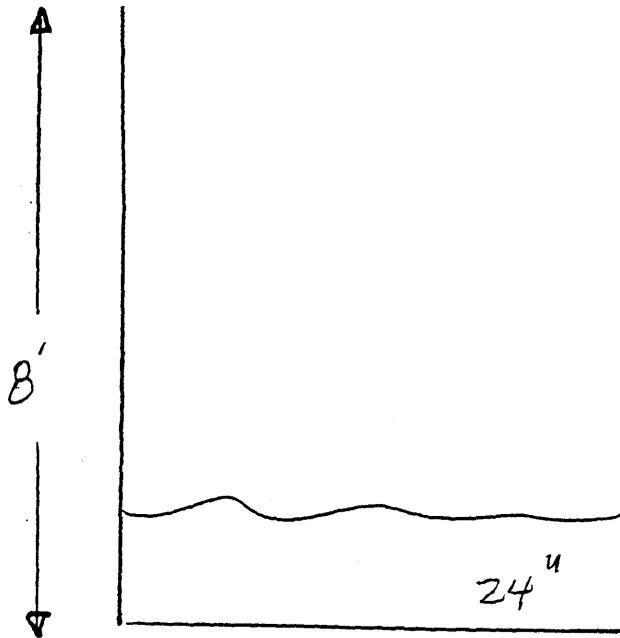
Structure # MH-67

- Notes: 80 1/2" flow
- CONCRETE CONSTRUCTION
  - FLOW EAST TO WEST FROM MH-11 TO MH-1
  - 18" CONCRETE RISER
  - STEEL COVER
  - STEEL LINES
  - 4" OUT 2' STOPPED

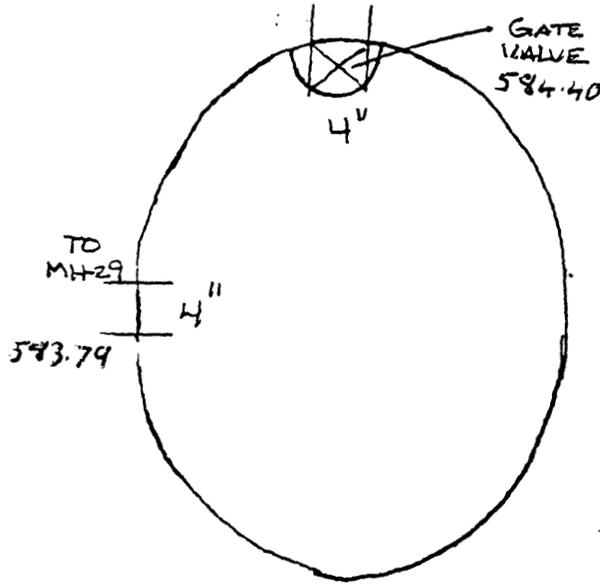
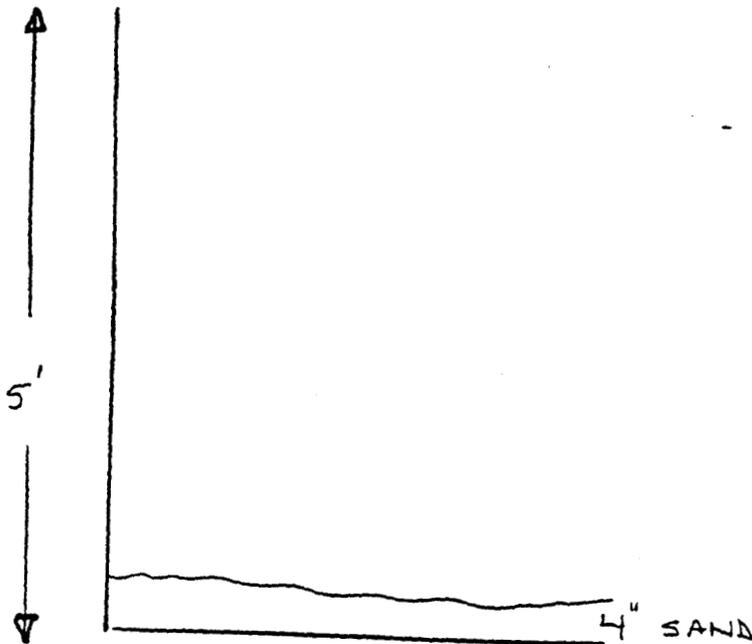
Structure # MH-71

- Notes: BC 7/12/00
- 4" LINE PVC TO MH-29
  - CONCRETE CONSTRUCTION
  - 4" LINE STEEL GATE VALVE
  - 48" DIA. TANK
  - INCOMING WATER FROM GATE VALVE IS WATER RUN OFF IN BID - FIELD
- Rim Elevation: 595.69

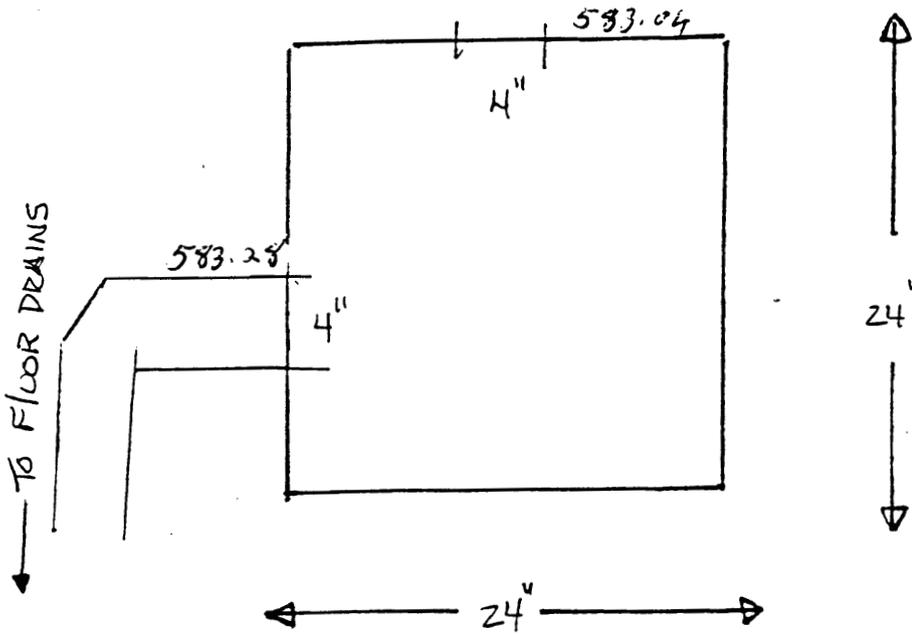
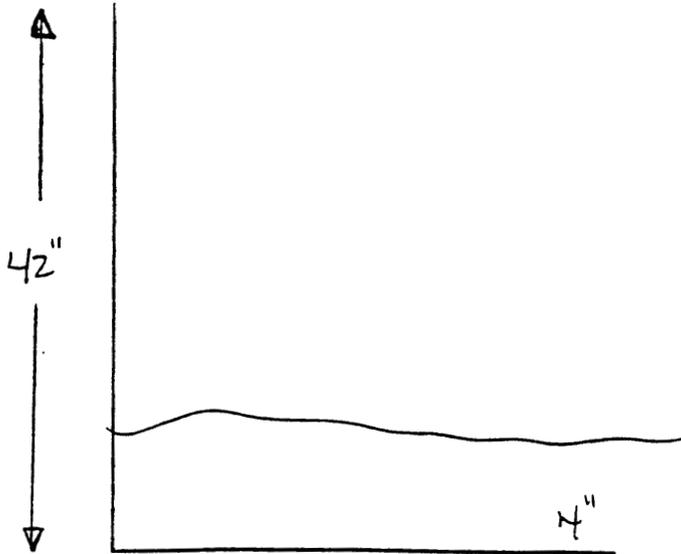
Structure # MH-72 (NEW NUMBER)

- NOTES: PC 1/21/00
- CONCRETE CONSTRUCTION
  - ON PAD, NEAR BOILER ROOMS.
  - STEEL PLATE COVER
  - 4" NORTH LINE OUT 3' DROPS INTO STRUCTURE 21' DC
  - 4" WEST LINE OUT 6' SOUTH PICKS UP FLOOR DE
- Rim Elevation. 585.52

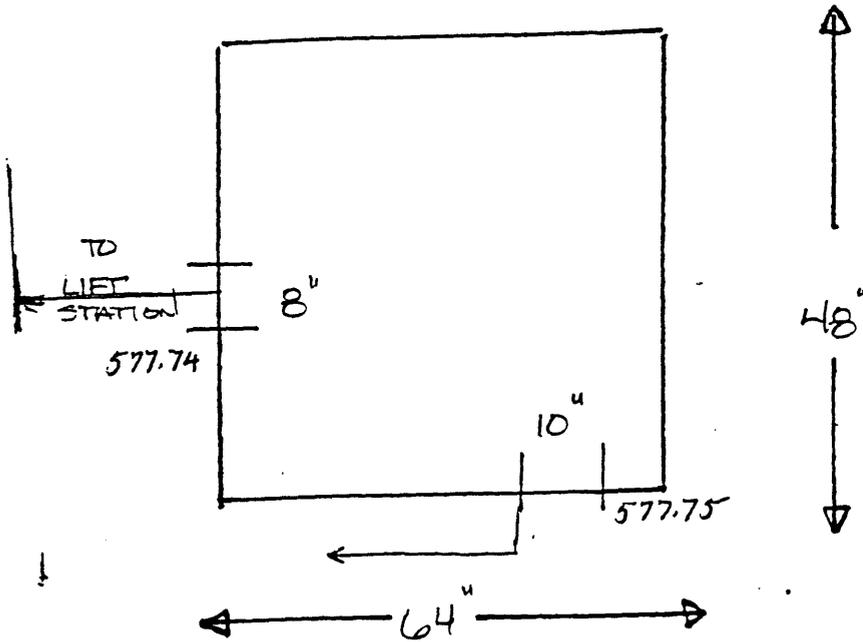
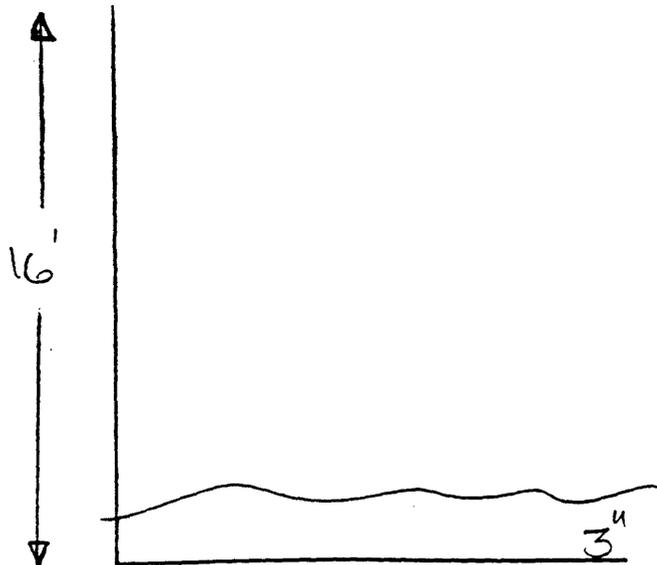
Structure # MH-74

Notes: BC 7/30/00  
formed concrete  
heavy product

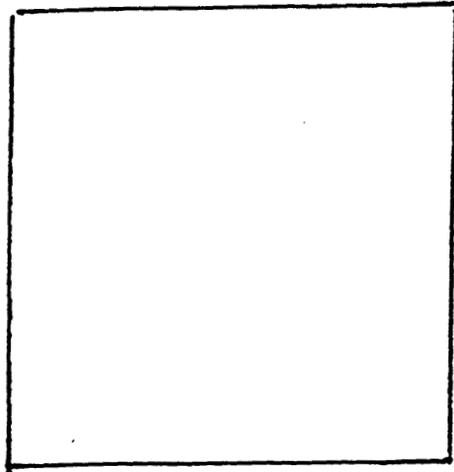
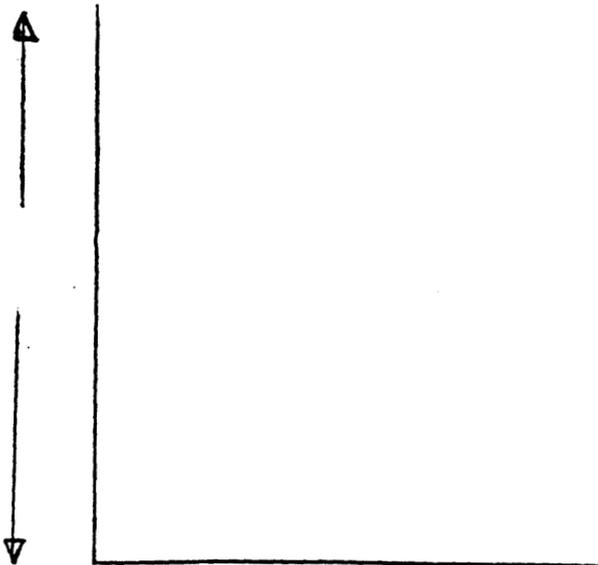
Structure # MH-76

Notes: BC 10/2/00  
- not accessible due to pit  
rack 6" from cover  
(4' x 10' x 1/2") notable to  
get equipment close to rim  
- stained on top

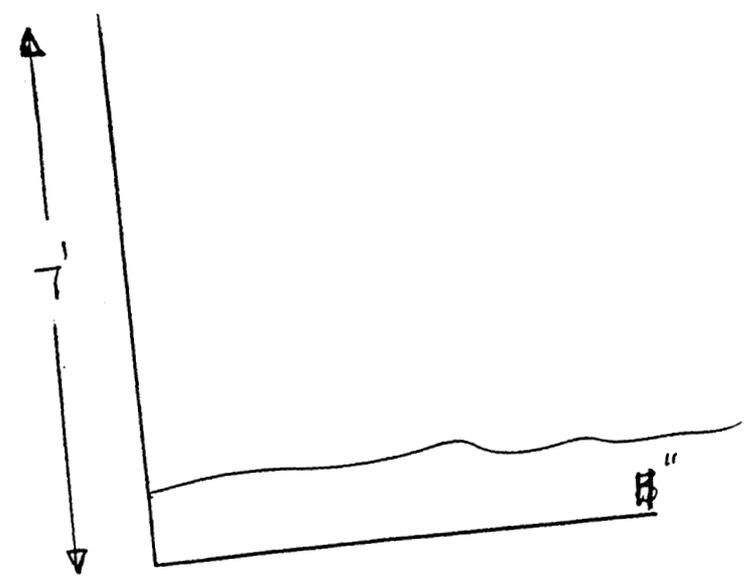
- Notes: 10/1/00
- Ruined structure
  - completely collapsed
  - result w/ back and curb blocks
  - NO INFORMATION

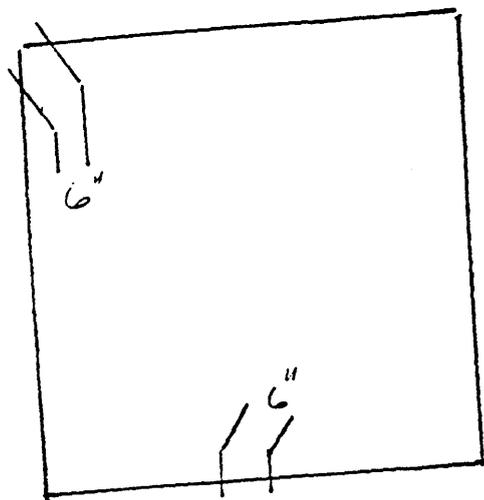
Structure # MH-72

- NOTES: BC 7/2/04
- CONCRETE CONSTRUCTION
- HEAVY OIL SLUDGE
- NOT ABLE TO SET
- LINES NOT ACCESSABLE TO DO READINGS
- STEEL PLATE COVER

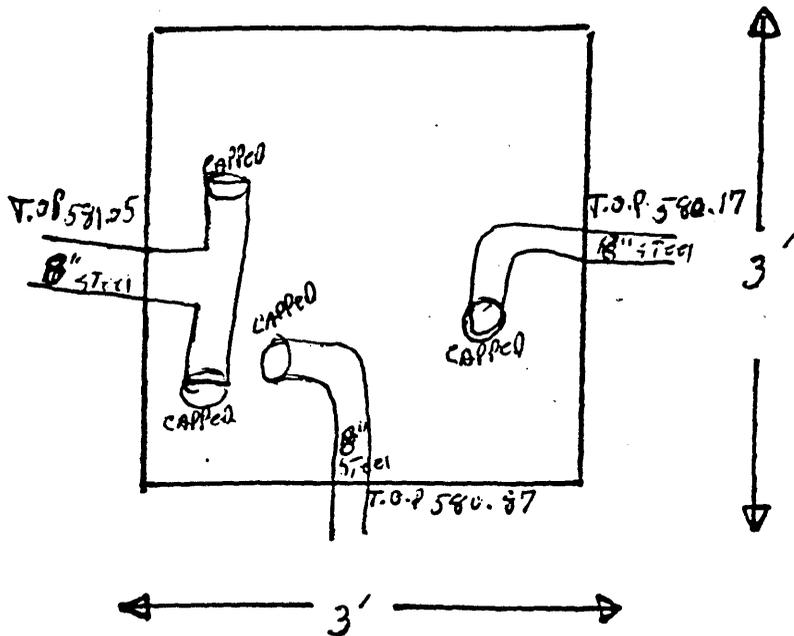
Structure # MH No # 85

All 8" steel pipes capped  
GOOD SHAPE.

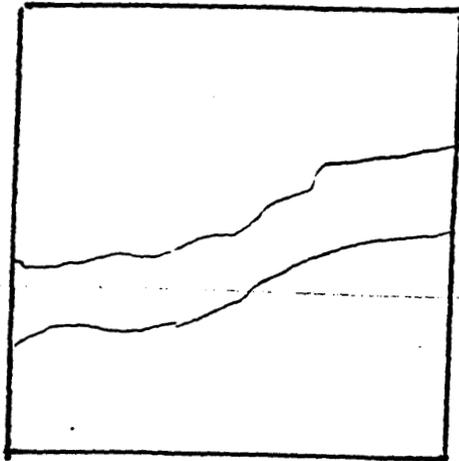
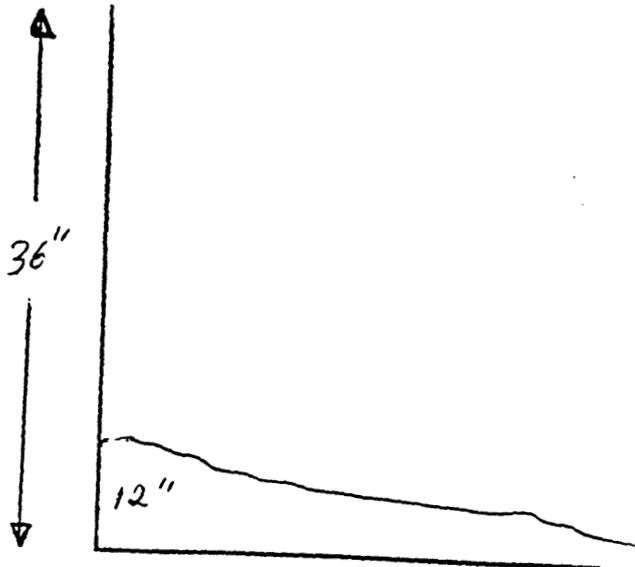
Structure # EMH 61

- CONCRETE CONSTRUCTION
- 2 WIRES PASS THRU STRUCTURE NORTH TO SOUTH.
- WIRES LOCATED APPROX. 20" BELOW RIM.

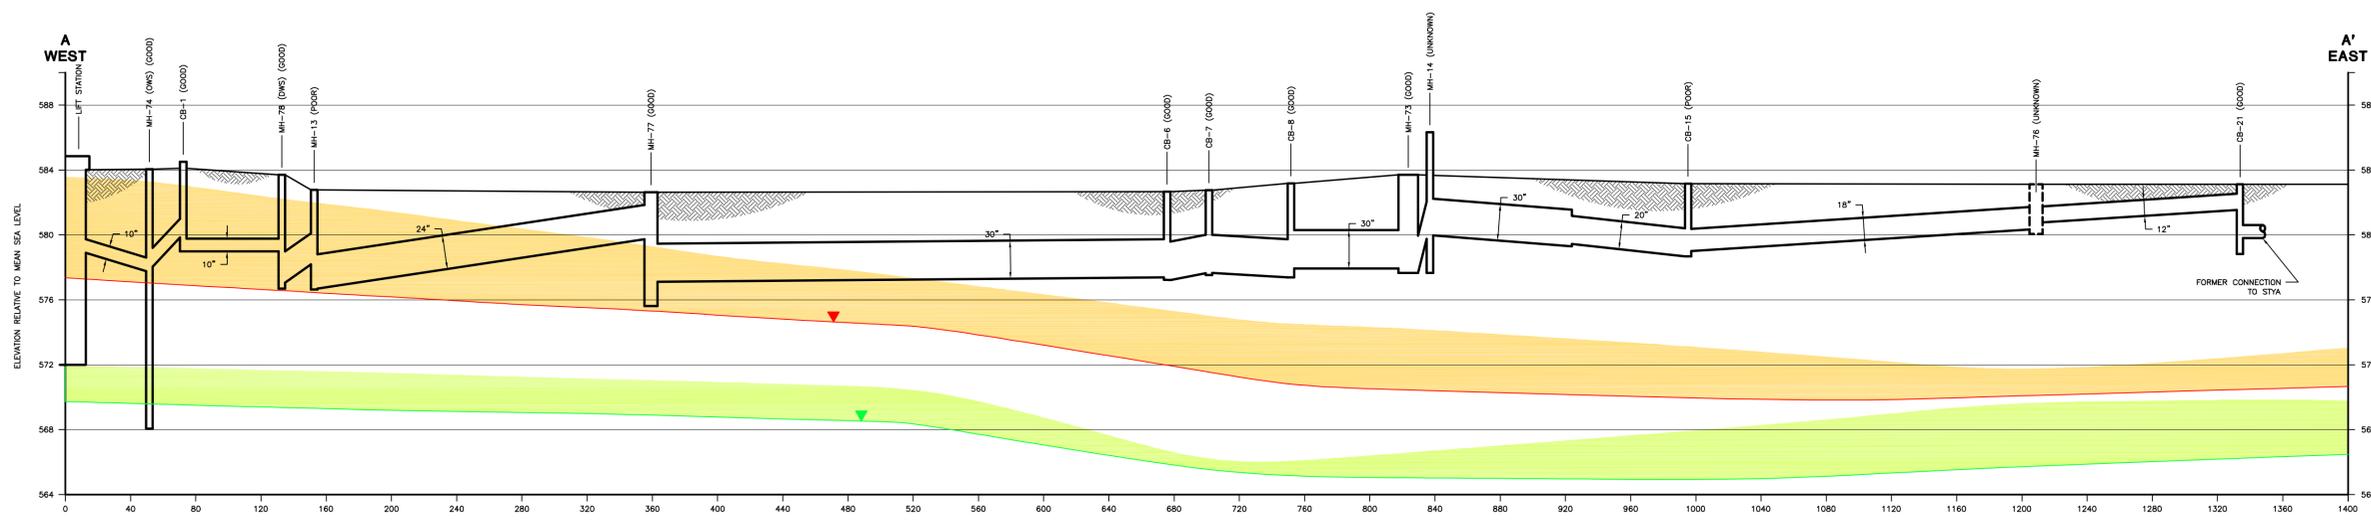
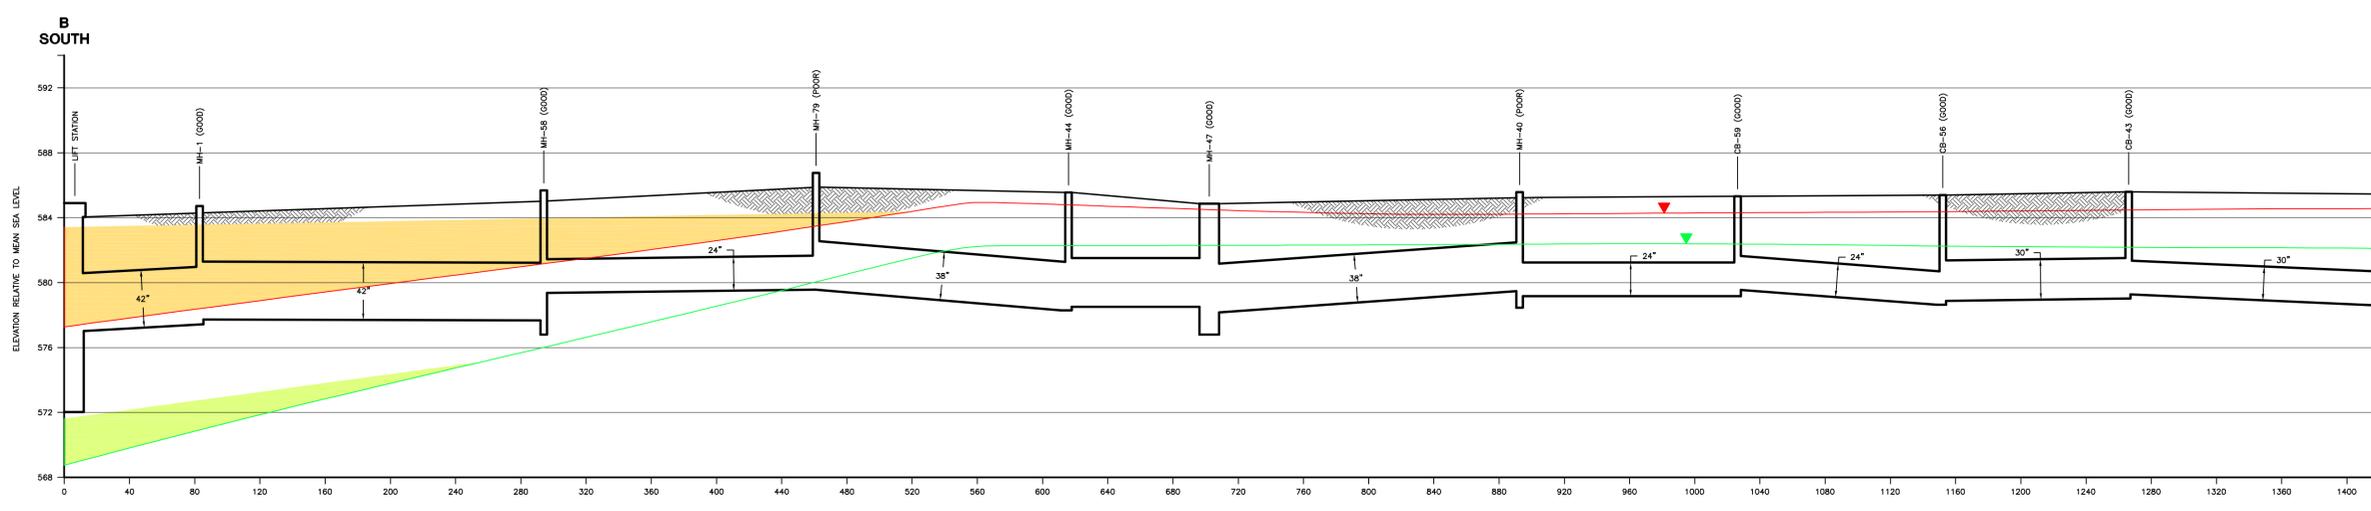
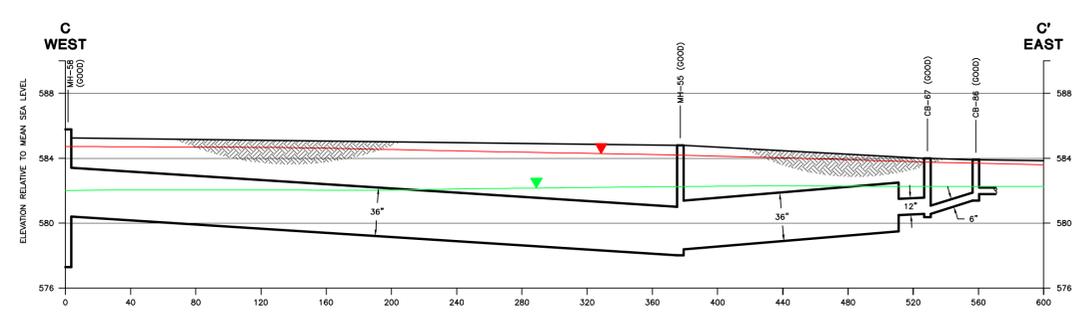
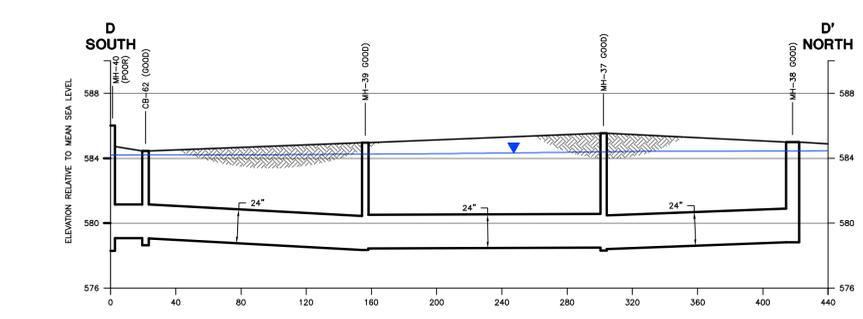
Profile A-A' demonstrates that there is limited potential for groundwater infiltration into the sewer system in most of the STYA and the southern portion of the FRA, except in the vicinity of lift station in the FRA, where there is potential for groundwater and separate-phase product infiltration during high groundwater conditions, depending upon the condition of the CB/MH. During low groundwater conditions, there is limited potential for separate-phase product infiltration into the sewer system in the vicinity of the lift station. The lower water table in the southern portion of the site is due to the combined influence of the natural gradient towards the river that exists under non-pumping conditions and the operation of the dual-phase recovery systems and the WPS.

Profile B-B' indicates that there is a potential for groundwater infiltration under low and high groundwater conditions throughout the areas represented by the profile, depending upon the condition of the CB/MH. Separate-phase product is present in the vicinity of lift station in the FRA, therefore, the potential exists for separate-phase product to enter the sewer system during high groundwater conditions, depending upon the condition of the CB/MH. During low groundwater conditions, there is limited potential for separate-phase product infiltration into the sewer system in the vicinity of the lift station.

Profile C-C' shows that the potential for groundwater infiltration exists throughout this portion of the Site during both high and low groundwater conditions.

Profile D-D' also indicates that the potential exists for groundwater infiltration into the sewers in this portion of the Site based on the groundwater table elevation data collected in January 2002 for MW-35.
