PUMP TEST REPORT

FORMER MOBIL SERVICE STATION 99-MST - 979 MAIN STREET (1001 MAIN STREET) BROWNFIELD CLEANUP PROGRAM SITE NO. C9915260

CITY OF BUFFALO, ERIE COUNTY, NEW YORK

September 2016

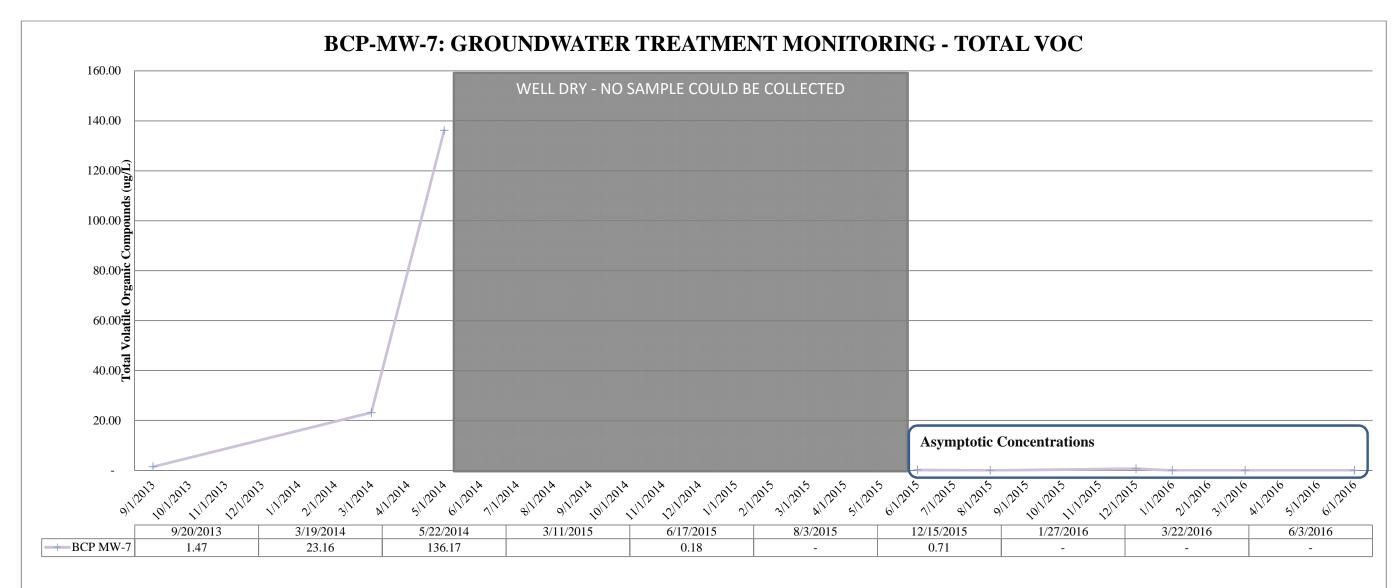
No groundwater sample was collected from this well on January 27, 2016. During the winter of 2016, C&S conducted a limited pump and treat to evaluate groundwater conditions by pumping from BCP-MW-3, 4, 5 and 6. In January 2016, samples were collected from these four wells only.
