January 18, 2023

Re: Revised Non-aqueous Phase Liquid Response
East End of Coal Yard Tunnel Conveyor Control and Junction Building
Riverview Innovation & Technology Campus, Inc.
Town of Tonawanda, New York

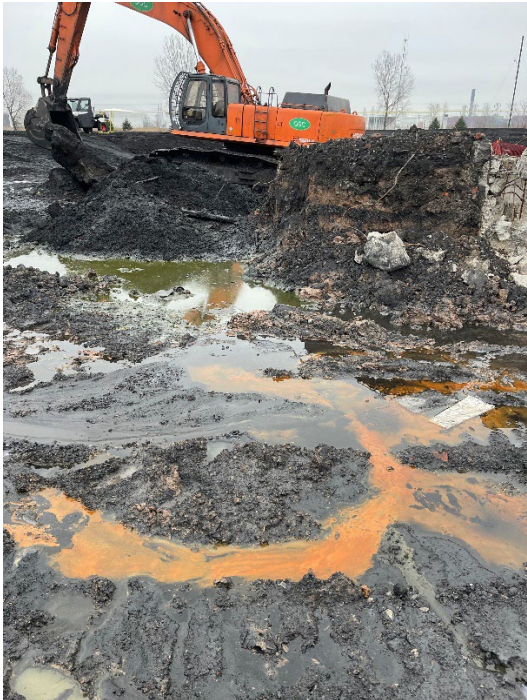
Direction Photo Taken: View looking southeast		
Description: Tar impacted fill removed from TP-CD-01		
Client Name: Riverview	Date of Site Visit: January 10, 2023	Project: Riverview
Photo No. 16
