Advanced Cleanup Technologies, Inc.

PHASE I / PHASE II ENVIRONMENTAL SITE ASSESSMENT

161 Sweet Hollow Road
Old Bethpage, New York

September 16, 1994

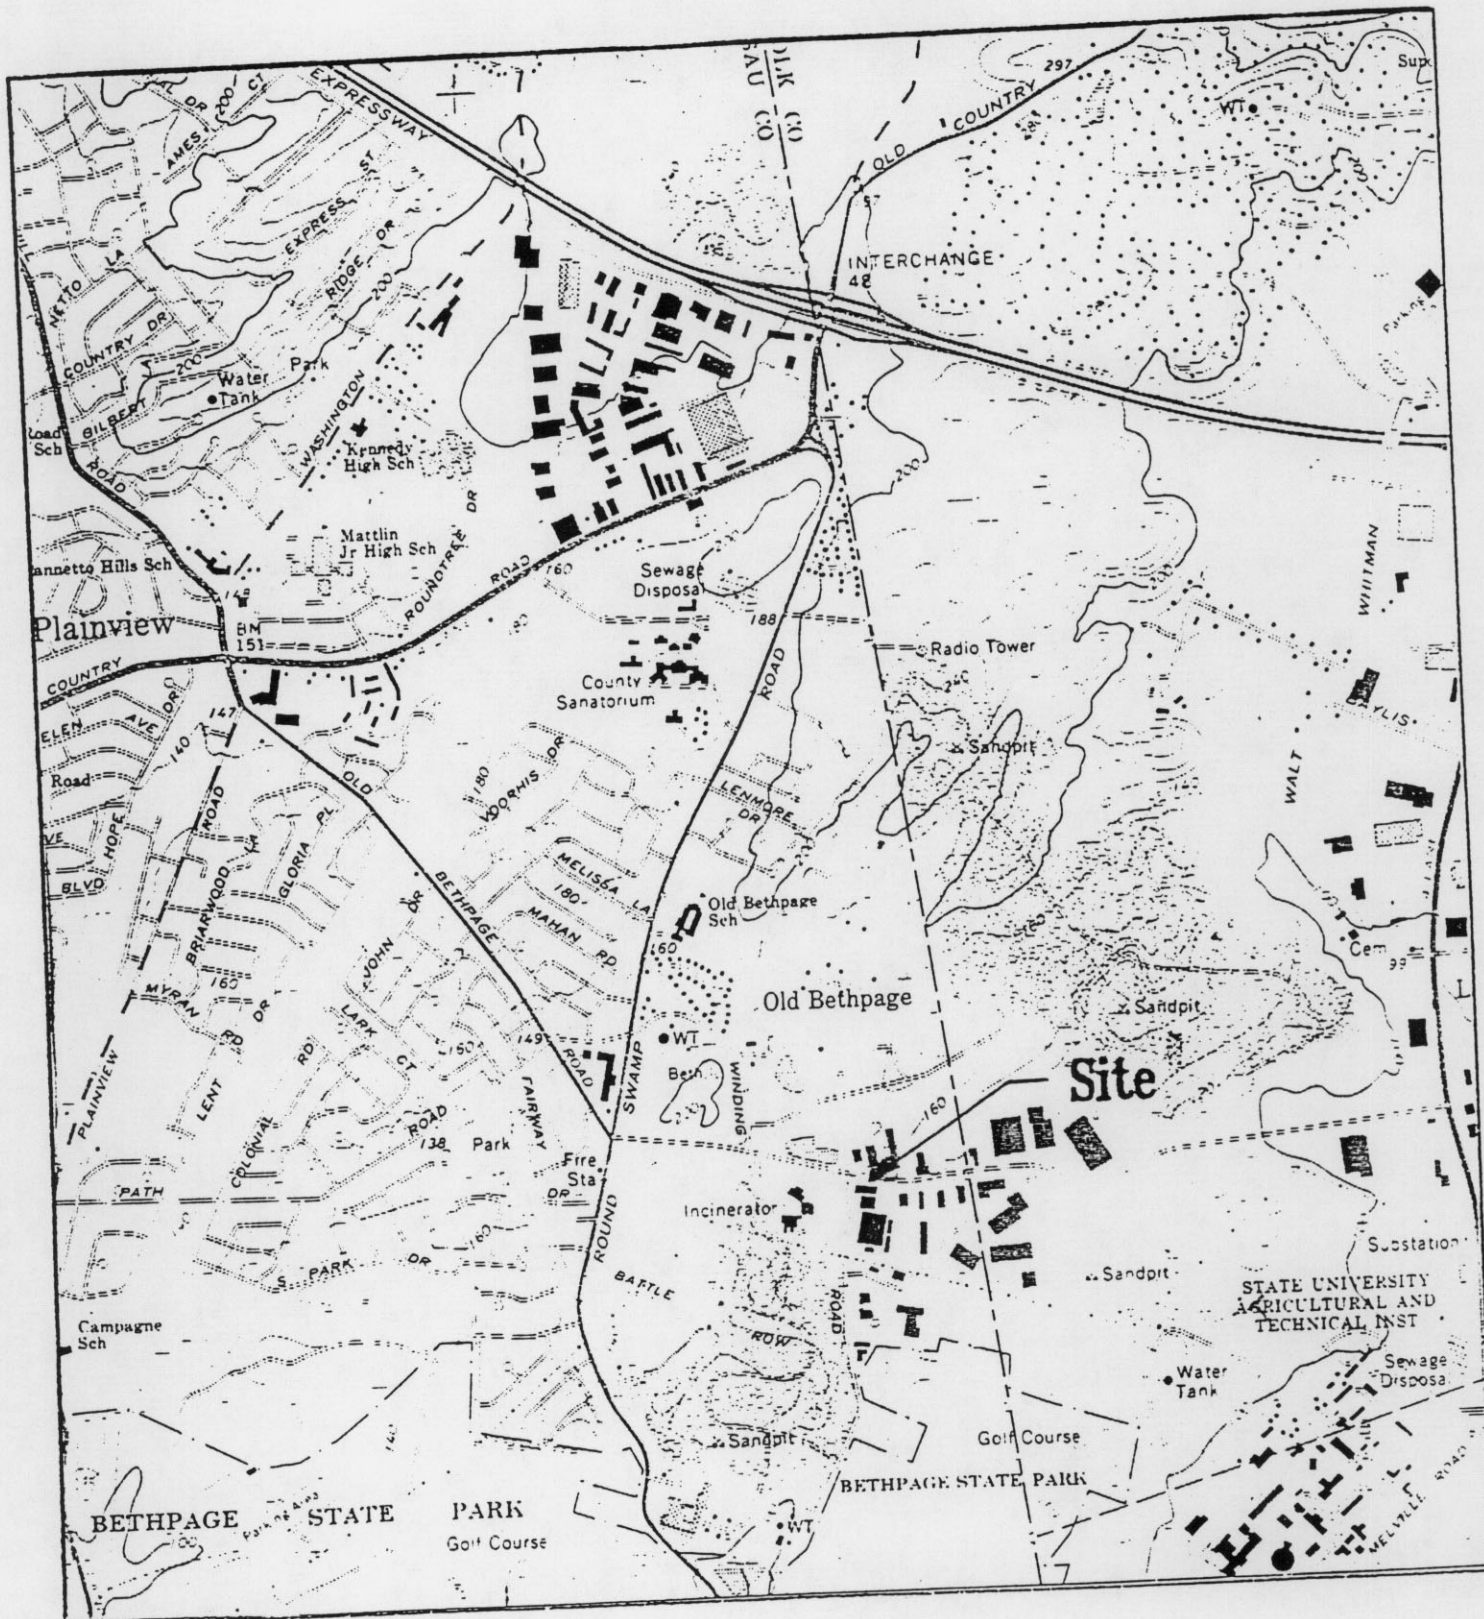
Contour interval is 20 Feet.

From USGS 7.5 min. Topographic map of New York, Huntington Quadrangle

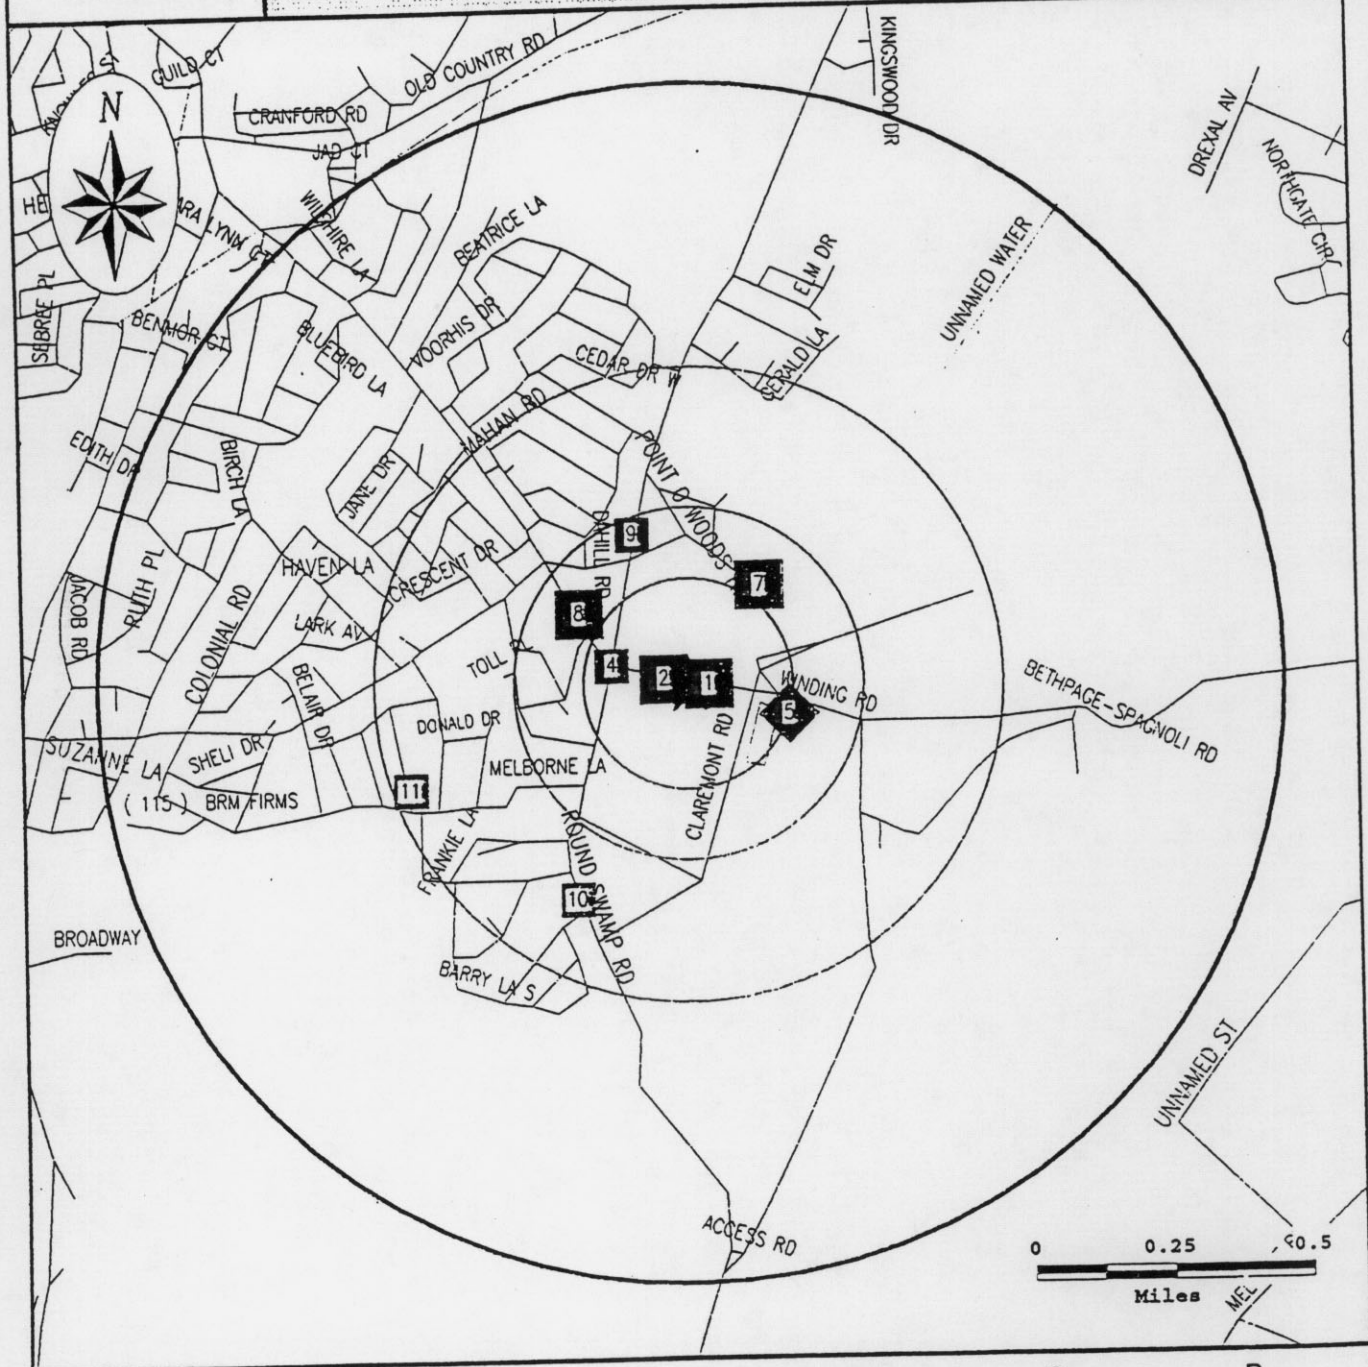
Map of Risk Sites within One Mile

The CERCLIS and NPL databases are maintained by the United States Environmental Protection Agency (USEPA) and contain records for each of the hazardous waste facilities nominated or chosen for the NPL. The CERCLIS database was searched for sites within a radius of ½-mile from the subject property. Three sites were found in the database within ½ mile of the subject property. These sites are shown in Figure 3 in the one mile search, Figure 4 in the ¼ mile search and Figure 5 in the Risk Radii diagram.

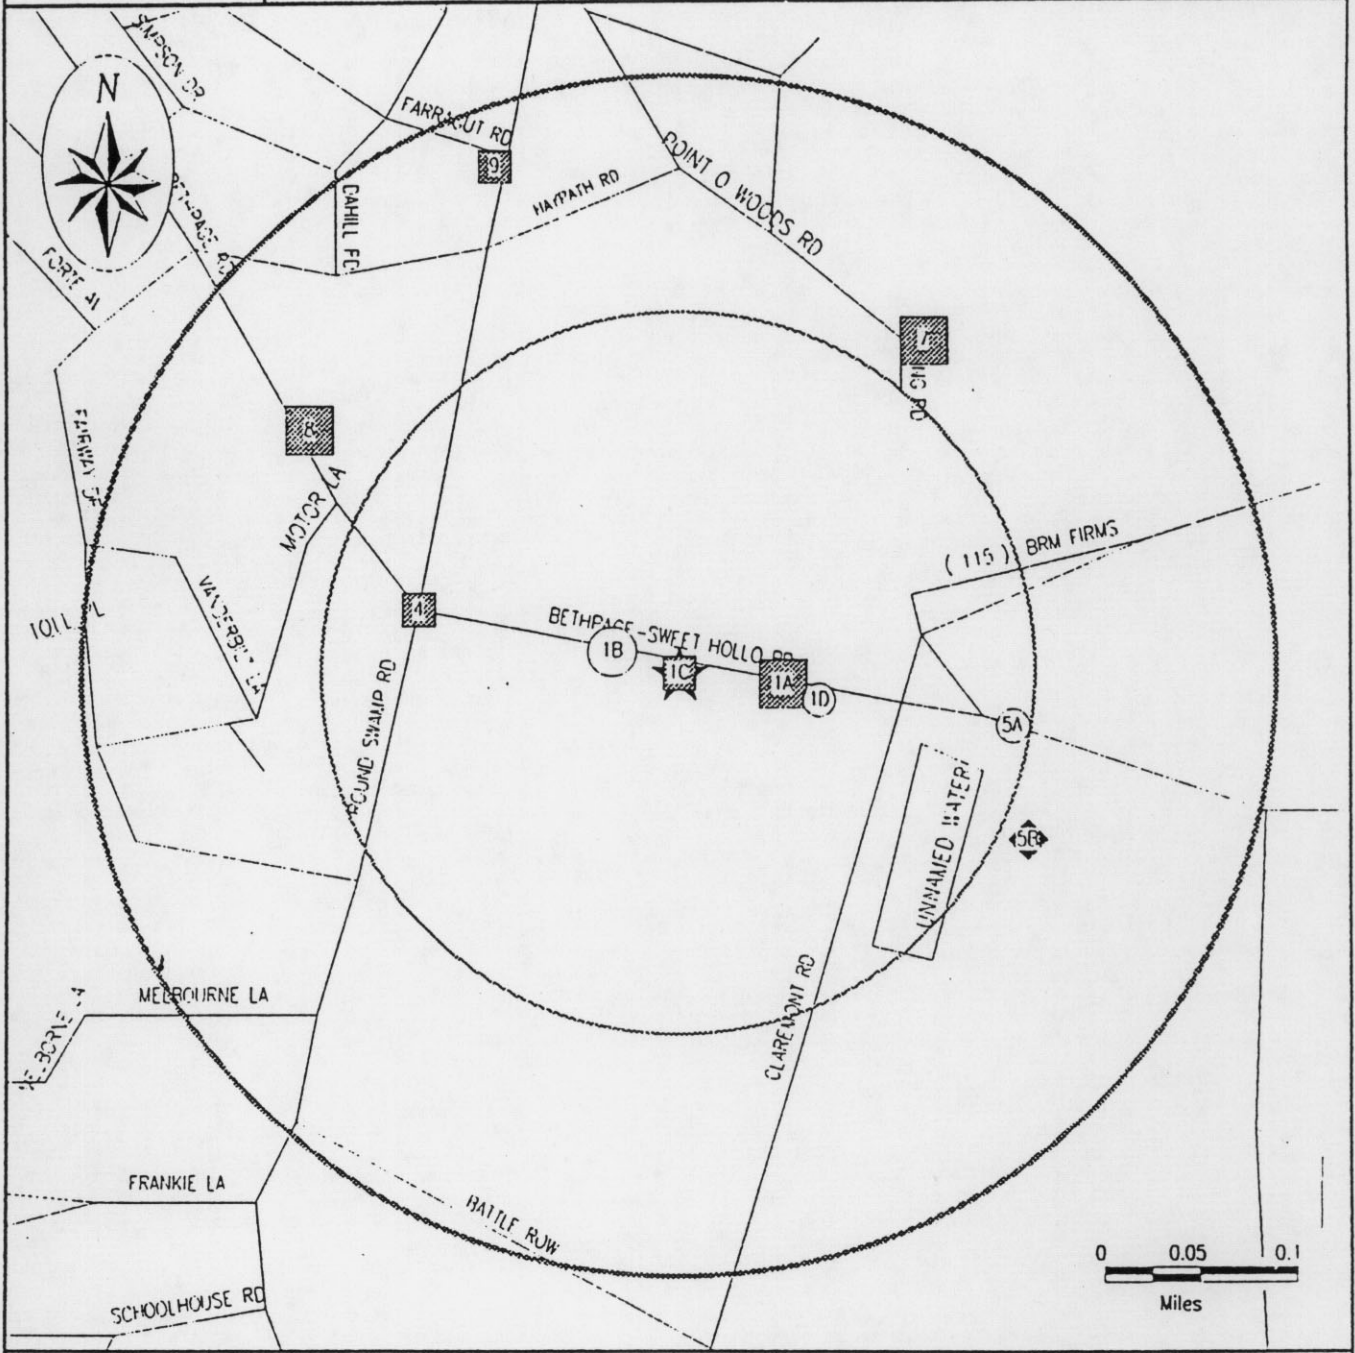
Map of Risk Sites within Quarter Mile

The subject property was listed in the RCRIS Generators database as a Large Generator. A Large Generator generates at least 1,000 kilograms of non-acutely hazardous waste per month or 1 kilogram of acutely hazardous waste per month. The subject property has an USEPA ID# NYD981488026. Four RCRIS Large Generators and 3 RCRIS Small Generators were found to be within ¼-mile of the subject property. Figure 4 provides a diagram showing the proximity of the RCRIS sites in reference to the subject property.

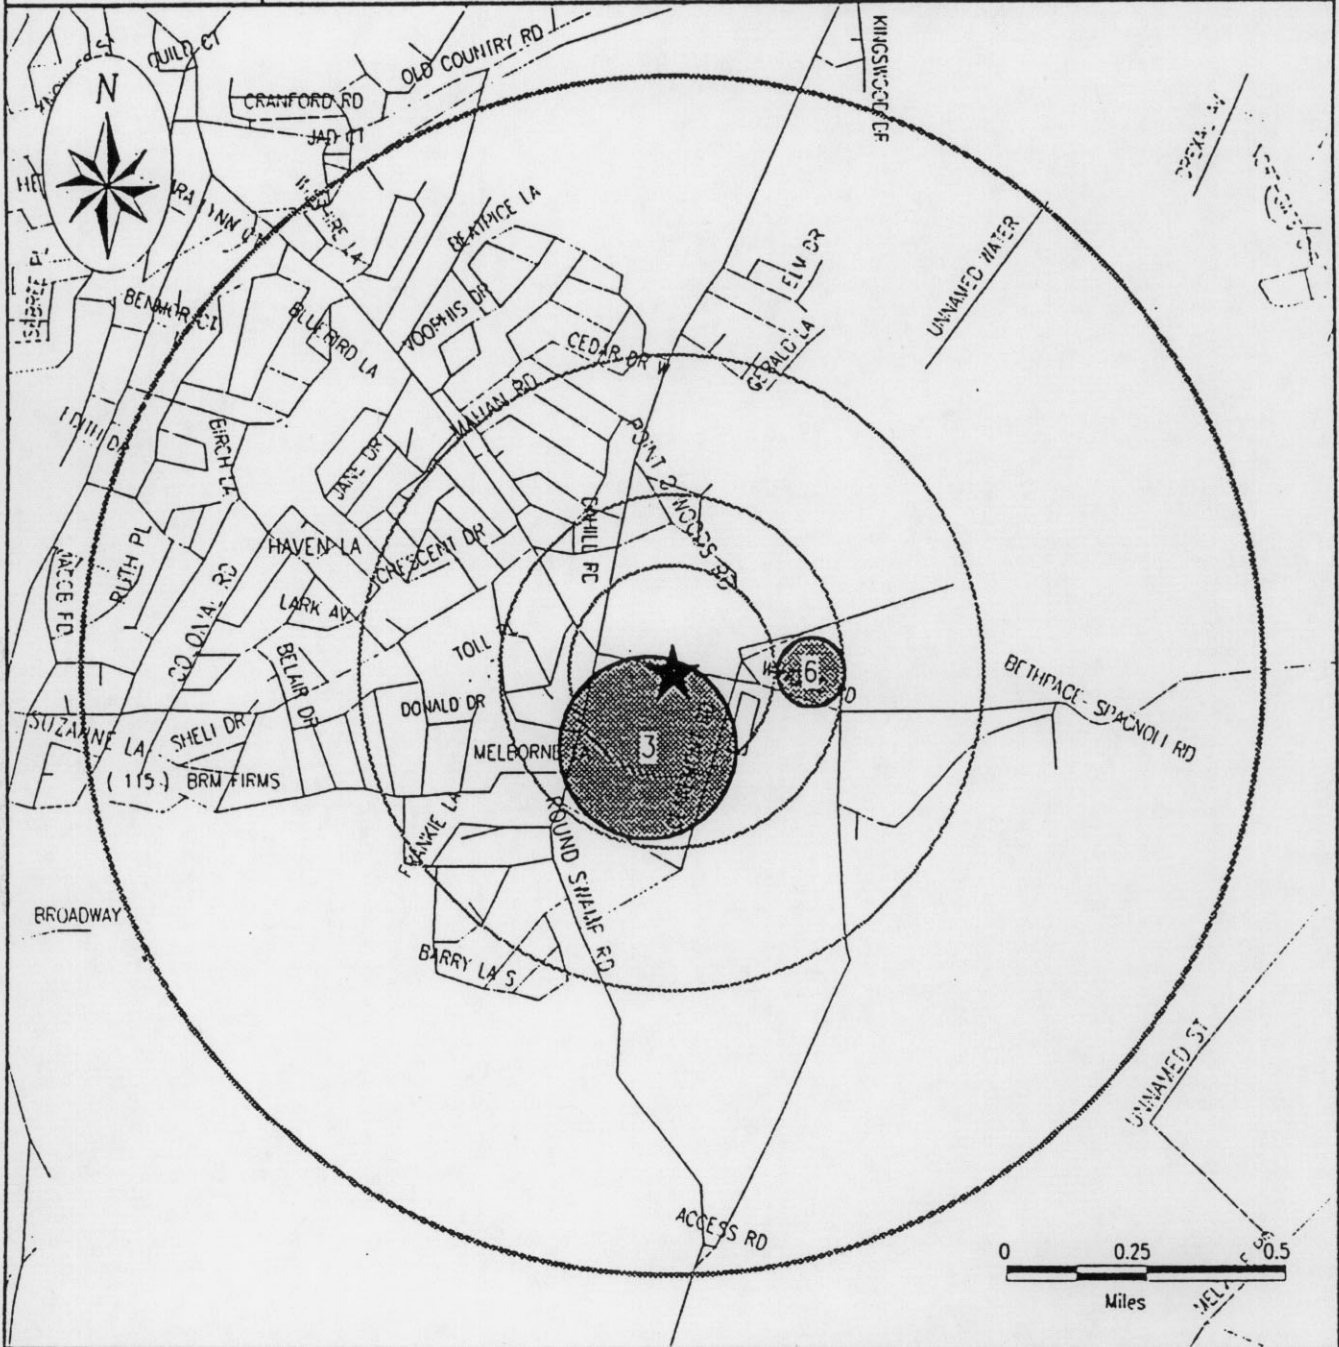
Map of Large Risk Sites within One Mile with Boundaries Mapped as Radii

These sites are plotted as radii to represent the approximate size of the risk properties, based on the furthest boundary of each property from its center.

The northeast boundary of the Old Bethpage Landfill is located immediately southwest of the subject property. The 65 acre area received municipal wastes and industrial wastes such as toluene, urethane, waste alcohol and PCBs. During a review of the USEPA public file at the Bethpage Public Library, it was learned that the glacial aquifer beneath the site is approximately 70 to 75 feet below ground surface and flows in a south-southeast direction. This ground water flow direction would place the subject property upgradient and crossgradient of the landfill. As Figure 5 shows, the risk radii of the Old Bethpage Landfill encompasses the subject property.
