**Residential Backyards 57-40, 57-42, and 57-48
57th Drive**

QUEENS, NEW YORK

Off-site Final Engineering Report

MAY 2009

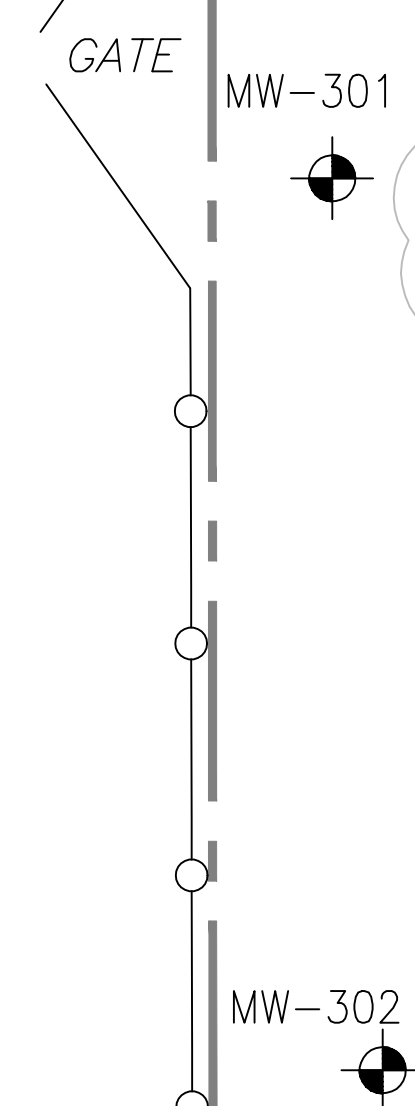
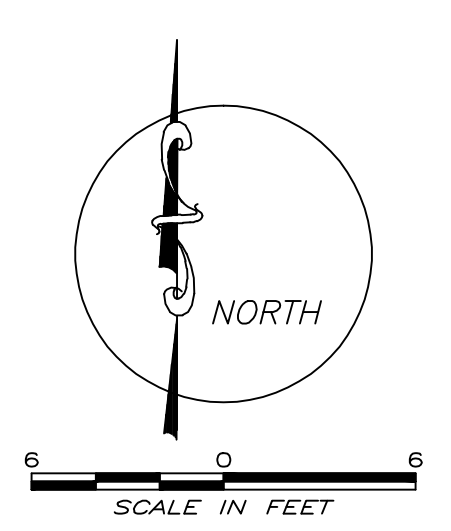
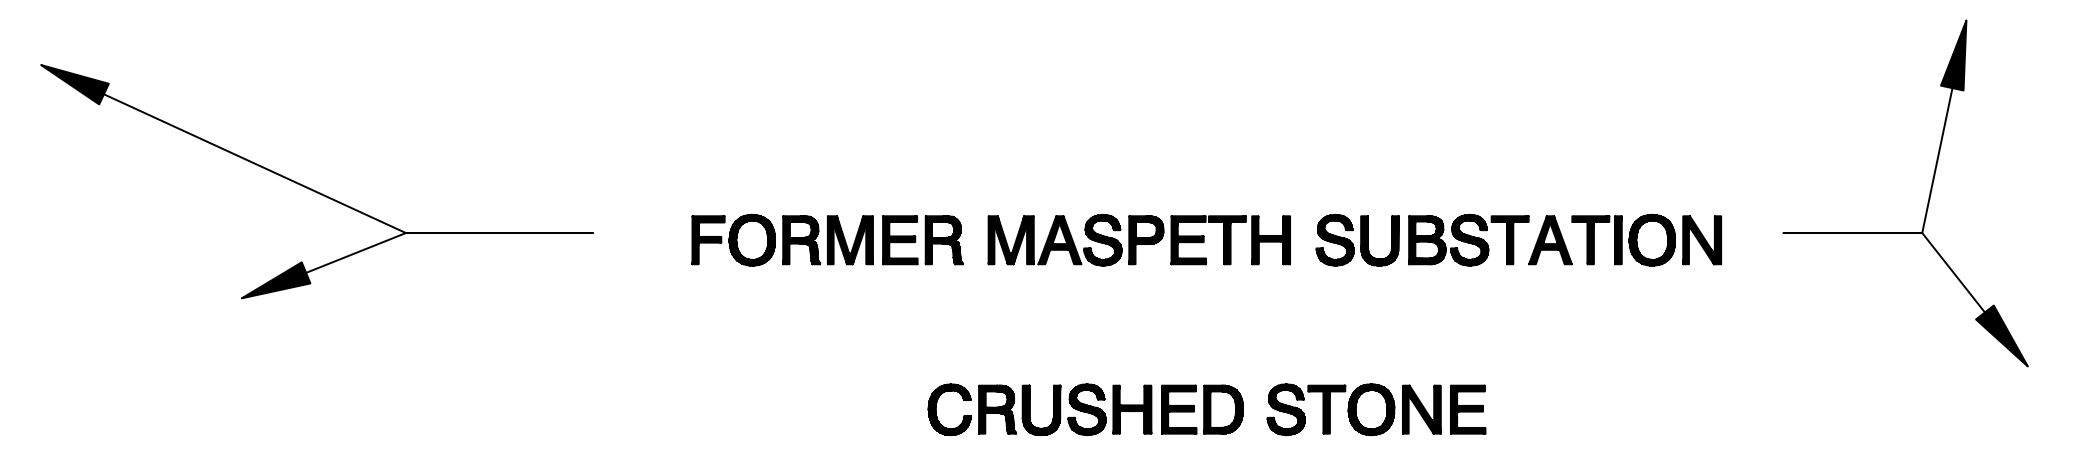
Analytical soil data generated during the remedial investigation noted above are presented in Tables 1-1 to 1-3. The soil data indicated that elevated concentrations of polychlorinated biphenyls (PCBs), specifically PCB Aroclor-1260, were present in the shallow subsurface soils (from ground surface to two-feet below ground surface) in the backyards of three residential properties located at 57-40, 57-42, and 57-48 57th Drive and underneath the concrete fence footer behind 57-42 57th Drive as shown on Figure 5.

MA-GP-62,64		
SAMPLE DEPTH (ft bgs)	CONCENTRATION (ppm)	NYSDEC RSCO (ppm)
6	334	1.0

MA-GP-67,64		
SAMPLE DEPTH (ft bgs)	CONCENTRATION (ppm)	NYSDEC RSCO (ppm)
5	762	1.0
