RE: Interim Remedial Measure Summary Report
Dalewood I Shopping Plaza
357 North Central Avenue, Hartsdale, NY
VCP Site V00457-3

INDOOR AREA INVESTIGATION AND INTERIM REMEDIAL MEASURE SUMMARY REPORT

**Dalewood I Shopping Plaza
357 North Central Avenue
Hartsdale, NY**

September 2003

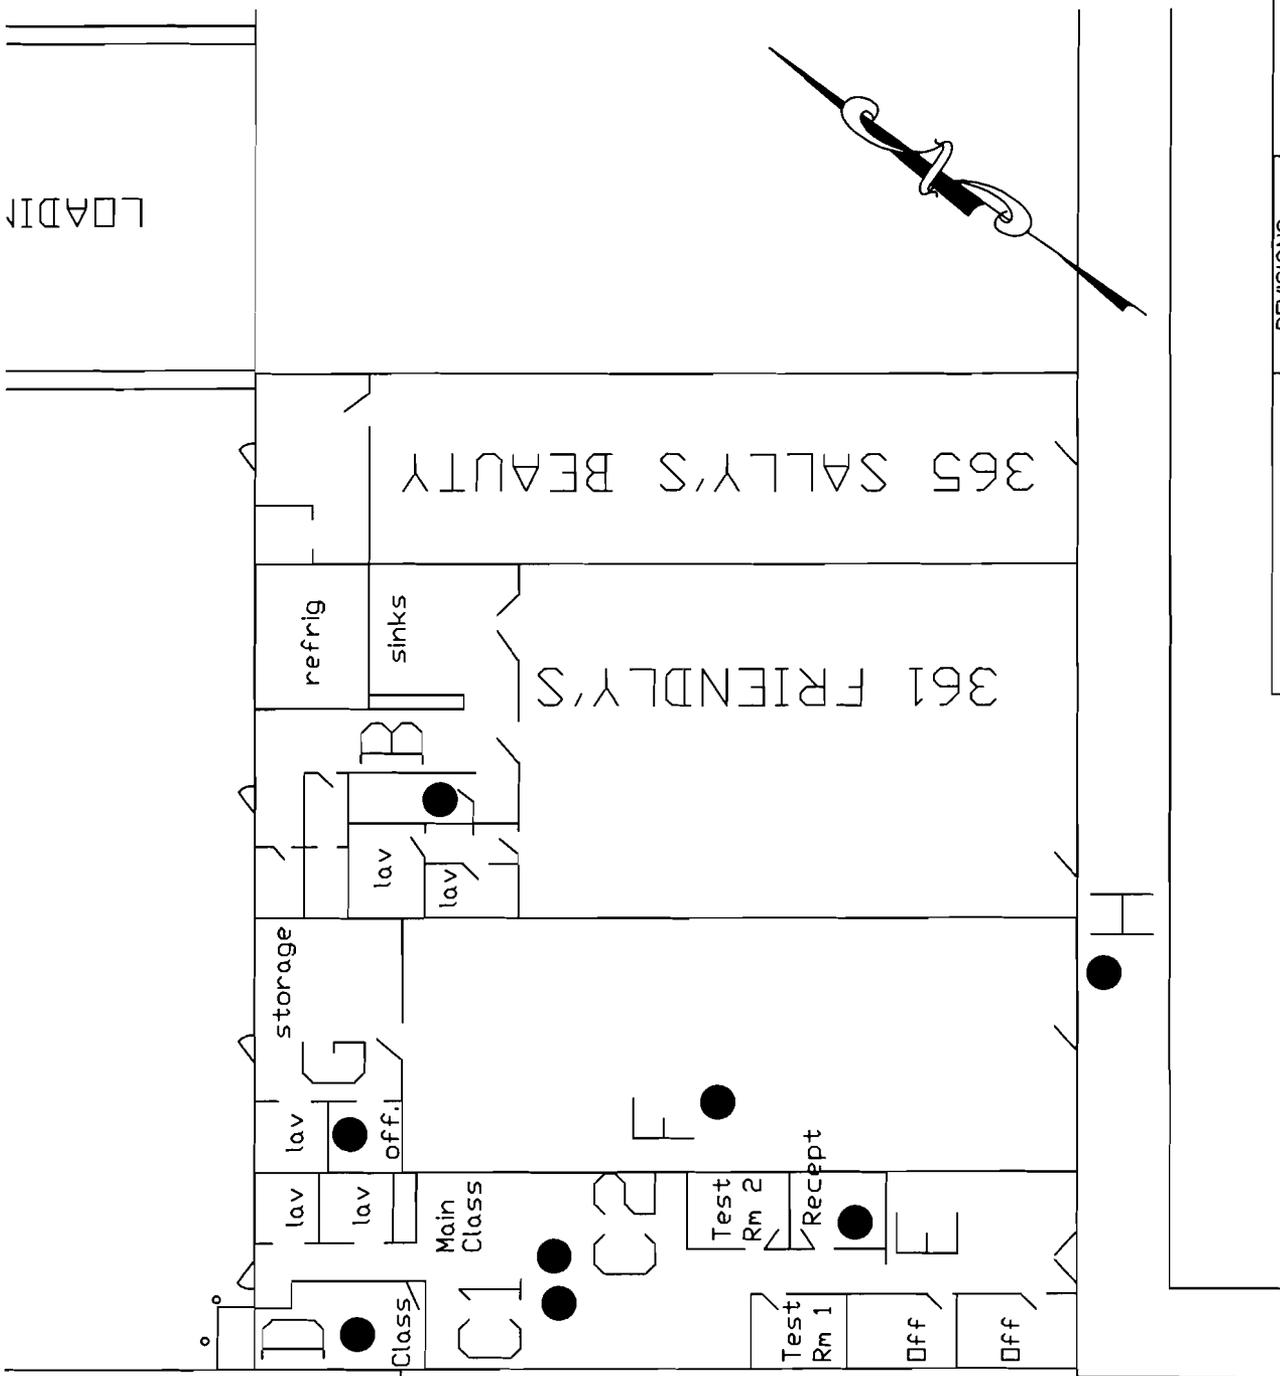
FIGURE 2—DALEWOOD PLAZA
INDOOR AIR SAMPLING LOCATIONS

As the results for most of the samples collected from within Unit 357 were over the NYSDOH guideline, an initial response was initiated and consisted of repair of the tenant space heating system and proper adjustment of the fresh air intake. Subsequently, Kroll field staff collected additional air samples from units 355, 357, and 359 on March 5, 2003 utilizing Summa canisters. The results of laboratory analysis for these samples ranged from 0.0026 to 0.0778 ppmv of PCE (see Table 1). Three of the samples collected from within unit 357 remained above the NYSDOH guideline.

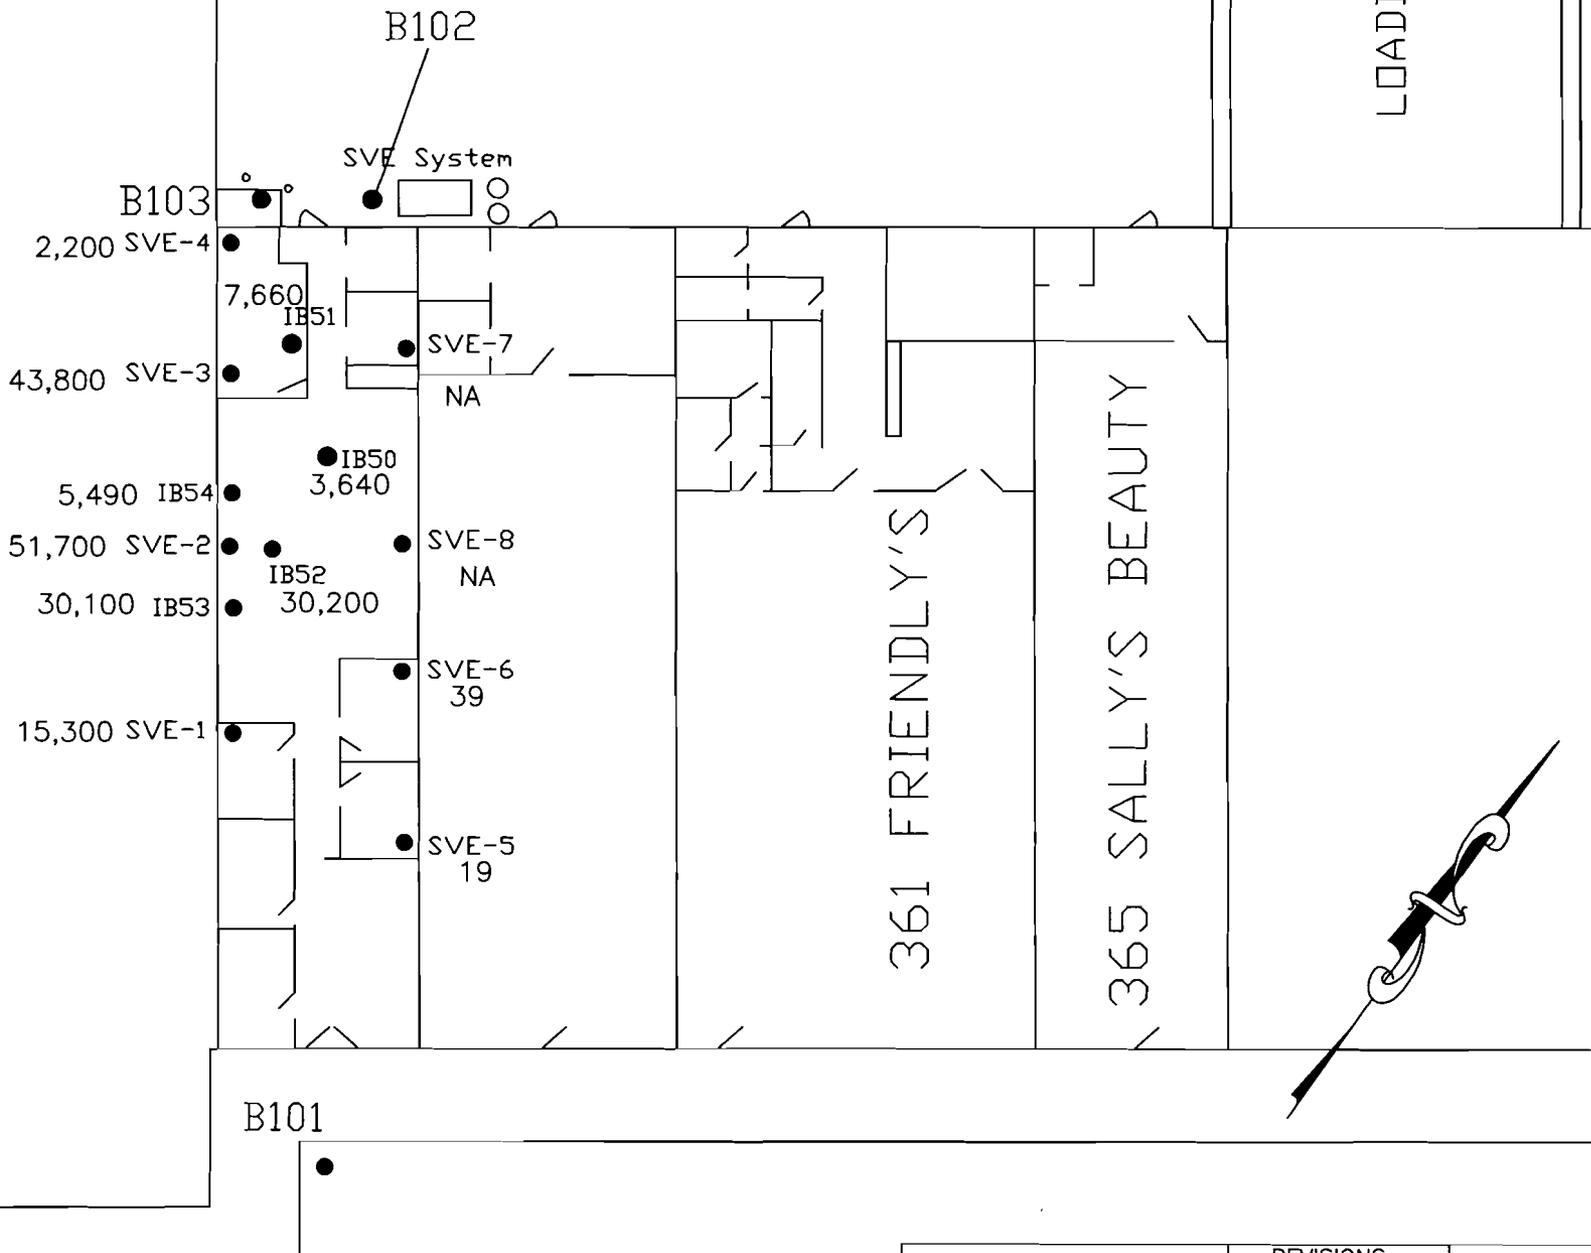
FIGURE 4 – DALEWOOD PLAZA
SUBFLOOR SOIL DATA

On March 13, 2003 a small hole (3 inches by 3 inches) was created in the sheetrock wall at the floor level in the area of the elevated readings to examine the interior wall/floor seam. Expansion joint material was observed between the concrete floor and concrete block wall. A sample of the expansion joint material was collected through the hole and appeared to be a typical heavy cardboard and/or fiber like material. The sample was sent to the laboratory for analysis. PCE was reported in the sample at a concentration of 29,500 ug/kg. A summary of the laboratory results is provided in Table 5.

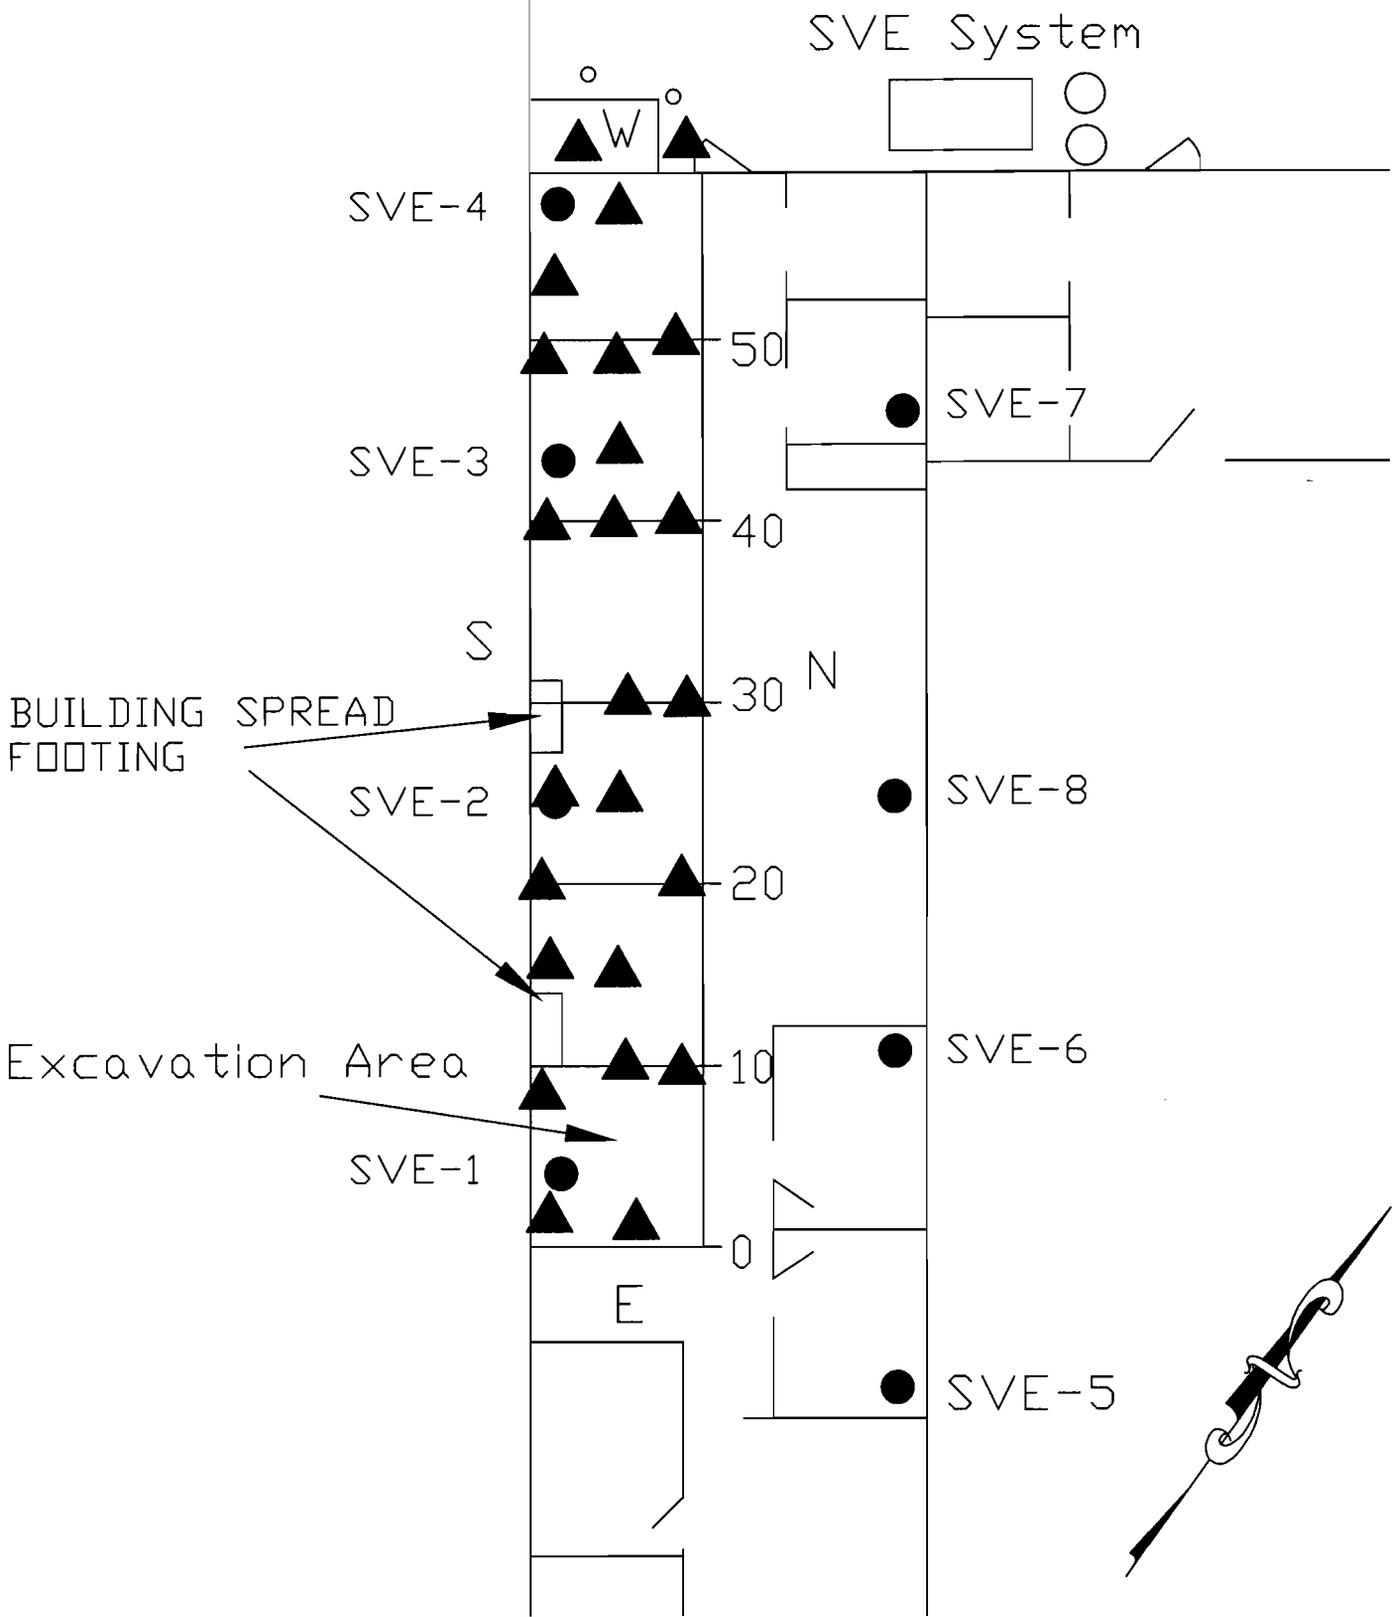
FIGURE 6 DALEWOOD PLAZA
 POST EXCAVATION
 SAMPLE LOCATIONS 5/22/03

The excavation bottom was field screened and exhibited elevated readings. Additional excavation of the bottom was completed that extended the full grid area down to 5' 9" below grade. Further excavation was completed between Grids #15 to #35. Excavation was completed in this area to a depth of 6' 2" below grade. As this depth was approximately one foot below the bottom of the wall footings, the area adjacent to the footings was sloped down into the excavation. The soil at this depth was moist to saturated, however groundwater was not entering the excavation. A six inch diameter hole was completed by hand in the middle of the excavation area and groundwater was encountered at 6' 5" below grade.
