**INTERIM REMEDIAL MEASURE
CONSTRUCTION COMPLETION REPORT
EAST WALL PORTION OF THE WASTEBED B/
HARBOR BROOK IRM
County of Onondaga, New York**

Honeywell

PARSONS

MAY 2014

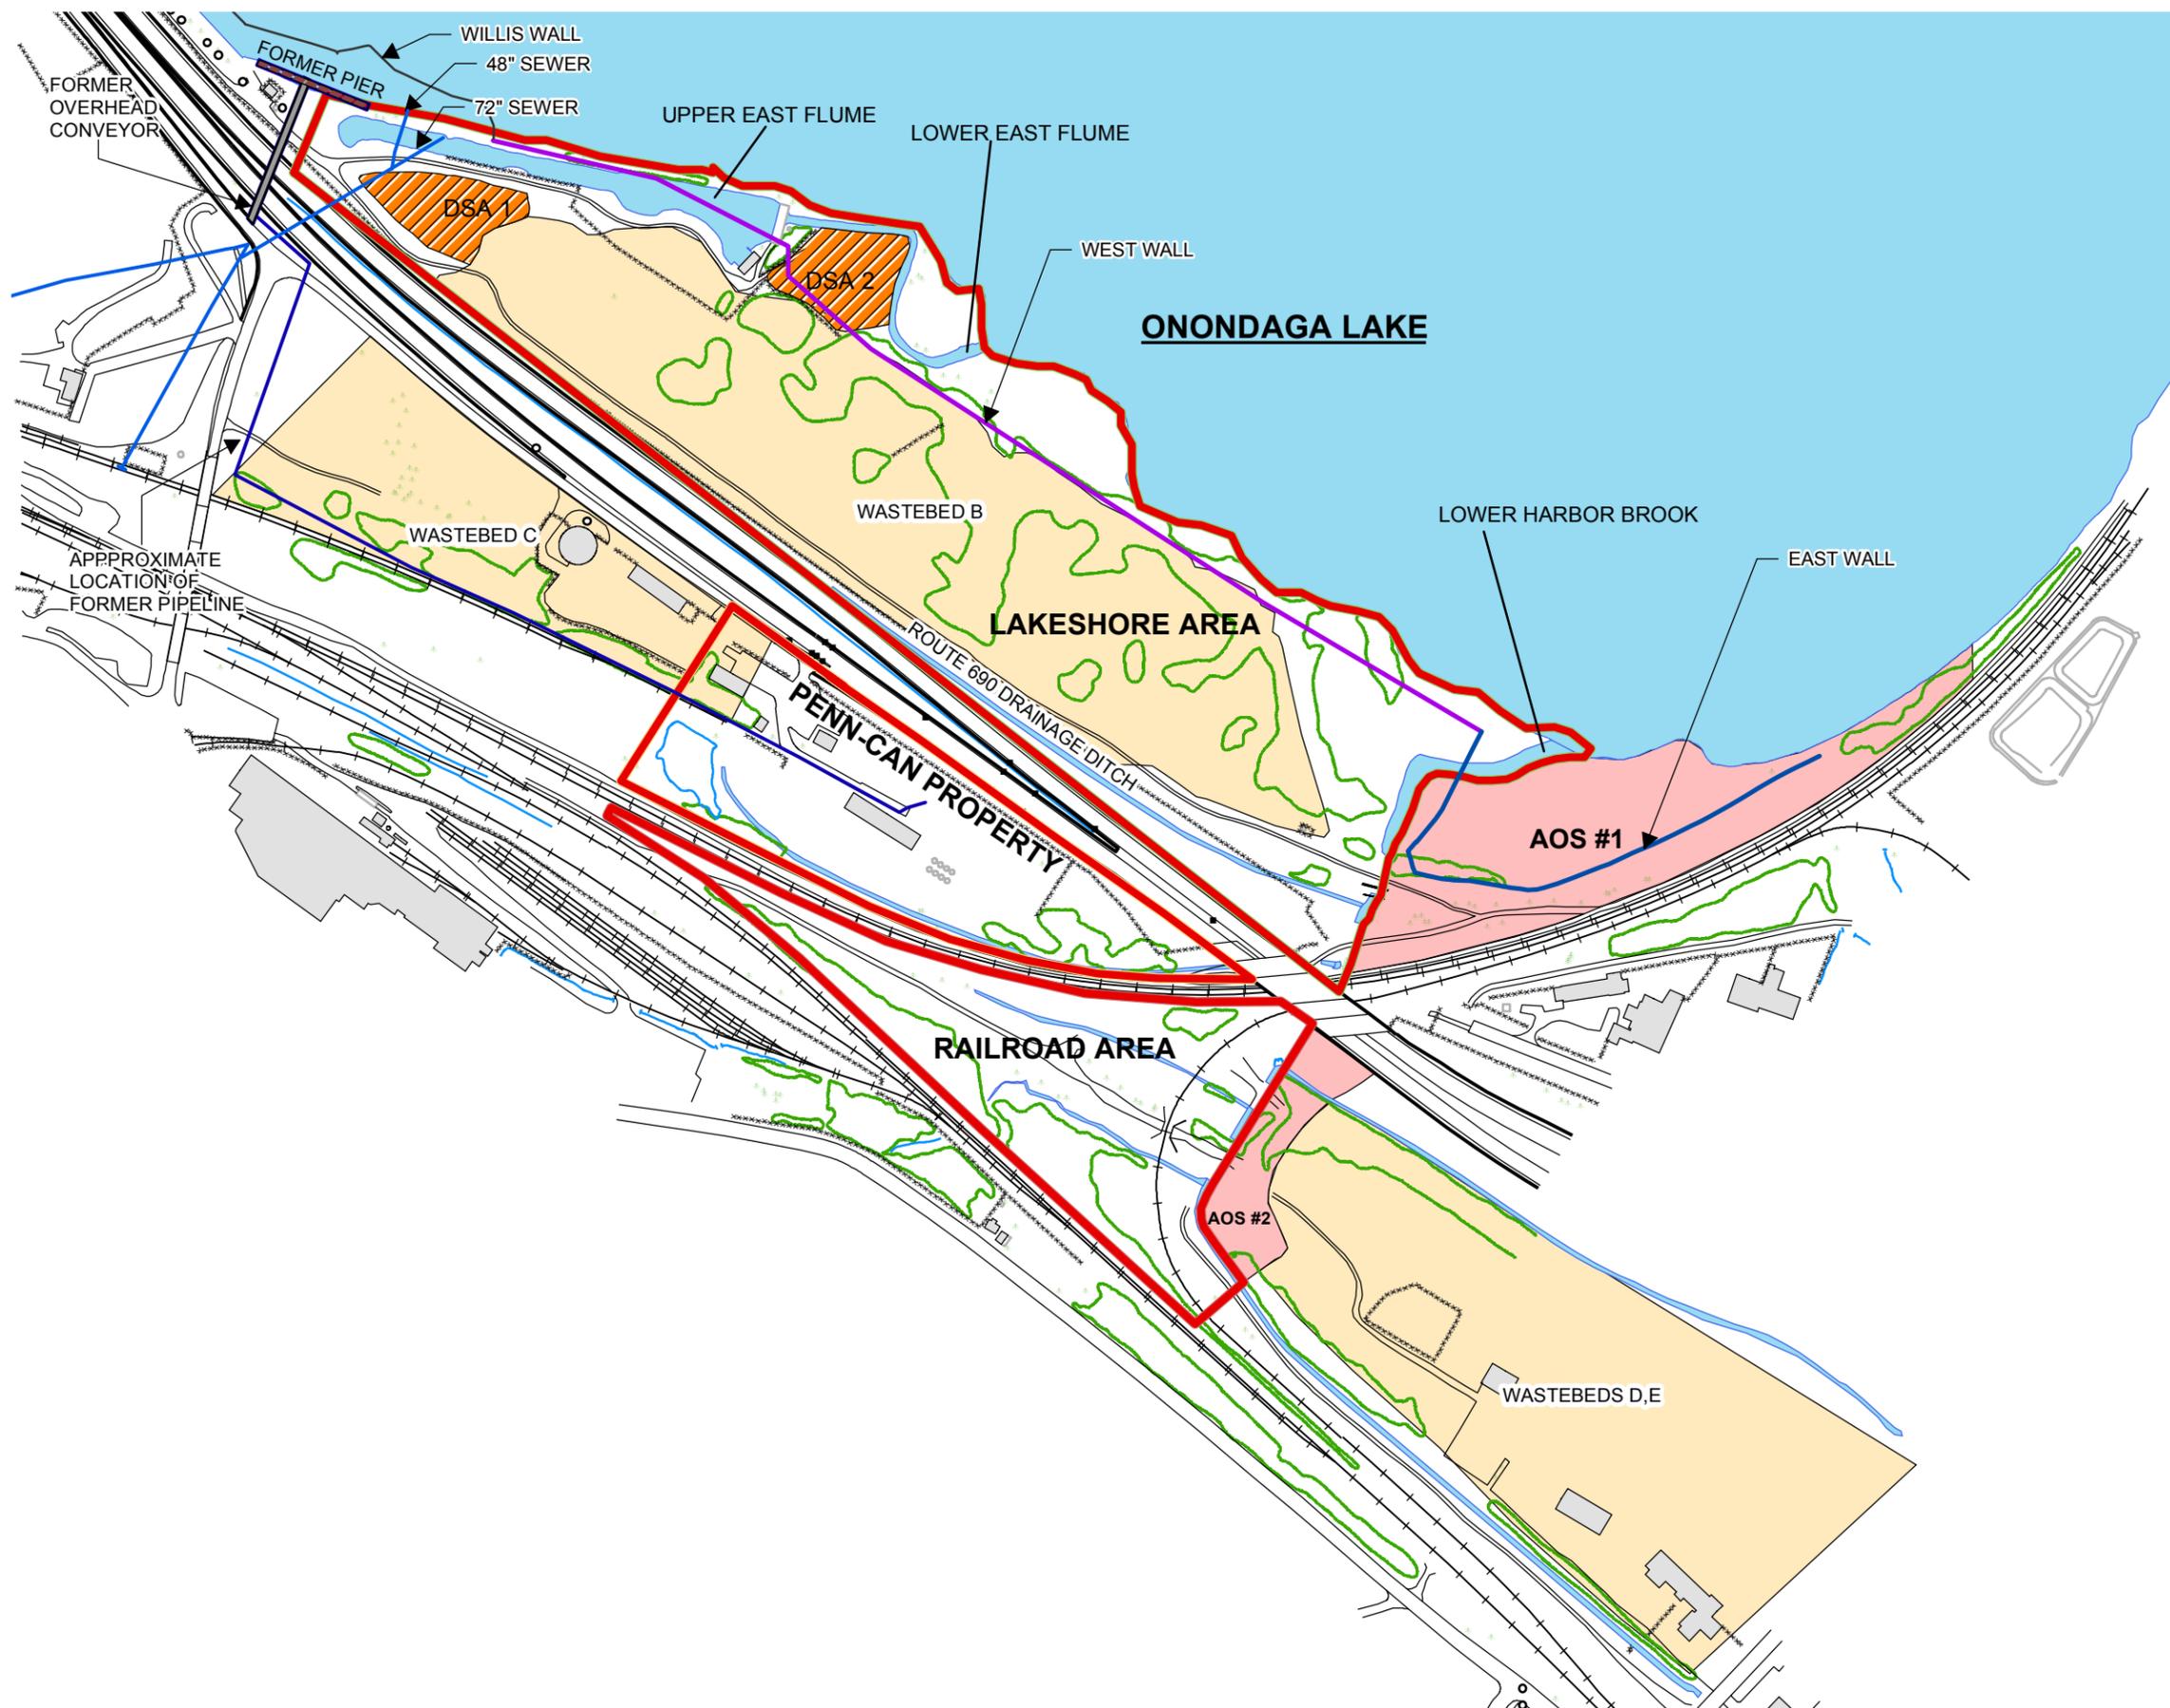
FIGURE 1.1

- Figure 1.1 Site Plan

The East Wall site is situated at the east end of the Lakeshore Area and in AOS #1. It is bounded by Onondaga Lake to the north, I-690 and railroad tracks to the south, railroad tracks to the east, and the Lakeshore Area to the west (see Figure 1.1). The site boundaries are detailed in the land title survey provided in Appendix A. This Construction Completion Report (CCR) addresses the East Wall which is a continuation of the work performed under the WBB/HB IRM (i.e., Willis/Semet and West Wall projects).
