Interim Remedial Measure Decision Document

**Empire Electric Site
Brooklyn, Kings County, New York
Site No. 224015
September 2012**

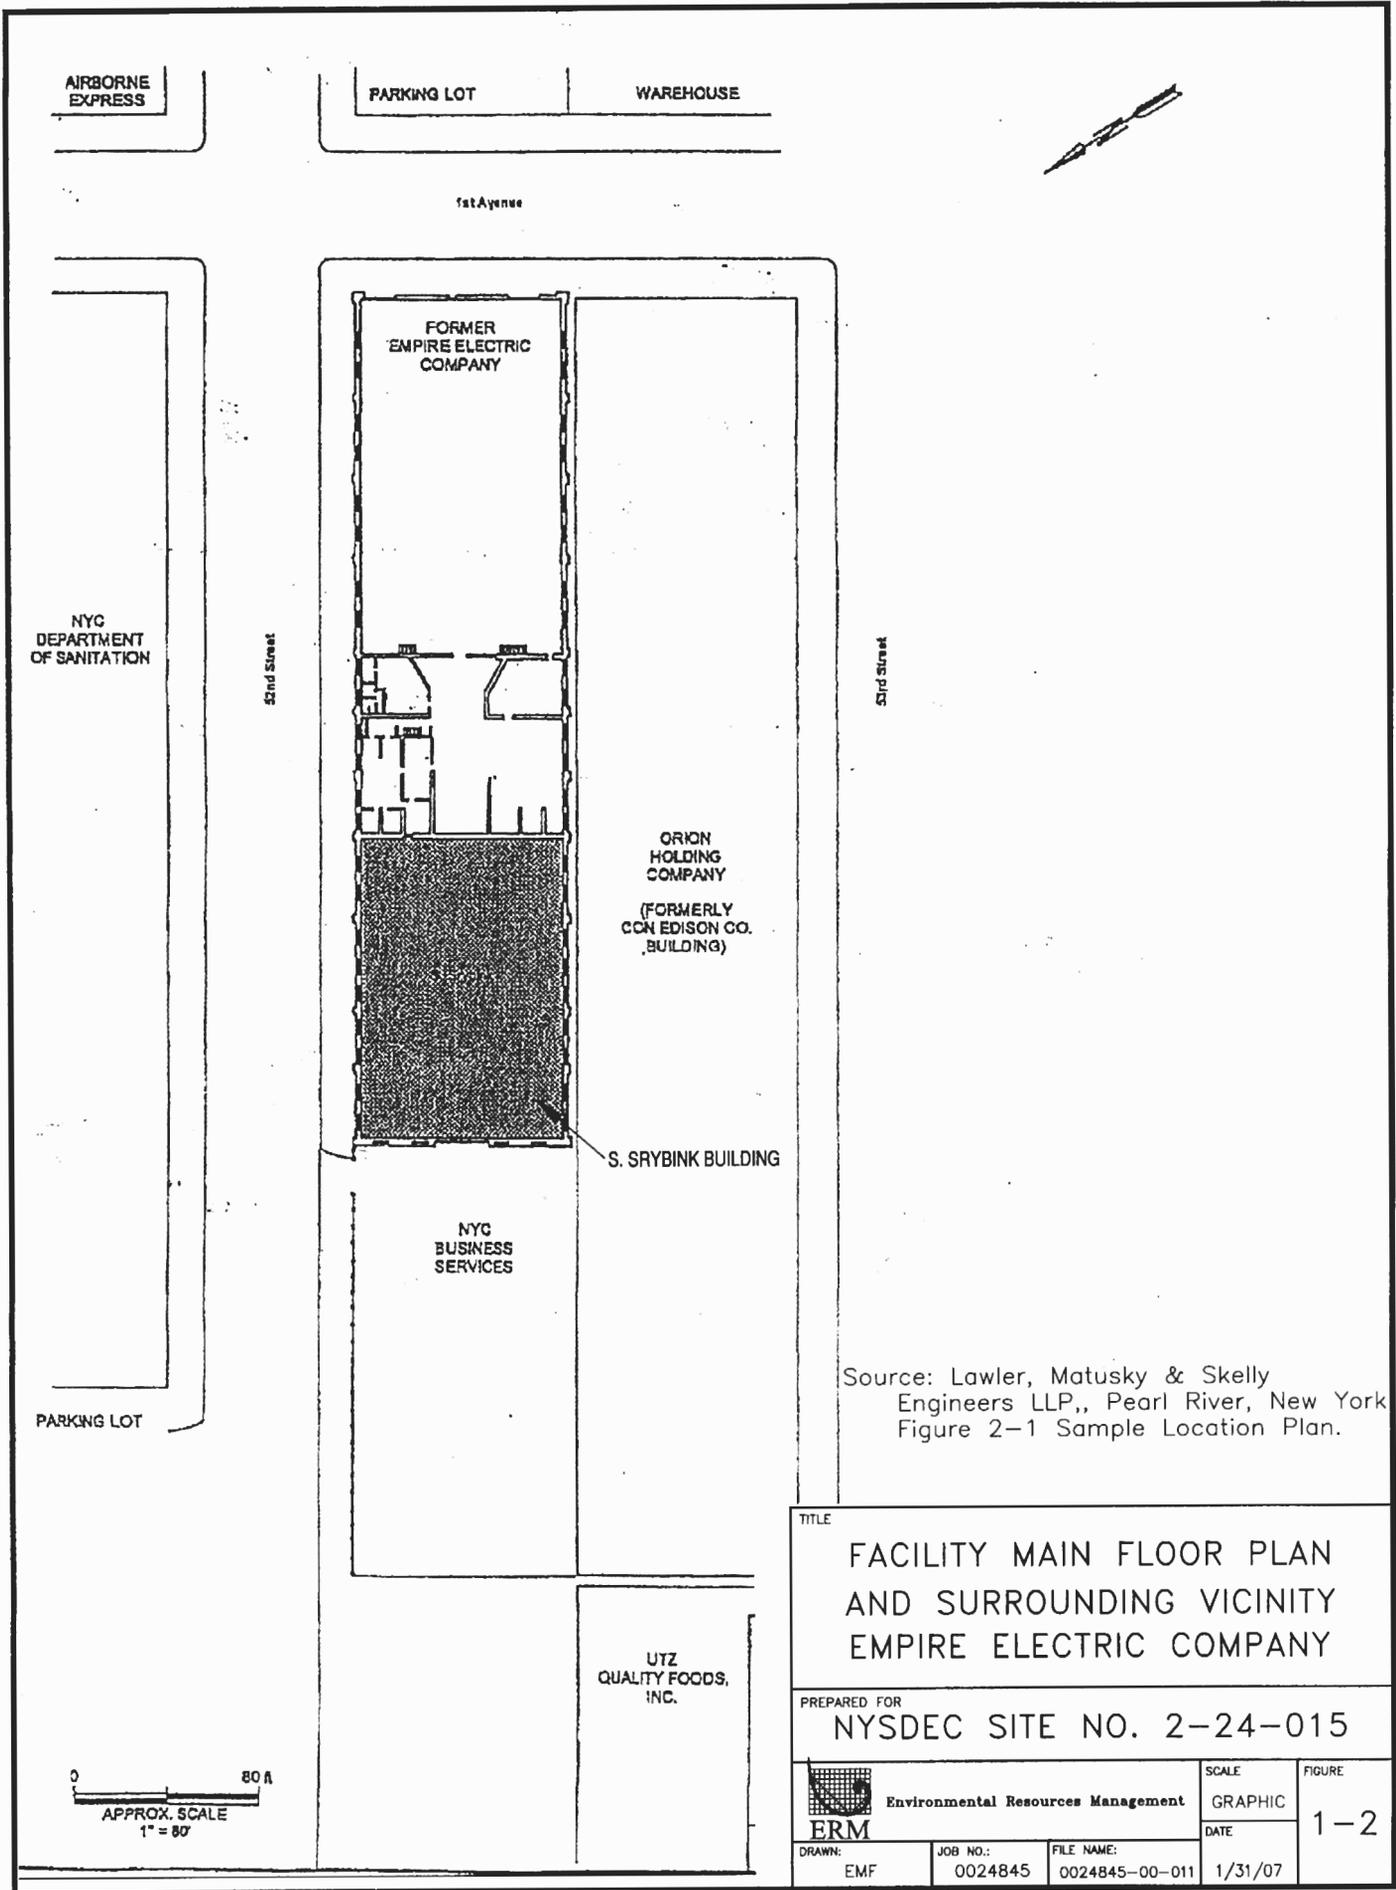
| ERM Environmental Resources Management | SCALE | FIGURE | |

Source: Lawler, Matusky & Skelly
 Engineers LLP,, Pearl River, New York
 Figure 2-1 Sample Location Plan.

| FACILITY MAIN FLOOR PLAN AND SURROUNDING VICINITY EMPIRE ELECTRIC COMPANY | | | |
