**POST CLOSURE
OPERATION & MAINTENANCE MANUAL
FOR THE CAPPING COVERAGE,
DRAINAGE & ROADWAY SYSTEMS
AT THE OLD BETHPAGE LANDFILL**

**TOWN OF OYSTER BAY
DEPARTMENT OF PUBLIC WORKS**

POST CLOSURE
OPERATION AND MAINTENANCE MANUAL
FOR THE
CAPPING COVERAGE, DRAINAGE AND ROADWAY SYSTEMS
AT THE OLD BETHPAGE LANDFILL
CONTRACT NO. TBI 86-415

Lockwood, Kessler & Bartlett, Inc.
Syosset, N.Y.

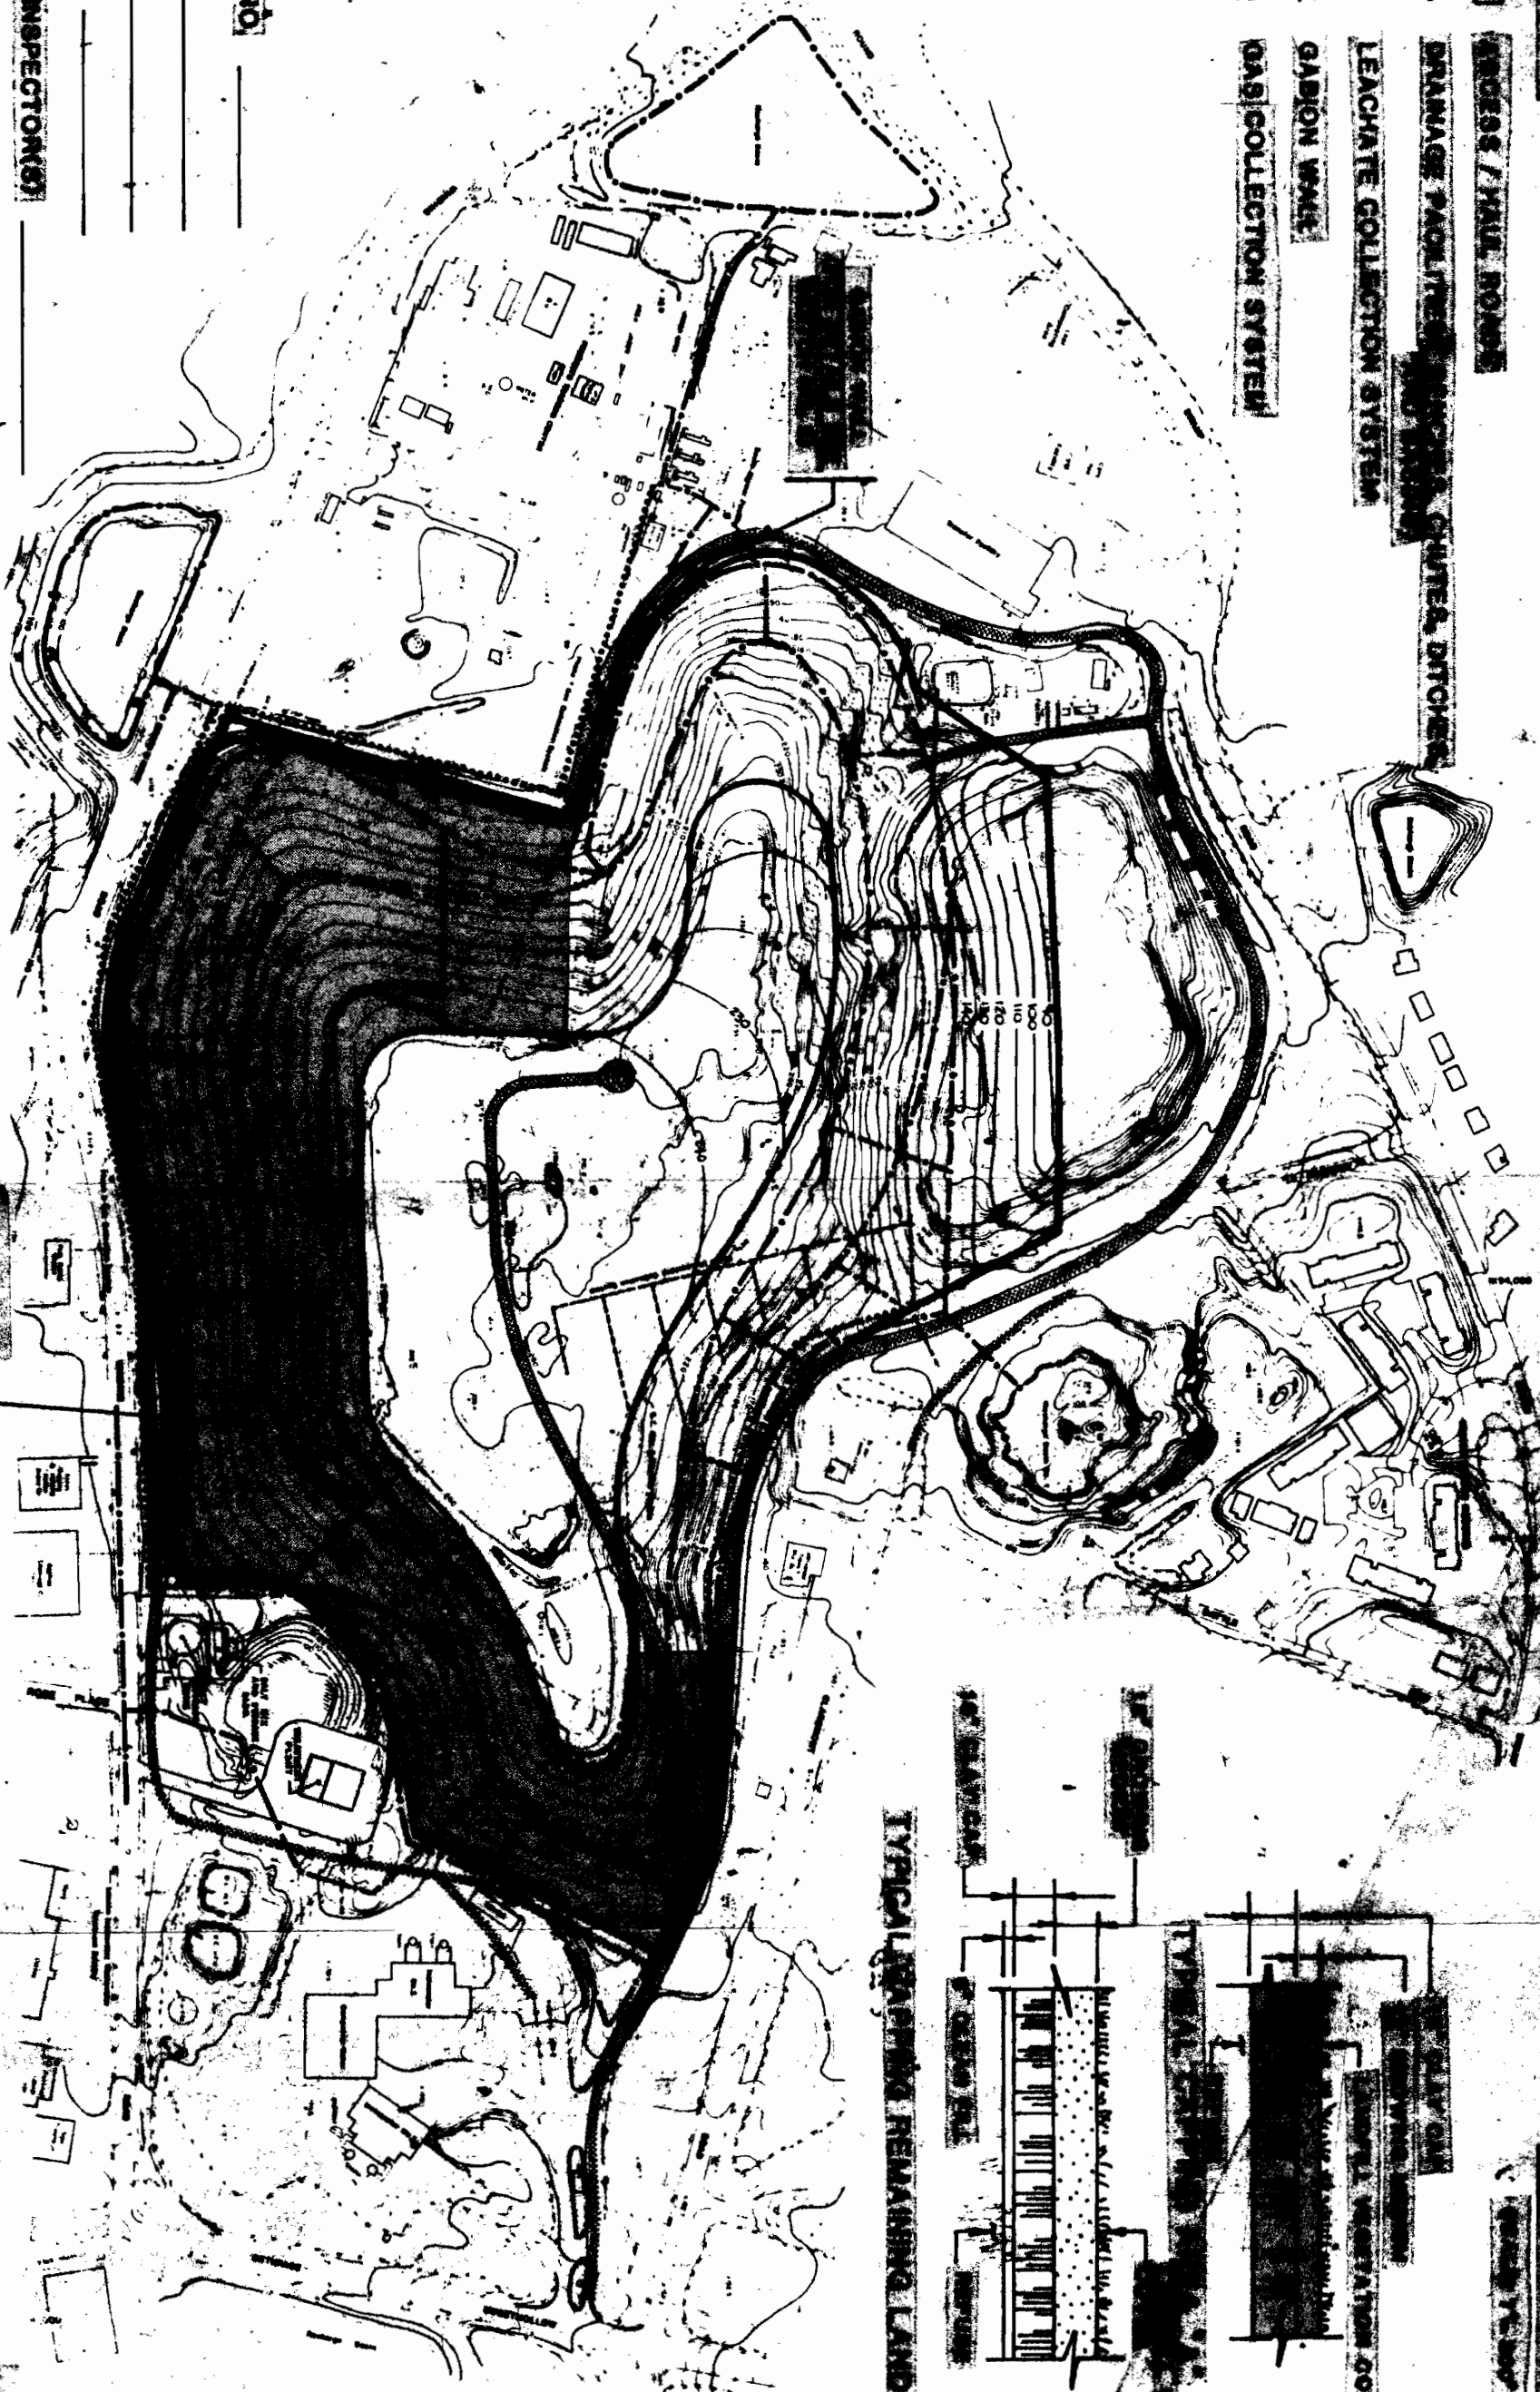
LANDFILL CAP

GASION WALL

GAS COLLECTION SYSTEM

18" CLAY GAP
18" GROWING MEDIUM

- 1) Identify location on Sketch Nos. 1 or 2 and describe defect on separate sheet. If no defects found, enter O.K. in identification column. As required, use more than one copy of Sketch Nos. 1 and/or 2 to locate all identified defects.
- 2) Describe defects as in the following examples:
 V1 20± sq. ft.
 C1 Minor settlement crack 30" long
 D1 Swale erosion requires gabion mattress repair
 D2 Vegetation growth in the ditch

The findings of the inspections shall be reported using copies of Sketches Nos. 1 and 2, to indicate the locations and nature of the damages. As might be necessary, brief description of the damages and recommended repairs shall be included in written reports accompanying the sketches.
