Construction Monitoring Report Ramapo Landfill Remediation

NYSDEC SITE NO. 3-44-004

**URS GREINER, INC.
282 DELAWARE AVENUE
BUFFALO, NEW YORK 14202**

DECEMBER 1998

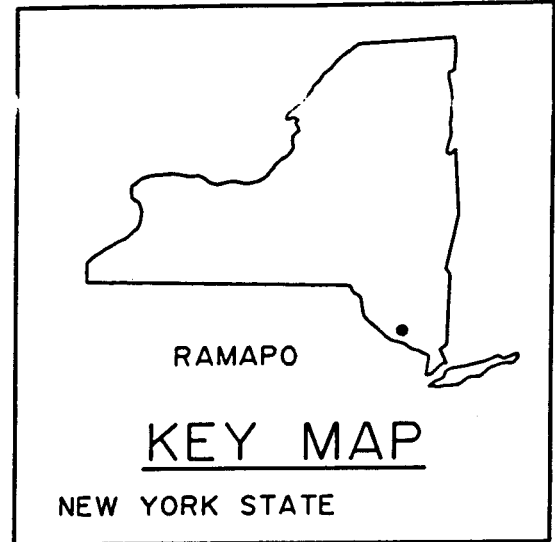
SOURCE:
HAGSTROM COMPANY, INC.

20,000' 0 20,000'
SCALE: 1" = 20,000'
