Former Al Tech Specialty Steel Corporation Site

TOWN OF COLONIE, ALBANY COUNTY, NEW YORK

Final Engineering Report

Operable Unit Number 03: On-Site Structures

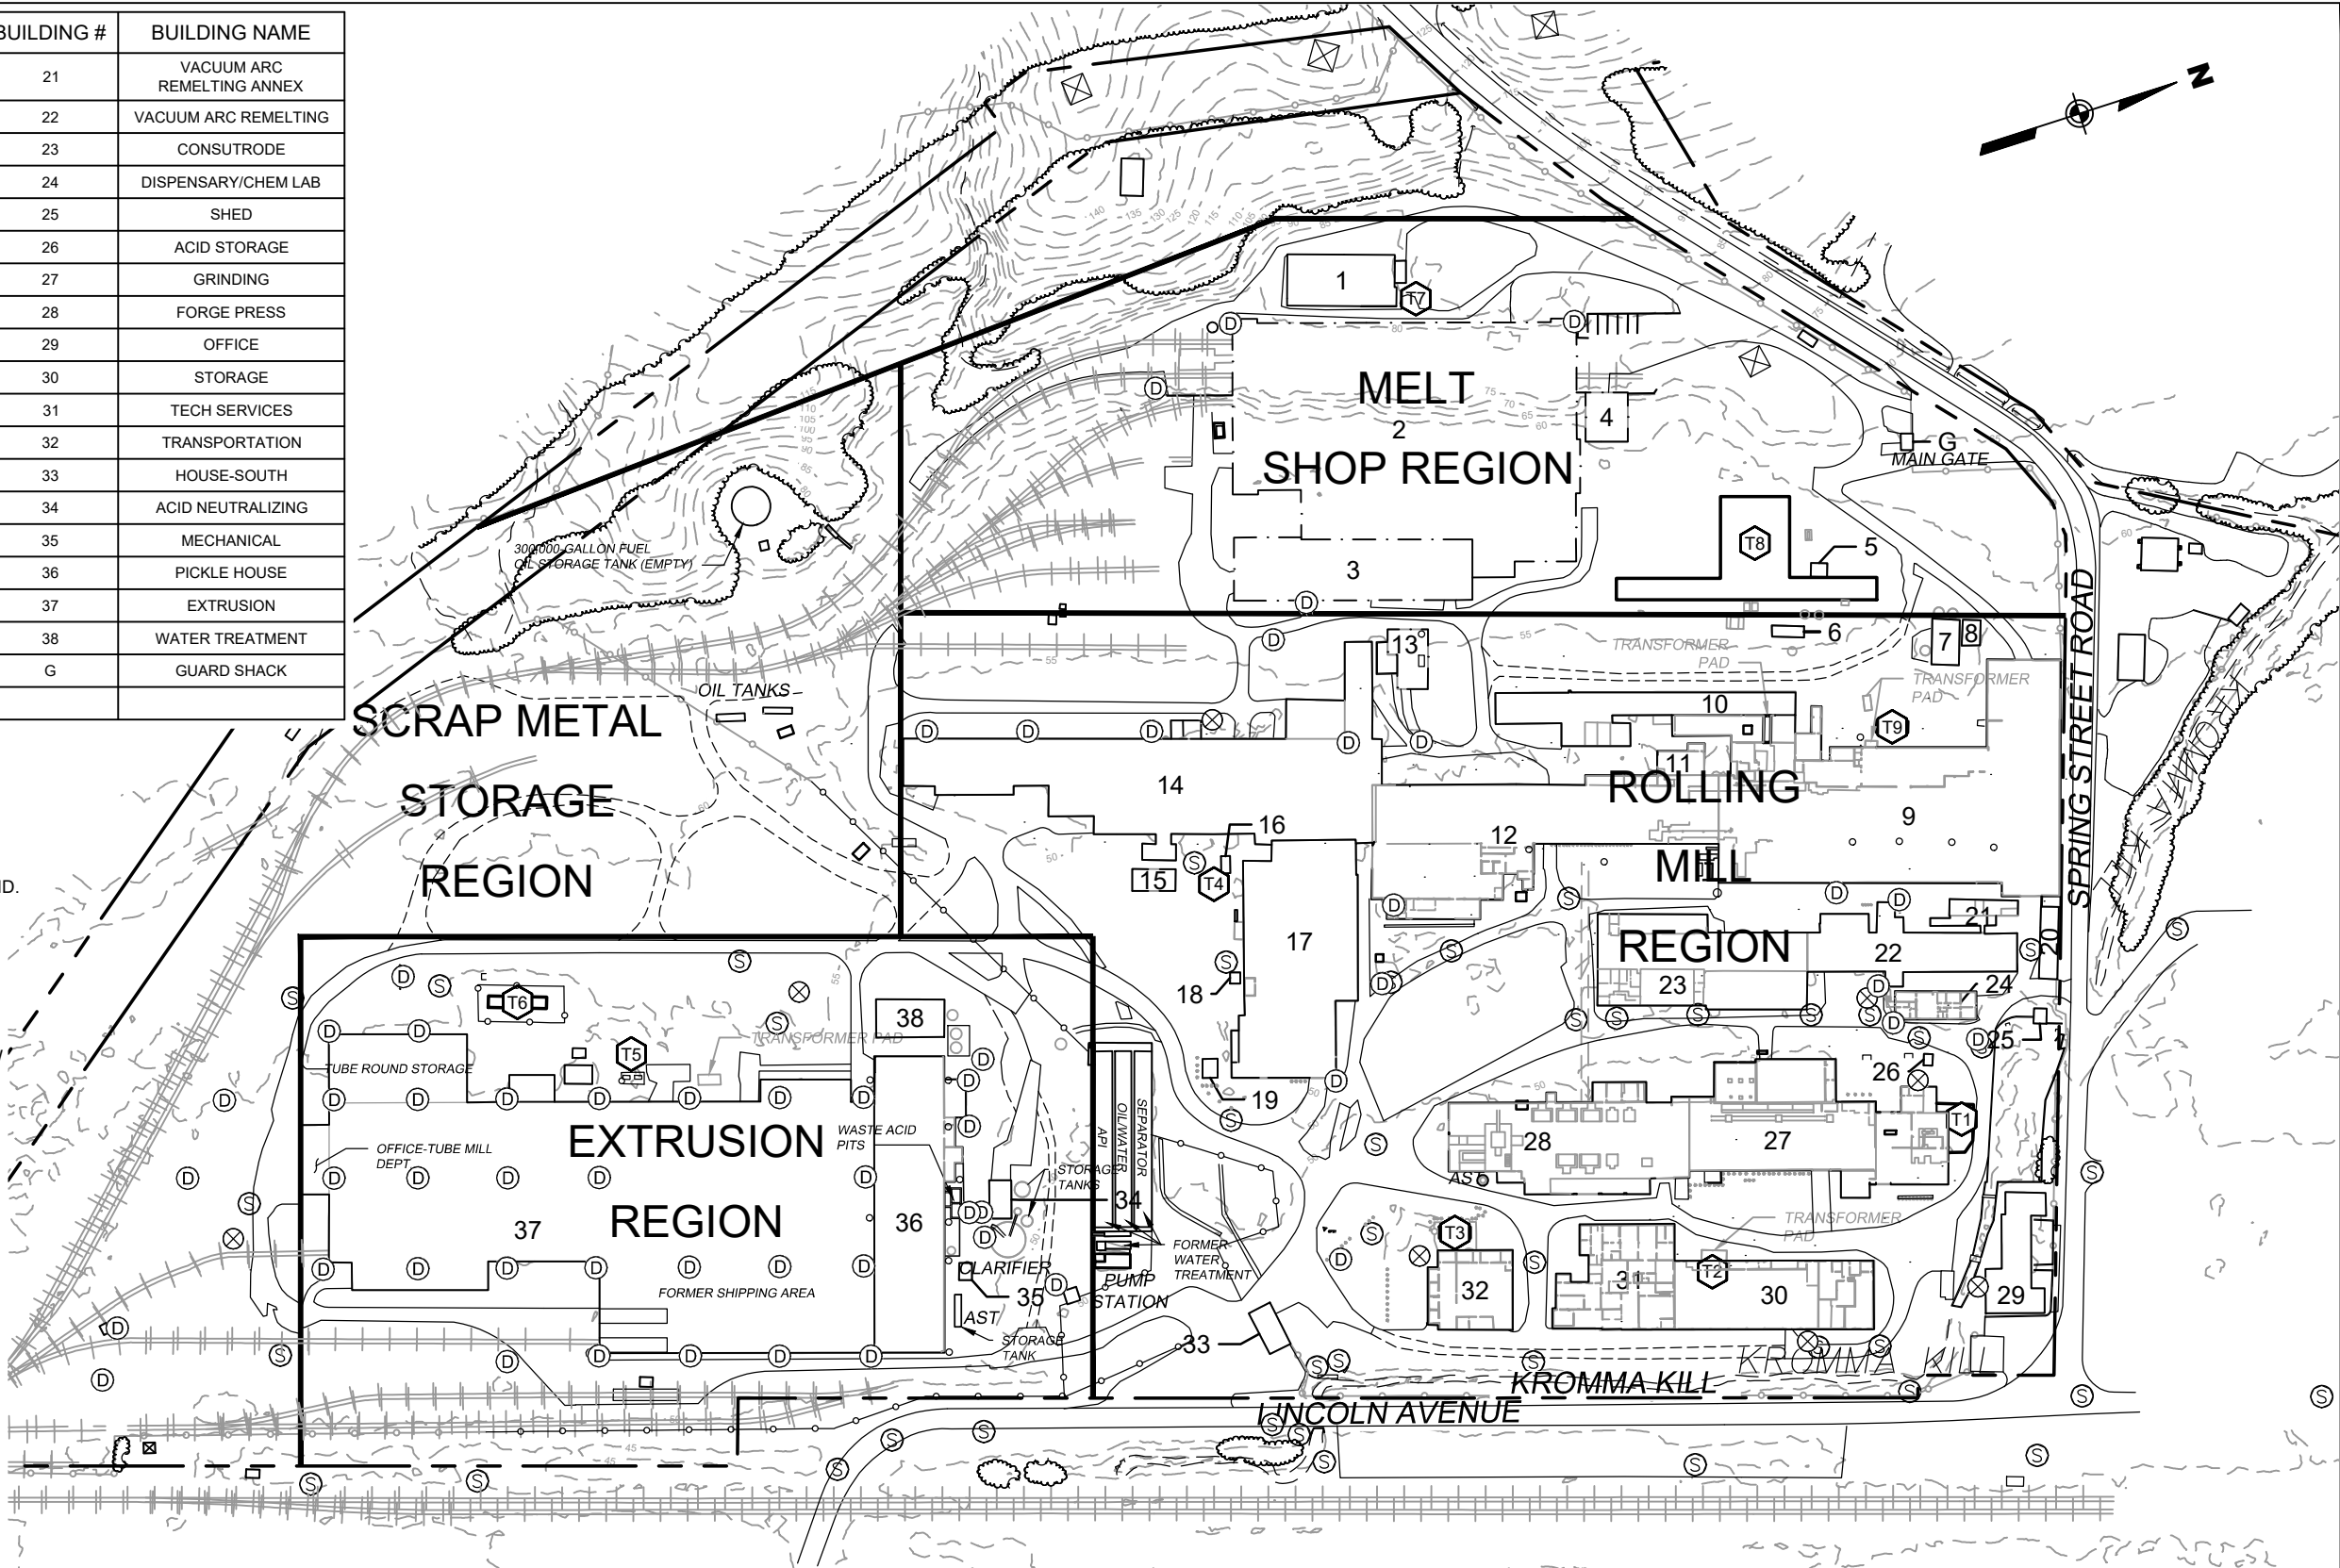
- MAPPING SHOWN BASED ON PLANS TITLED: 1) "AL_TechSTL 2019" BY MJ ENGINEERING, DATED NOVEMBER 18, 2019, INCLUDING ALL NOTES AND REFERENCES THEREIN; 2) "SITE LAYOUT - RFI REPORT" BY ENVIRONMENTAL STRATEGIES CORPORATION, DATED NOVEMBER 6, 1997, INCLUDING ALL NOTES AND REFERENCES THEREIN.
- THE HORIZONTAL DATUM IS ON NORTH AMERICAN DATUM OF 1983, NEW YORK STATE PLANE EAST ZONE 3101
- THE VERTICAL DATUM IS THE NORTH AMERICAN VERTICAL DATUM OF 1988 (NAVD88)

- INFORMATION SHOWN HEREON IS FROM: A LIDAR SCAN COLLECTED BETWEEN MAY 14 AND MAY 24, 2019; A MOBILE SCAN DATA COLLECTED ON MAY 24, 2019; 2008 USGS AERIAL LIDAR INFORMATION; AND 2005 SITE MAP DRAFTED BY REALCO INC - DRAWING NUMBER: WMPA0501.
- PIT AND RUBBLE PILE EXTENTS SHOWN HEREON ARE BASED ON SURFACE EVIDENCE AND INFORMATION RECORDED DURING LIDAR SURVEY.
- THIS MAPPING DOES NOT PURPORT TO SHOW ALL UNDERGROUND FEATURES ON SITE AND IS SUBJECT TO FIELD VERIFICATION.
- UTILITY INFORMATION IS SHOWN ALIGNED ONTO CURRENT SURVEY BASE MAPPING FROM VARIOUS SOURCES AND SHALL BE CONSIDERED APPROXIMATE.

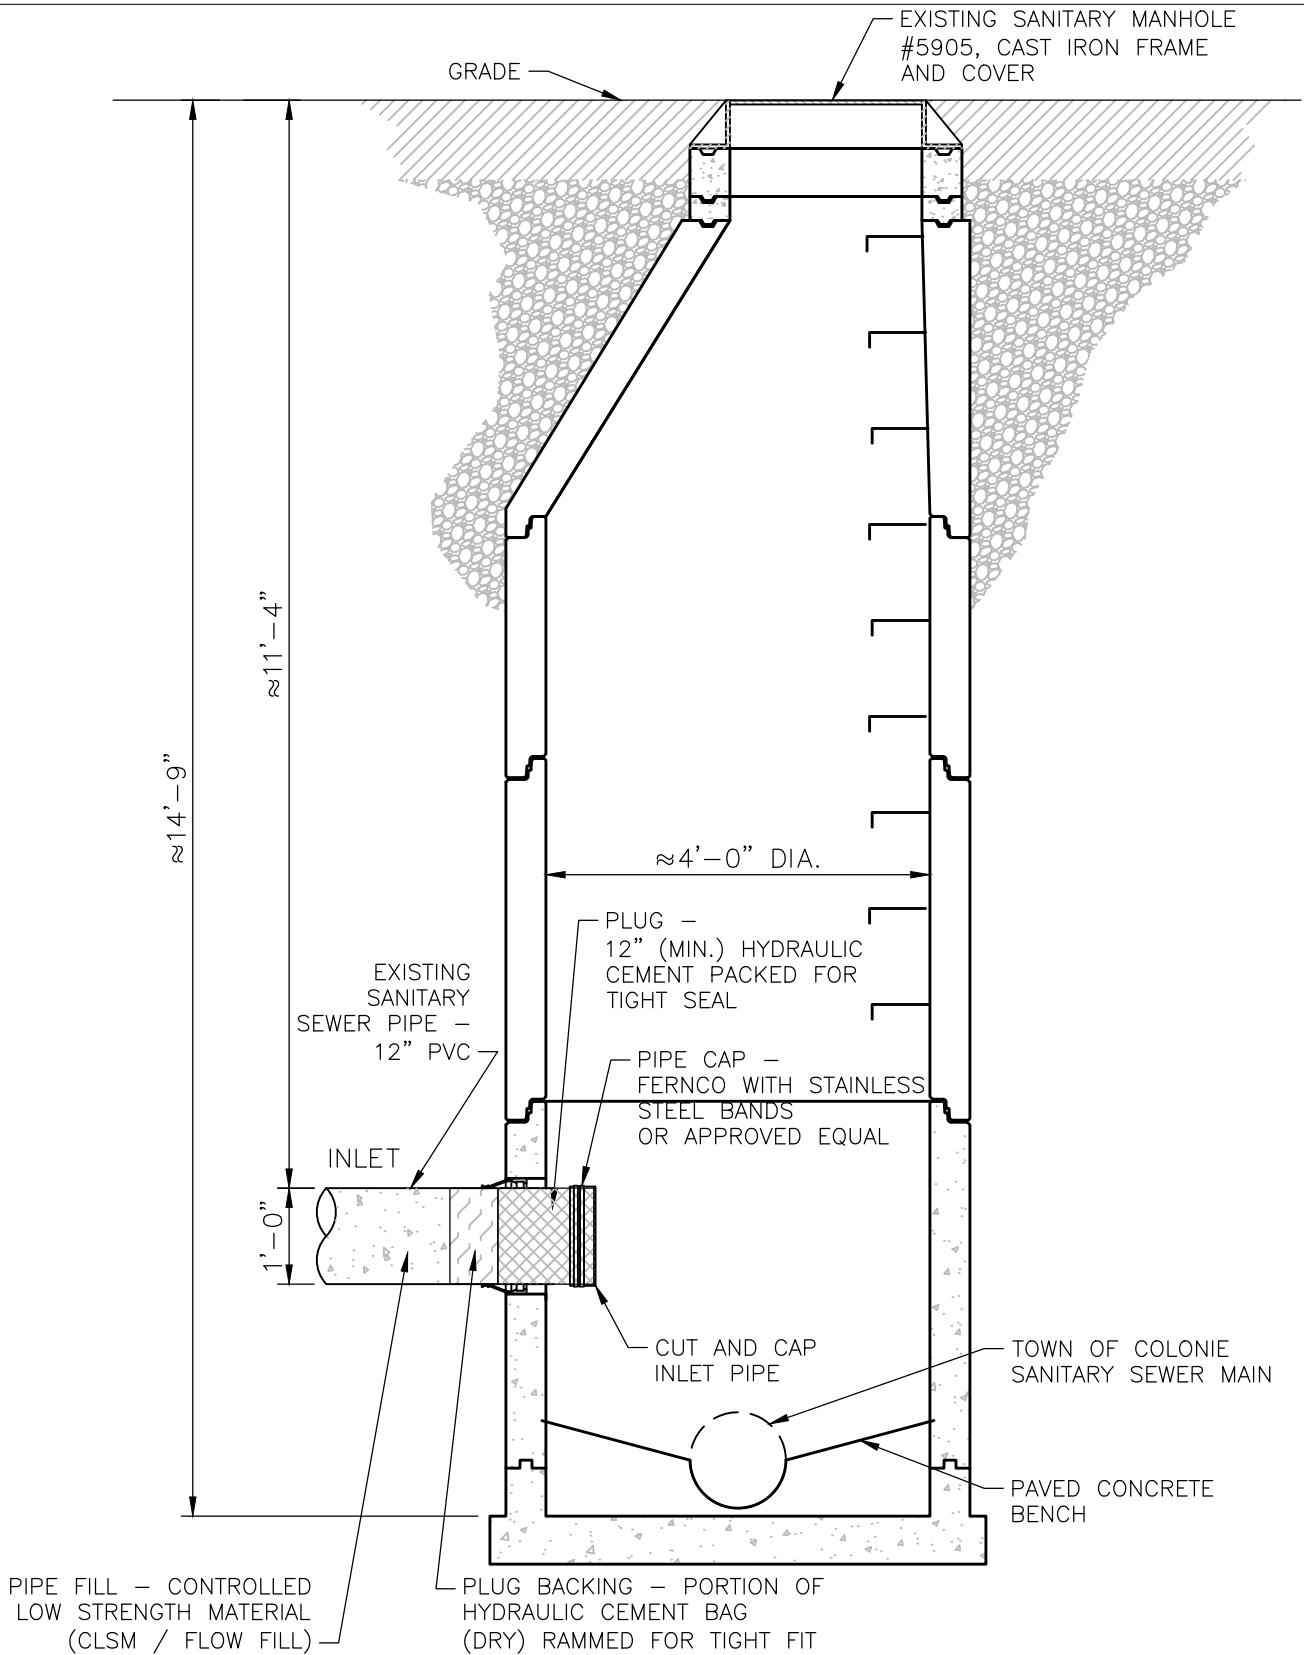
- FORMER FUEL OIL DISTRIBUTION SYSTEM
- FUEL OIL ICM INTERCEPTOR TRENCH
- SANITARY SEWER MANHOLE
- SANITARY SEWER
- WATER LINE
- MISSING/PRESUMED ABSENT OR DESTROYED MANHOLE

- NOTES:
- ALL SEWER MANHOLE COVERS AND COVERPLATES WERE REMOVED AND SALVAGED
 - ALL LAVATORY SINK AND TOILET PENETRATIONS WERE SEALED WITH CONTROLLED LOW STRENGTH MATERIAL (CLSM)
