WASTE MANAGEMENT OF NEW YORK, LLC McKENNA LANDFILL REMEDIATION CLOSURE PROJECT ALBION, NEW YORK	REV No.	DESCRIPTION	BY	DATE
CLAY BARRIER WALL SHELBY TUBE LOCATIONS	SCALE IN FEET		DRAWN BY: DEW	
	30 60 120 240		DATE: DECEMBER 2001	
PROJECT No. 55024		GZA GZA GeoEnvironmental of New York		
FIGURE No. 2

<p>WASTE MANAGEMENT OF NEW YORK, LLC McKENNA LANDFILL REMEDIATION CLOSURE PROJECT ALBION, NEW YORK</p> <p style="text-align: center;">LOW PERMEABILITY SOIL LAYER SHELBY TUBE AND DENSITY TEST LOCATIONS - FIRST LIFT</p>	<p>REV No. _____</p> <p style="text-align: center;">SCALE IN FEET</p>	<p>DESCRIPTION _____</p>	<p>BY _____</p> <p>DATE: DECEMBER 2001</p>
<p>PROJECT No. 55024</p> <p>FIGURE No. 3</p>

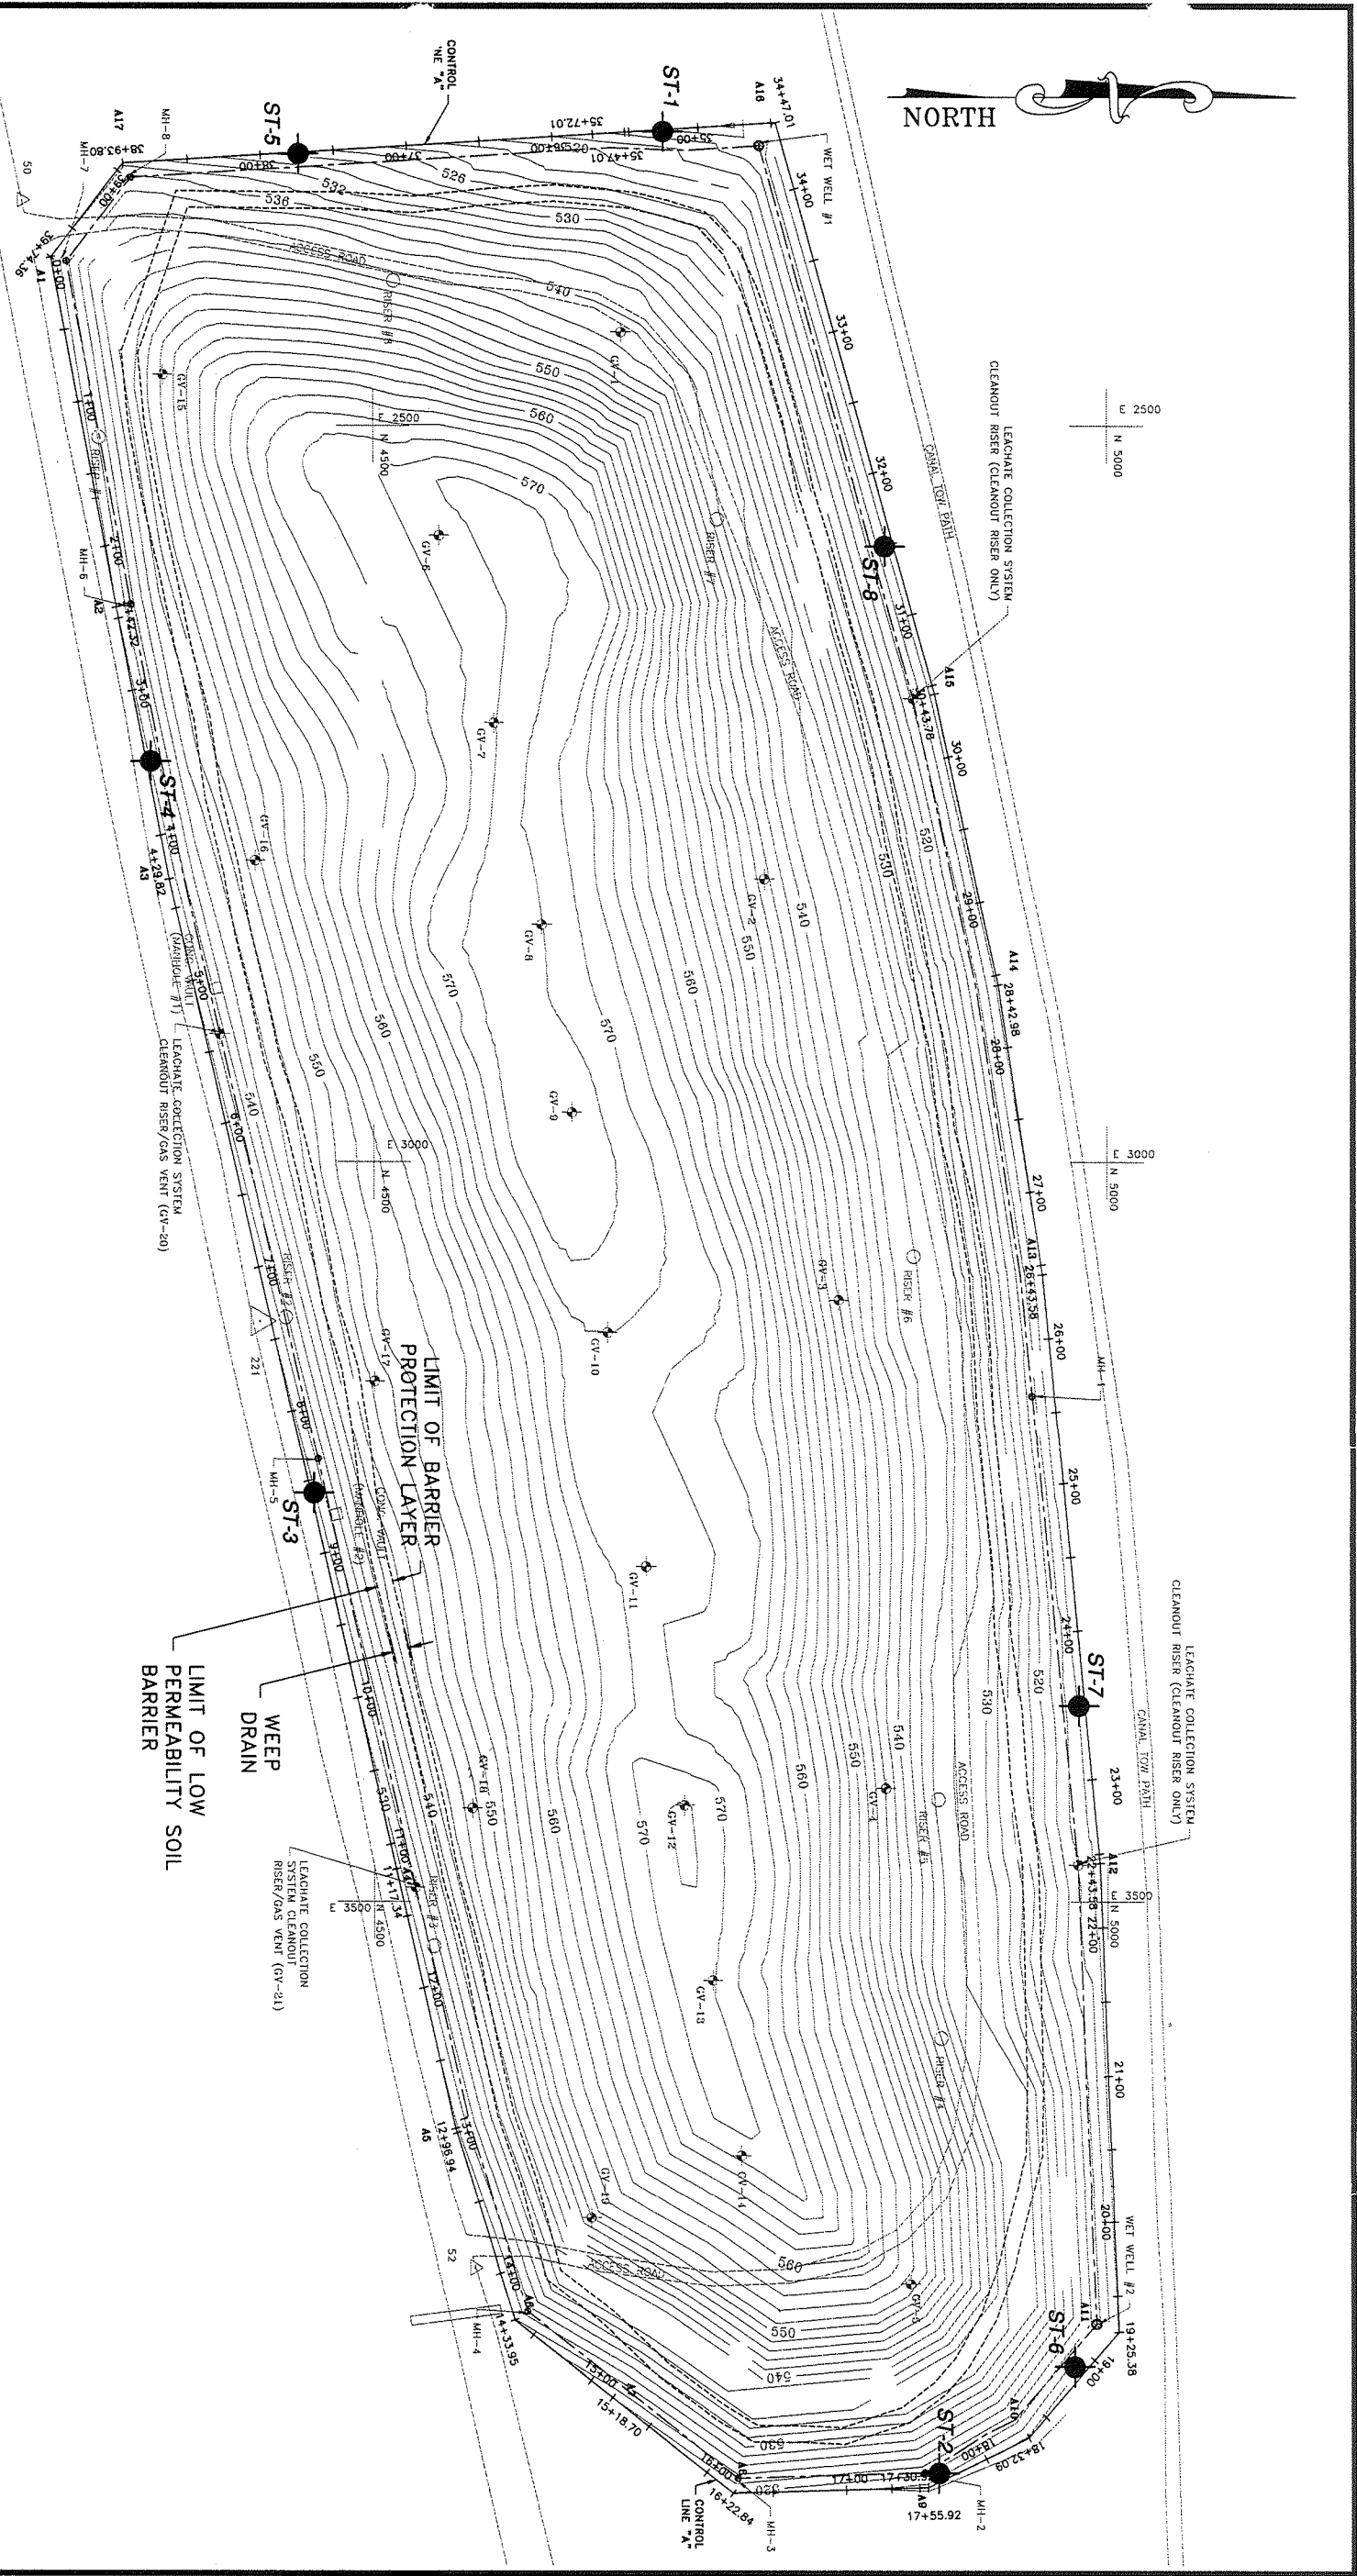
SHELBY TUBE LOCATIONS			
SHELBY TUBE No.	PERMEABILITY (cm/sec.)	TEST DRY DENSITY (pcf)	TEST MOISTURE CONTENT (%)
ST-1	3.1E-08	102.9	21.4
ST-2	1.1E-08	102.3	23.6
ST-3	8.9E-09	104.2	22.8
ST-4	4.7E-08	97.7	24.9
ST-5	2.1E-08	96.0	19.5
ST-6	1.3E-08	102.0	23.6
ST-7	8.5E-09	99.6	24.4
ST-8	1.2E-08	98.9	26.5
