Date **Final Engineering Report**

**Scajaquada Creek Sediment Remediation
Buffalo, New York
NYSDEC Site # 91514B**

RETEC Engineering, P.C.

**National Fuel Gas Distribution Corporation
10 Lafayette Square
Buffalo, New York 14203**

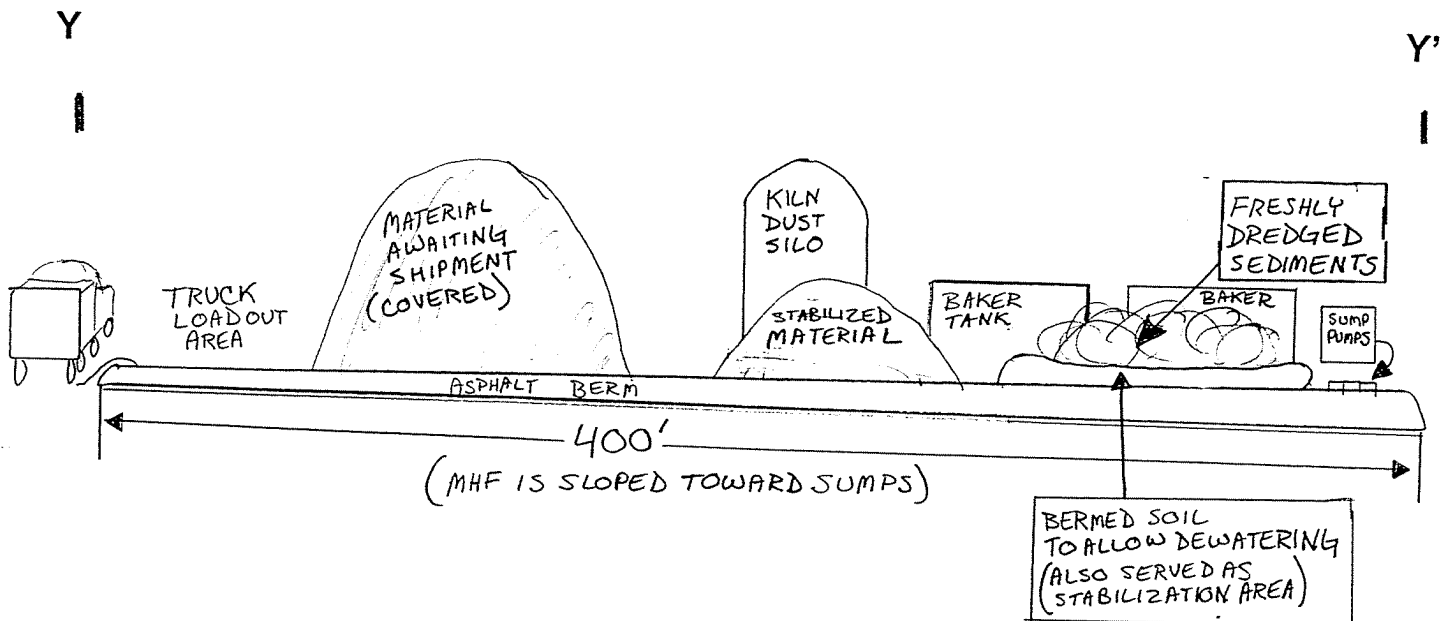
RETEC
RETEC ENGINEERING, P.C.
DRAWING NO. _____ REV _____
Figure 2-3

CROSS-SECTION
X-X' ON MHF DIAGRAM
VIEW FROM CREEK

LONGITUDINAL VIEW
Y-Y' ON MHF DIAGRAM
VIEW FROM FEDCO PARKING LOT

MHF Cross Section
and Longitudinal
Views

Materials handling and offsite transport and disposal was accomplished in accordance with the Technical Specifications. The materials handling facility (MHF) was constructed by placing hot asphalt and seal coat on a 160-foot x 400-foot surface of a former parking lot adjacent to the site. Asphalt berms were constructed on the perimeter to control water run-on and run-off. The location of the MHF is shown in Figure 2-2. Cross section and longitudinal views are provided in Figure 2-3.
