# **PROPOSED REMEDIAL ACTION PLAN**

## **BOONE PARK**

### **Environmental Restoration Project**

**Site No. B00196-9**

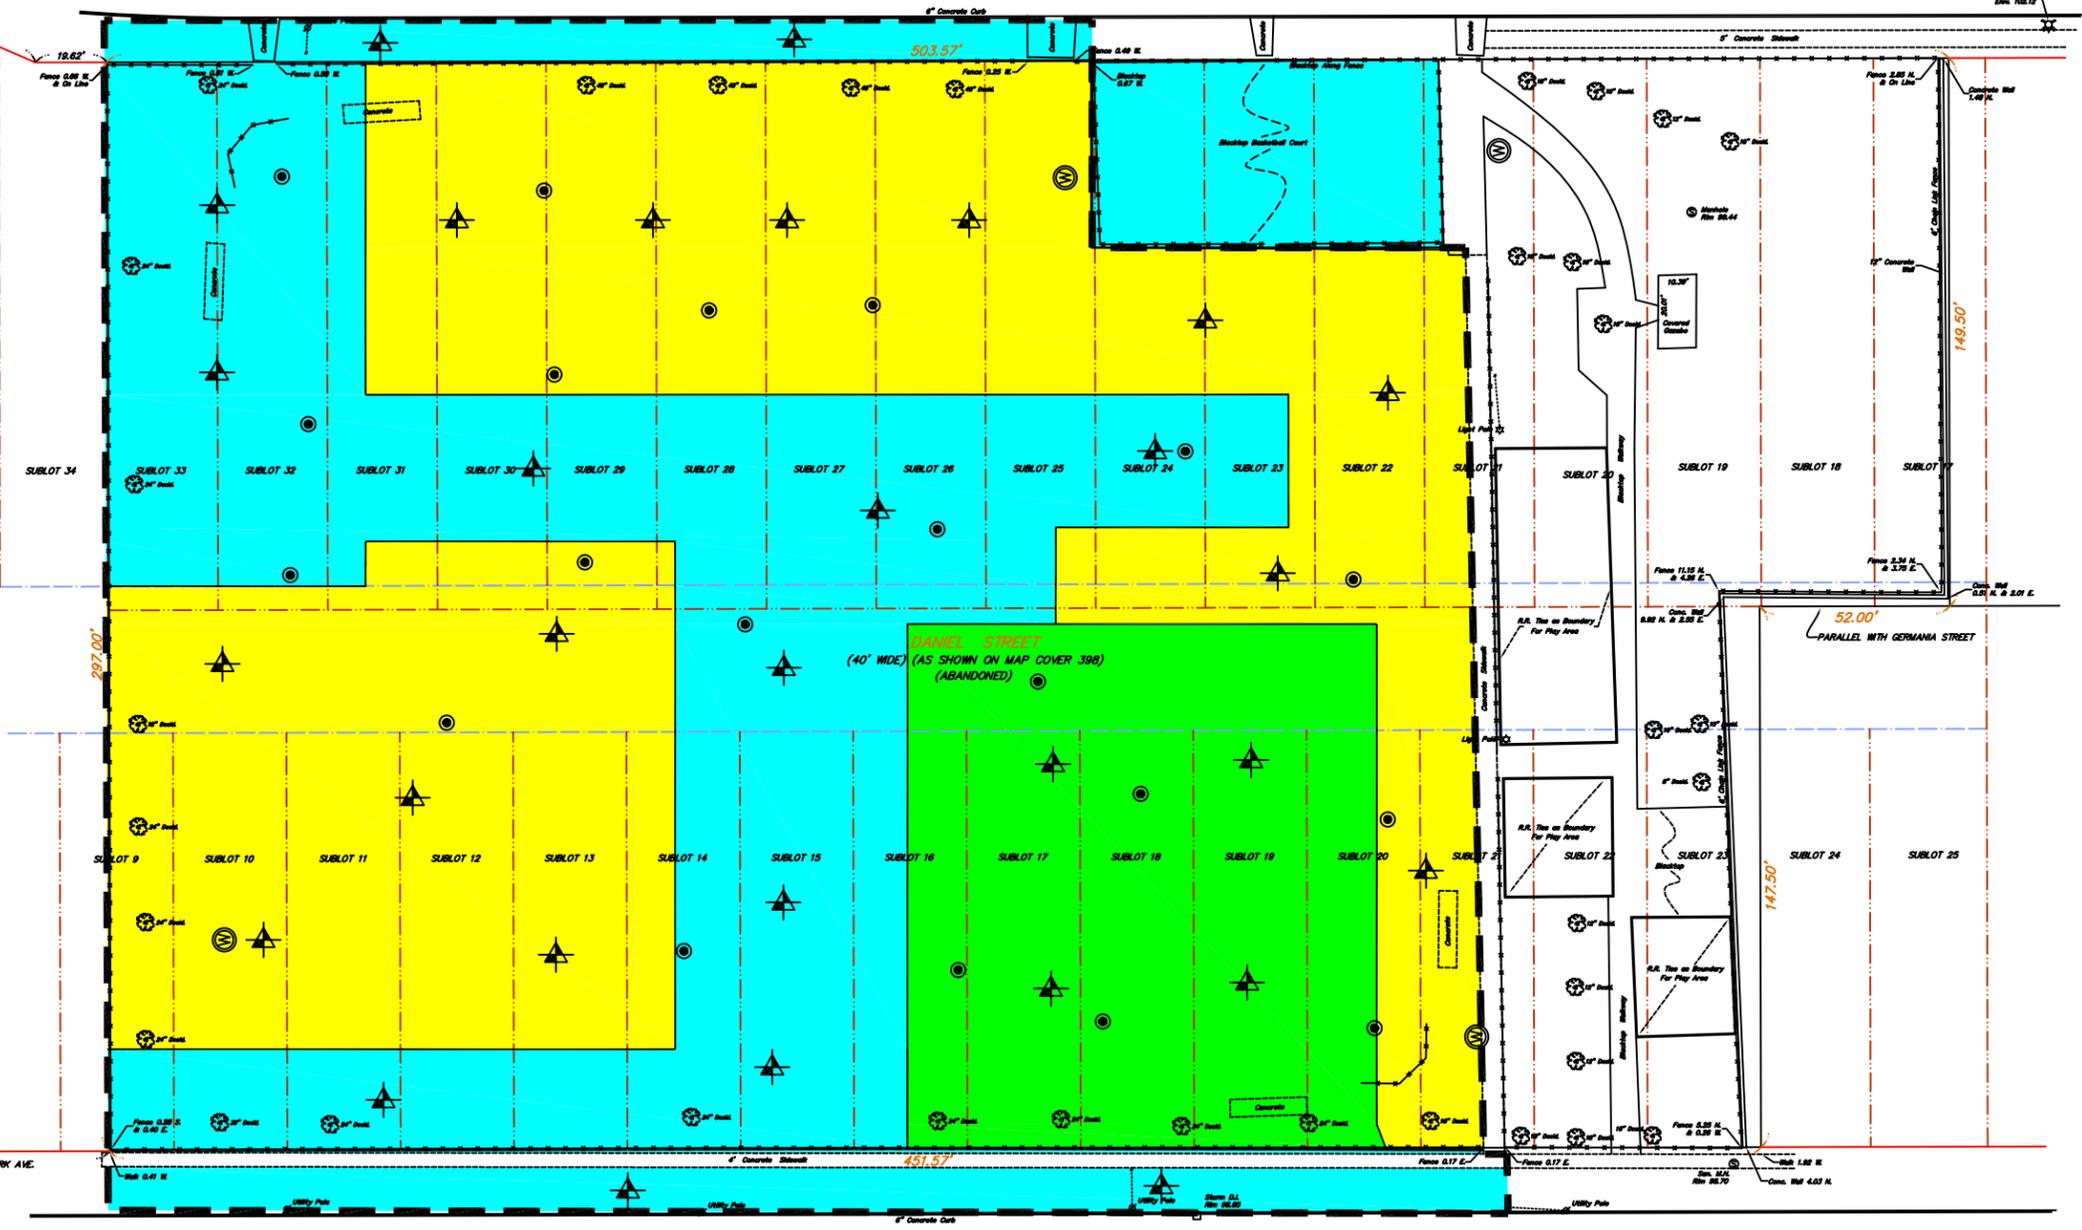
- LIMITS OF IRM EXCAVATIONS
- PRELIMINARY DESIGN TO DEPTH OF 6"
- PRELIMINARY DESIGN TO DEPTH OF 12"
- PRELIMINARY DESIGN TO DEPTH OF 18"
- NO EXCAVATION (SURFACE BARRIER)
- PROPOSED CONFIRMATION SAMPLING LOCATION
- S I SAMPLING LOCATION

Figure 2 shows the areas where IRM excavation to 12 inches or eighteen inches was anticipated, based on SI arsenic data. Figure 3 provides the final depth to which excavation was completed. Soil confirmation data indicate that the RAO was achieved at the vertical limits of excavation (excavation bottom) within each of the 31 soil confirmation sampling areas.

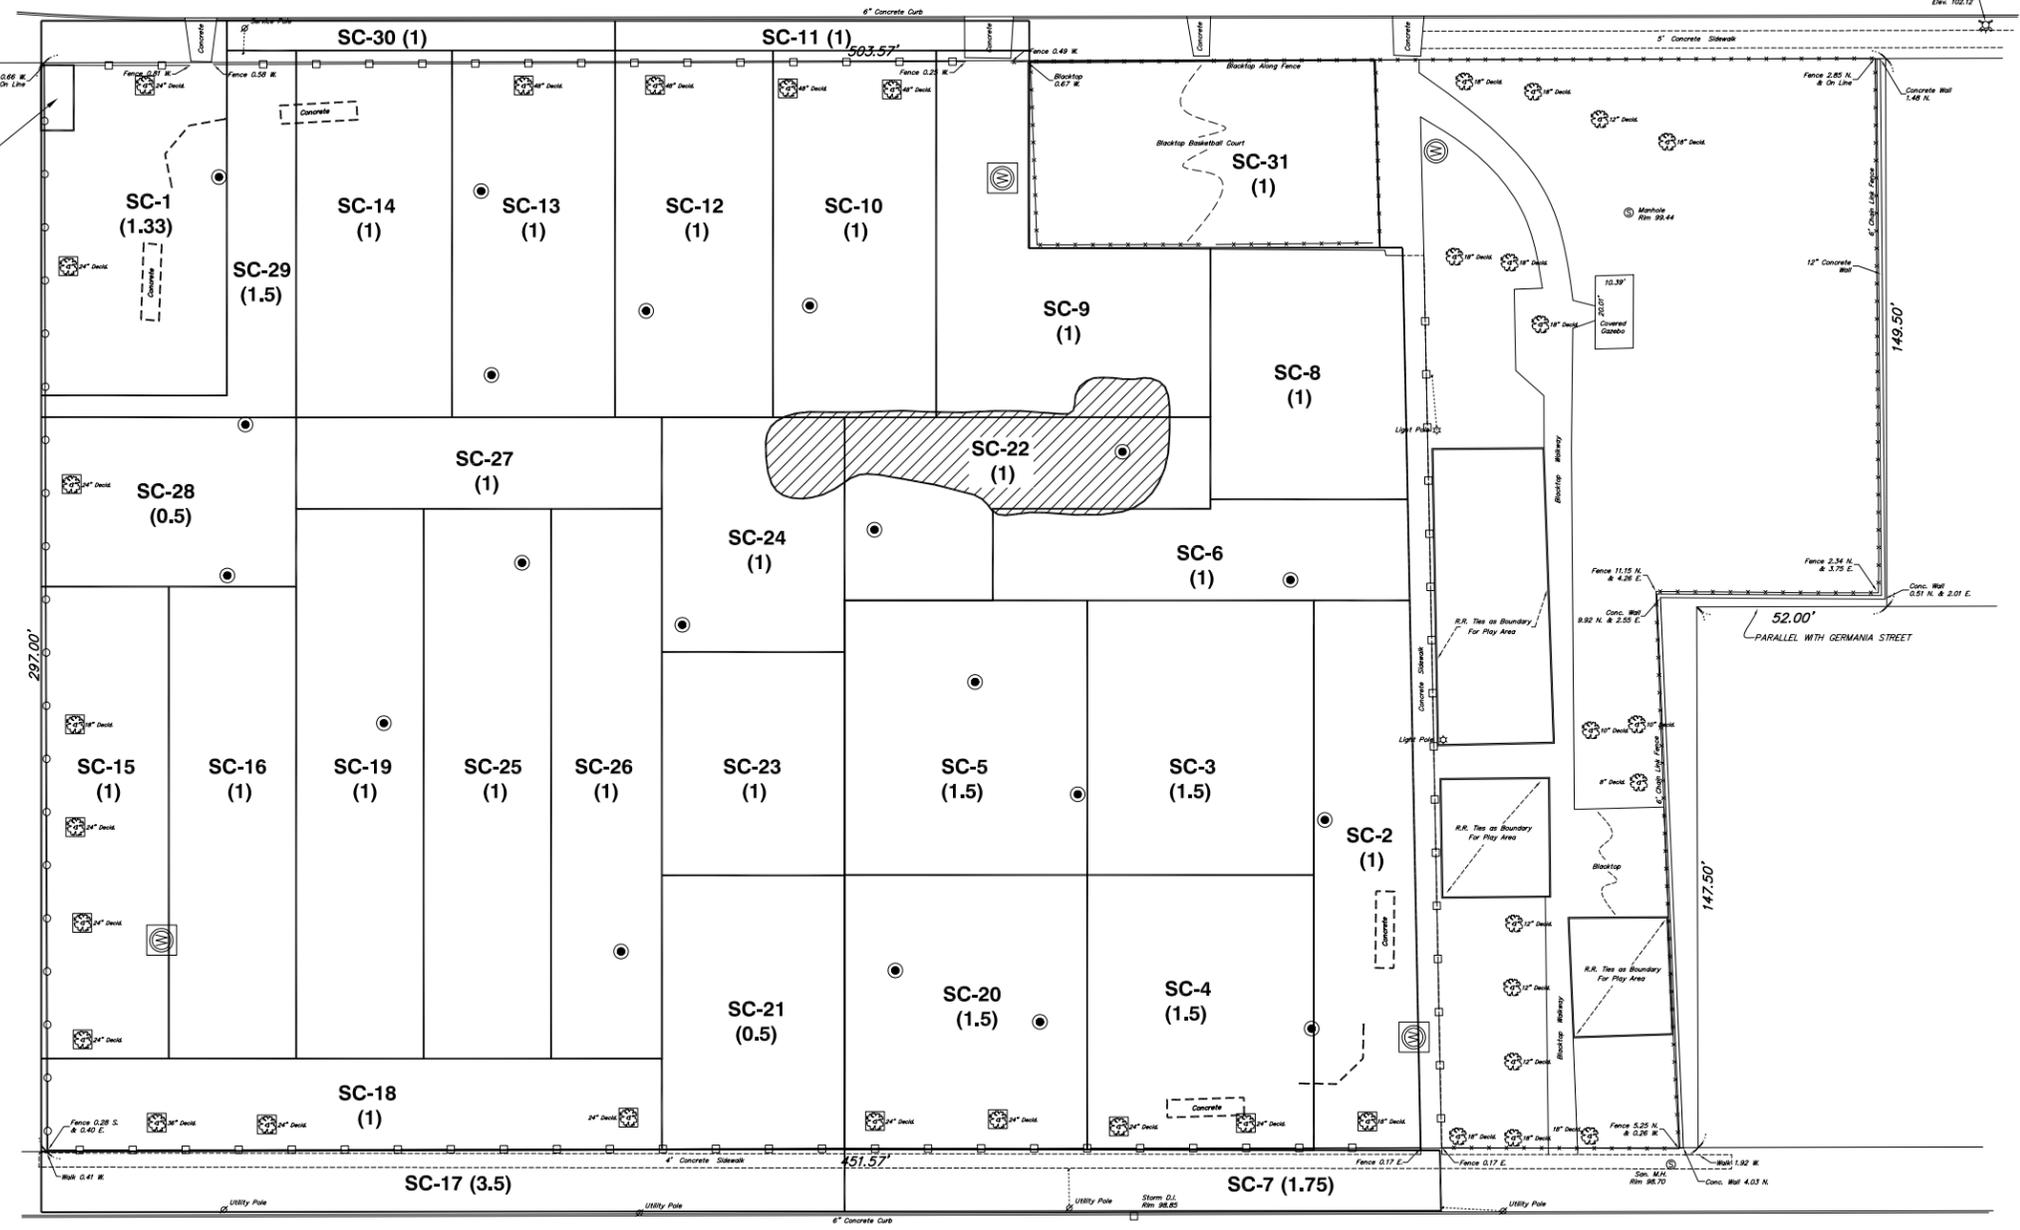
**FIGURE 3  
IRM SOIL CONFIRMATION  
SAMPLE AREAS AND EXCAVATION DEPTHS**

- DELINEATES SPECIFIC SOIL CONFIRMATION SAMPLING AREA
- SC-13 (1)** - CONFIRMATION SAMPLE I.D. (FINAL DEPTH OF EXCAVATION IN FEET)
- NOTE: SEE TABLE 1 FOR SOIL CONFIRMATION SAMPLING DATES, ANALYTICAL RESULTS, AND APPROXIMATE AREAS AND VOLUMES EXCAVATED.
- ⊙ - SI MONITORING WELL LOCATION
- ⊖ - MONITORING WELL REMOVED AND DISPOSED
- - SI SOIL SAMPLE LOCATION
- ☼ - MATURE DECIDUOUS TREE
- ☼ - MATURE TREE REMOVED, DISPOSED AND REPLACED  
NOTE: REPLACEMENT TREES PLANTED AT EVEN INTERVALS ALONG GERMANIA AND BOONE STREET BOUNDARIES.
- - FENCE REMOVED AND DISPOSED
- - FENCE REMOVED, DISPOSED, AND REPLACED
- - - - - BASEBALL FIELD STRUCTURE REMOVED AND DISPOSED
- ▨ - APPROXIMATE AREA WHERE APPARENT FOUNDRY SAND MATERIALS WERE FOUND

USEPA data indicated two locations at the site where soils from deeper than eighteen inches below the ground surface contained arsenic at concentrations exceeding the RAO. IRM excavations in two areas (Areas 7 and 17, Figure 3) extended deeper than eighteen inches before the RAO could be achieved. A limited zone of material that exceeded the site RAO for arsenic was left in place beneath a sidewalk and curb near the northwest corner of the site at a depth of approximately two feet. It is unlikely that routine future maintenance or repair of the sidewalk or curb would disturb this material. However, the City will place a copy of the Record of Decision in the park file and make it
