FRACTURE TRACE ANALYSIS REPORT

Re: Fracture Trace Analysis
Troy Belting & Supply
Watervliet, NY

This report was prepared by Alpha Geoscience (Alpha) for Sterling Environmental Engineering, P.C. (Sterling), to present the results of a fracture trace analysis conducted for the Troy Belting & Supply site at 70 Cohoes Rd, Watervliet, NY (Figure 1). The fracture trace analysis was conducted in order to assist Sterling in the placement of monitoring wells at the site and surrounding area, based on the premise that ground water flow through bedrock is predominantly along bedrock fractures, which can be oriented parallel to bedding planes or at some angle relative to them. In order to evaluate bedrock fracture patterns in the area, Alpha reviewed historical aerial photographs and topographic maps of the site and surrounding area, reviewed the geological literature pertaining to the area, and visited bedrock outcrops in the area.

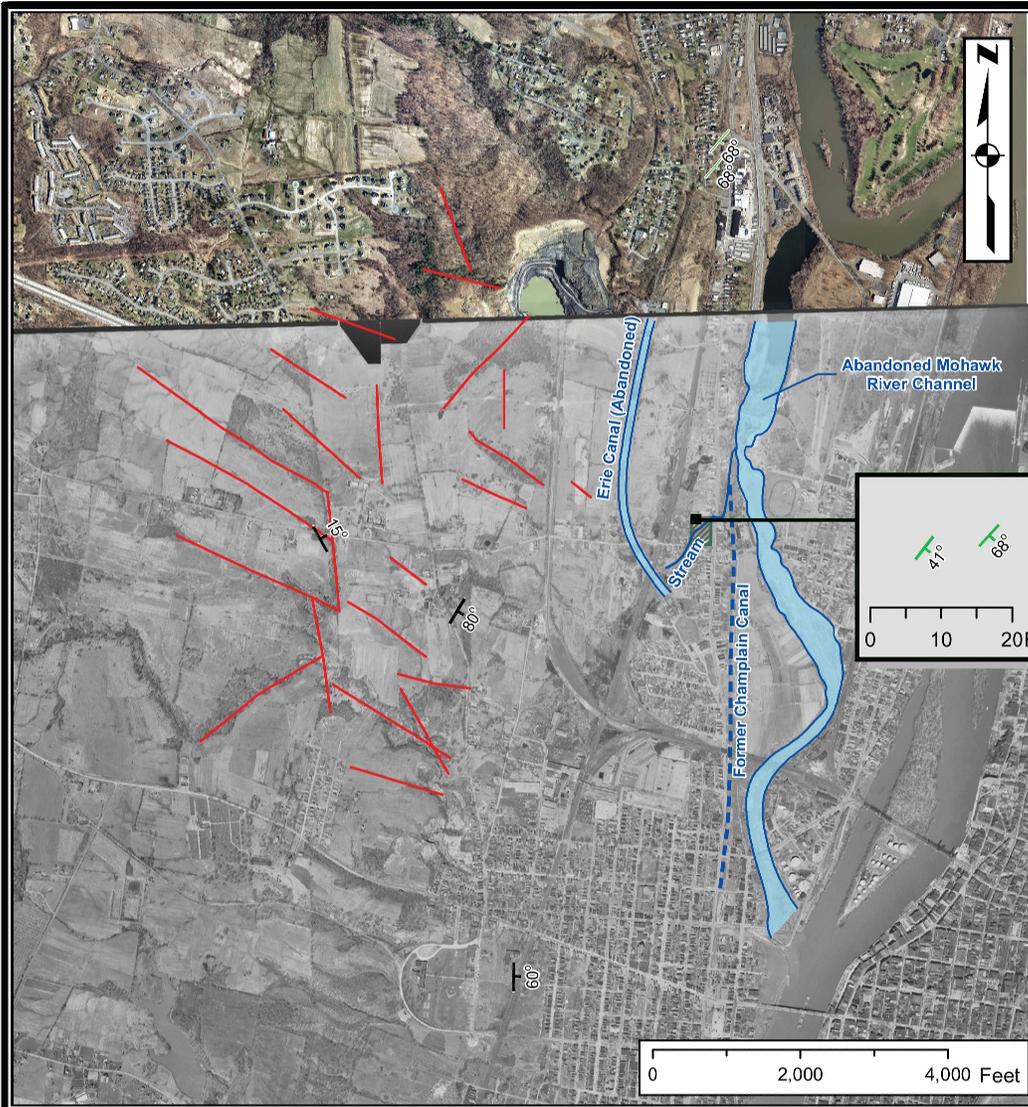
FIGURE 2
Fracture Traces
 Troy Belting Fracture Trace Analysis
 Town of Colonie
 Albany County, New York

- Potential Bedrock Fracture Trace
- +— Strike & Dip Measurement
 - +— Alpha, 3/11/2014
 - +— Plesch, 1994
- Site Boundary (approx.)

Figure 2 shows the traces of the bedrock fractures that were observed on the 1952 aerial photographs, along with those obtained from topographic contours. Figure 2 also shows the location of the abandoned Erie Canal (upgradient from the site), the abandoned Champlain Canal (downgradient from the site) and a former channel of the Mohawk River at its confluence with the Hudson River, all of which were visible in the 1952 photographs. Much of the former Mohawk River channel and the abandoned canals were likely filled in during construction of I-787 and Route 7. The majority of the bedrock fracture traces observed in the aerial photographs and topographic maps were found to be in the uplands west of the site.

The area between the uplands and the site had been too disturbed by previous construction activities to be able to detect natural linear features. The major fracture trend derived from the photograph analysis is oriented NW-SE, with a secondary orientation of N-S. There is an additional, minor fracture set that is oriented SW-NE.

A site visit was made on March 11, 2014 to inspect bedrock outcrops in the area and measure orientations of bedrock fractures and bedding planes. Snow cover in the area was extensive and likely obscured many of the available outcrops west of the site. Outcrops were found along the D&H railroad about a mile north of the site and in the ditch along the northern edge of the site. Bedding could not be discerned from foliation and cleavage at these outcrops and to do so would require a more intensive study. The bedrock at both locations is described as being part of the Waterford Flysch Zone of the Cohoes Melange by Plesch (1994) and Kidd et al (1995). This type of bedrock is extremely fissile shale and siltstone with slaty to phacoidal cleavage. The result of this is that there are several planes of weakness along which the rock tends to split or fracture. The strike, or trend, of these planes was measured consistently to be oriented in the SW-NE direction (Figure 2), specifically N40°E. The dip of the planar fabric averaged approximately 68° toward the southeast. The angle of dip varied greatly within each of the outcrops but was consistently eastward. This is consistent with the bedding or cleavage plane dips measured by Plesch (1994) at outcrops west of the site (Figure 2).

site (noted in blue on Figure 2). The path of this stream cuts diagonally through the present location of the Troy Belting and Supply building (Figure 3). The former position of stream is also indicated on a 1928 USGS topographic map of the site (Figure 4). This stream has since been rerouted around the building and much of its upstream reach is now conveyed by underground piping. The location of the backfilled stream may still present a preferential pathway for shallow ground water flow at the site.

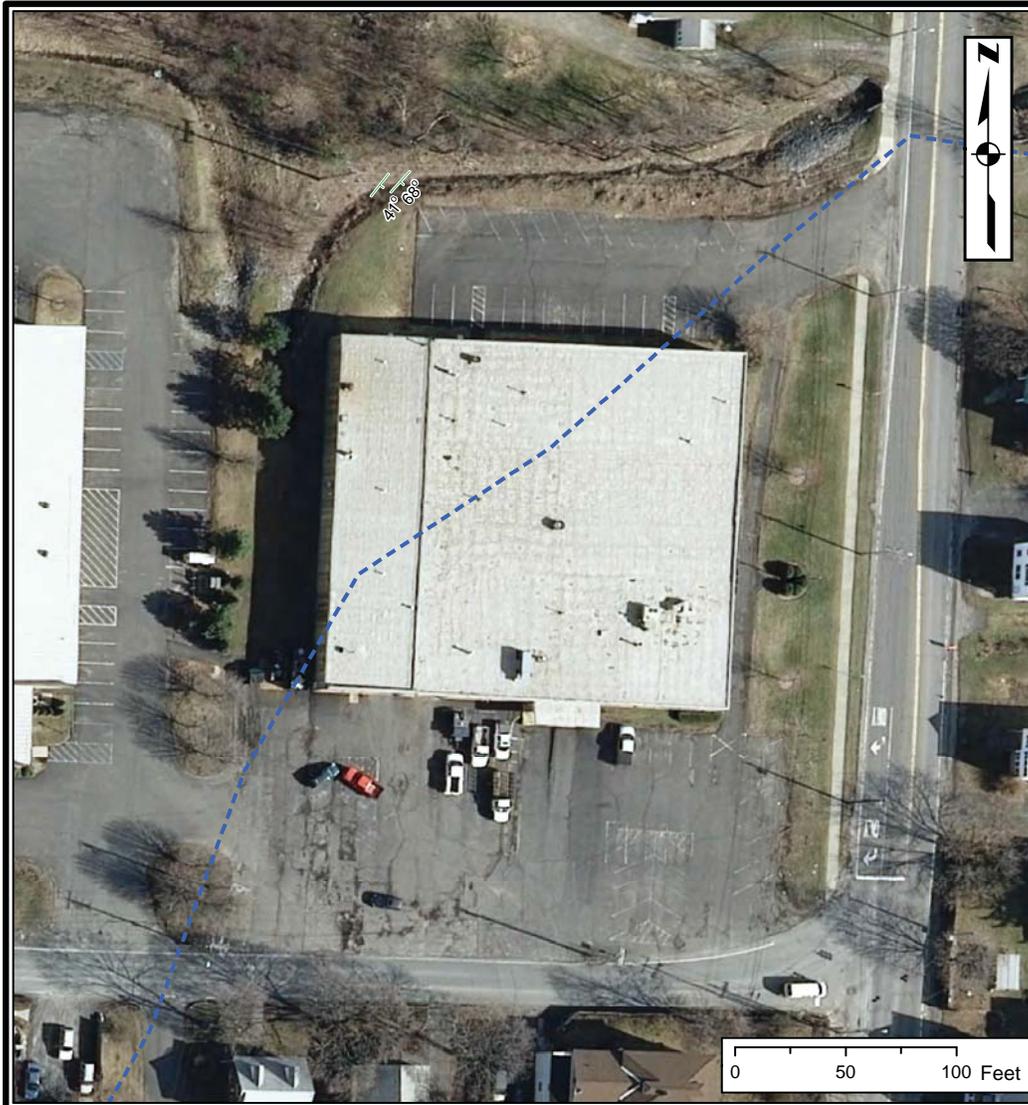
FIGURE 3
Troy Belting Site
 Troy Belting Fracture Trace Analysis
 Town of Colonie
 Albany County, New York

- Approximate Stream Location From 1952 Aerial Imagery
- Strike & Dip Measurement
- | Alpha, 3/11/2014
