RE: Alternatives Analysis Report & Decision Document
Highland Plaza BCP Site, Site No. C915293
Tonawanda, Erie County

DECISION DOCUMENT

Highland Plaza
Brownfield Cleanup Program
Tonawanda (T), Erie County
Site No. C915293
December 2017

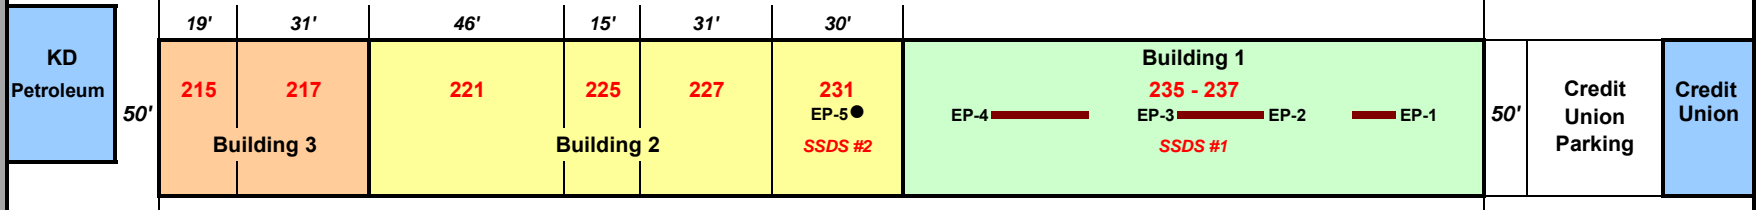
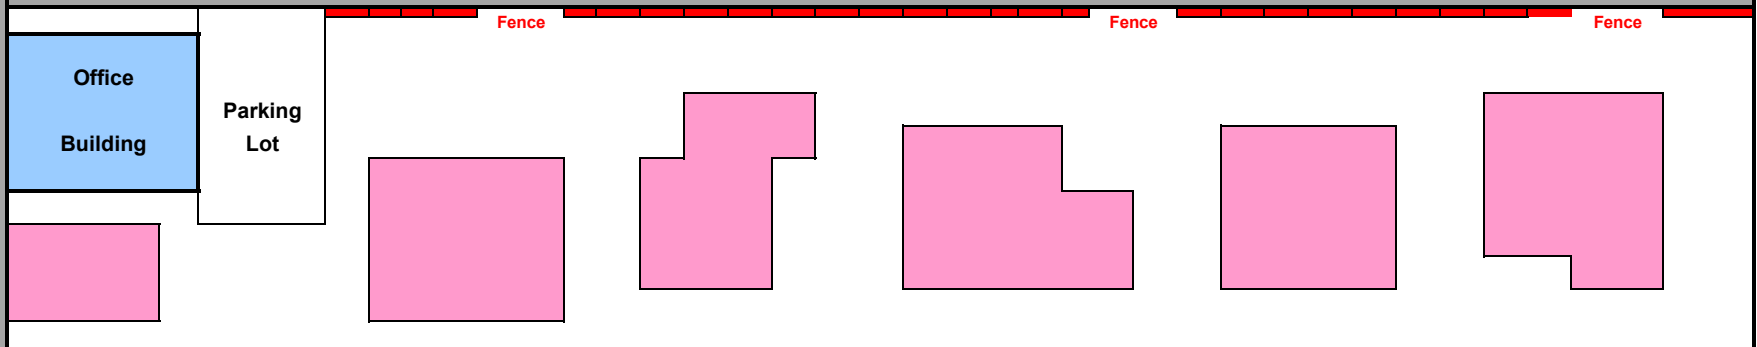
- Building 1
- Building 2
- Building 3
- 215, 217.....231 Tenant Space Address
- Residence
- Commercial Building

- SSDS with separate blowers
- EP Blower/Fan Location

2. Vapor Mitigation: Continued operation and optimization of the sub-slab depressurization systems to prevent the migration of sub-slab soil vapor into Buildings 1 and 2.

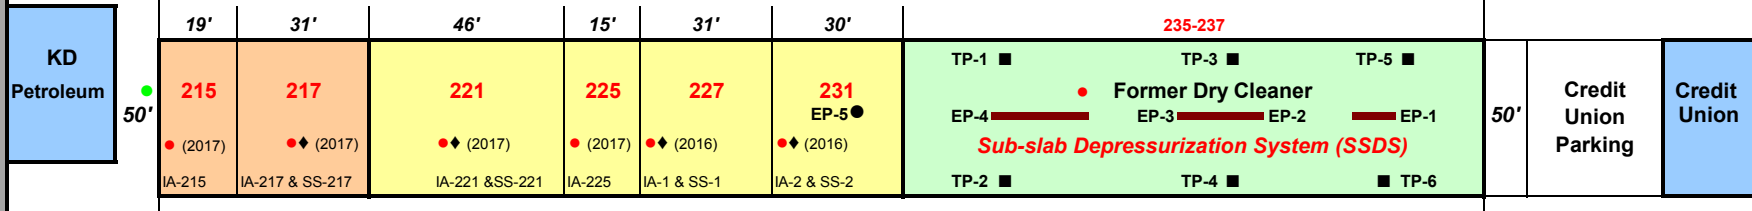
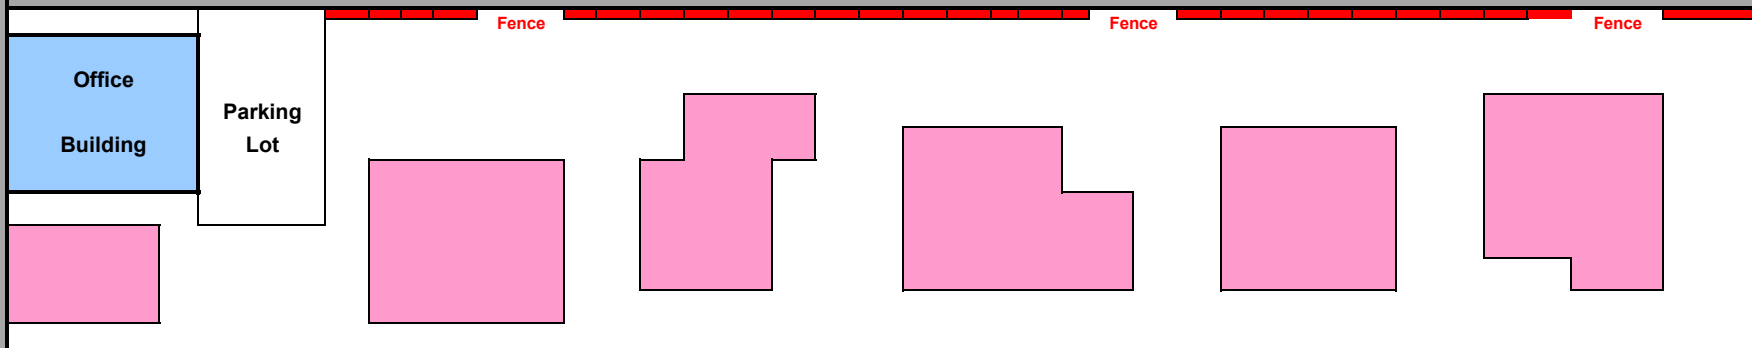
Figure 3. SVI Sampling Points for the 2016 & 2017 Investigations Highland Plaza Tonawanda, New York
Not to Scale

- Building 1
- Building 2
- Building 3
- Residence
- Commercial Building
- Outdoor Air Sample Location (Estimated)
- Indoor Air Sampling Locations
- Sub-slab Sampling Locations
- Background Air Sampling Location
- Pressure Test Point
- SSDS with separate blowers
- EP Blower/Fan Location
