**HIGHLAND PLAZA  
BROWNFIELD SITE # C915293**

**215 to 237 HIGHLAND PARKWAY  
TONAWANDA, NEW YORK**

**REMEDIAL INVESTIGATION**

**FINAL REPORT**

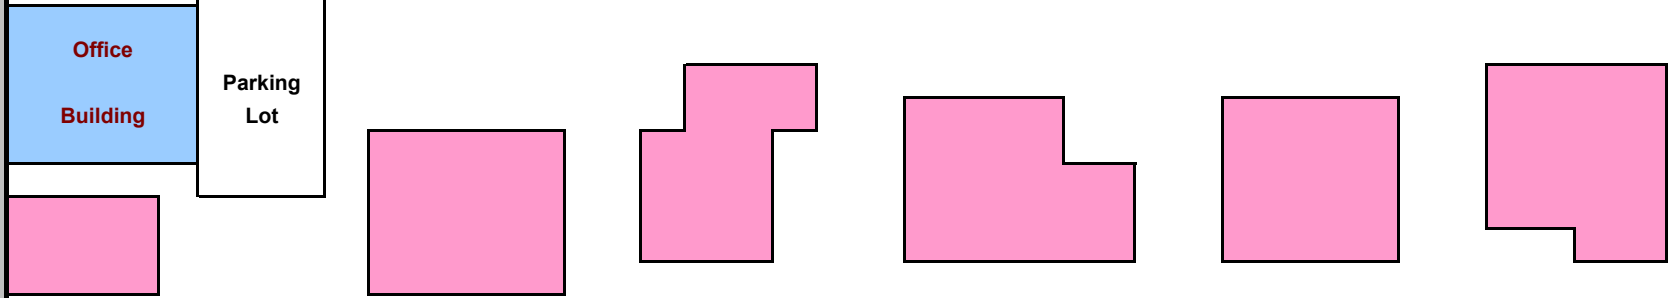
- Building 1
- Building 2
- Building 3
- Residence
- Commercial Building
- Outdoor Air Sample Location (Estimated)
- Indoor Air Sampling Locations
- Sub-slab Sampling Locations
- Background Air Sampling Location
- Pressure Test Point
- SSDS with separate blowers
