Division of Environmental Remediation

**Phase I
Remedial Investigation
Scope of Work**

**Highland Plaza Off-Site Area
Tonawanda, Erie County, New York
Site Number C915293A**

April 2017

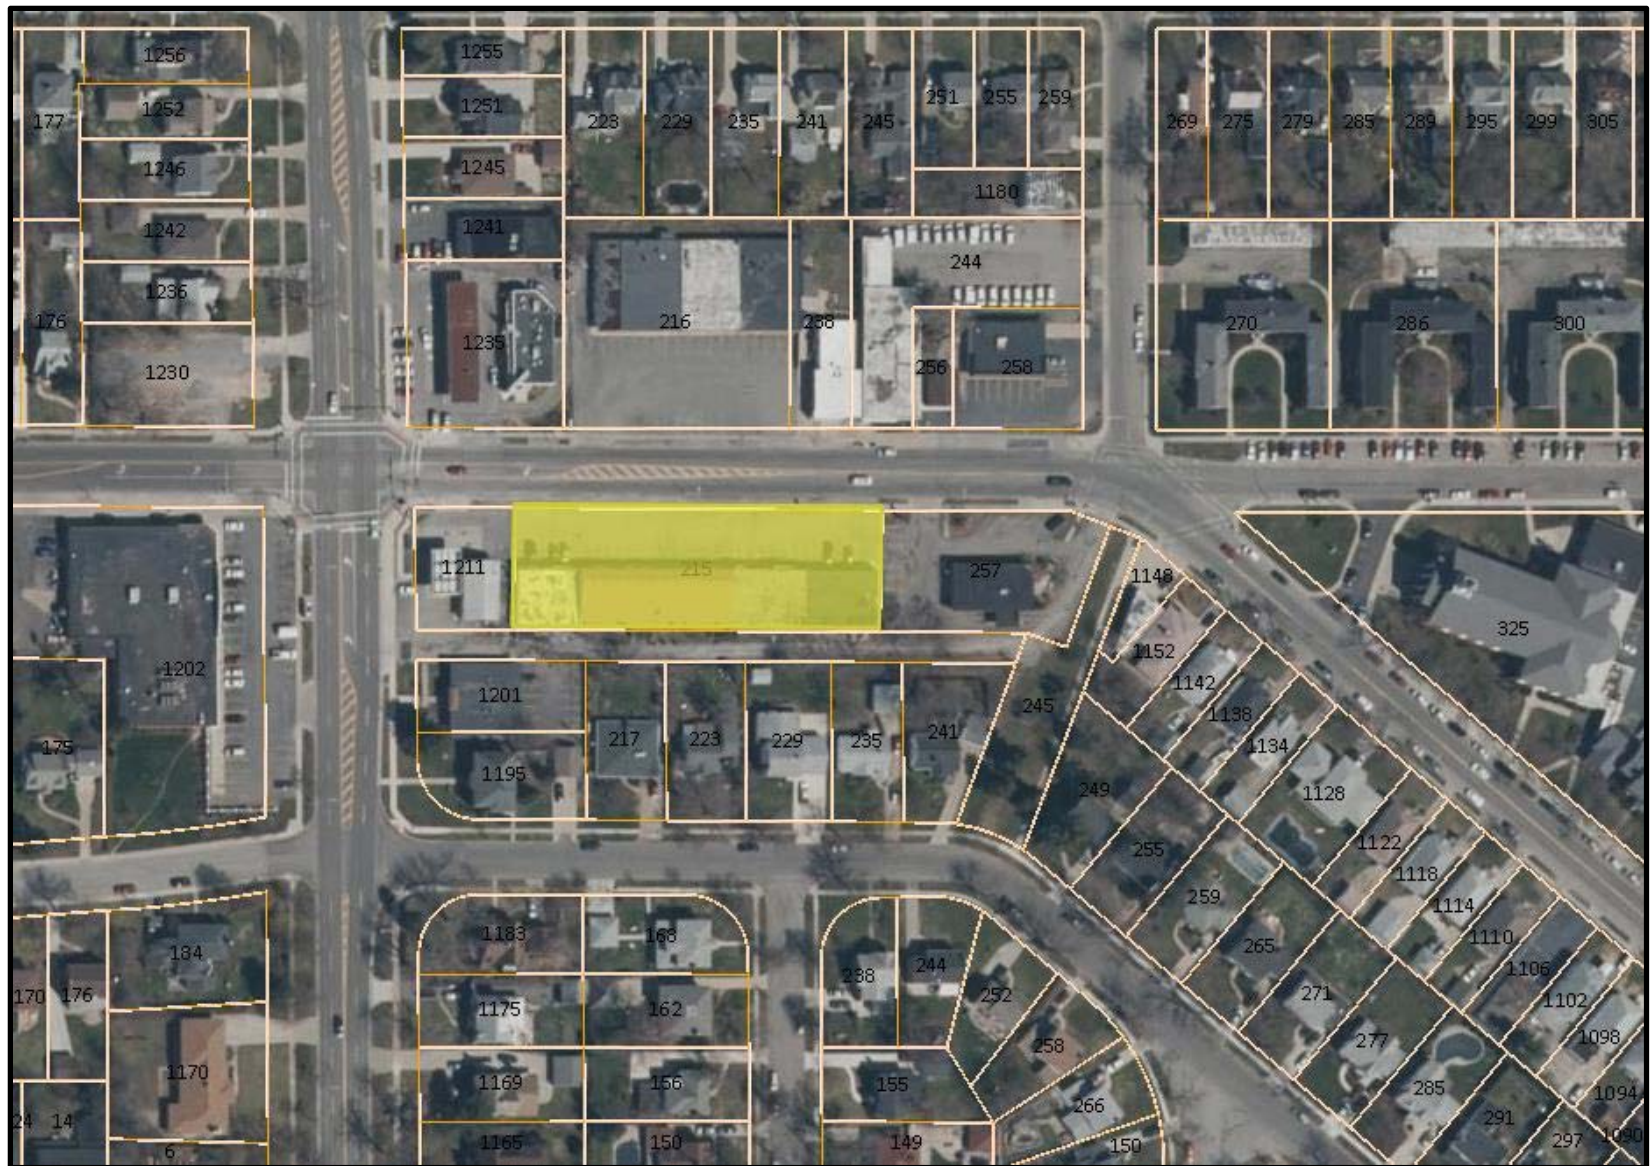
Figure 2. Highland Plaza BCP Site with Surrounding Properties.

A surveyor licensed in the State of New York will complete a site survey that includes: (1) property boundaries; (2) site features such as buildings, fences, parking lots, sidewalks, etc.; (3) locations of shallow soil and fill samples collected from the alleyway during the Remedial Investigation of the Highland Plaza BCP Site; (4) locations of all soil borings and monitoring wells completed during the Remedial Investigation of the Highland Plaza BCP Site; and (5) utilities on and immediately adjacent to the alleyway. The boundaries of the site extend from Highland Parkway to the north, Colvin Boulevard to the west, Grimsby Road to the south, and the eastern boundary of the 245 Grimsby Road property to the east (Figure 2).

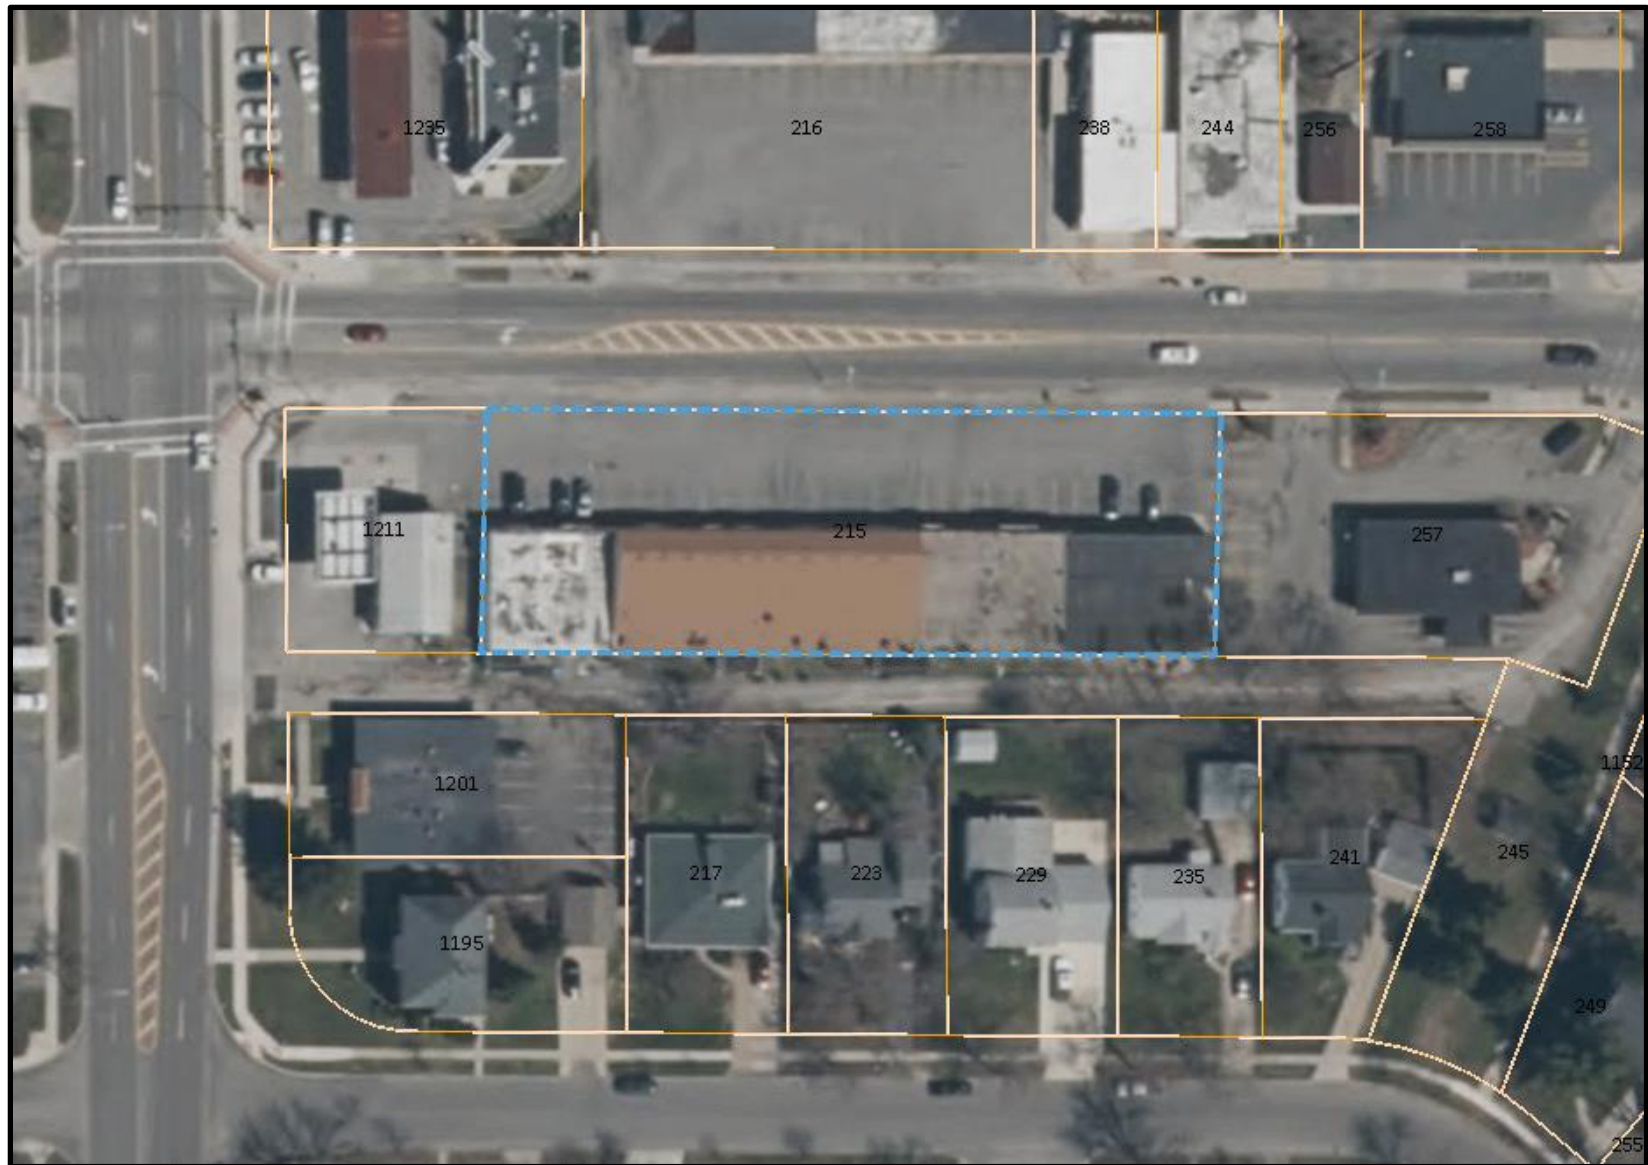
Figure 3. Detailed map of the Highland Plaza BCP Site showing site features. Note the service road behind the plaza.

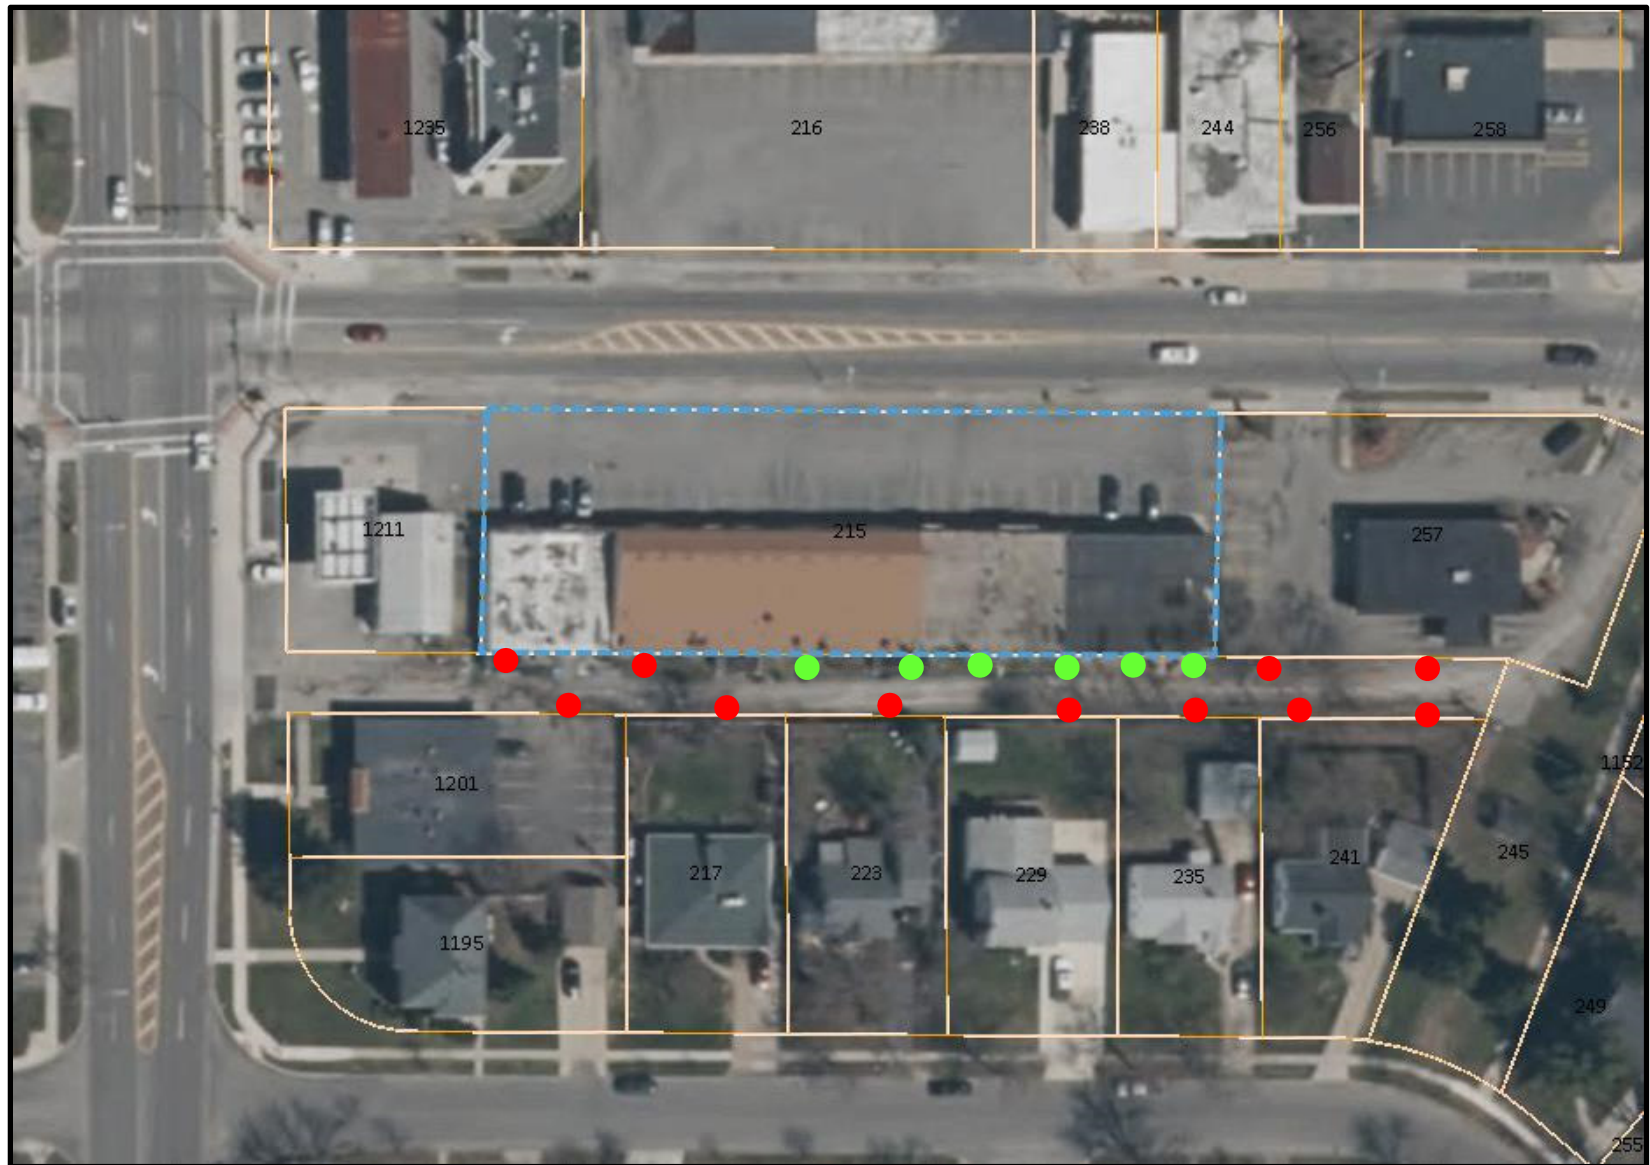
Figure 7. Proposed surface soil sample location map. Green dots are the approximate locations of the samples to be collected from soils placed behind Highland Plaza during construction of the sub-slab depressurization system in the former dry cleaner tenant space.

Seventeen (17) surface soil (0" to 2" depth) samples will be collected from throughout the service alleyway during the Phase I Remedial Investigation to evaluate potential direct contact exposures. Six (6) of these samples will be collected from soil placed behind the plaza to level the ground surface and to inhibit surface water infiltration into the building from the alleyway. This soil originated from under the floor slab of the former dry cleaner tenant space when a sub-slab depressurization system was installed. The approximate locations of these samples are shown on Figure 7. The surface soil samples will be collected from 0" to 2" depth following the removal of the vegetative cover, if present.

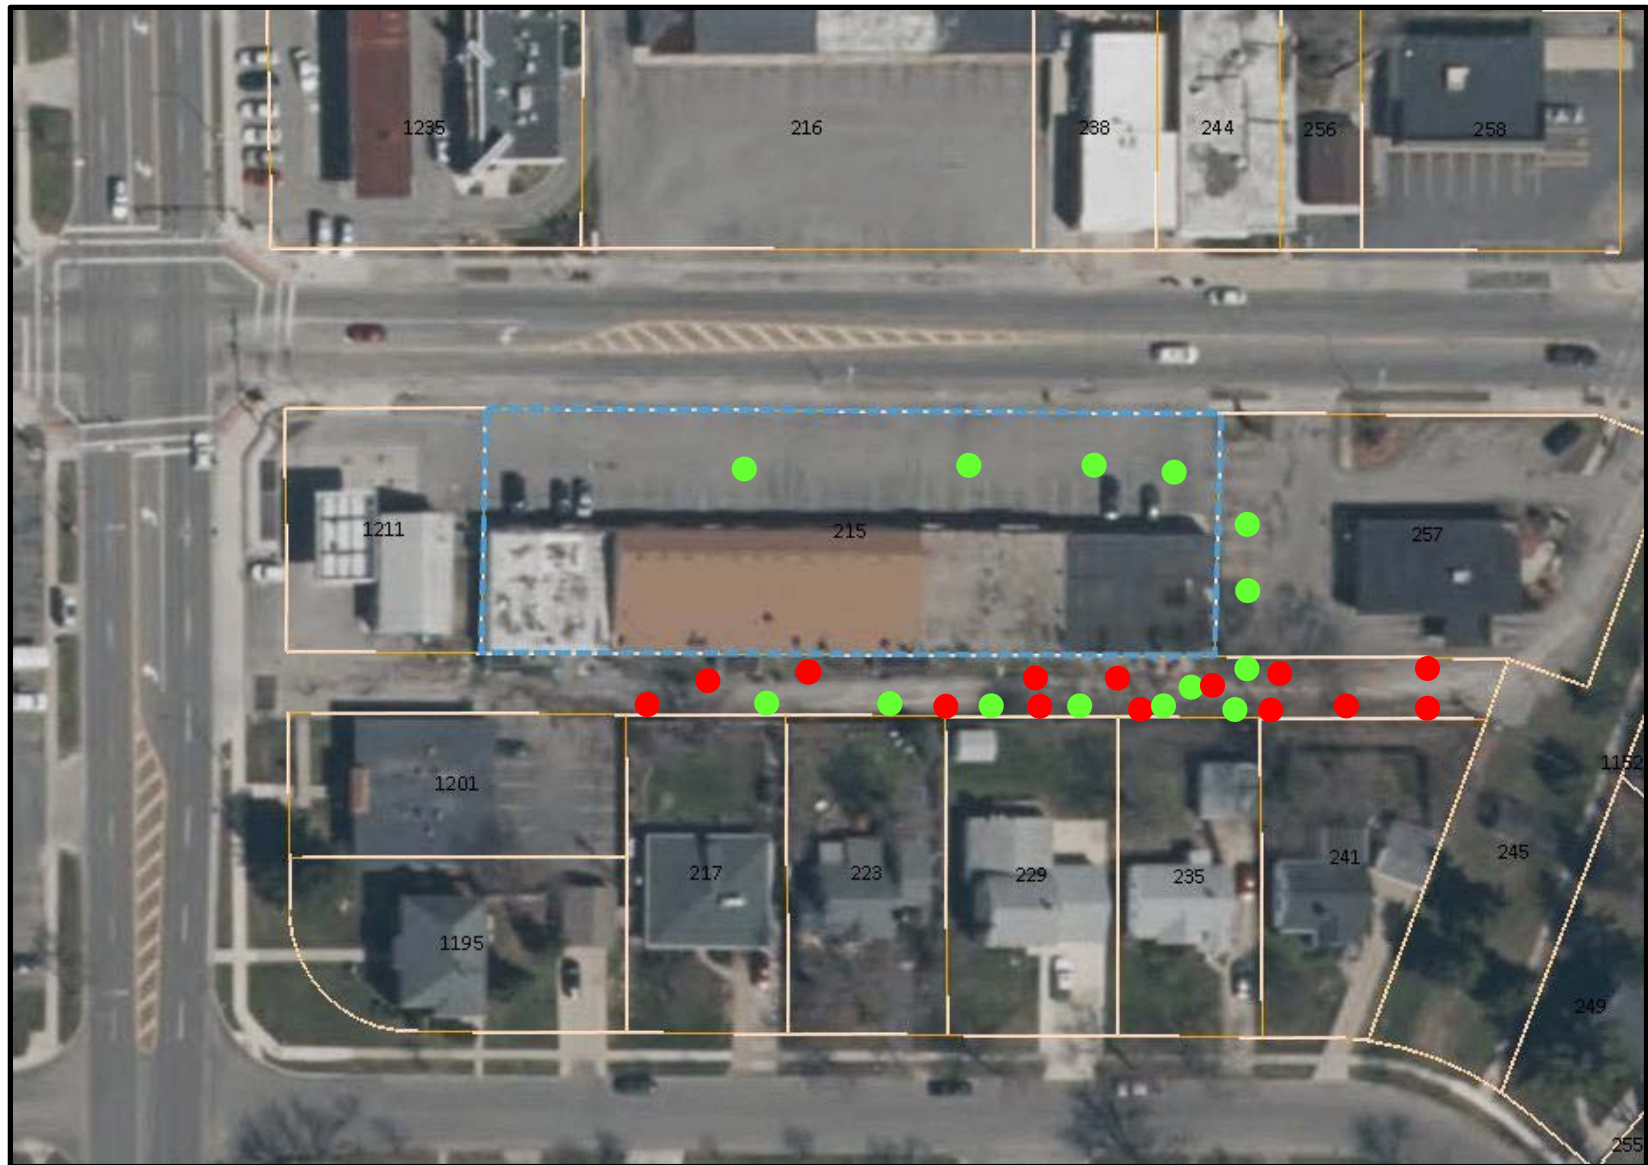
Figure 8. Proposed soil boring (red dots) location map. Green dots are the approximate locations of the soil borings completed during the Remedial Investigation of the Highland Plaza BCP Site.

One of the objectives of the Phase I Remedial Investigation, therefore, is to better delineate the extent of contamination, especially from chlorinated VOCs, in the service alleyway. To accomplish this objective, fourteen (14) soil borings will be completed throughout the alleyway at the approximate locations shown on Figure 8.

The direct-push technique is the most cost and time effective method of completing the soil borings shown on Figure 8. Based upon the subsurface conditions encountered, alternative drilling and sampling methods may be required. Either a truck or track mounted direct-push vehicle can be used for the Phase I Remedial Investigation.

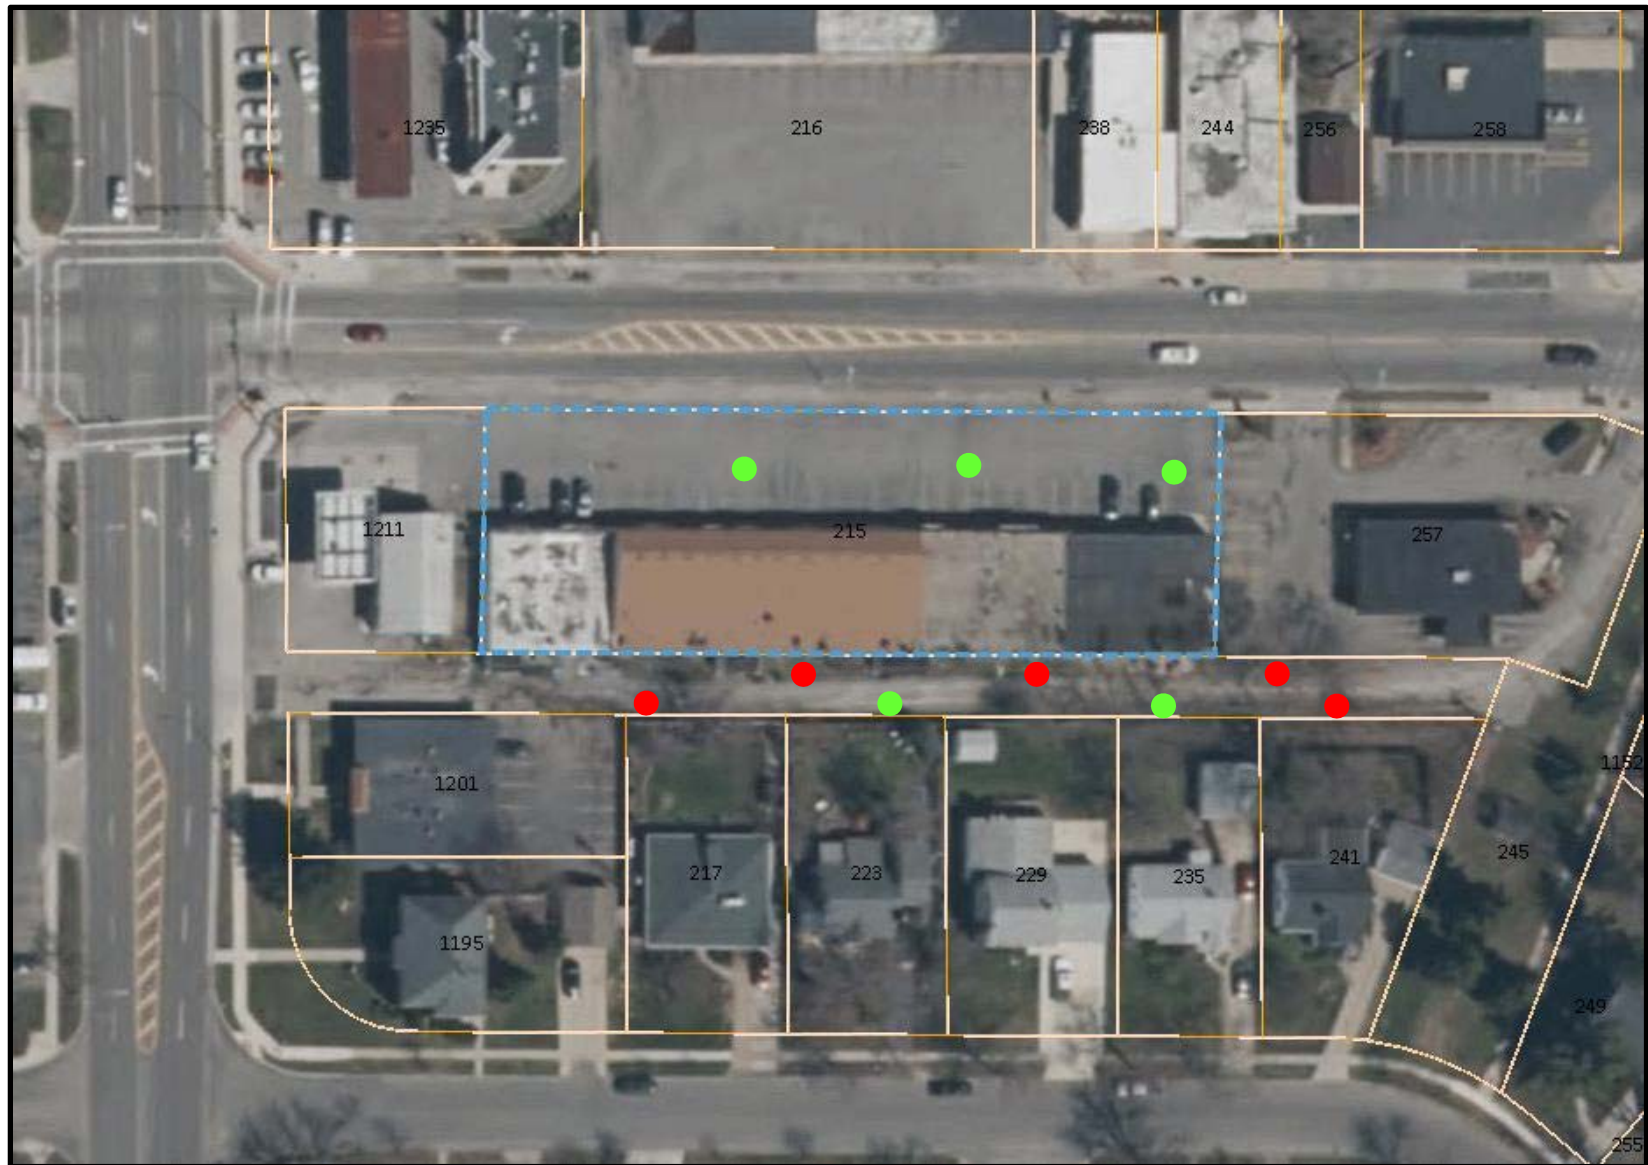
Figure 9. Proposed monitoring well (red dots) location map. Green dots are the approximate locations of the monitoring wells completed during the Remedial Investigation of the Highland Plaza BCP Site.

Five (5) overburden monitoring wells have been installed at the Highland Plaza BCP Site and Highland Plaza Off-Site Area (Figures 5 and 9), and monitor the reddish brown silty clay deposit (Table 7). One of the objectives of the Remedial Investigation is to complete a comprehensive hydrogeologic evaluation of the site to determine the full impact of the site on groundwater quality. To partially accomplish this objective, five (5) overburden monitoring wells will be installed during the Phase I Remedial Investigation at the approximate locations shown on Figure 9 to expand the existing monitoring well network at the site. The monitoring wells to be installed are distributed as follows:
