**SITE MANAGEMENT PLAN  
1 - 15 BUFFALO STREET  
HAMBURG, NEW YORK**

GZA GeoEnvironmental of New York  
Buffalo, New York

February 2006  
File No: 21.0055727.10

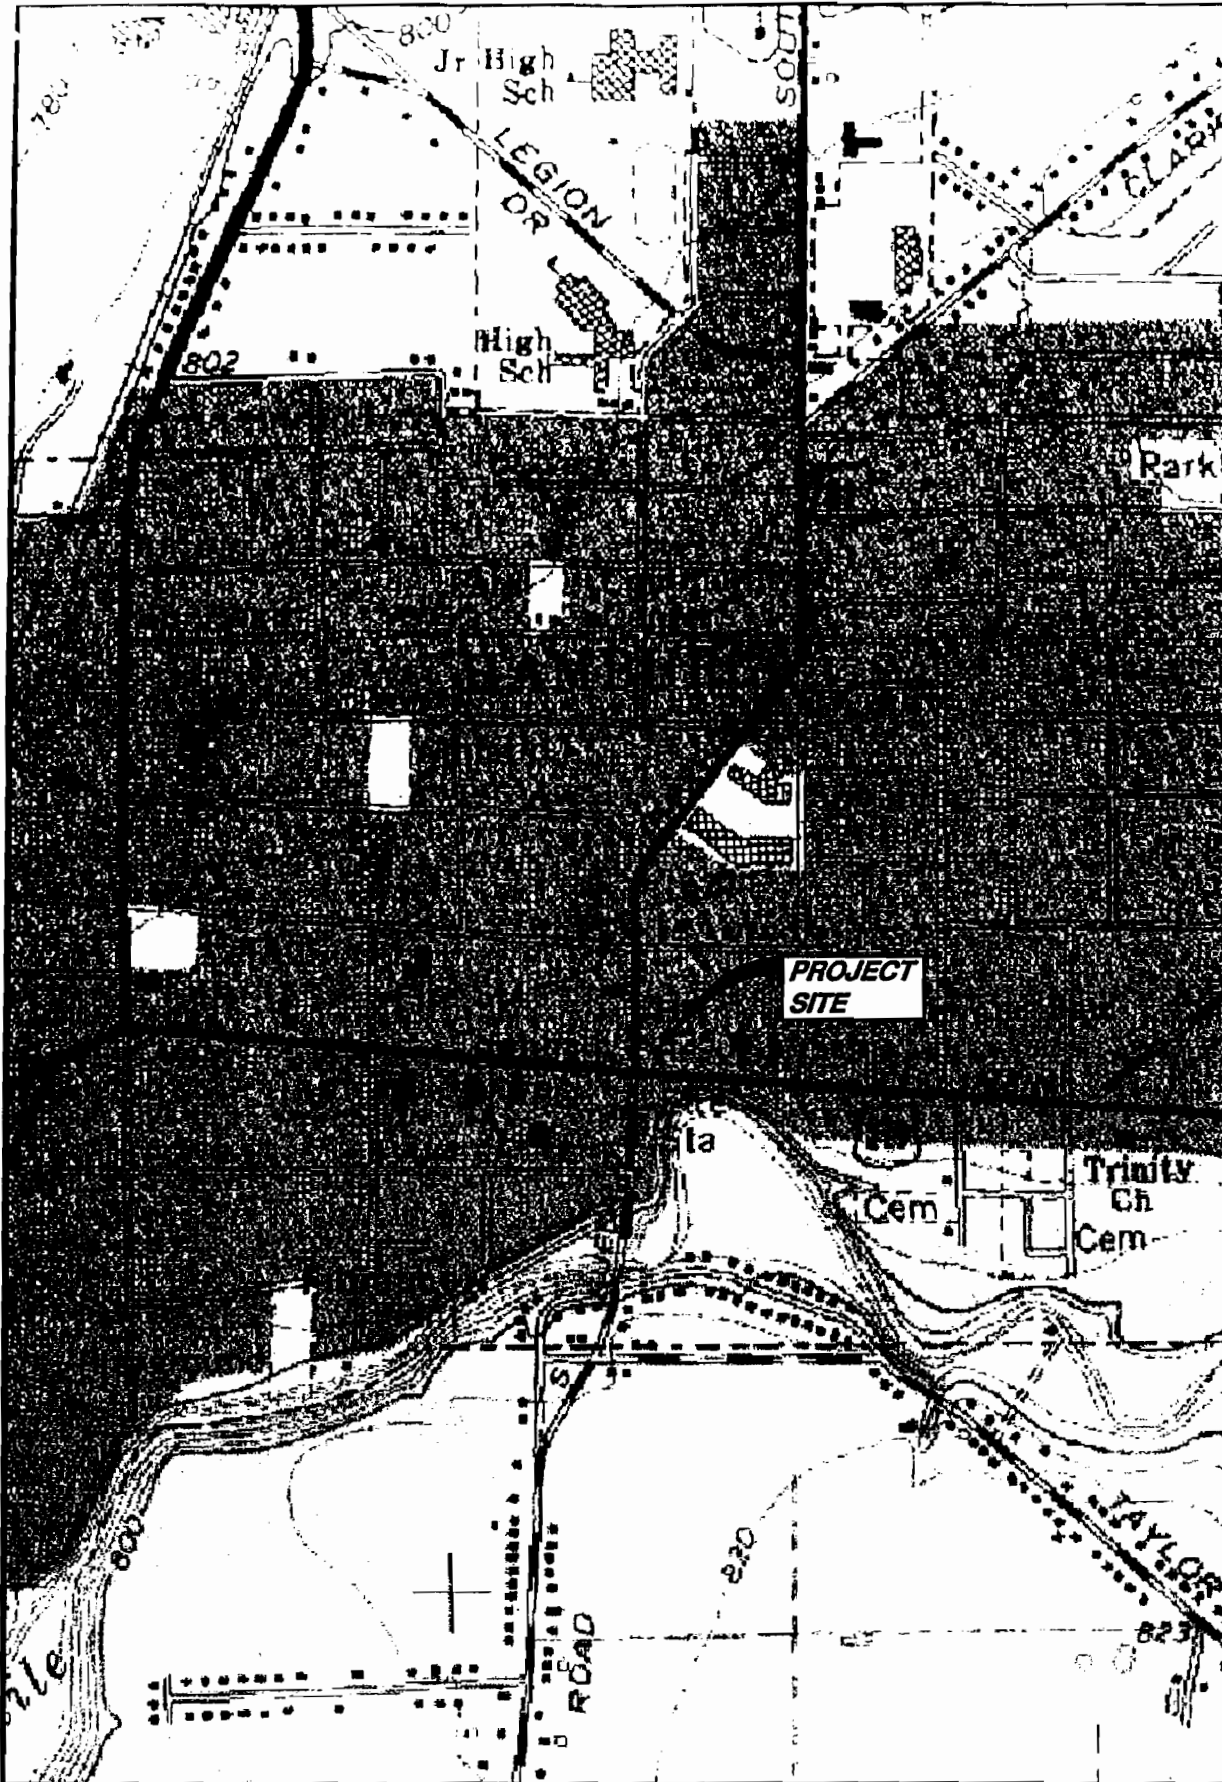
**LOCUS PLAN**

BASE MAP ADAPTED FROM U.S.G.S.  
TOPOGRAPHIC MAPS DOWNLOADED  
FROM TERRASERVER.MICROSOFT.COM

FIGURE 1           LOCUS PLAN

The Site is an approximate 0.6-acre commercial retail property, currently owned by the Estate of Anthony Ilardo, located at 1 to 15 Buffalo Street in Hamburg, New York. The location of the property is shown on Figure 1. Site conditions have been characterized during several previous investigations, which are identified below.
