**Final Engineering Report**  
**Buffalo Business Park**  
**Voluntary Clean Up Program**

Buffalo Business Park  
1800 Broadway Avenue  
Buffalo, New York

American Consulting Professionals of New York, PLLC

**REVISED: February 20, 2011**

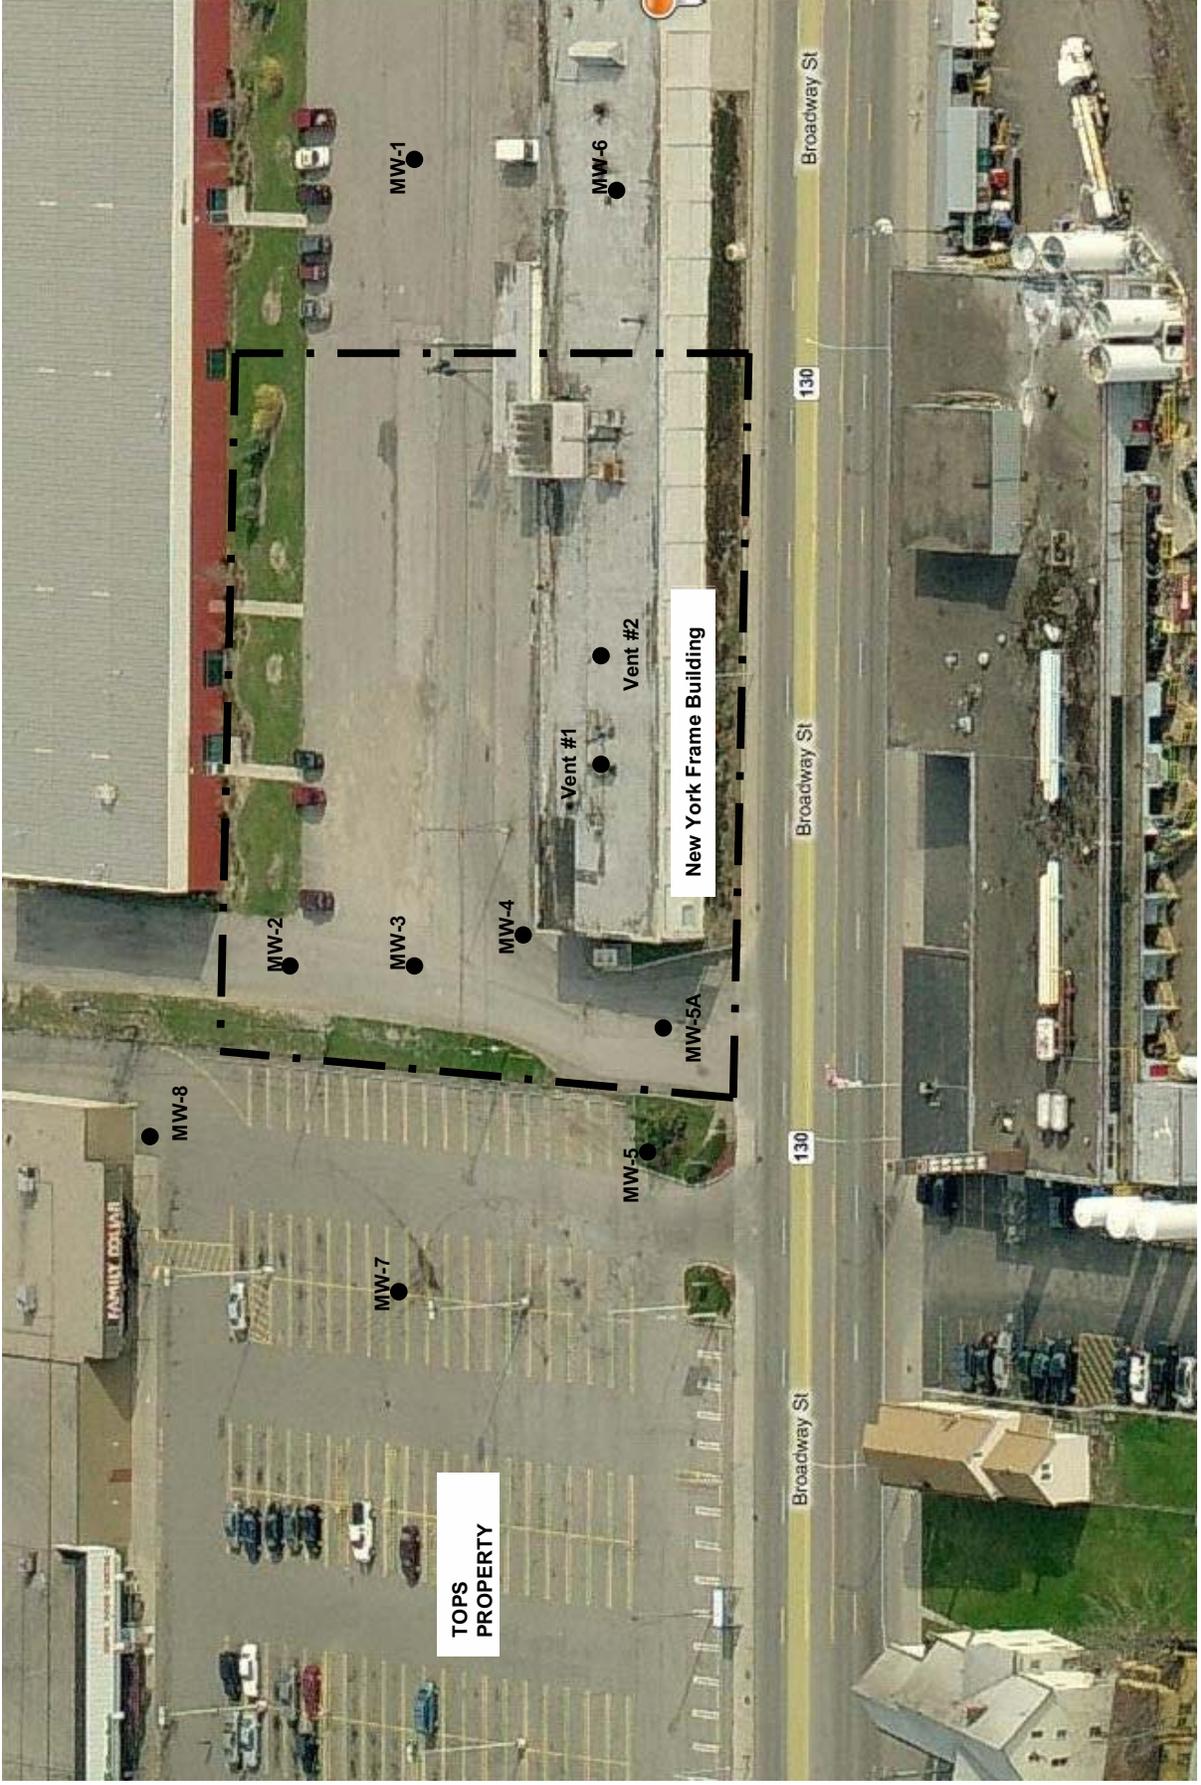
Figure 2B- Aerial Photograph of Area Subject to SMP and Deed  
Restriction

● MW-7 Well/ Building Vent

--- Limits On-Site OU#2
