**New York State Department of Environmental Conservation
Waste Tire Stockpile Assessment Summary Sheet - Site 1-01**

**New York Tire/Izzo Property
Town of Smithtown**

Region 1, Suffolk County

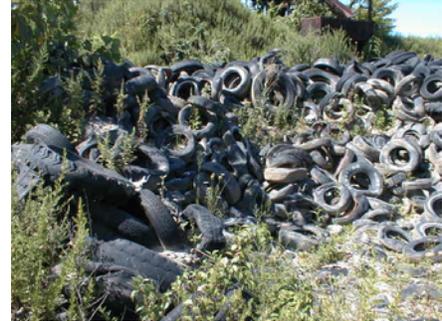
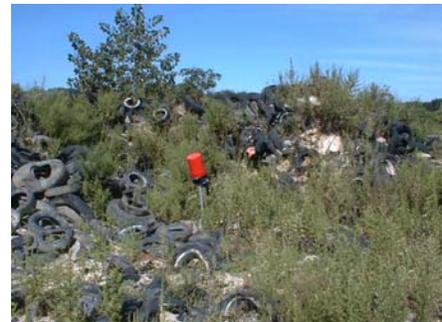
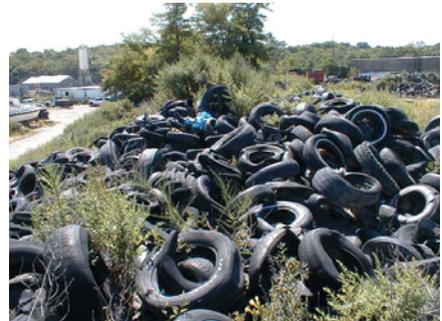
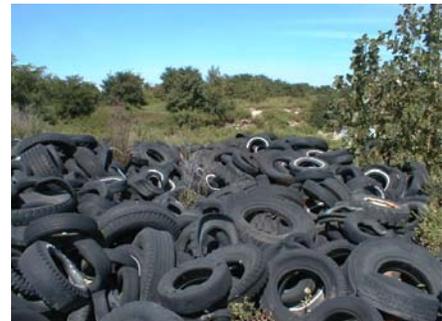
Surrounded by scrubby vegetation, the site consists of one large pile of tires and several smaller non contiguous piles.

Number of tires: 500,000 estimated whole tires are on this site. A separate pit of depth varying from 10-35 feet is filled with shredded tires. This pit is estimated to contain an additional 1.5 million shredded tires. Total of 2 million tire equivalents estimated.

Mix of old, dirty tires covered with vegetation and clean, exposed tires.

There is direct access to an improved road. Fire breaks were created but have since become overgrown. Some tires border the edge of a large pit and have fallen in. They will be difficult to remove.

Proximity to light industry and human activity. Fire and Vectors
