**New York State Department of Environmental Conservation
Waste Tire Stockpile Assessment Summary Sheet - Site 5-01**

Mohawk Tire Towns of Waterford & Halfmoon

Region 5, Saratoga County

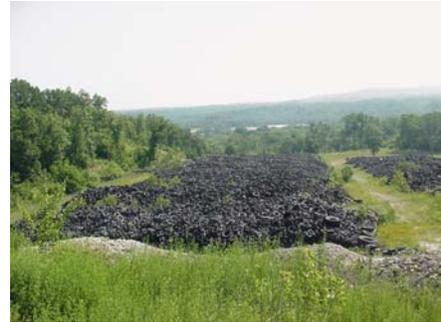
**Site Setup: Divided into 2 sections
one section has burned tires and chips
other section piles of tires**

**Number of piles: 19 on main section, whole tires,
3 on lower section, chipped and burned,
mixed with other waste and debris**

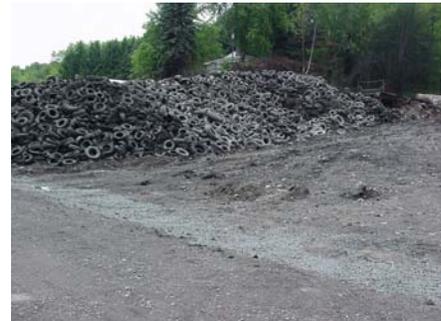
**Separation of tire piles: lanes between each one,
approx. 40-50 ft. wide**

**Dimensions of tire piles: 19 piles are relatively
uniform, 54 X 200 X 25**

Number of tires: 8,000,000 estimated

Condition of Tires:

Majority are whole tires

Some are chipped or cut out of sidewalls

Few with rims still in (< 5%)

Few OTR tires

Dirt and concrete mixed in with some piles

Some piles have weeds growing on top
