**New York State Department of Environmental Conservation
Waste Tire Stockpile Assessment Summary Sheet - Site 5-07**

**Shanahan Scrap
Town of Ticonderoga**

Region 5, Essex County

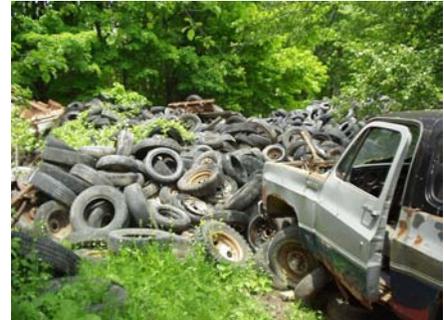
Scrap yard located behind a wooden fence very close to the north edge of the road. Majority of tires located in a pile approximately 100' behind the building. Site is in a very rural setting.

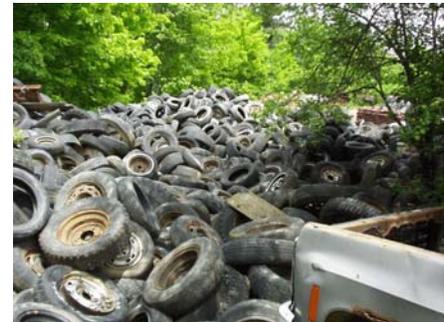
**Smallest pile 10'W X 18'L X 4'H
Largest pile 66'W X 73'L X 5'H**

Mix of car and larger truck tires. Some tire piles co-mingled with debris.

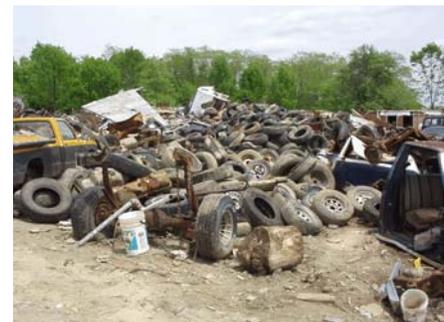
Fence with two open gates. One small tire pile is right on the shoulder of the road outside the gate. Some piles inaccessible due to location amongst piles of debris. Firefighting access to the largest pile behind the building is questionable.
