New York State Department of Environmental Conservation
Waste Tire Stockpile Assessment Summary Sheet - Site 5-15

U Save Tire Town of Plattsburgh

Region 5, Clinton County

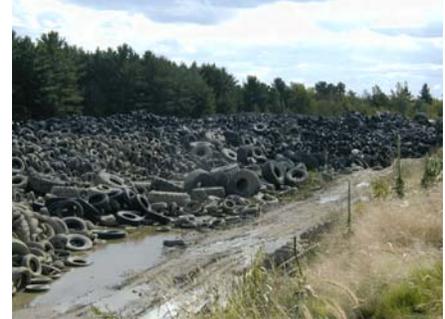
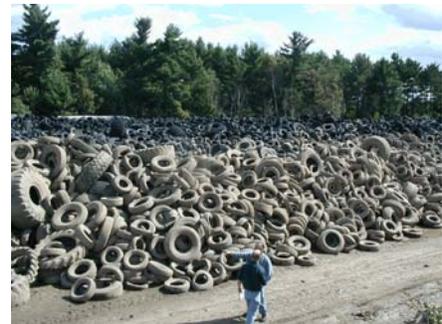
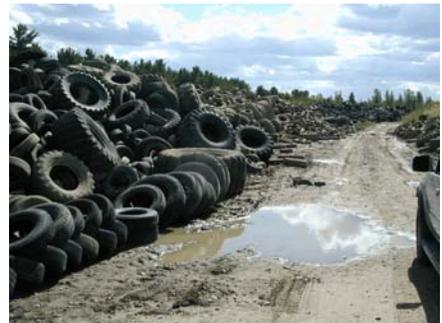
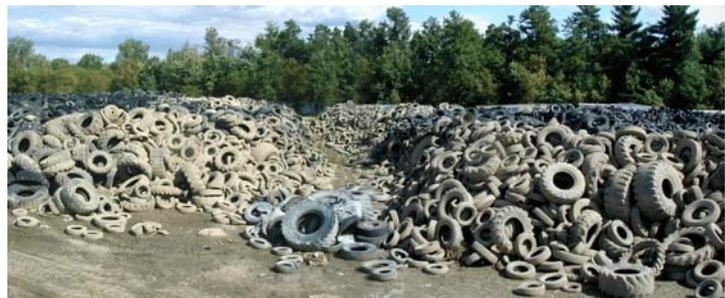
Site Setup: Site consists of one tire pile at the rear of the property. Tire pile is accessible via dirt road. House trailers located nearby with some junk cars in a clearing near the tire pile.

Separation of tire piles: Single tire pile with a separation of 12 feet through the middle. The separation is not sufficient to prevent fire spread nor provide apparatus access.

Condition of Tires: Majority off rims. Approx. 70% passenger/light truck- 30% large tractor/OTR. Dirty on outside.

Access: The tire pile is located approximately 1/4 mile from the main road with access through a 15' wide dirt road. Road has potholes.

Concerns: Fire, vectors.
Property located 1/4 mile from school.

Additional Information:
Permit allows up to 52,000 tires. Regional Office met with the facility's attorney to discuss removal of tires.
