**New York State Department of Environmental Conservation  
Waste Tire Stockpile Assessment Summary Sheet - Site 5-17**

**John Post Property  
Town of Galway**

**Region 5, Saratoga County**

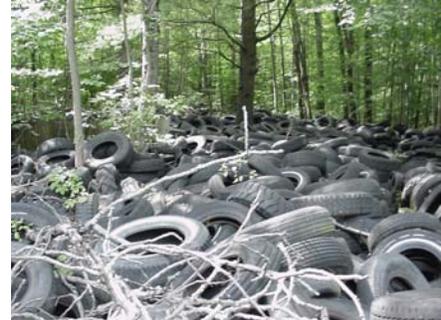
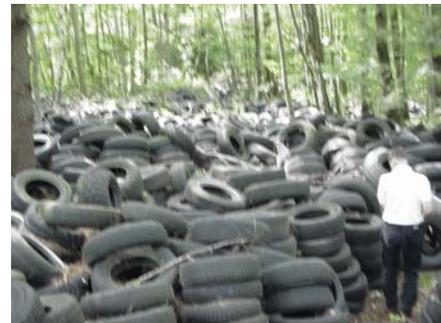
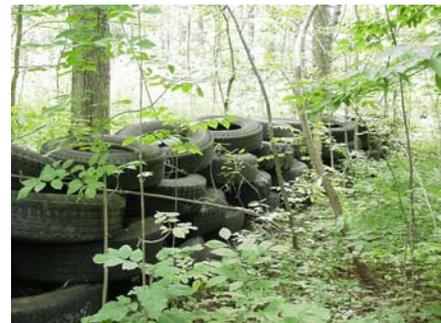
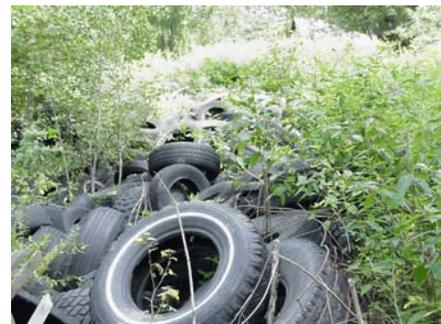
**Site of a tire dump behind the burned down residence. Tires are spread in a non-uniform continuous manner under trees - not one solid pile. Narrow walking path between tires. Tires stacked to mark path. Over grown brush all around. Majority of tires in woods.**

**Some tires on rims. All tires appears to be above grade. Many tires filled with water.**
