**New York State Department of Environmental Conservation
Waste Tire Stockpile Assessment Summary Sheet - Site 6-12**

**White's Lisbon Iron & Metal
Town of Lisbon**

Region 6, St. Lawrence County

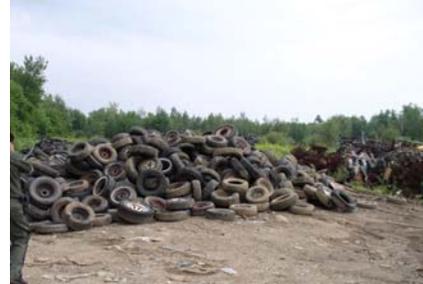
Formerly Whites Iron & Metal.

The site was an active junkyard until recently.

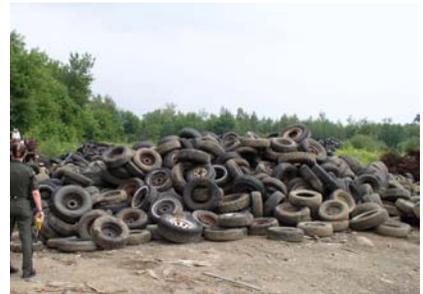
Poor condition. Most of the tires remain on the rims and are dirty. Several of the piles are contaminated with other scrap and debris.
